National Register of Historic Places Registration Form

historic name Gilkerson, William and Agnes, Farm

state Vermont code VT county Caledonia code 005 zip code 05861

Gilkerson, William and Agnes, Farm
Barnet, Caledonia Co., Vermont

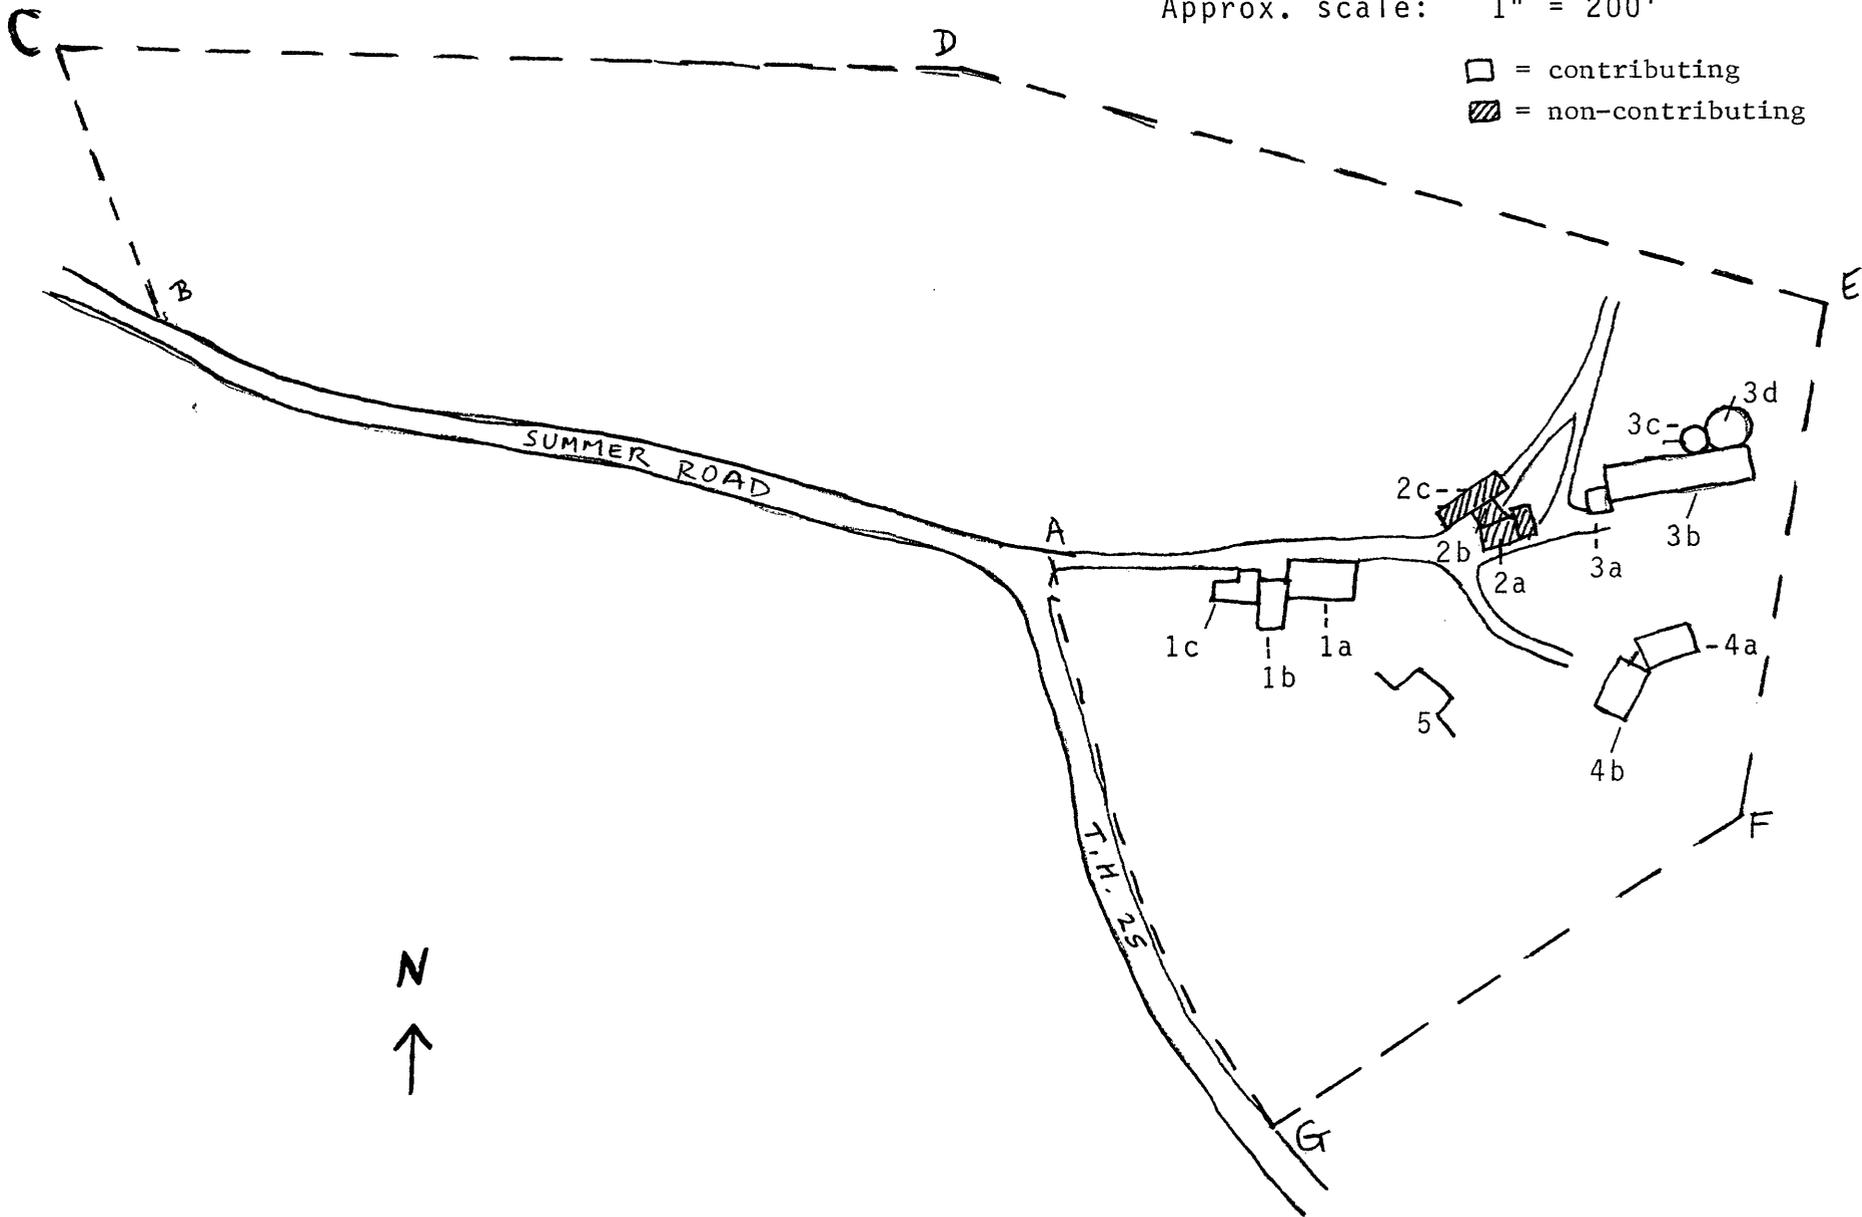
Approx. scale: 1" = 200'

- = contributing
- ▨ = non-contributing
