National Register of Historic Places  
Registration Form

historic name Arter, Philip & Uriah, Farm  
other names CARR-1666

CARR-1666  
Arter, Philip & Uriah, Farm

## Description Summary:

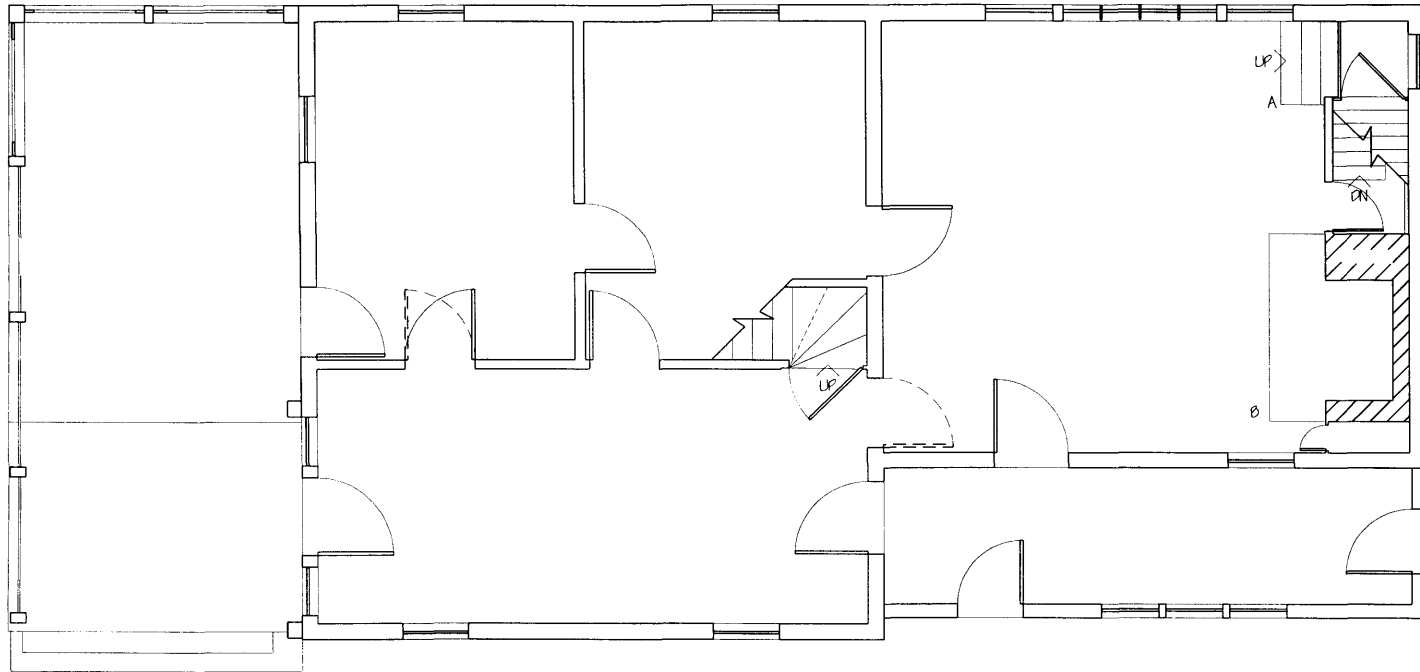
- A STEPS REBUILT AND BLOKED OFF
- B NEW TILE HEARTH
