1) Wheeling Custom House

2) Wheeling, West Virginia

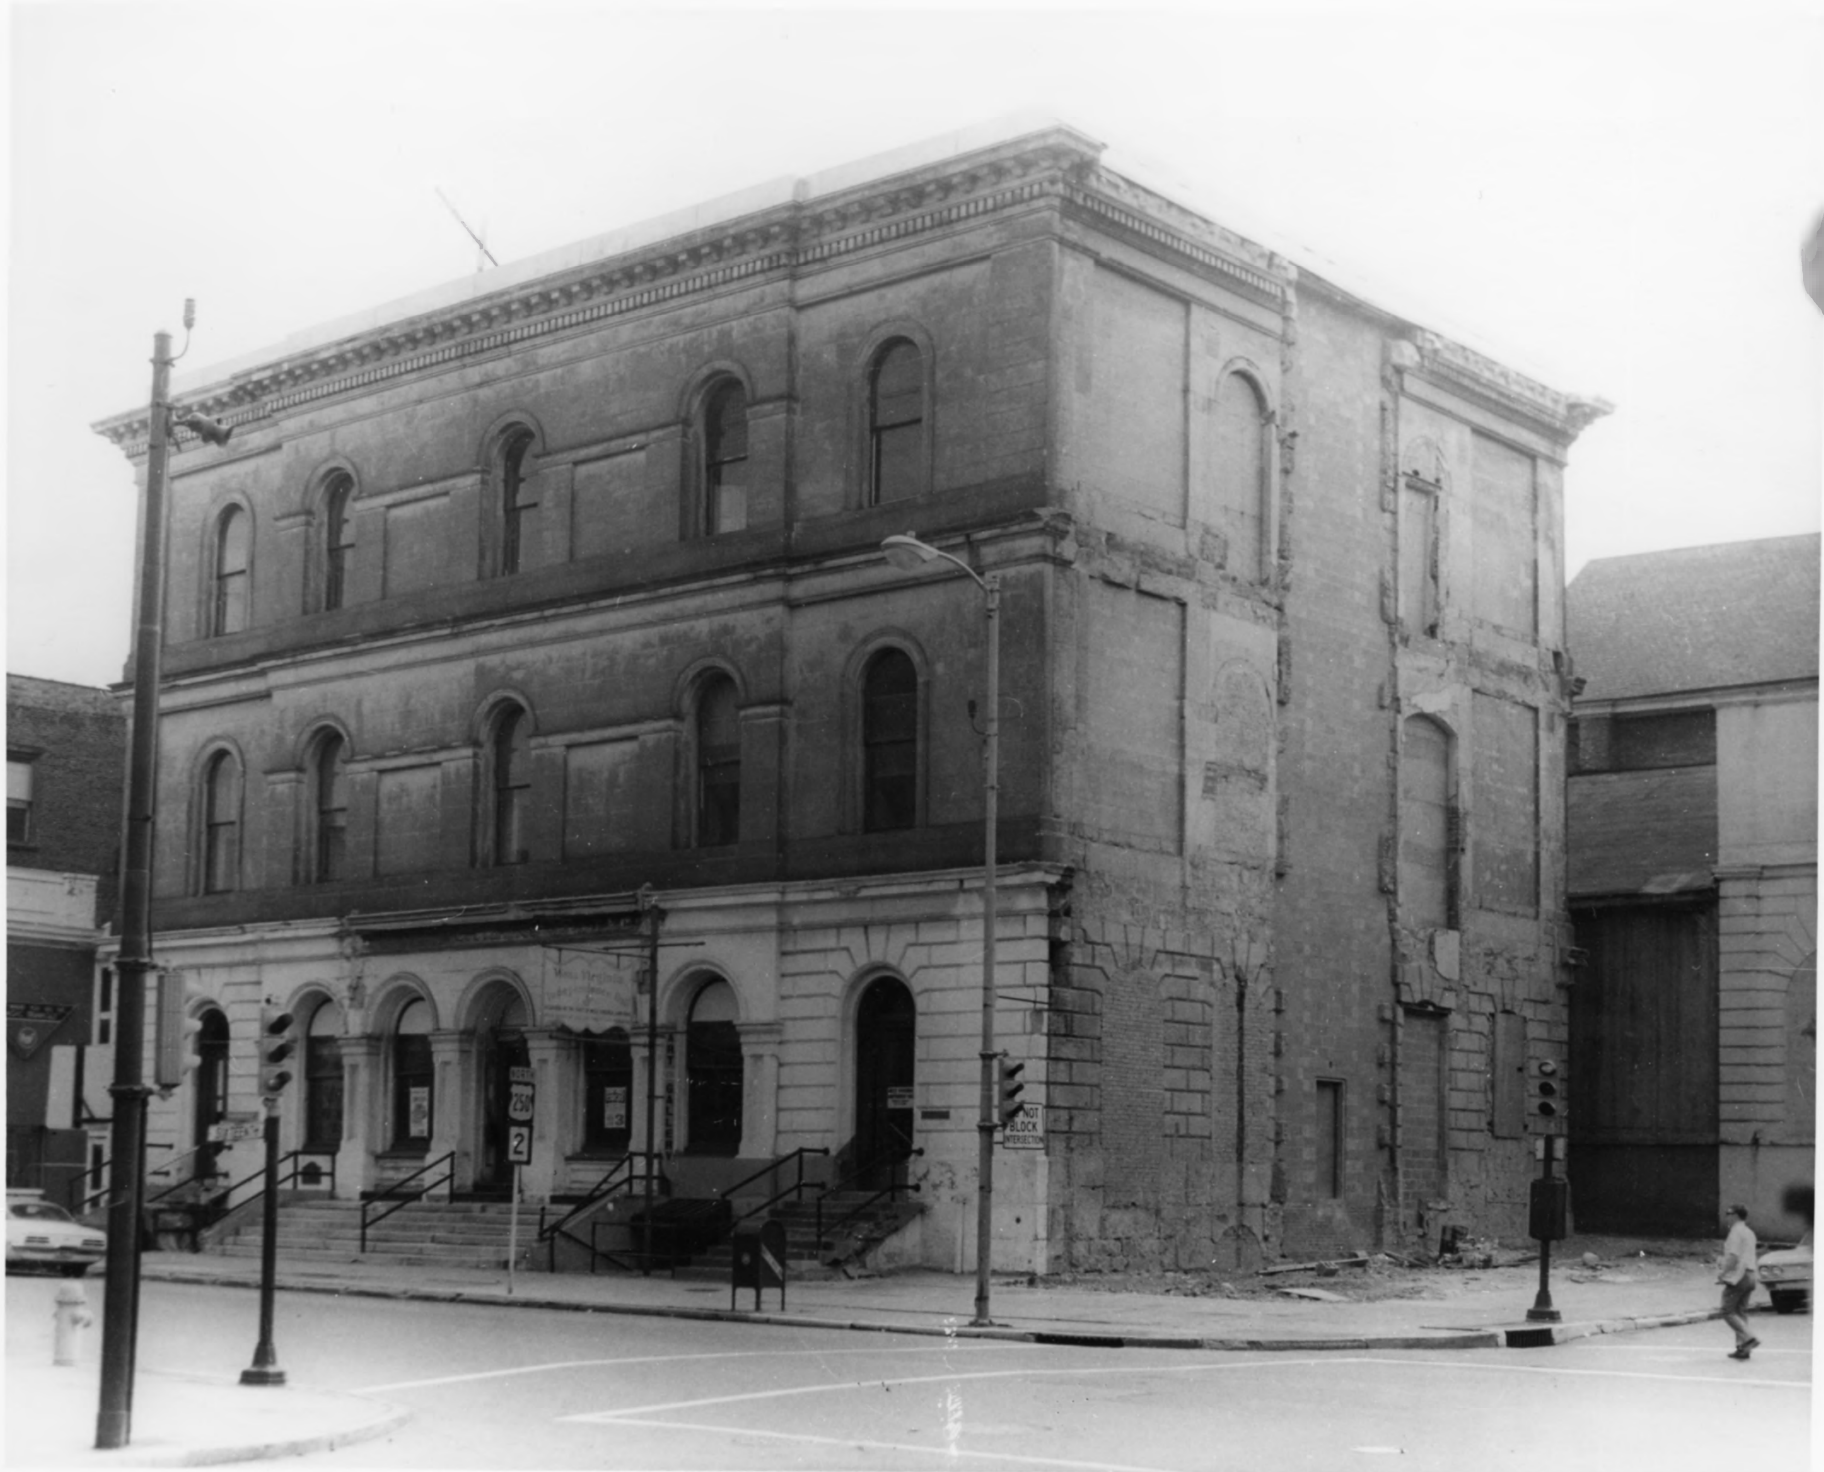
6) West and South elevations of building,

showing first phase of restoration work

(building returned to original dimensions)

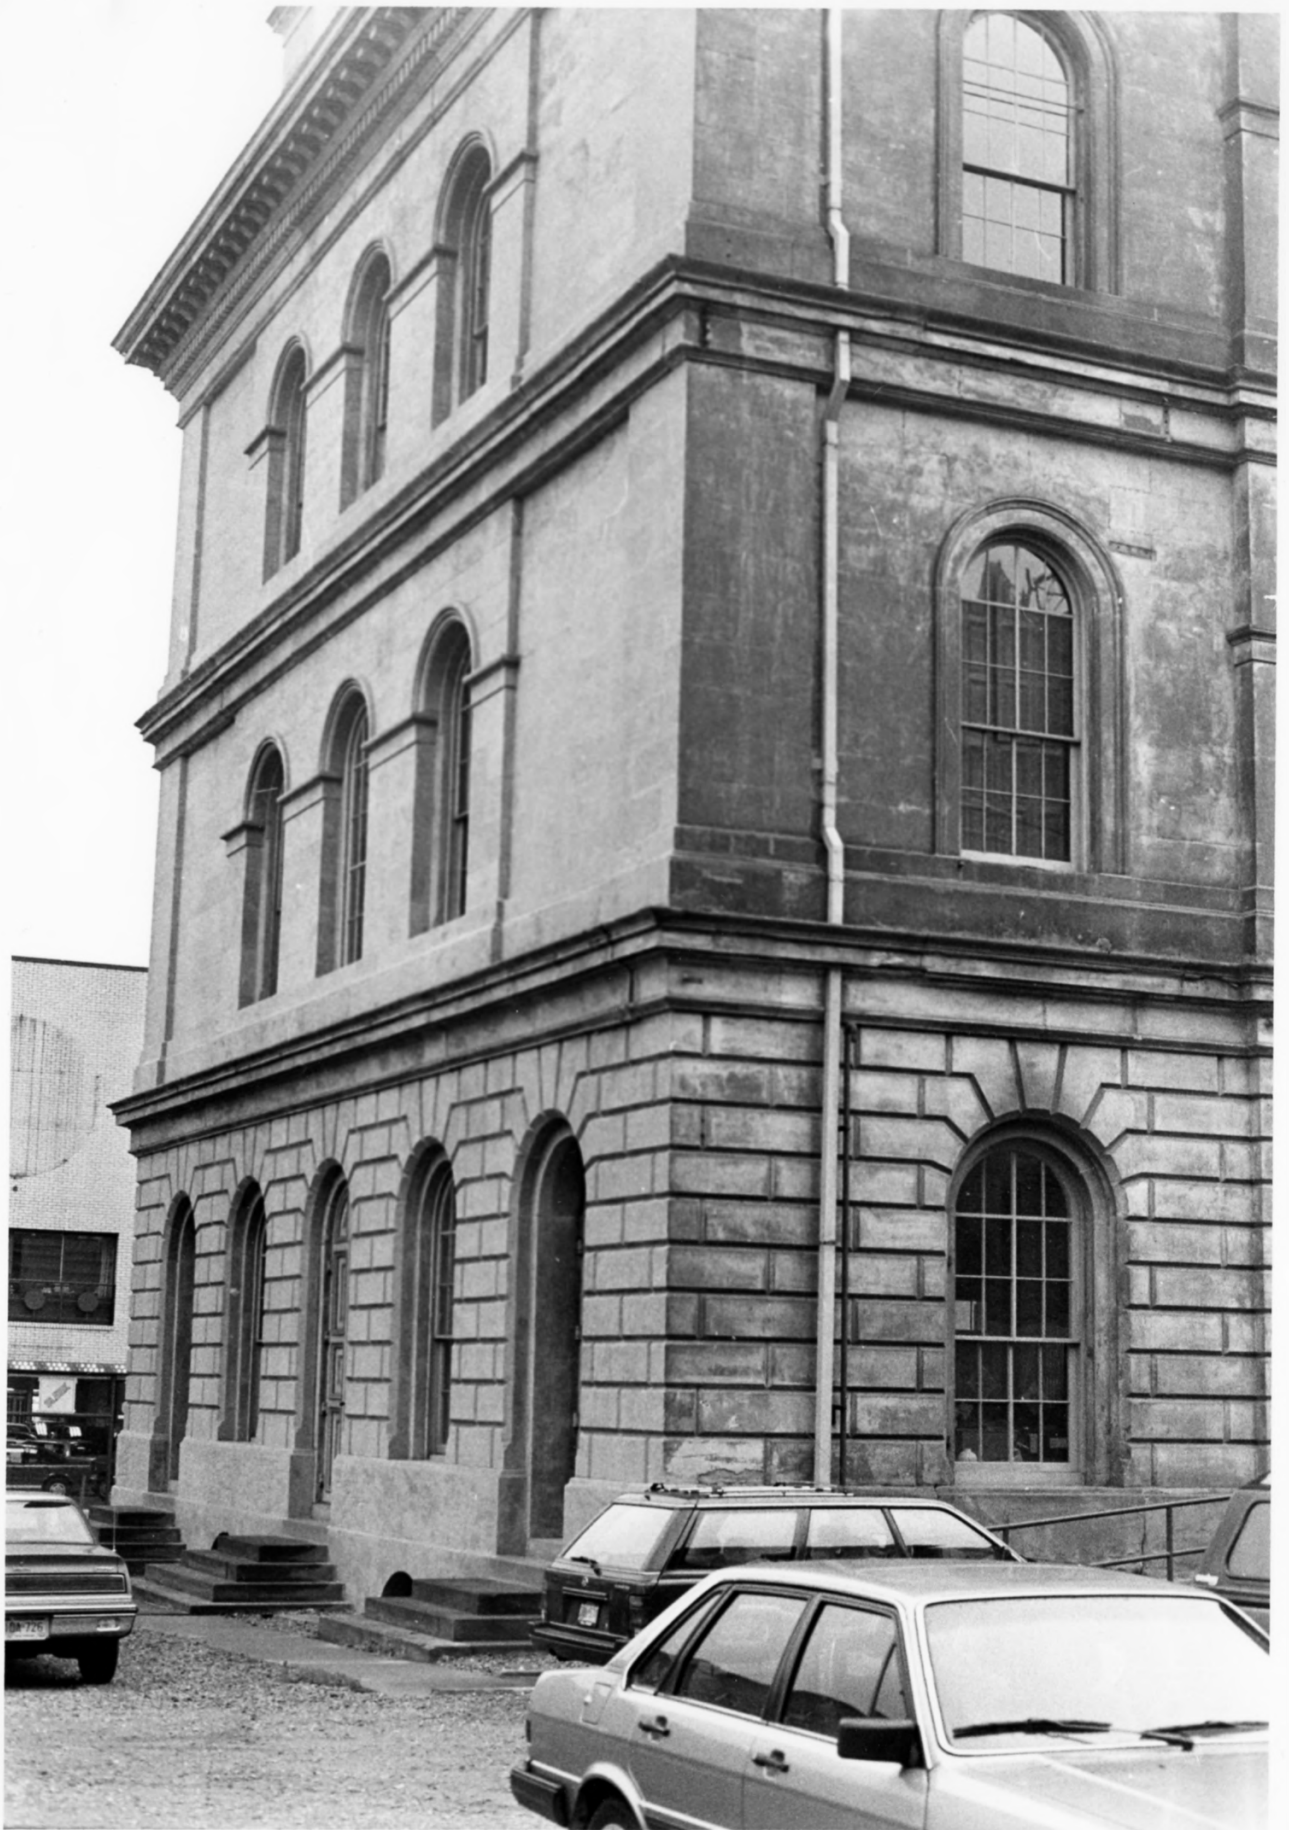
view: Exterior of Wheeling Custom House,
side where "DeKoset" was used when
addition and "wart" were removed.
South side of building. Camera
facing west

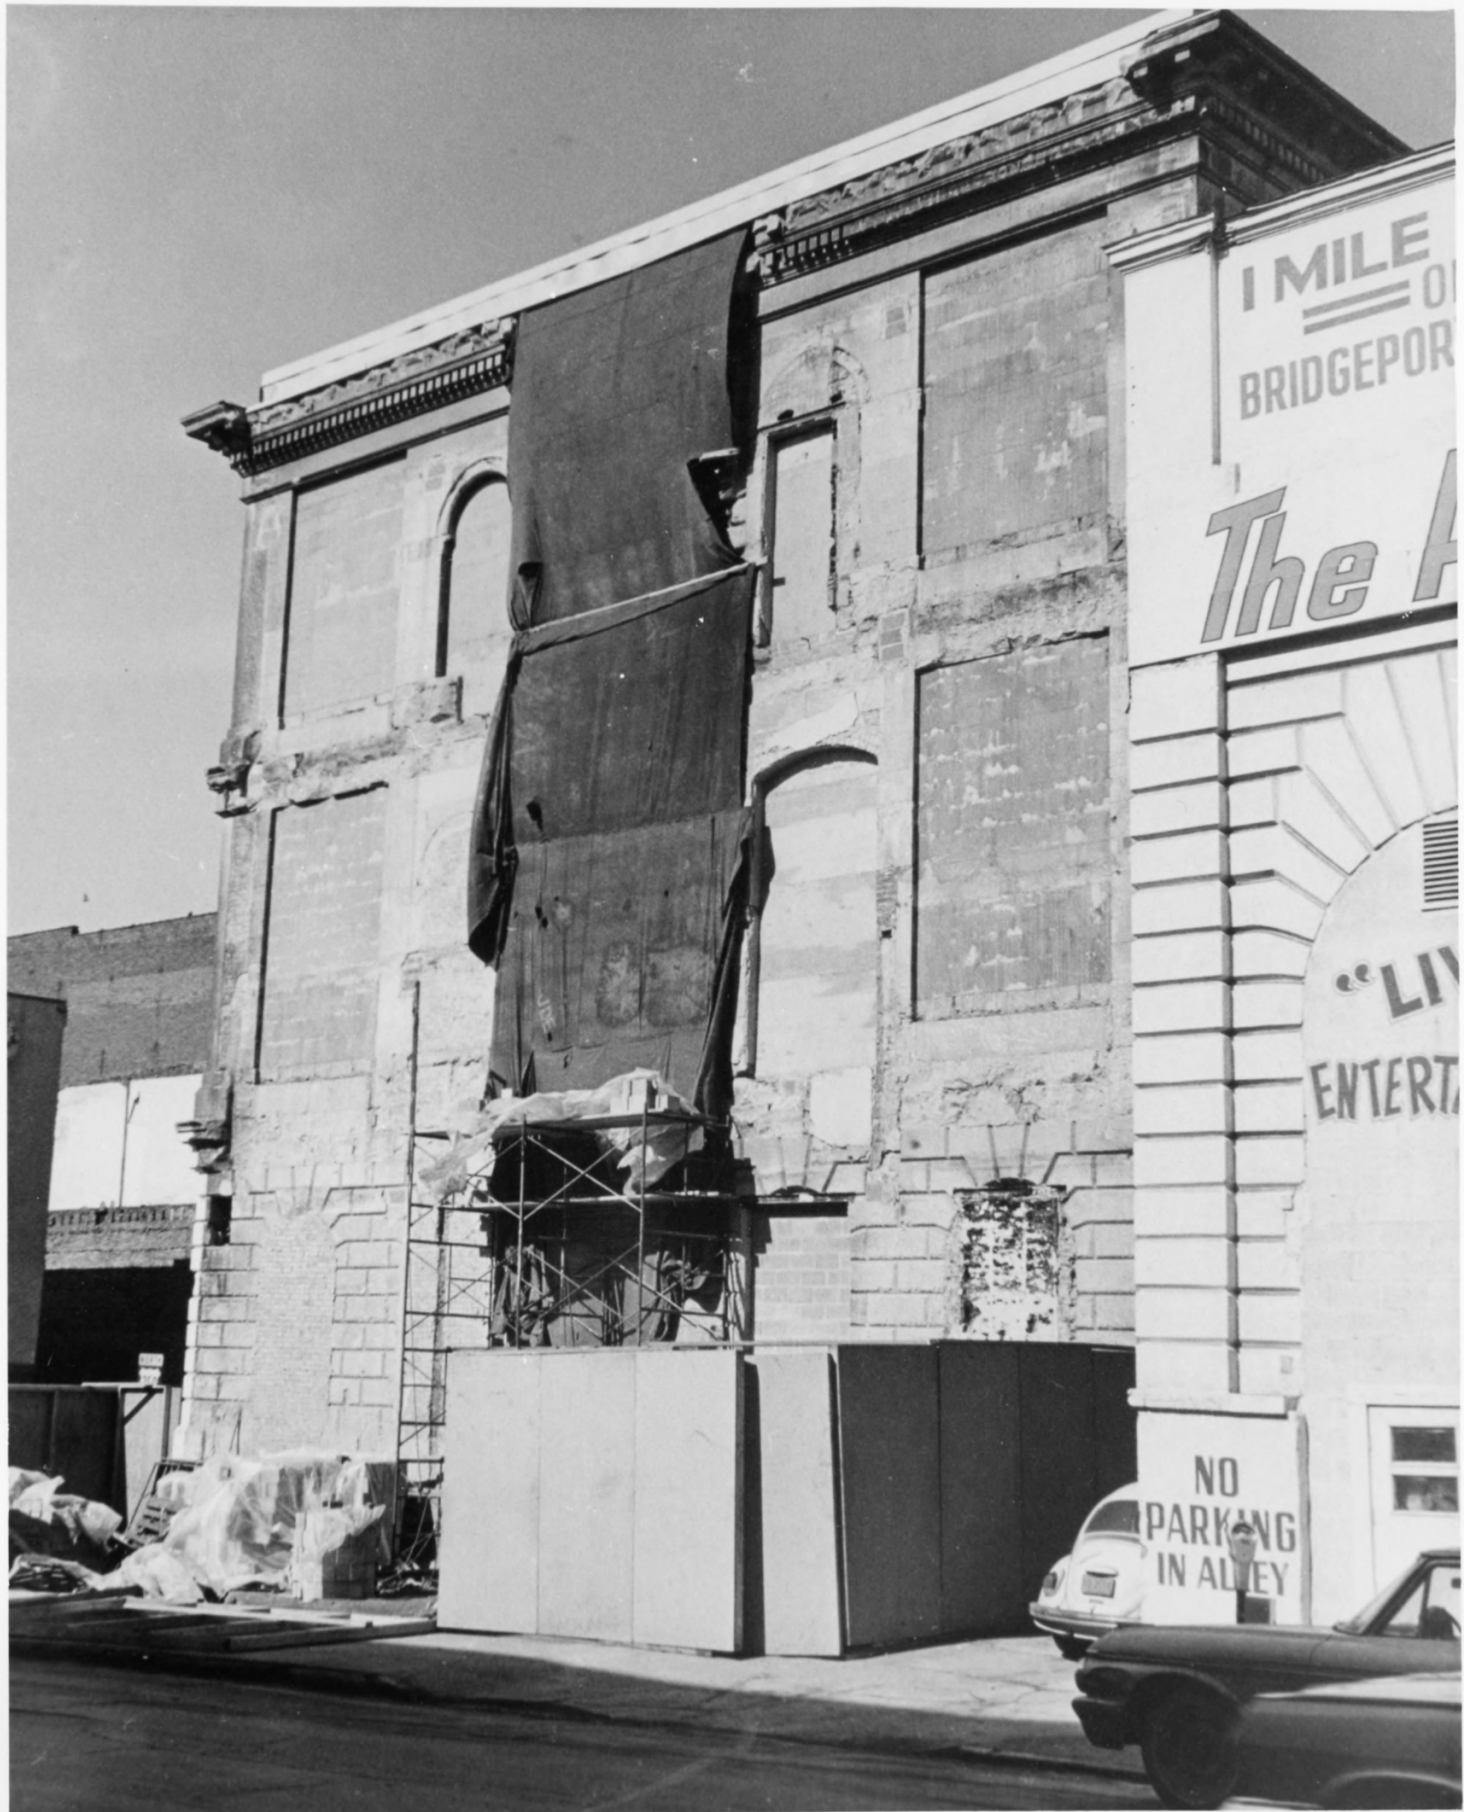
- 1) Wheeling Custom House
- 2) Wheeling, West Virginia
- 3) unknown
- 4) February 22, 1970
- 5) West Virginia Independence Hall Foundation
- 6) South elevation, showing removal of #89-90 bay; includes building built around north and east areas of original building; camera facing northwest

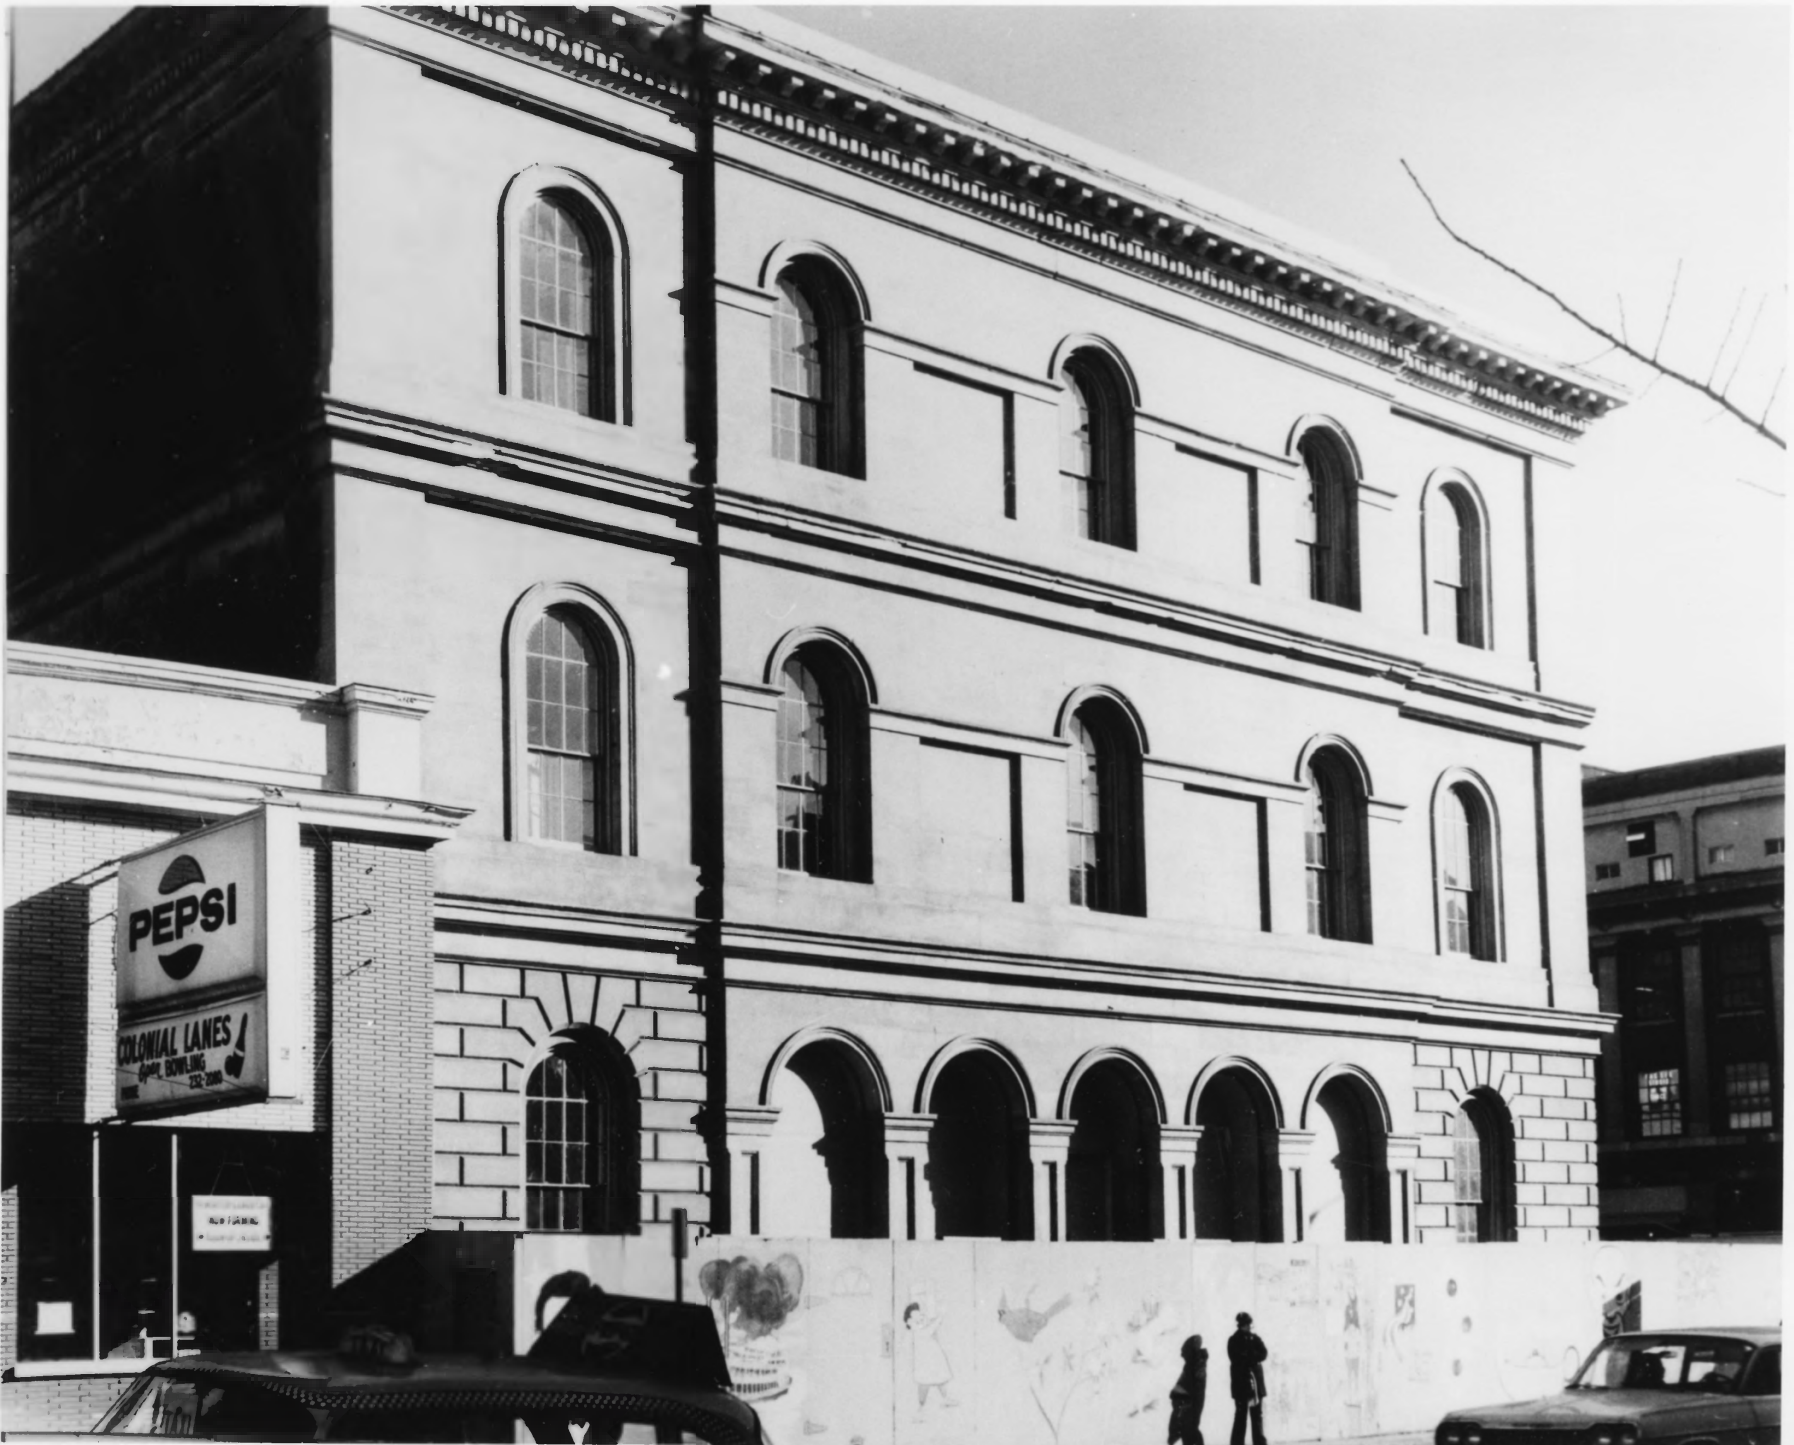
6) restored west front (except iron doors). Building
to north is part of building seen in
February 22, 1970 photo

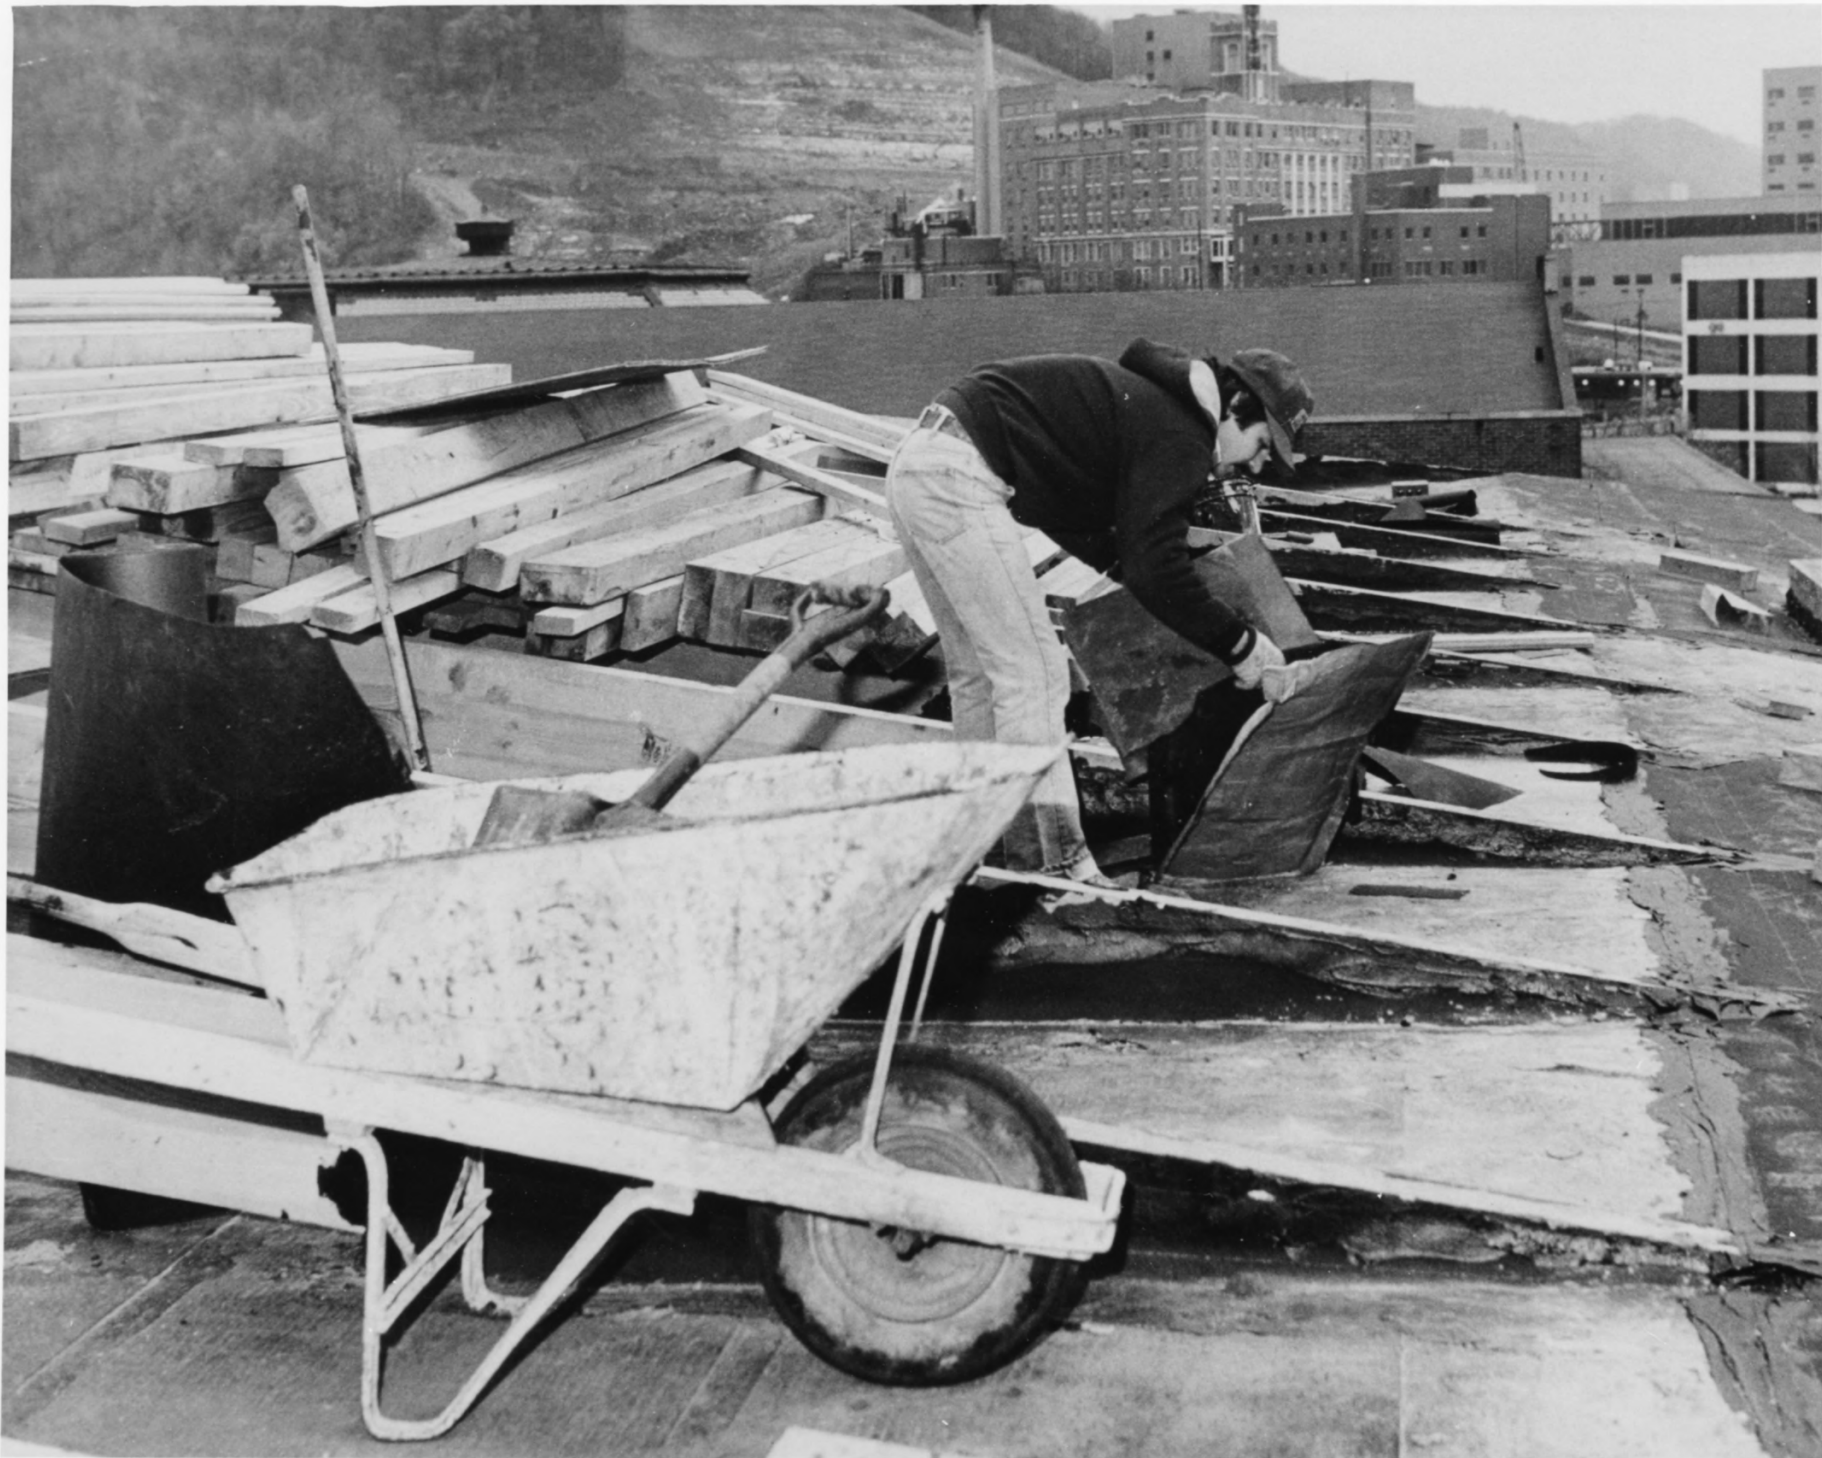
- 1) Wheeling Custom House
- 2) Wheeling, West Virginia
- 3) Mike Harvilla
- 4) November 13, 1974
- 5) West Virginia Independence Hall Foundation
- 6) restoration of roof; camera facing

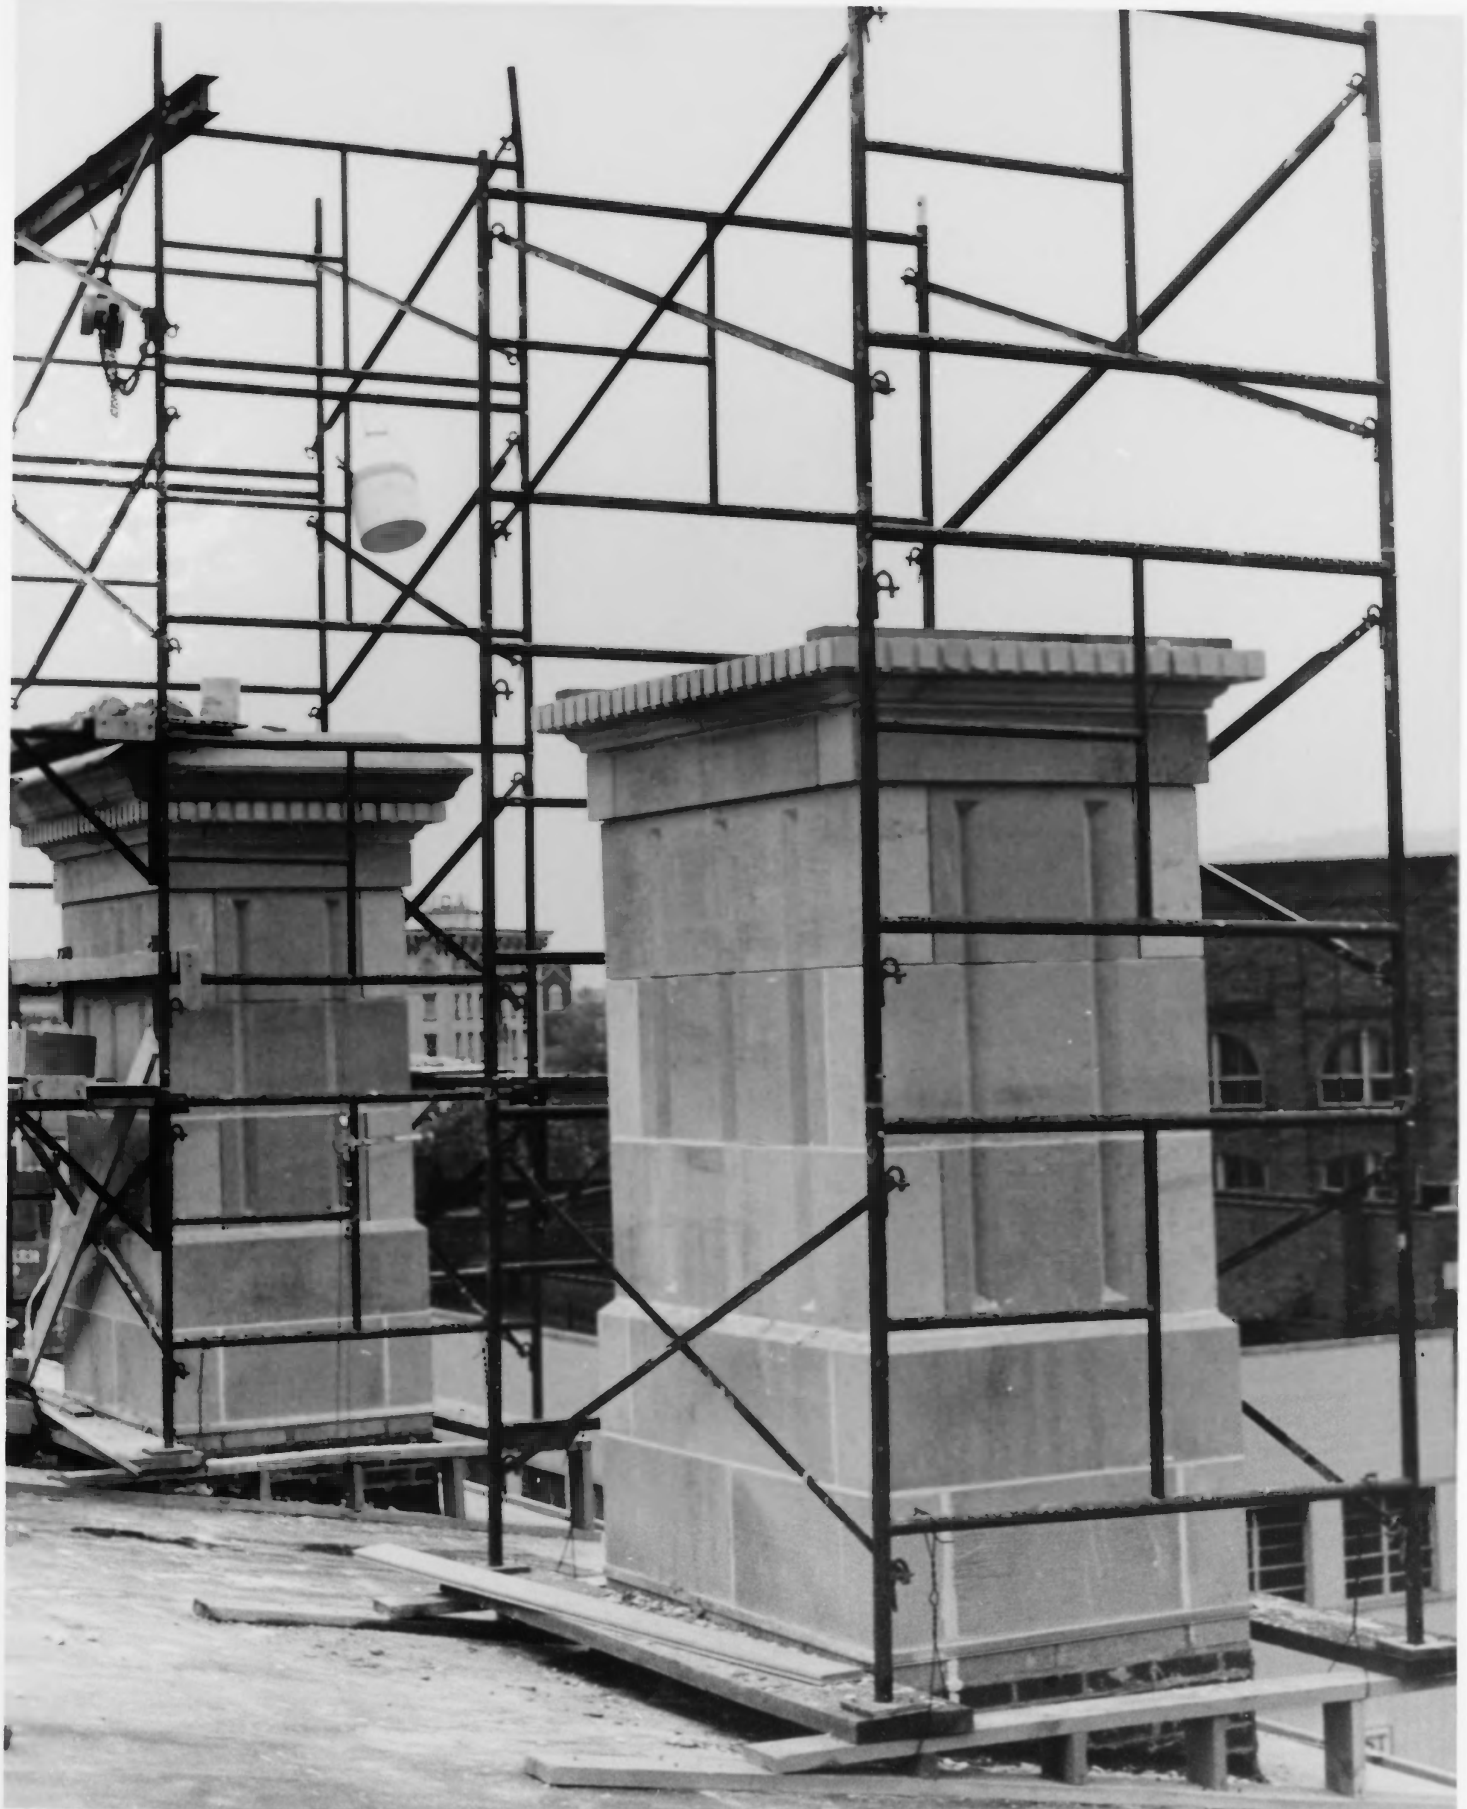
- 1) Wheeling Custom House
- 2) Wheeling, West Virginia
- 3) Gerald S. Ratloff
- 4) 1988
- 5) West Virginia Independence Hall Foundation
- 6) reconstruction of chimneys; camera facing

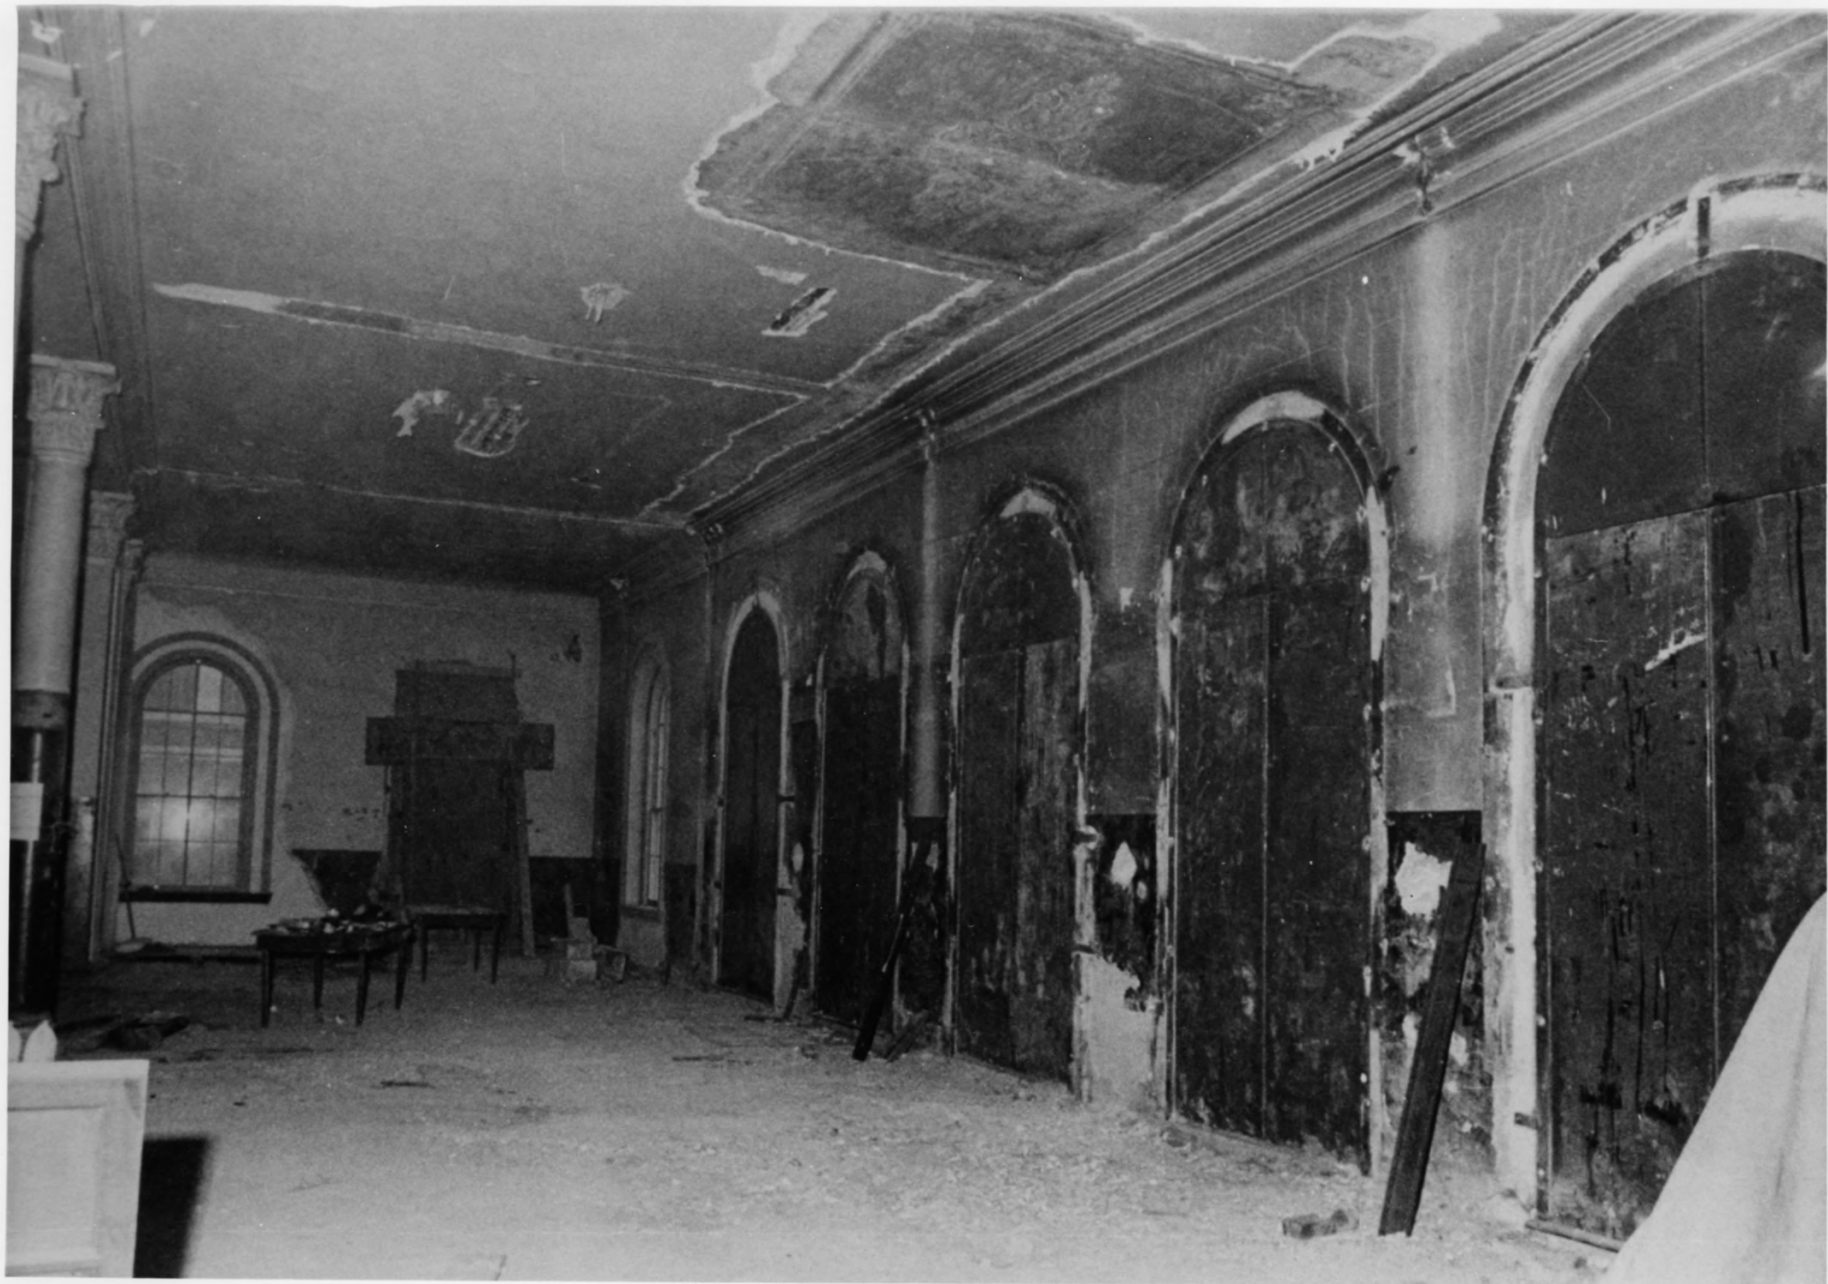
- 1) Wheeling Custom House
- 2) Wheeling, West Virginia
- 3) Don Muhleman
- 4) January 1976
- 5) West Virginia Independence Hall Foundation
- 6) early stage of 1st floor port office vestibule restoration; note 5 front doorways on right (west elevation), original columns where screenline will be reconstructed, recovery of ceiling frescoes; camera facing southwest

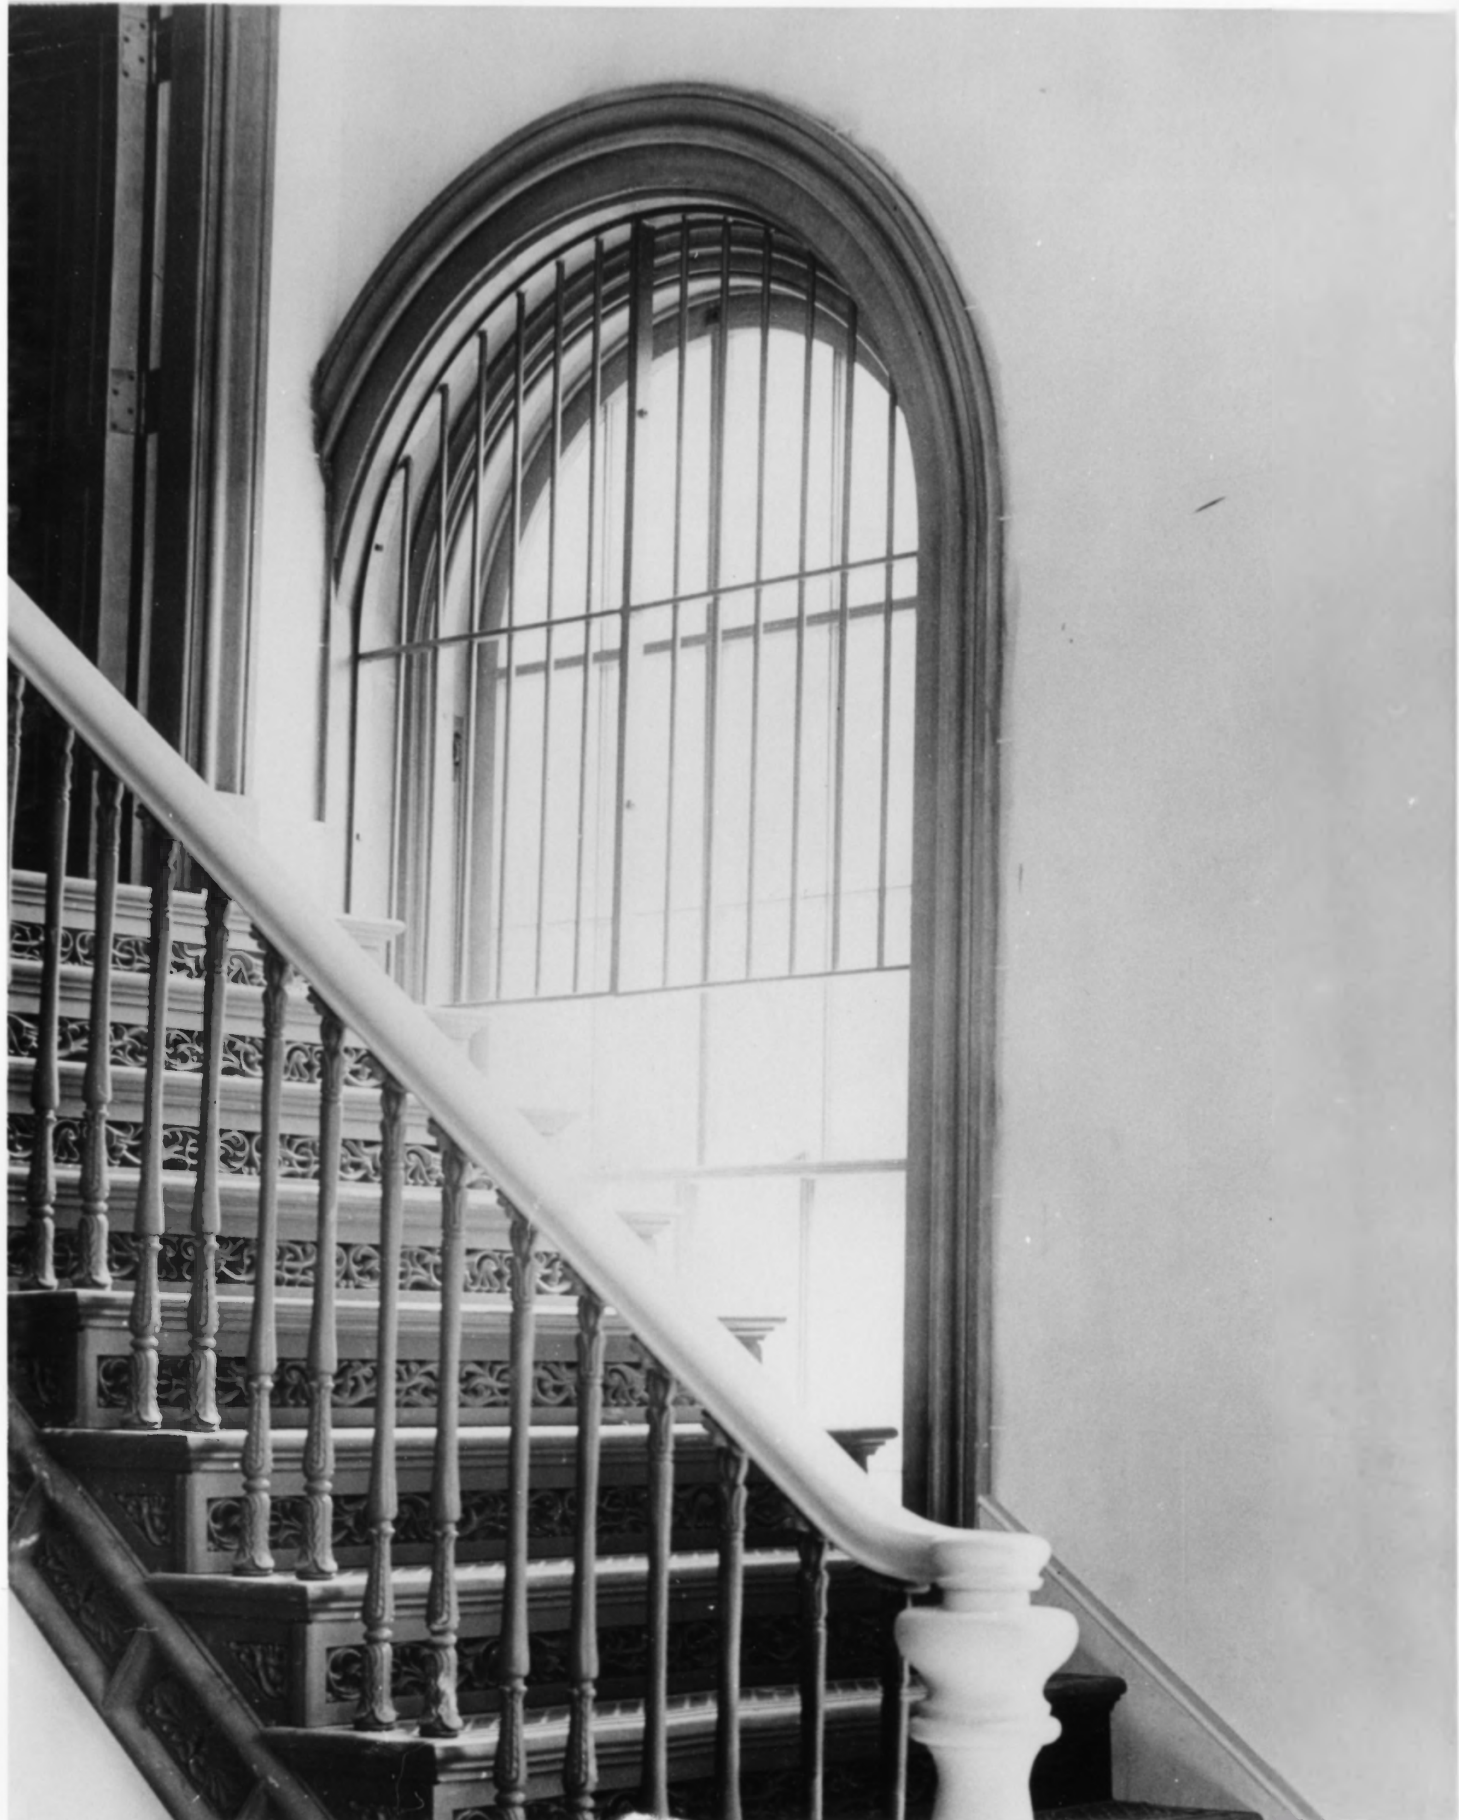
- 1) Wheeling Custom House
- 2) Wheeling, West Virginia
- 3) Don Muhleman
- 4) January 1976
- 5) West Virginia Independence Hall Foundation
- 6) north and east walls of first story;
camera facing northeast
