1) Wheeling Custom House

2) Wheeling, West Virginia

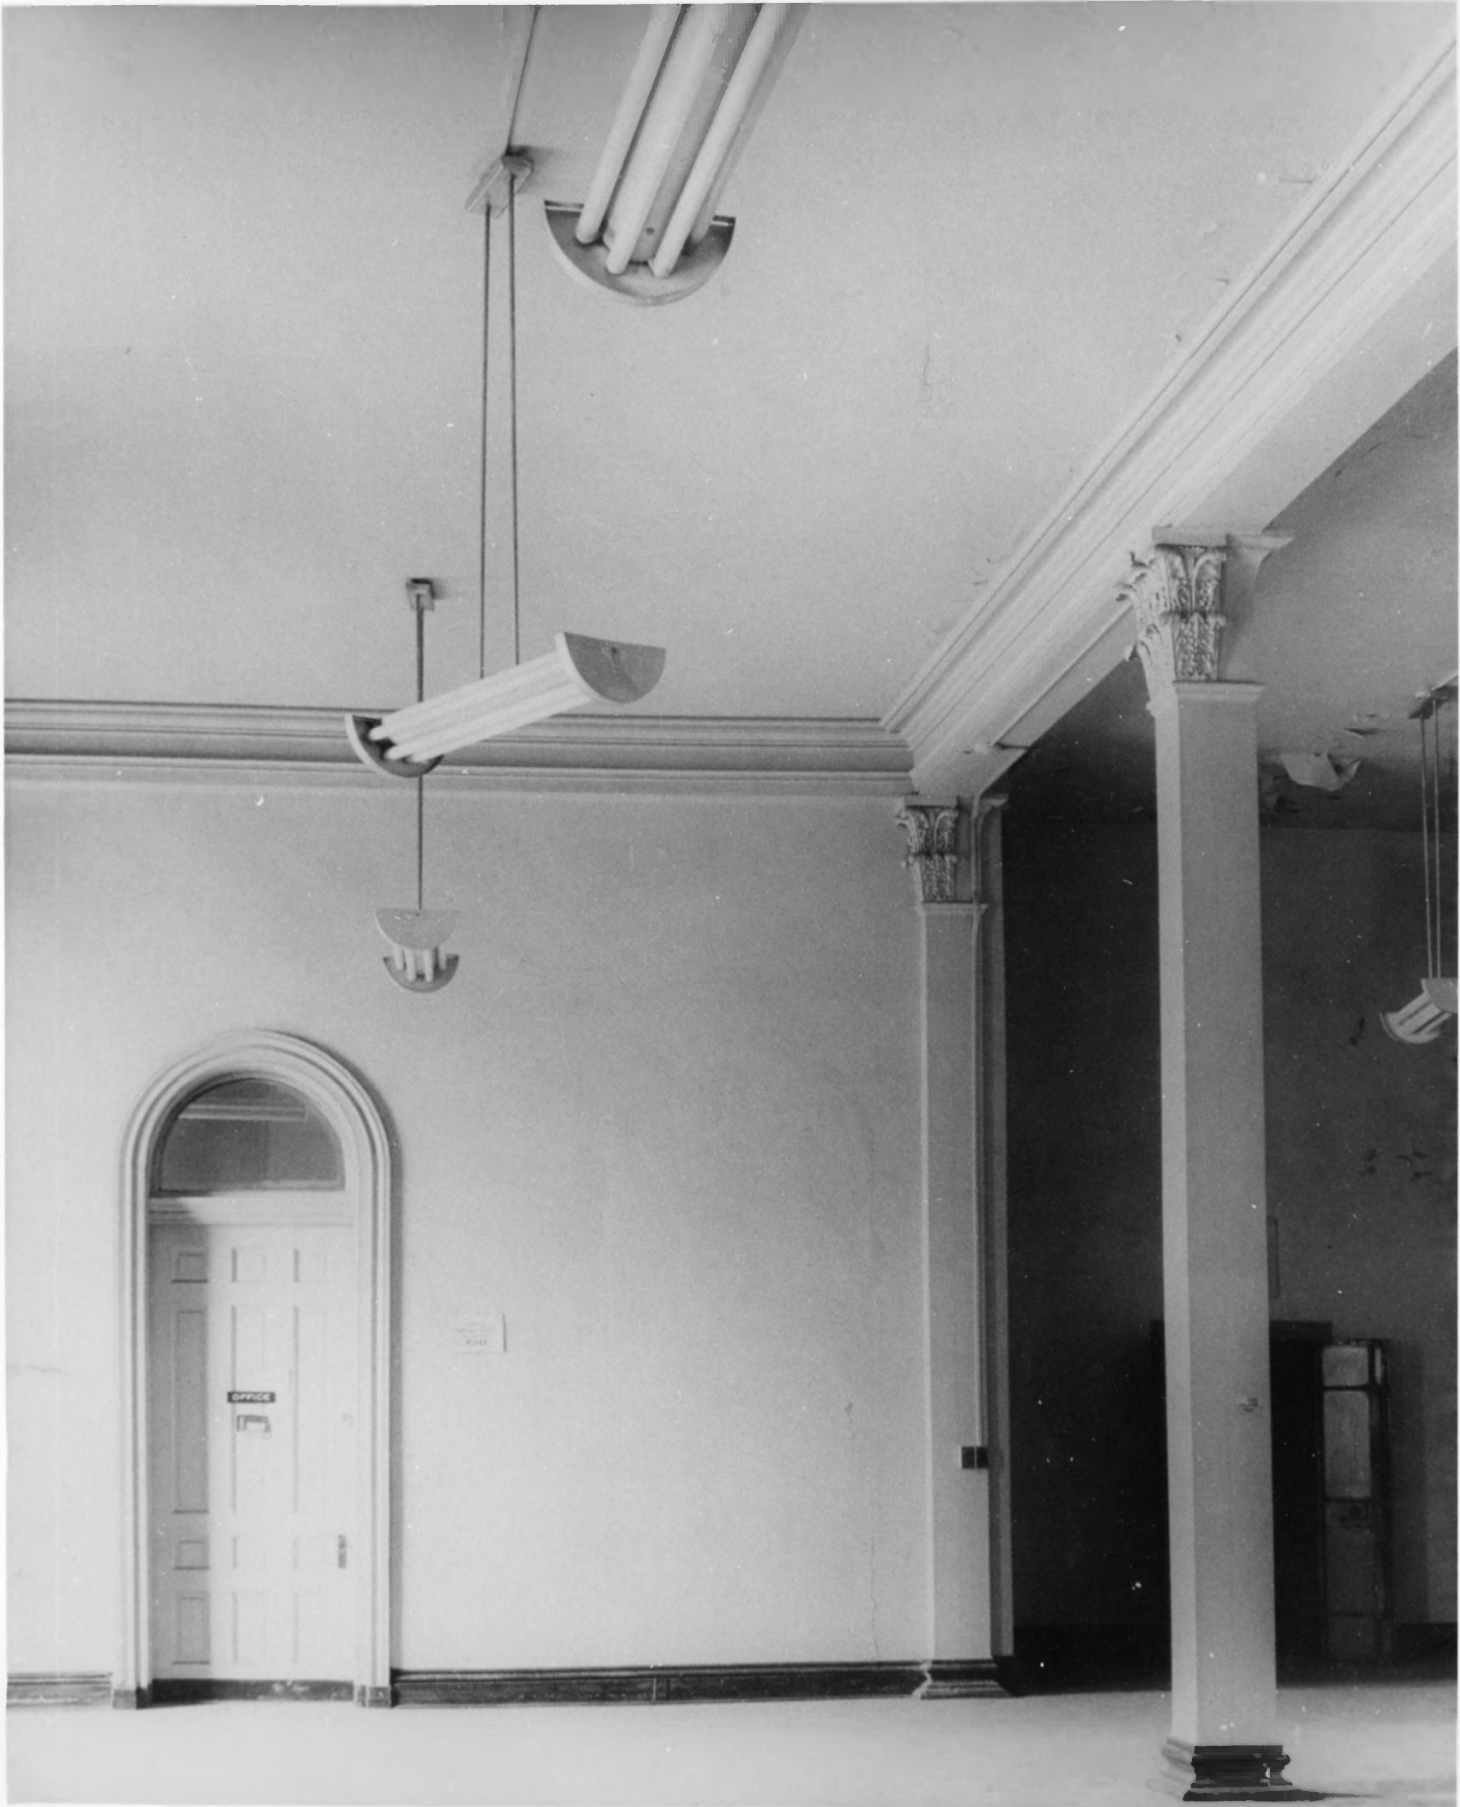
- 1) Wheeling Custom House
- 2) Wheeling, West Virginia
- 3) Frasier Smith
- 4) 1971
- 5) West Virginia Independence Hall Foundation
- 6) 2nd story with doorway in northwest corner which was marked "Steamboat Inspector" on 1855 plans

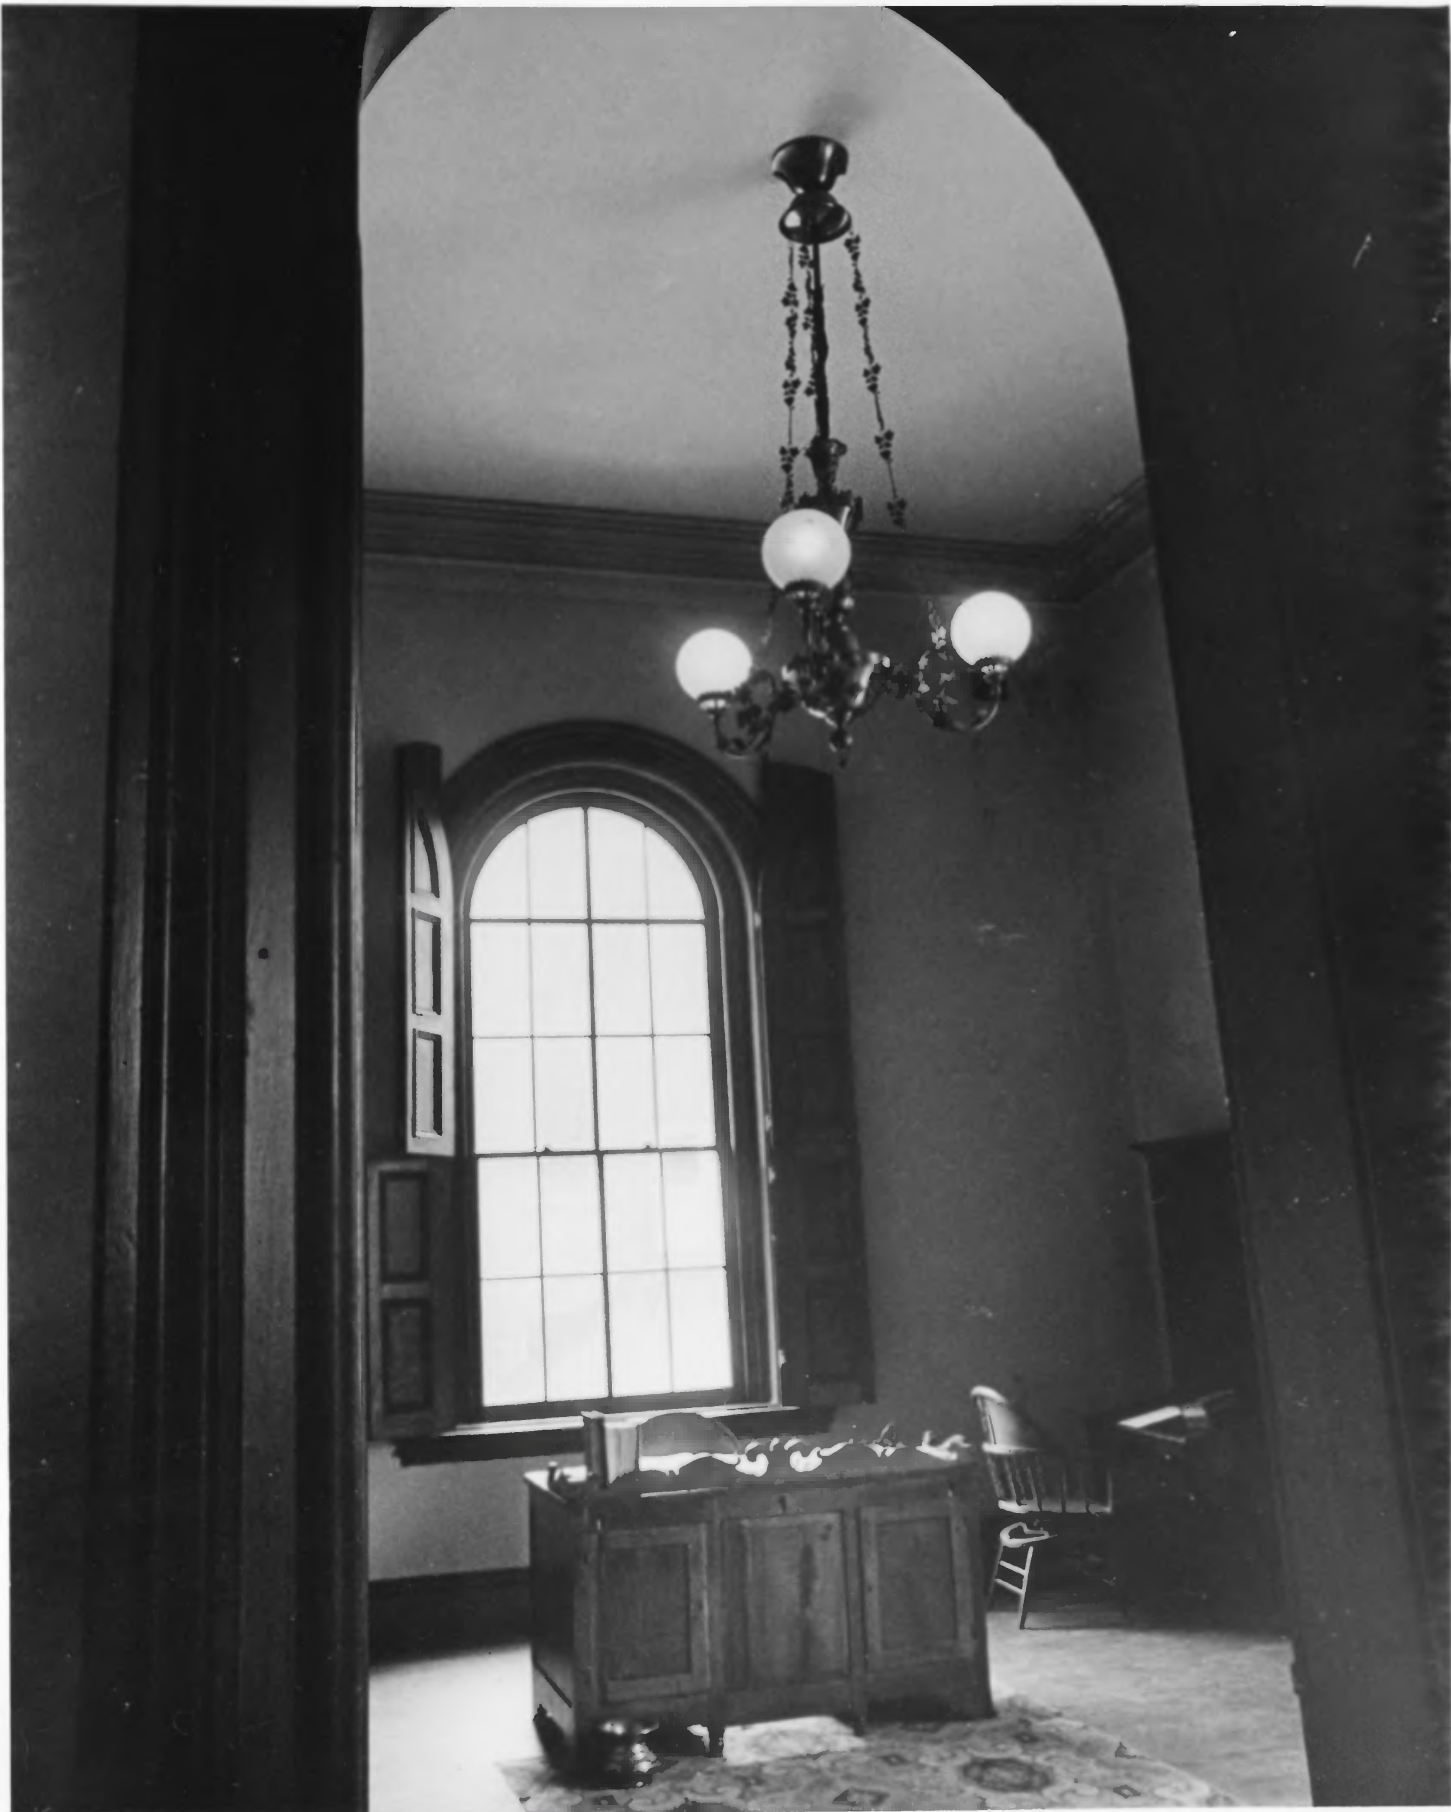
- 1) Wheeling Custom House
- 2) Wheeling, West Virginia
- 3) Gerald S. Ratliff
- 4) 1980
- 5) West Virginia Independence Hall Foundation
- 6) Governor's office (1855 District Attorney's office),
showing original iron shutters, new replica windows,
copy of original gasolier; southeast corner room
on 2nd story; camera facing southeast

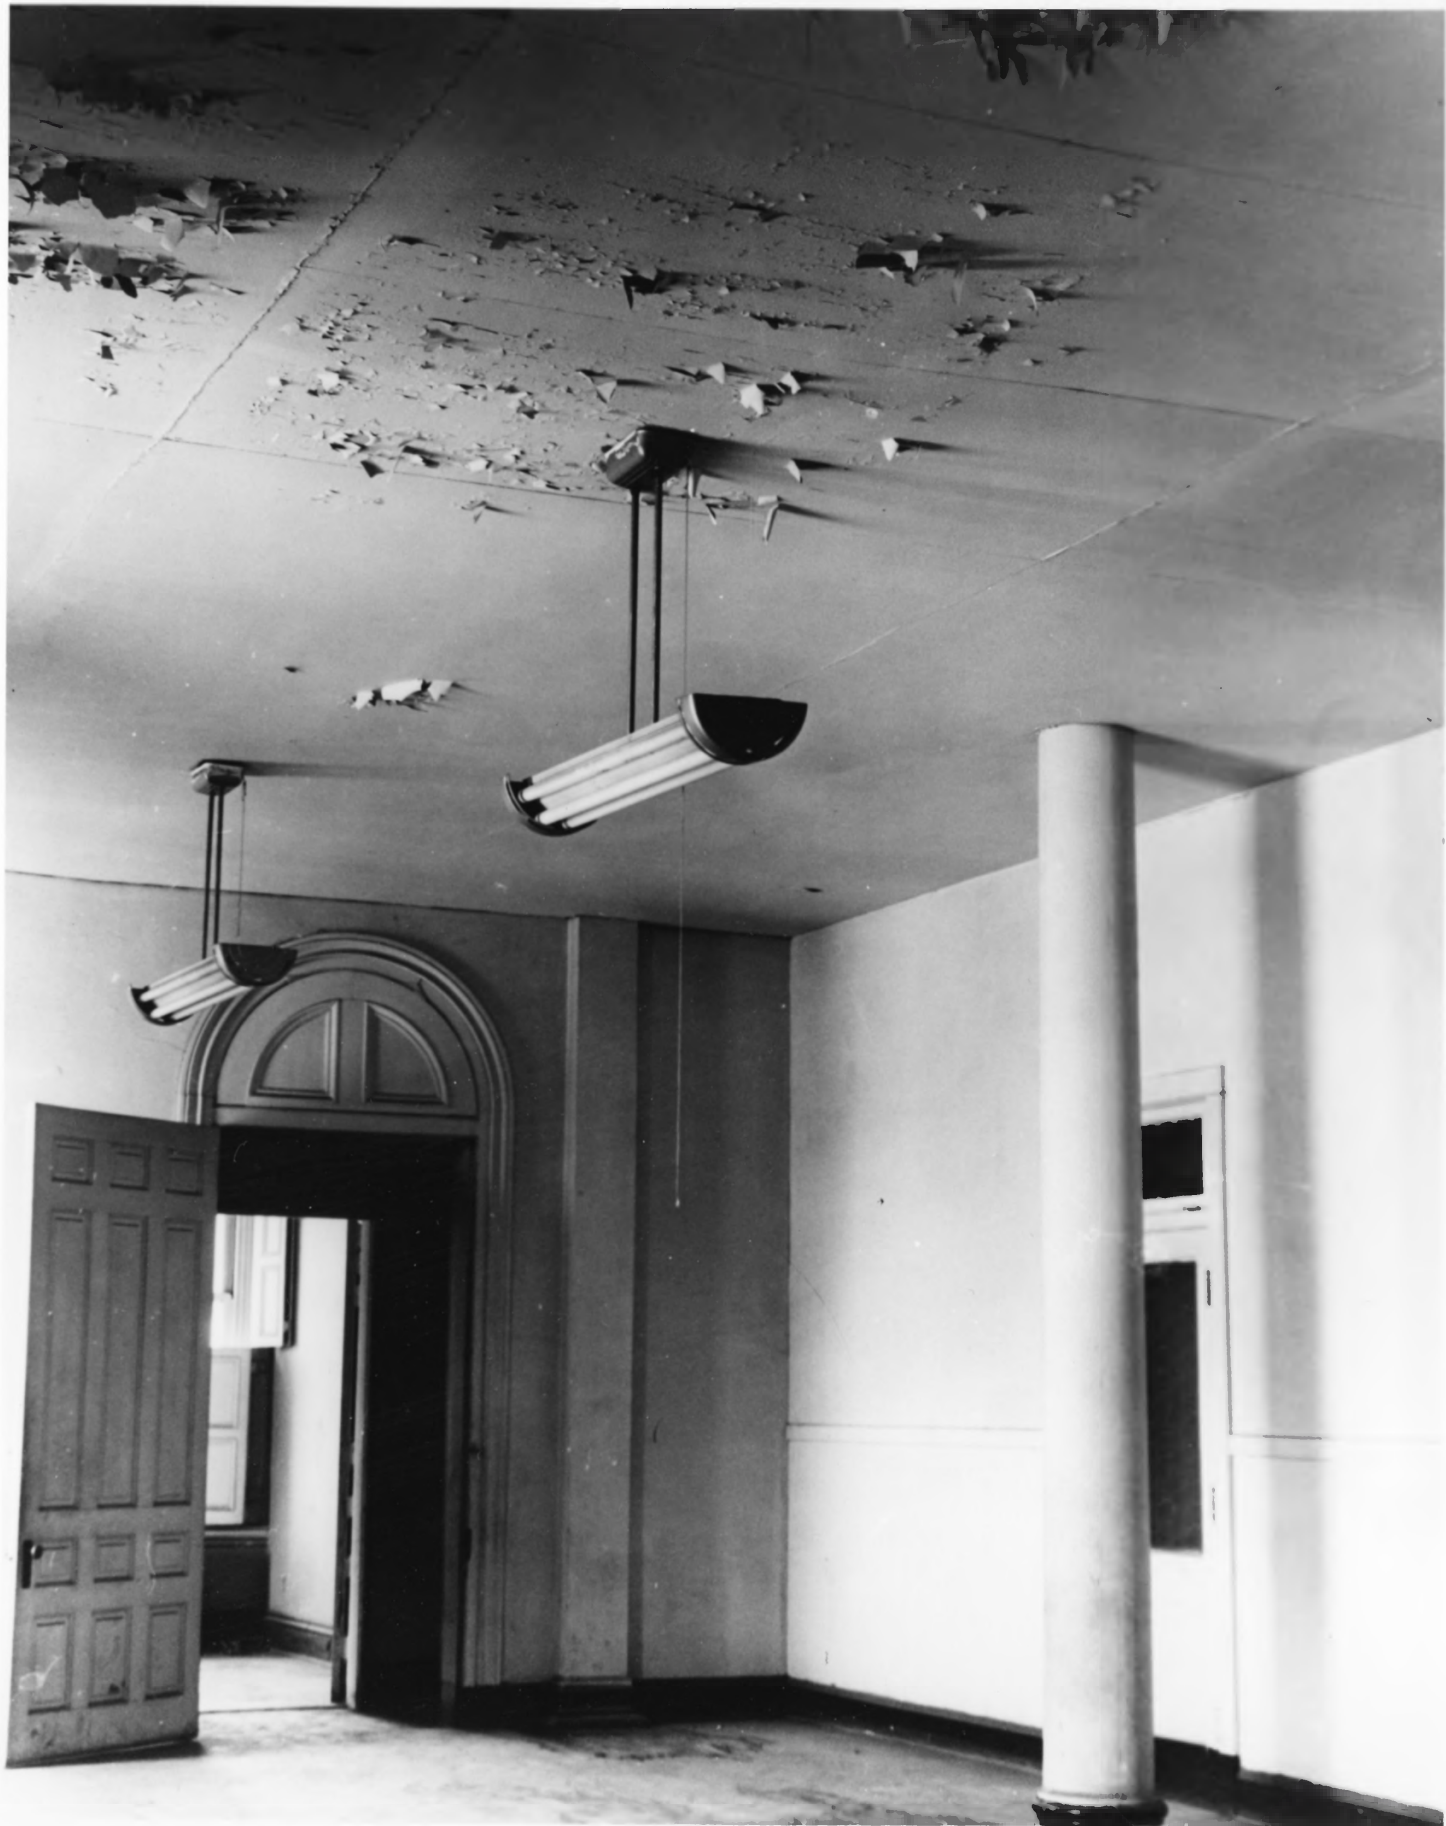
6) 3rd story court room with false ceiling addition; partition wall also later addition; Camera facing north.

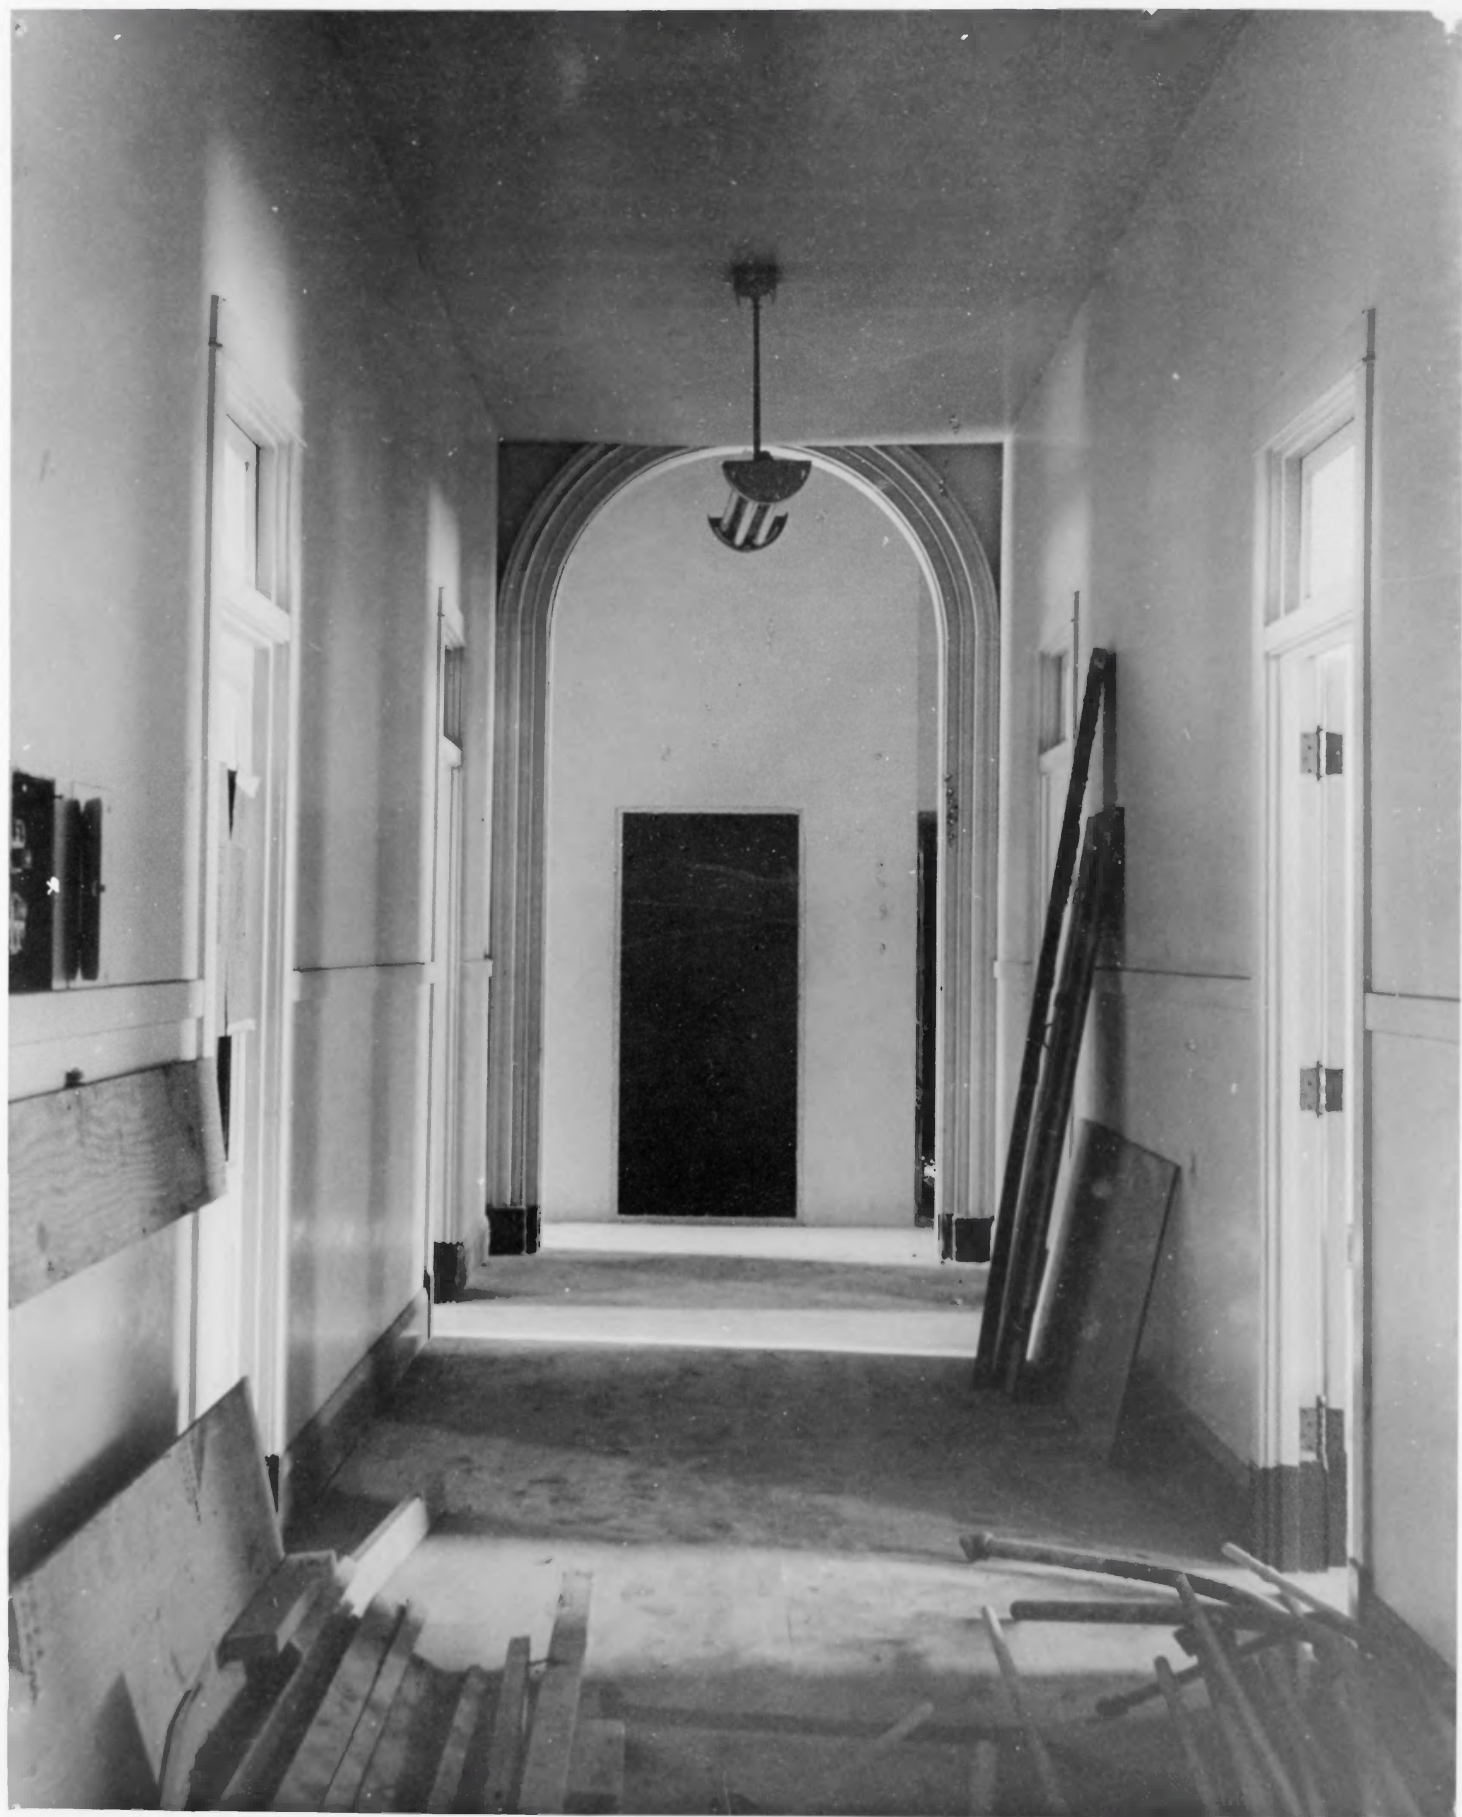
- 1) Wheeling Custom House
- 2) Wheeling, West Virginia
- 3) Beverly Fluty
- 4) July 1970
- 5) West Virginia Independence Hall Foundation
- 6) 3rd floor courtroom, showing later partition walls, lighting fixtures, flooring, and suspended ceiling; dark doorway in center of photo is for elevator shaft that had been added as part of restoration to provide handicapped access; camera facing south

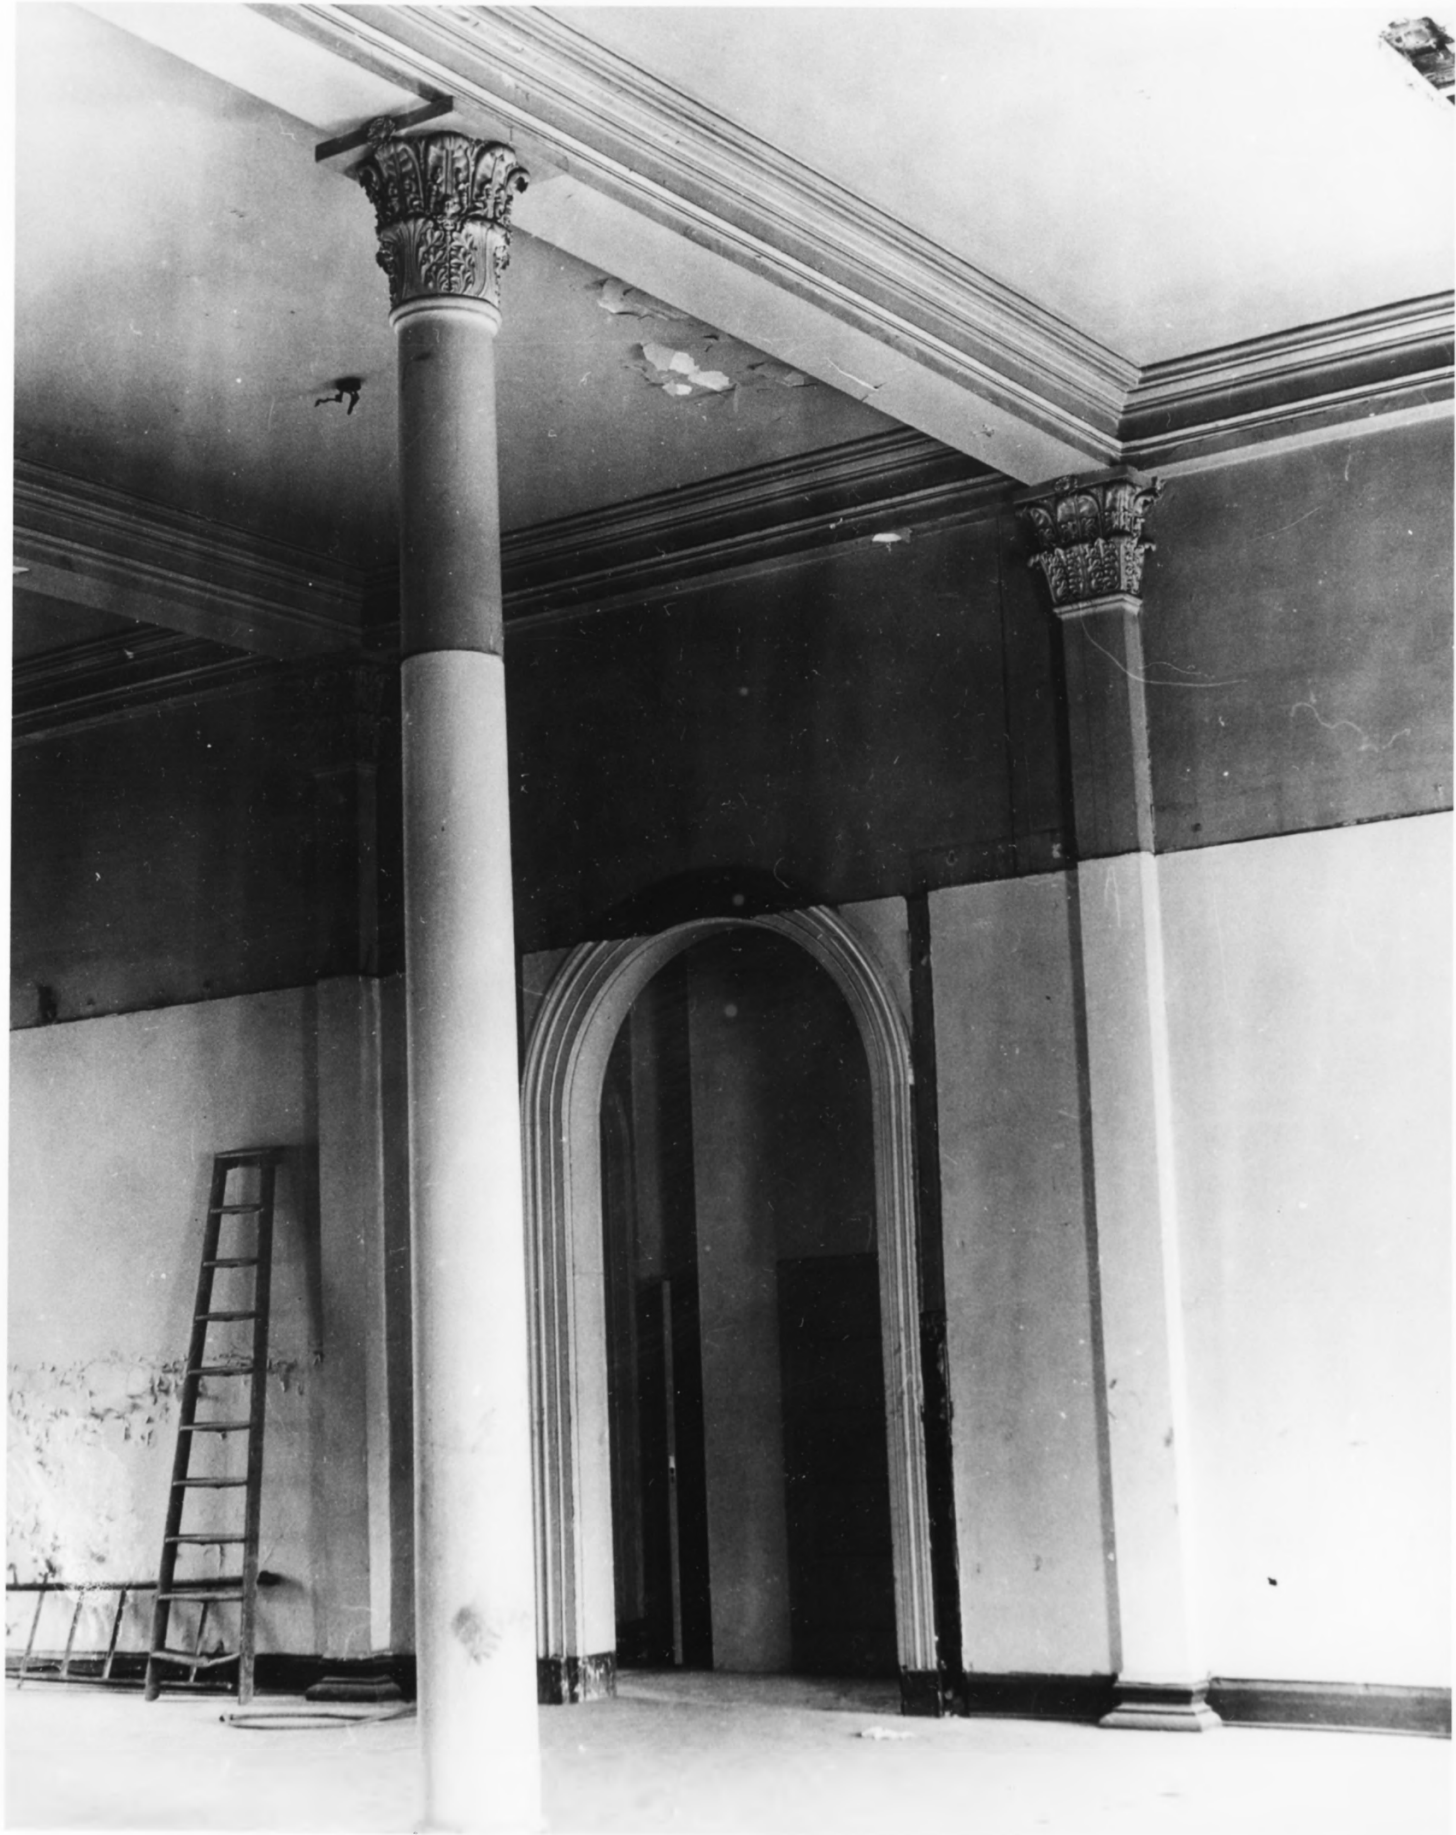
- 1) Wheeling Custom House
- 2) Wheeling, West Virginia
- 3) Frasier Smith
- 4) c. 1970
- 5) West Virginia Independence Hall Foundation
- 6) Photograph of 3rd story court room with false ceiling removed, ceiling and wall frescoes hidden under layers of paint; camera facing southeast

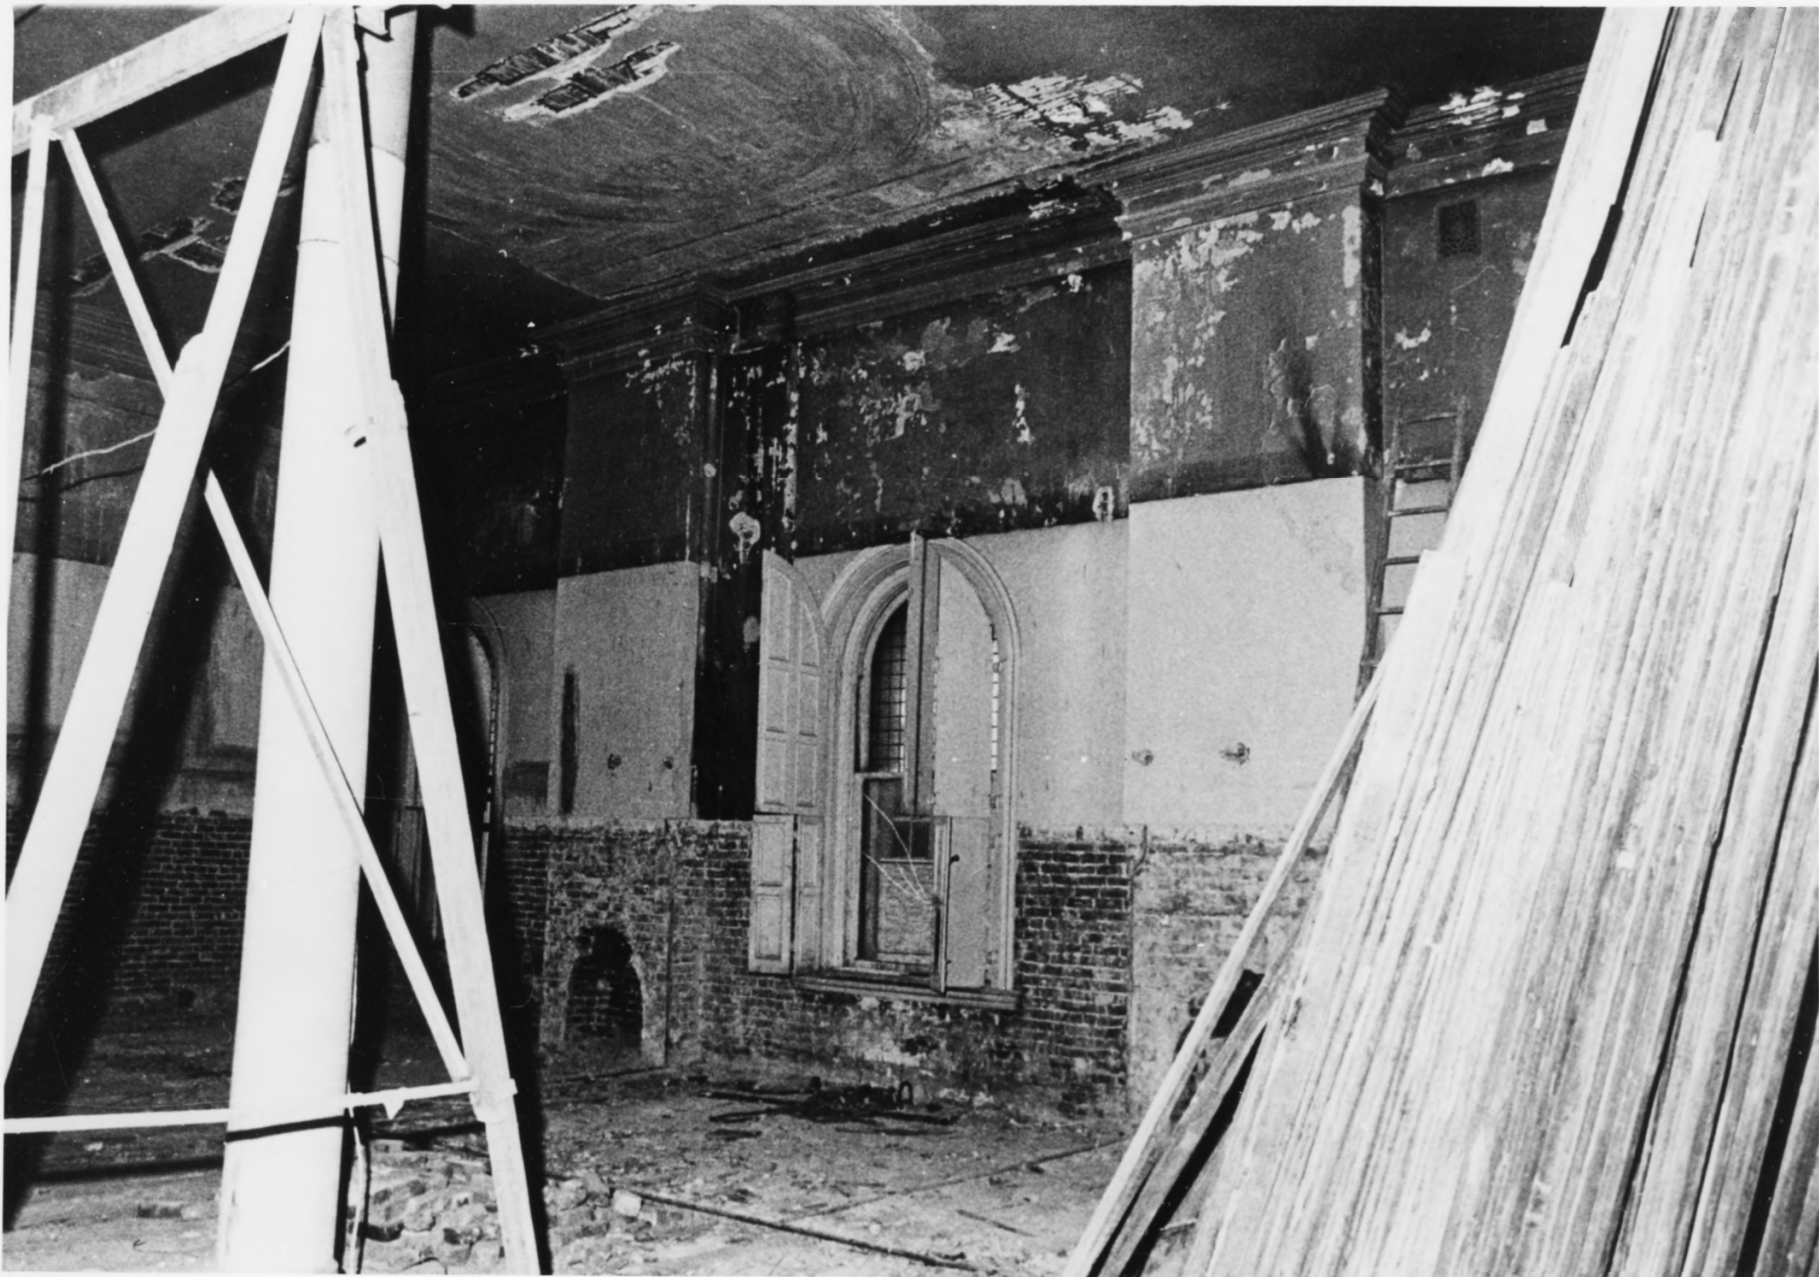
- 1) Wheeling Custom House
- 2) Wheeling, West Virginia
- 3) Don Muhleman
- 4) January 1976
- 5) West Virginia Independence Hall Foundation
- 6) Courtroom during restoration, showing north and east walls; camera facing northeast

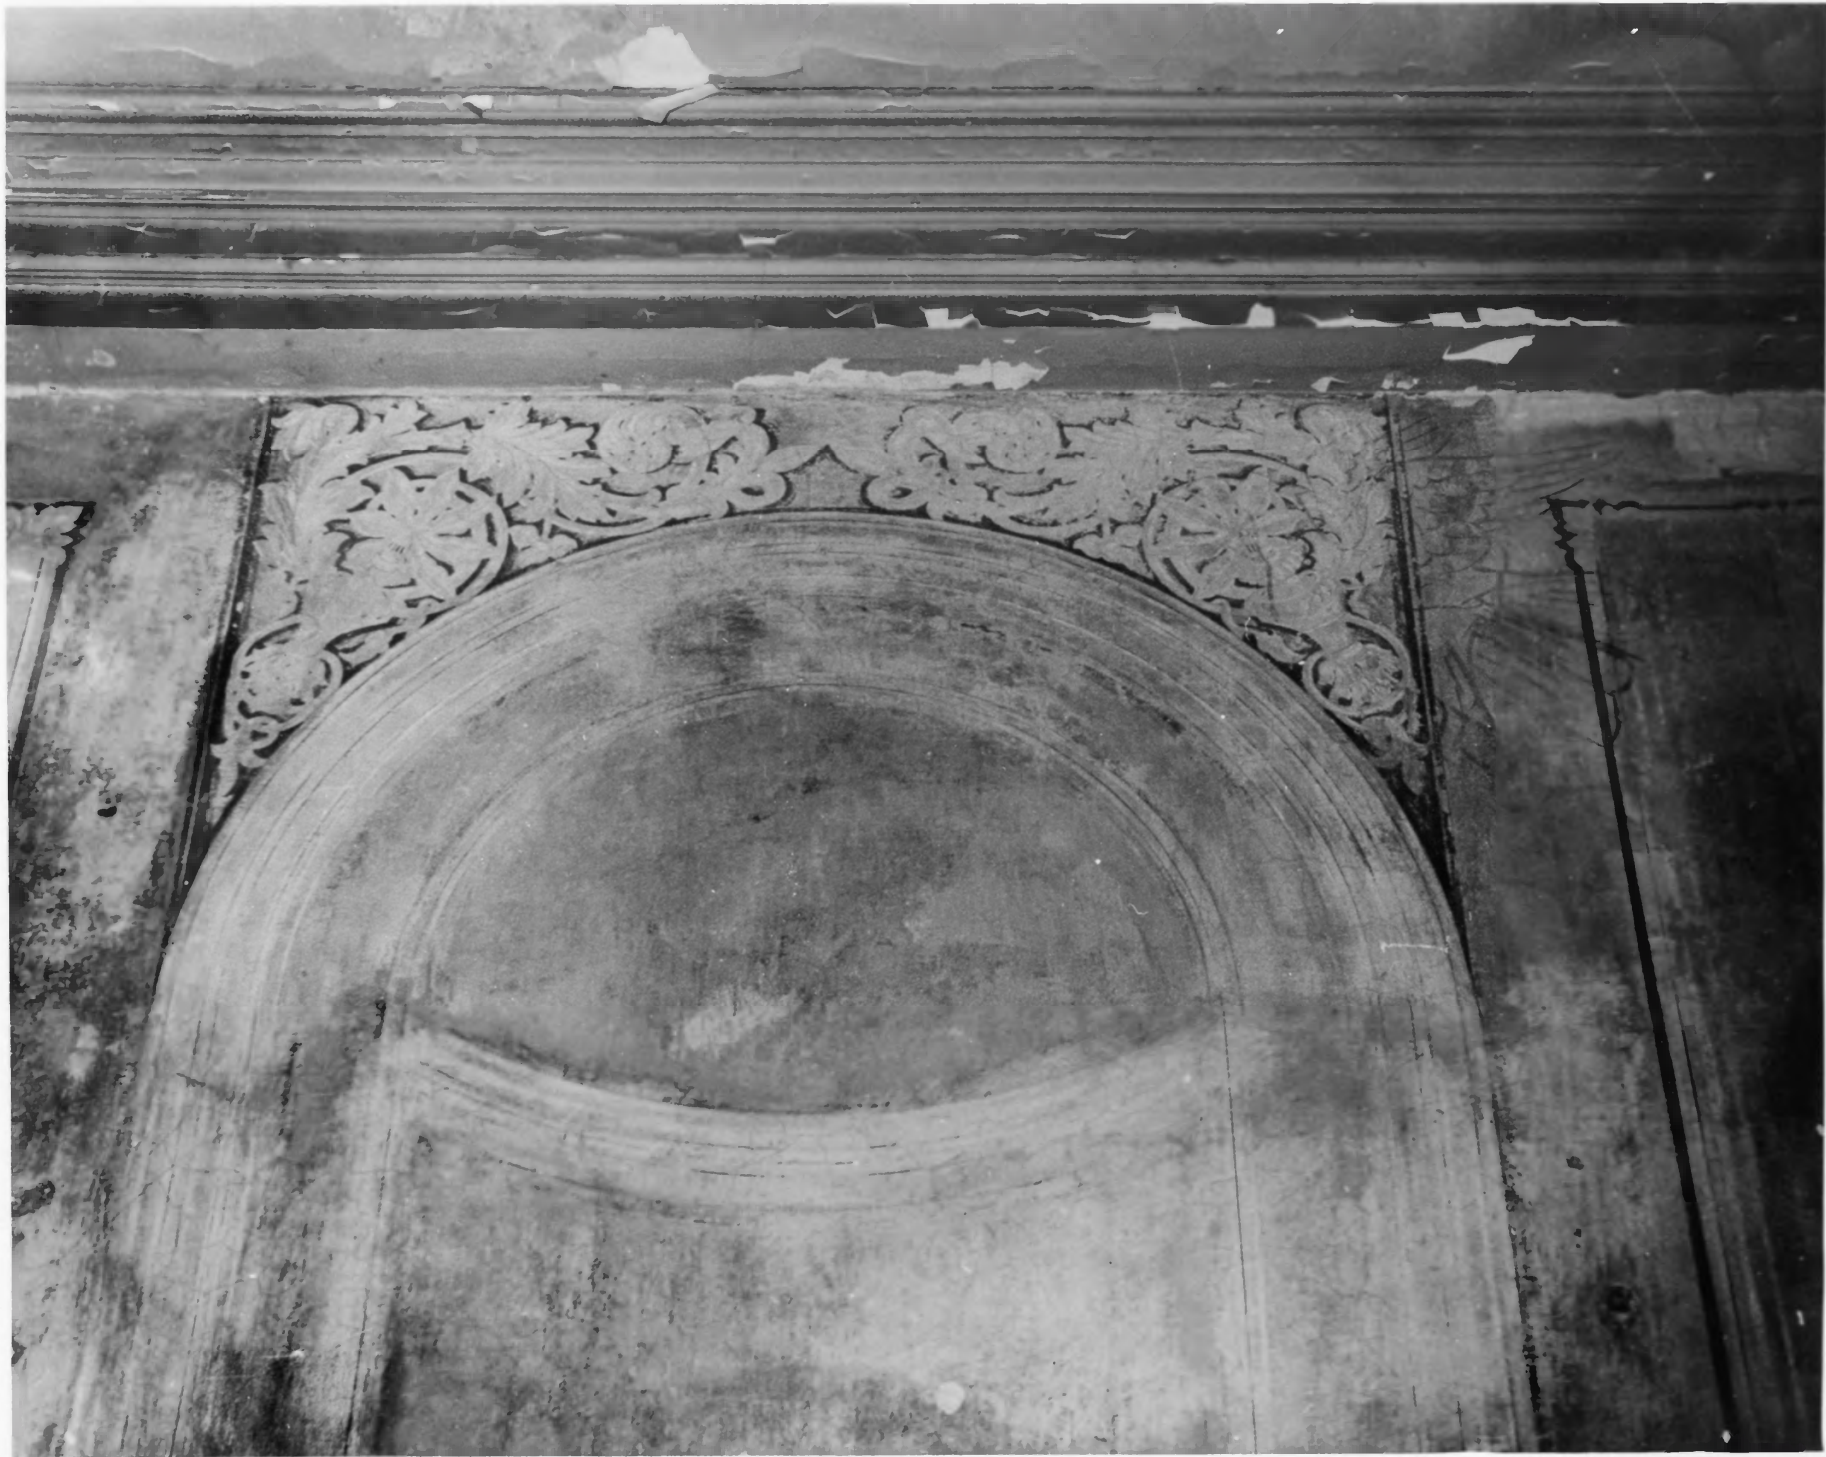
- 1) Wheeling Custom House
- 2) Wheeling, West Virginia
- 3) Beverly Plutz
- 4) c 1976
- 5) West Virginia Independence Hall Foundation
- 6) frescoes on north wall of courtroom above judge's desk; camera facing north

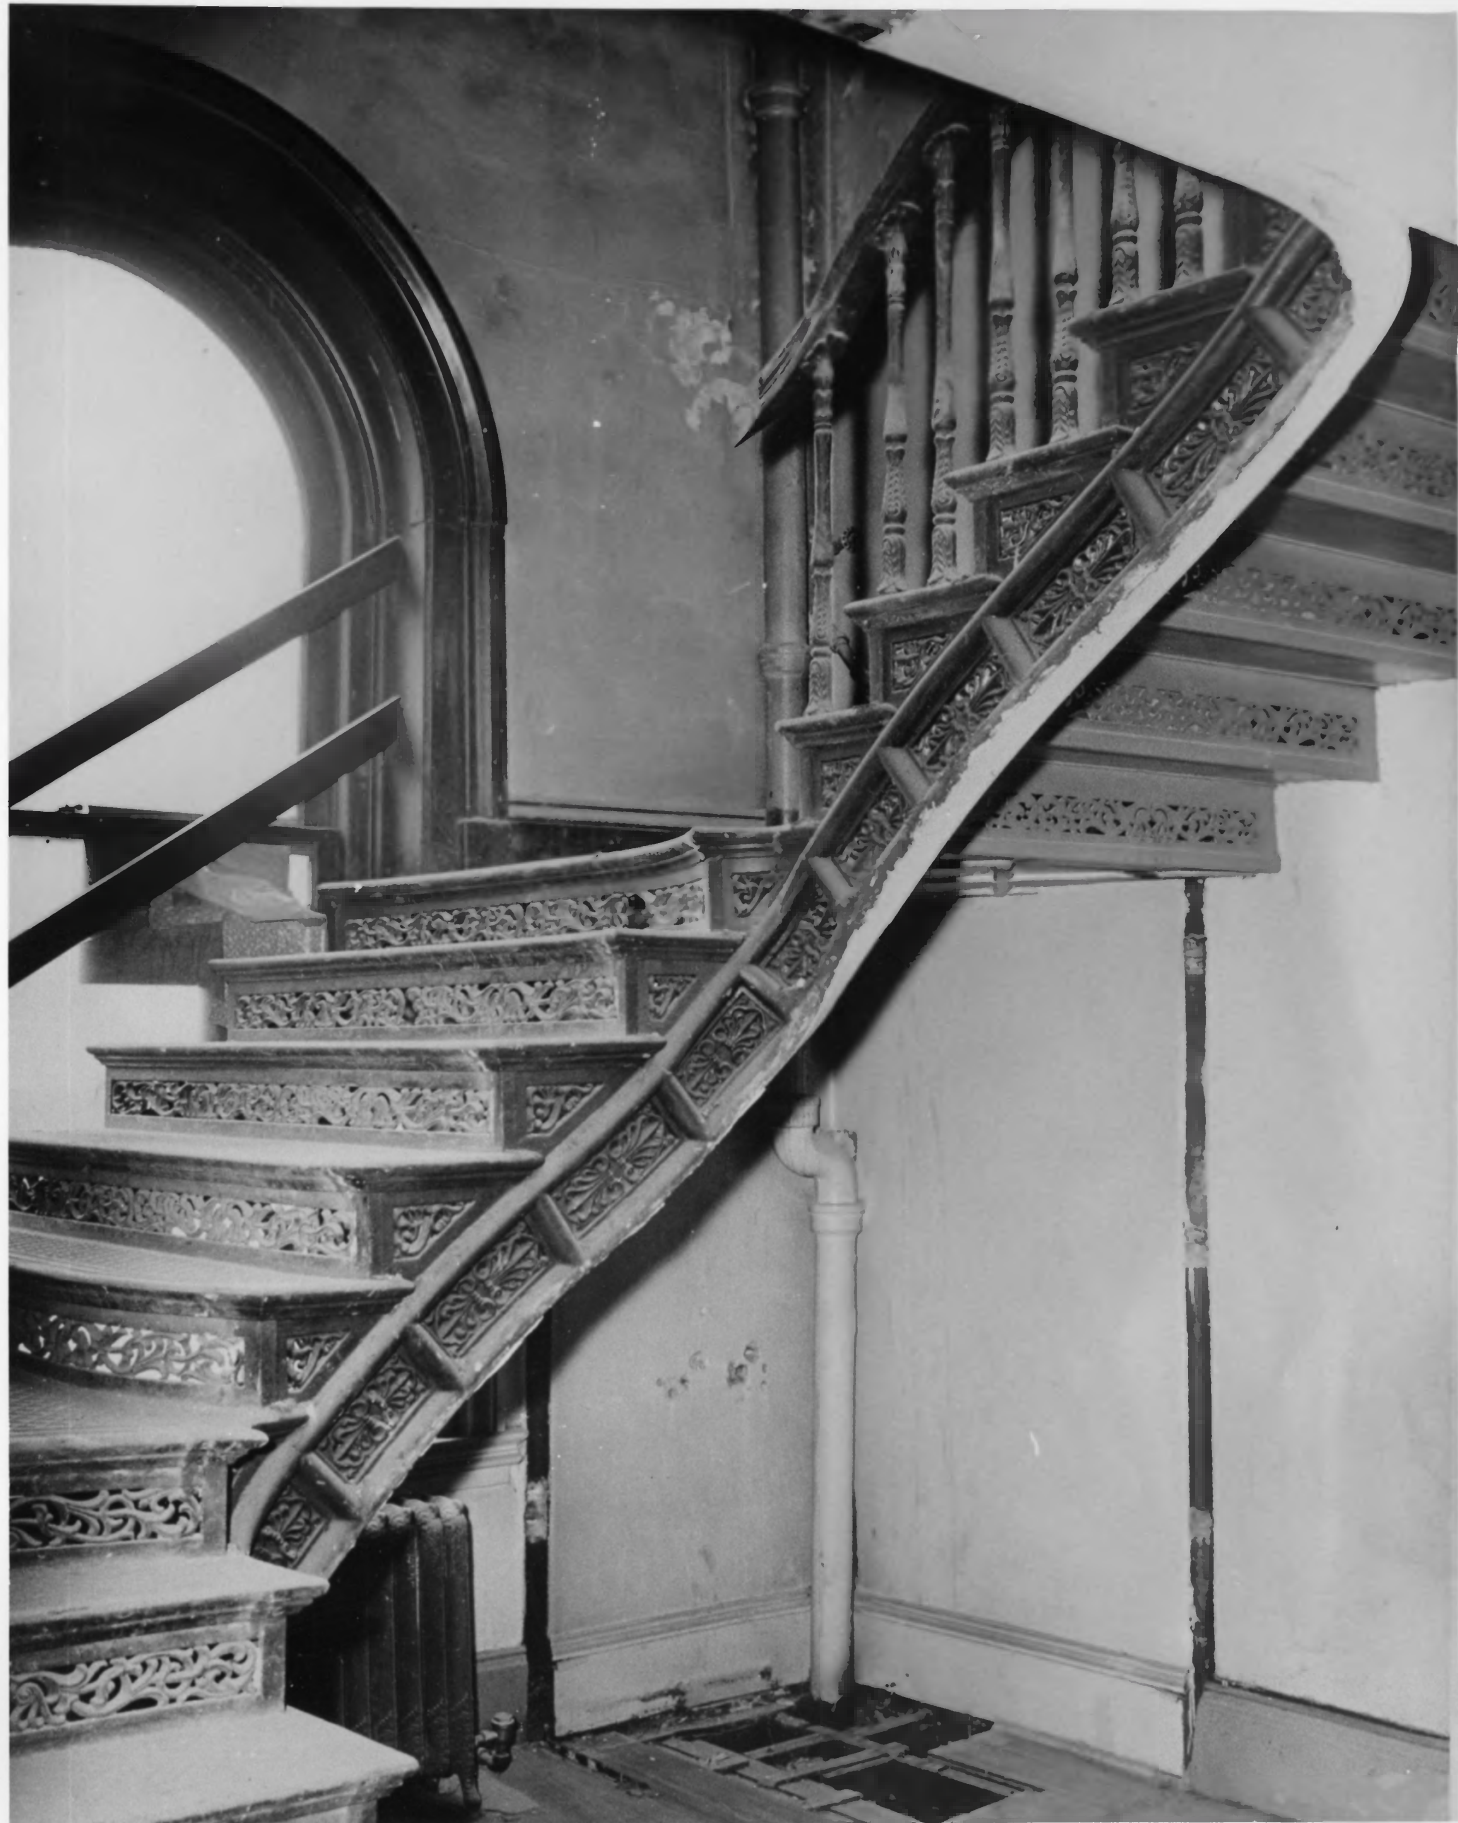
6) 1858 staircase from north end of 3rd

floor, leading to petit jury rooms on

mezzanine; camera facing northeast
