1) Wheeling Custom House

2) Wheeling, West Virginia

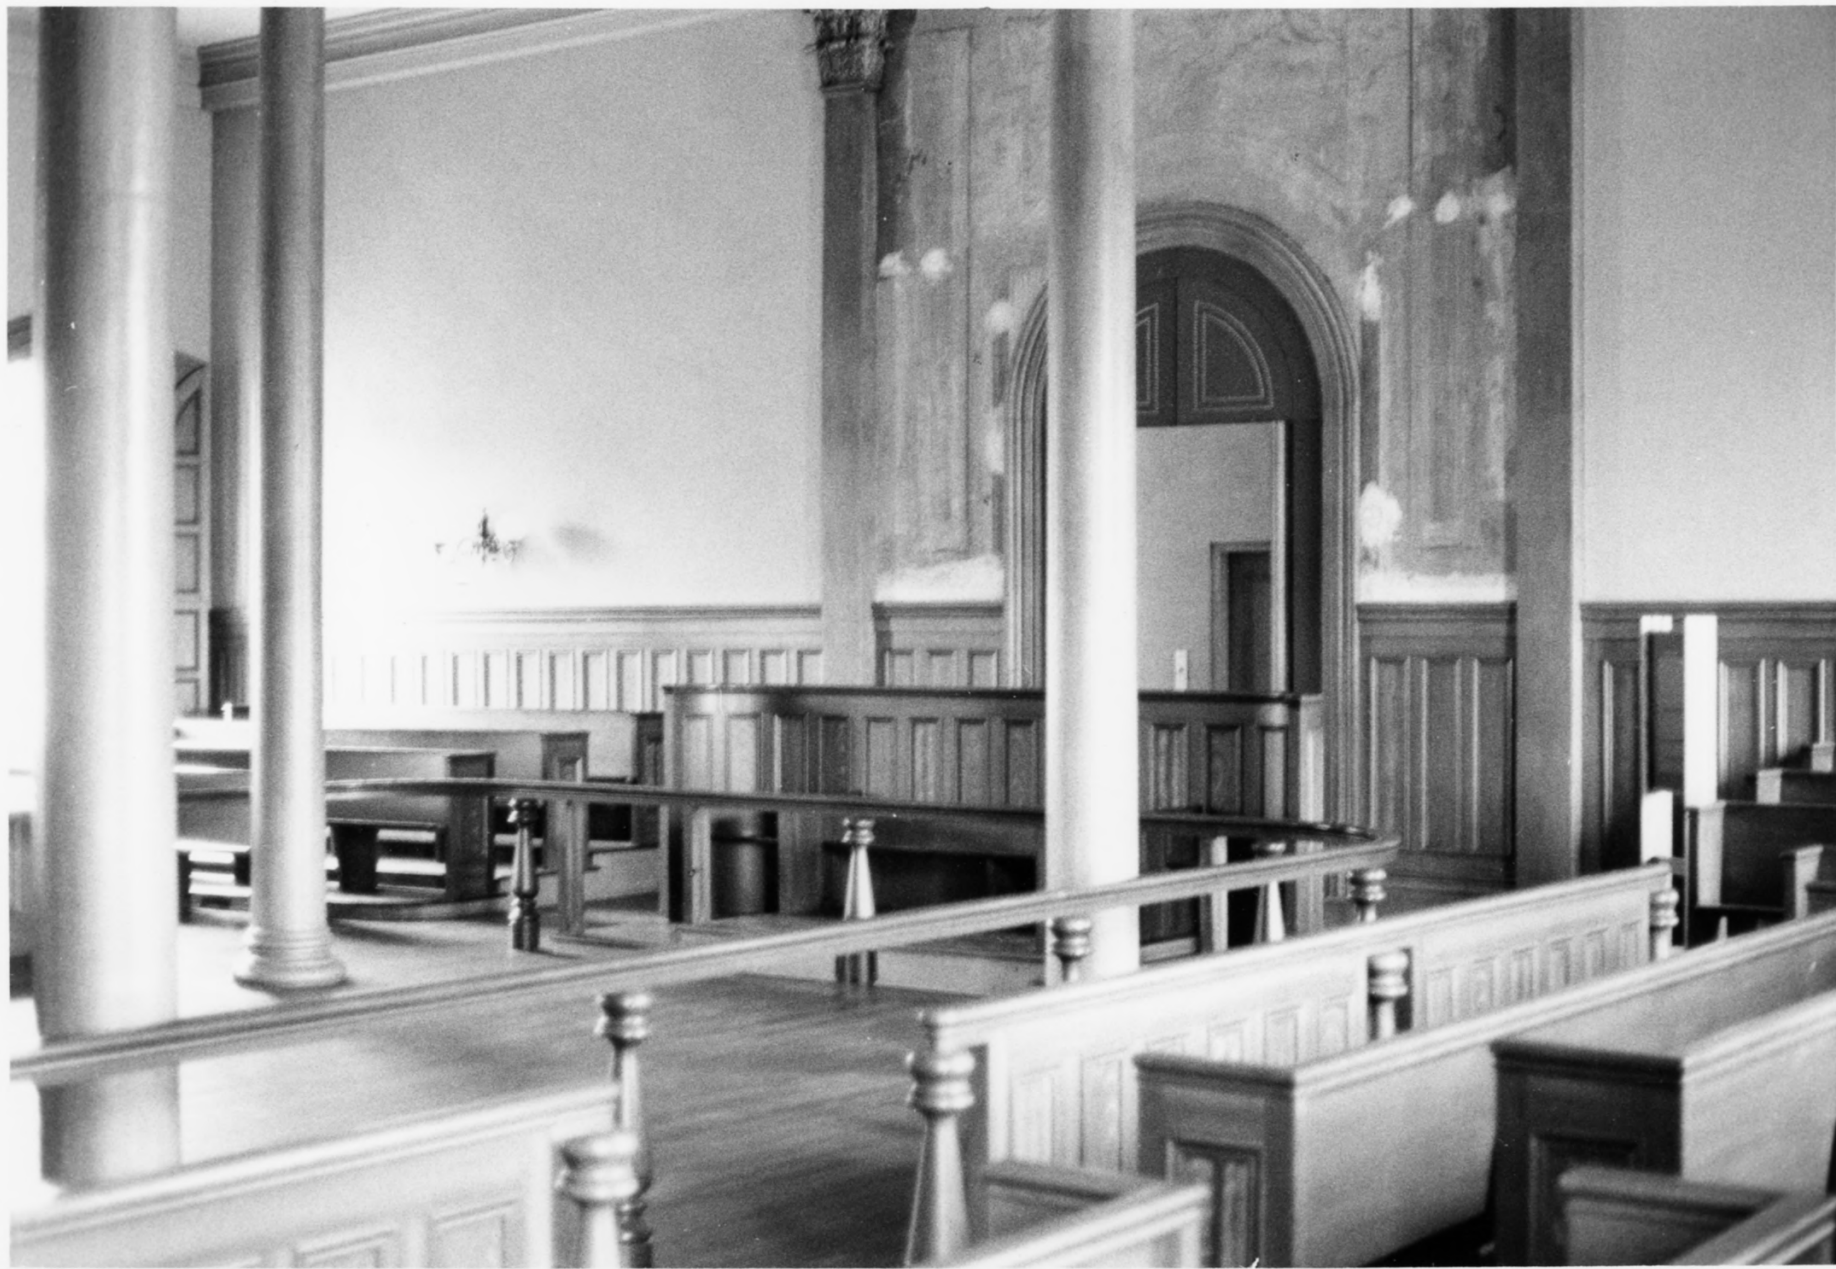
View: Courtroom showing entrance to
courtroom with unrestored "cartoons"
around door. Camera facing
Southeast.

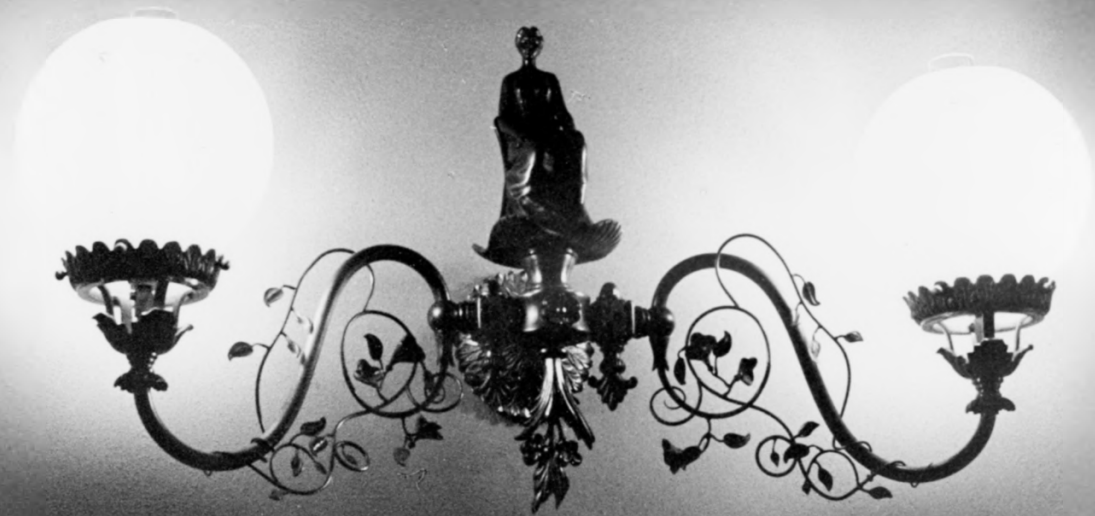
view: Sample gas light in courtroom.

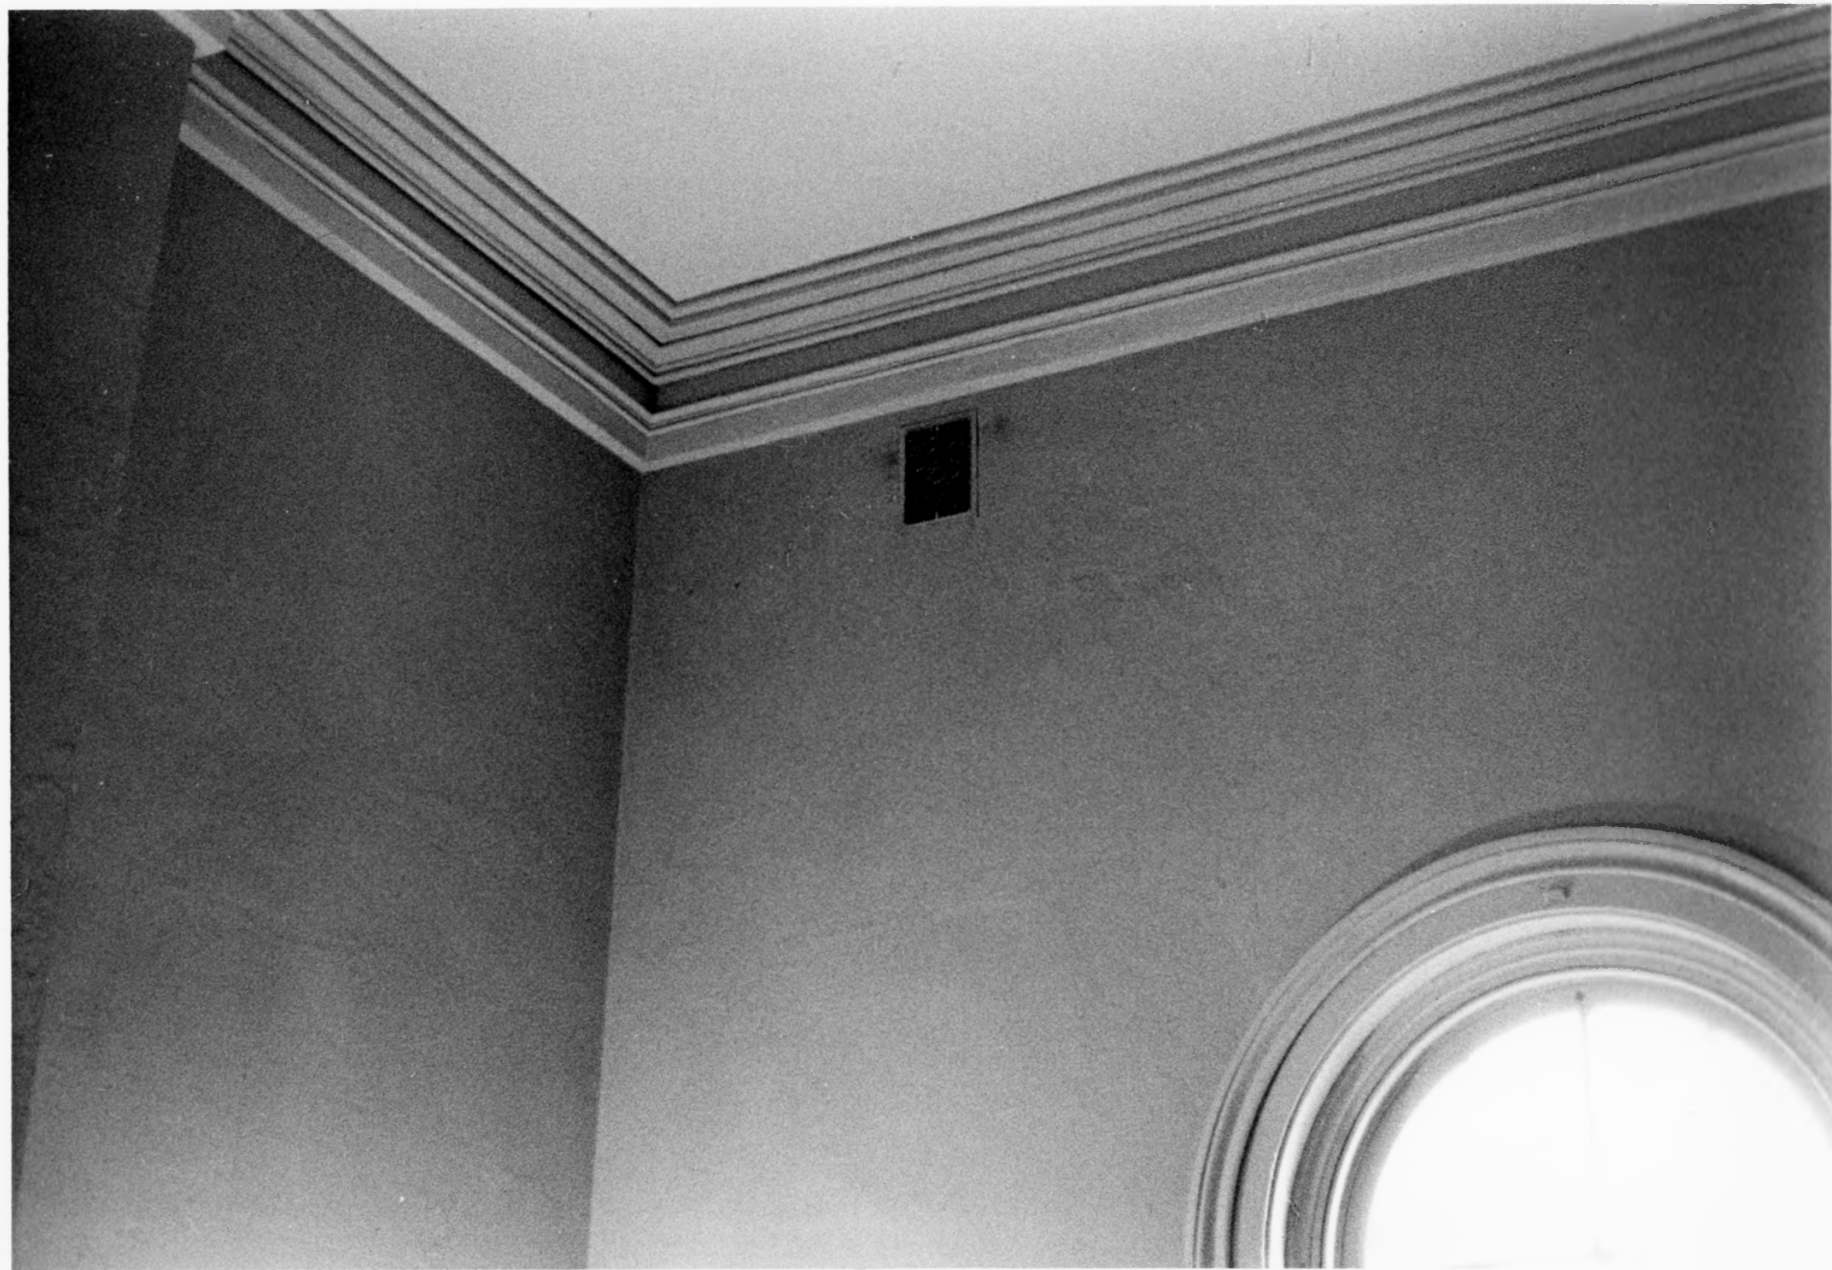
view: Third floor Marshal's Room. Original
heating system return air duct
in wall in photo center. Camera
facing southwest

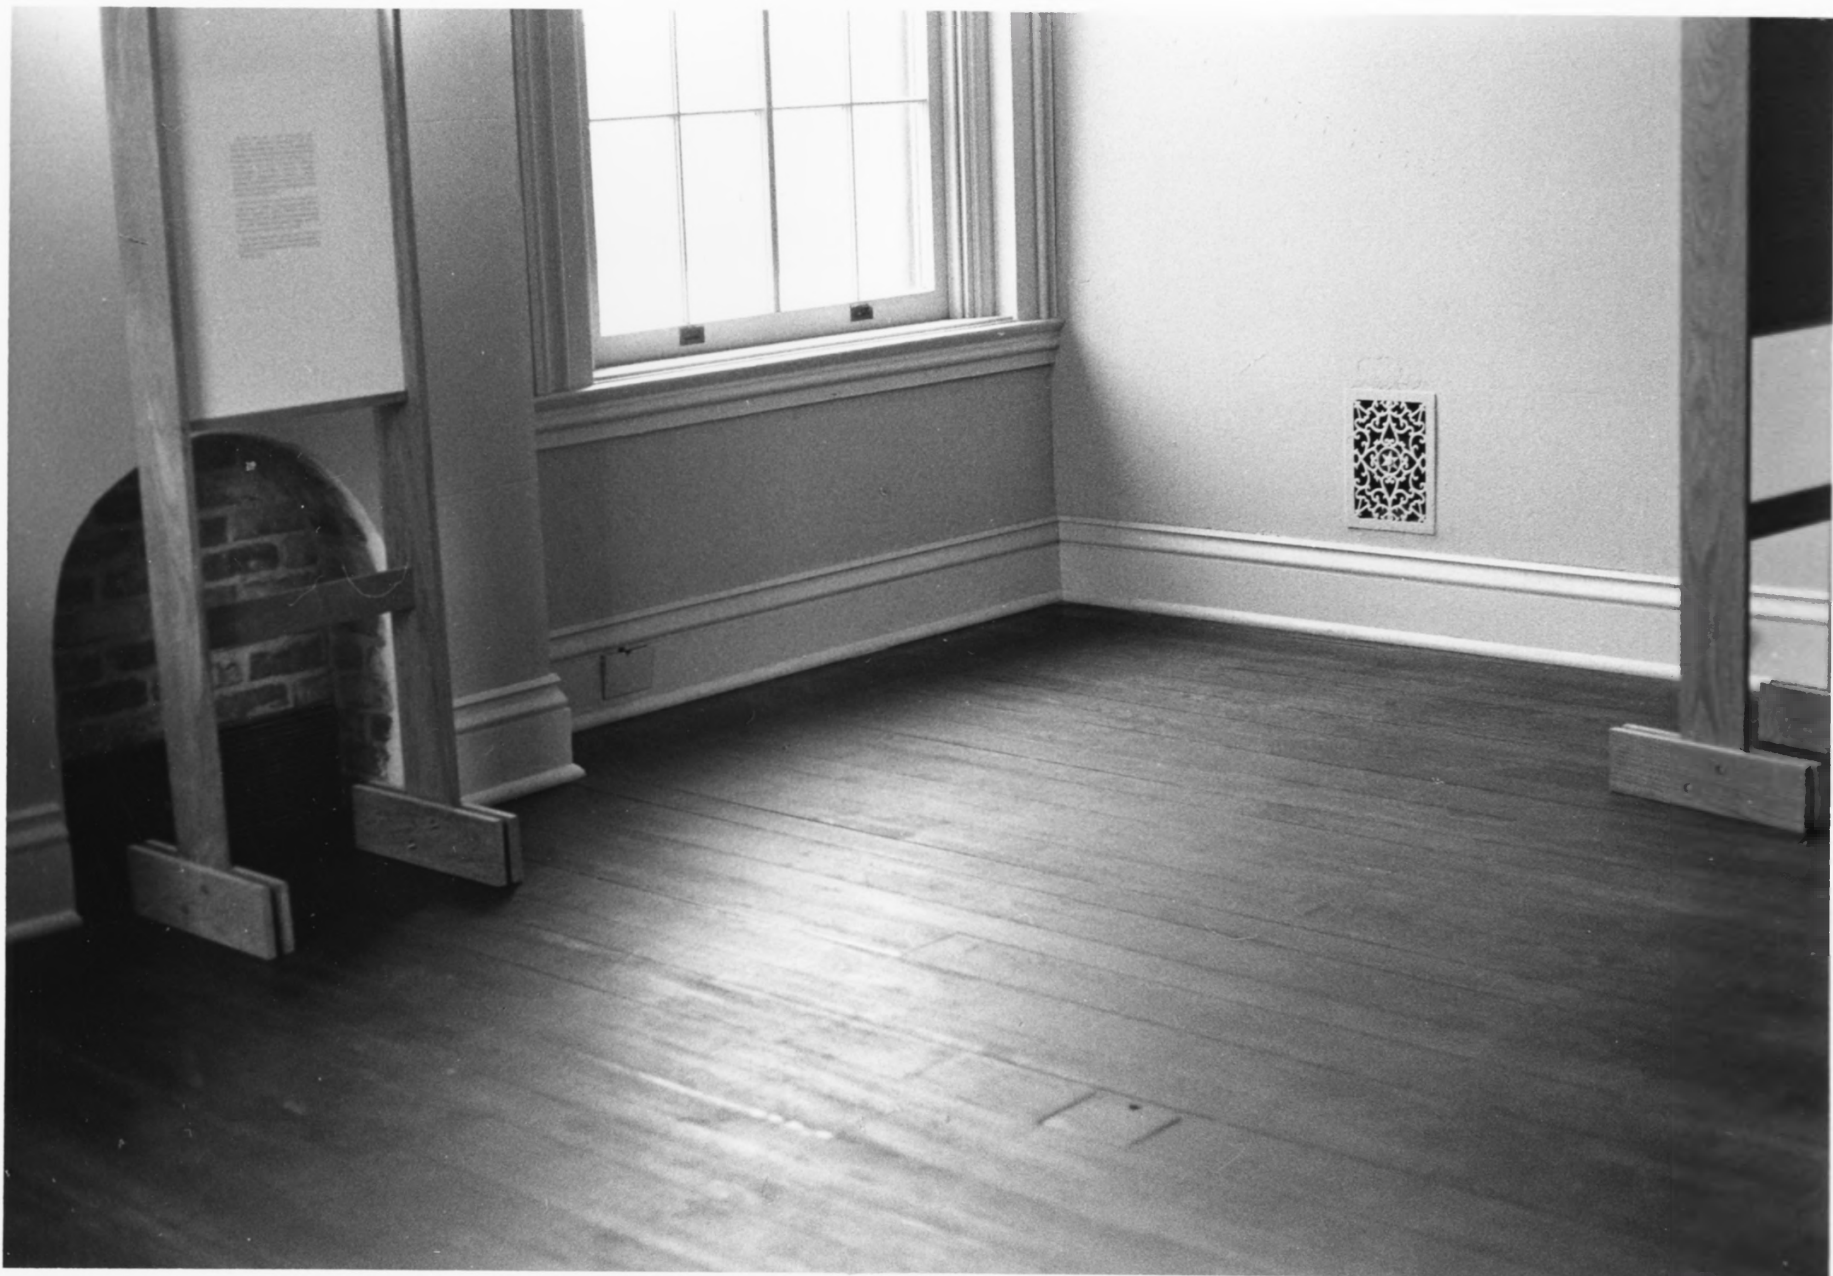
view: Third floor library. Original heating duct on wall
at right; modern vent in bottom of fireplace
at left for airconditioning system. Camera
facing southwest.

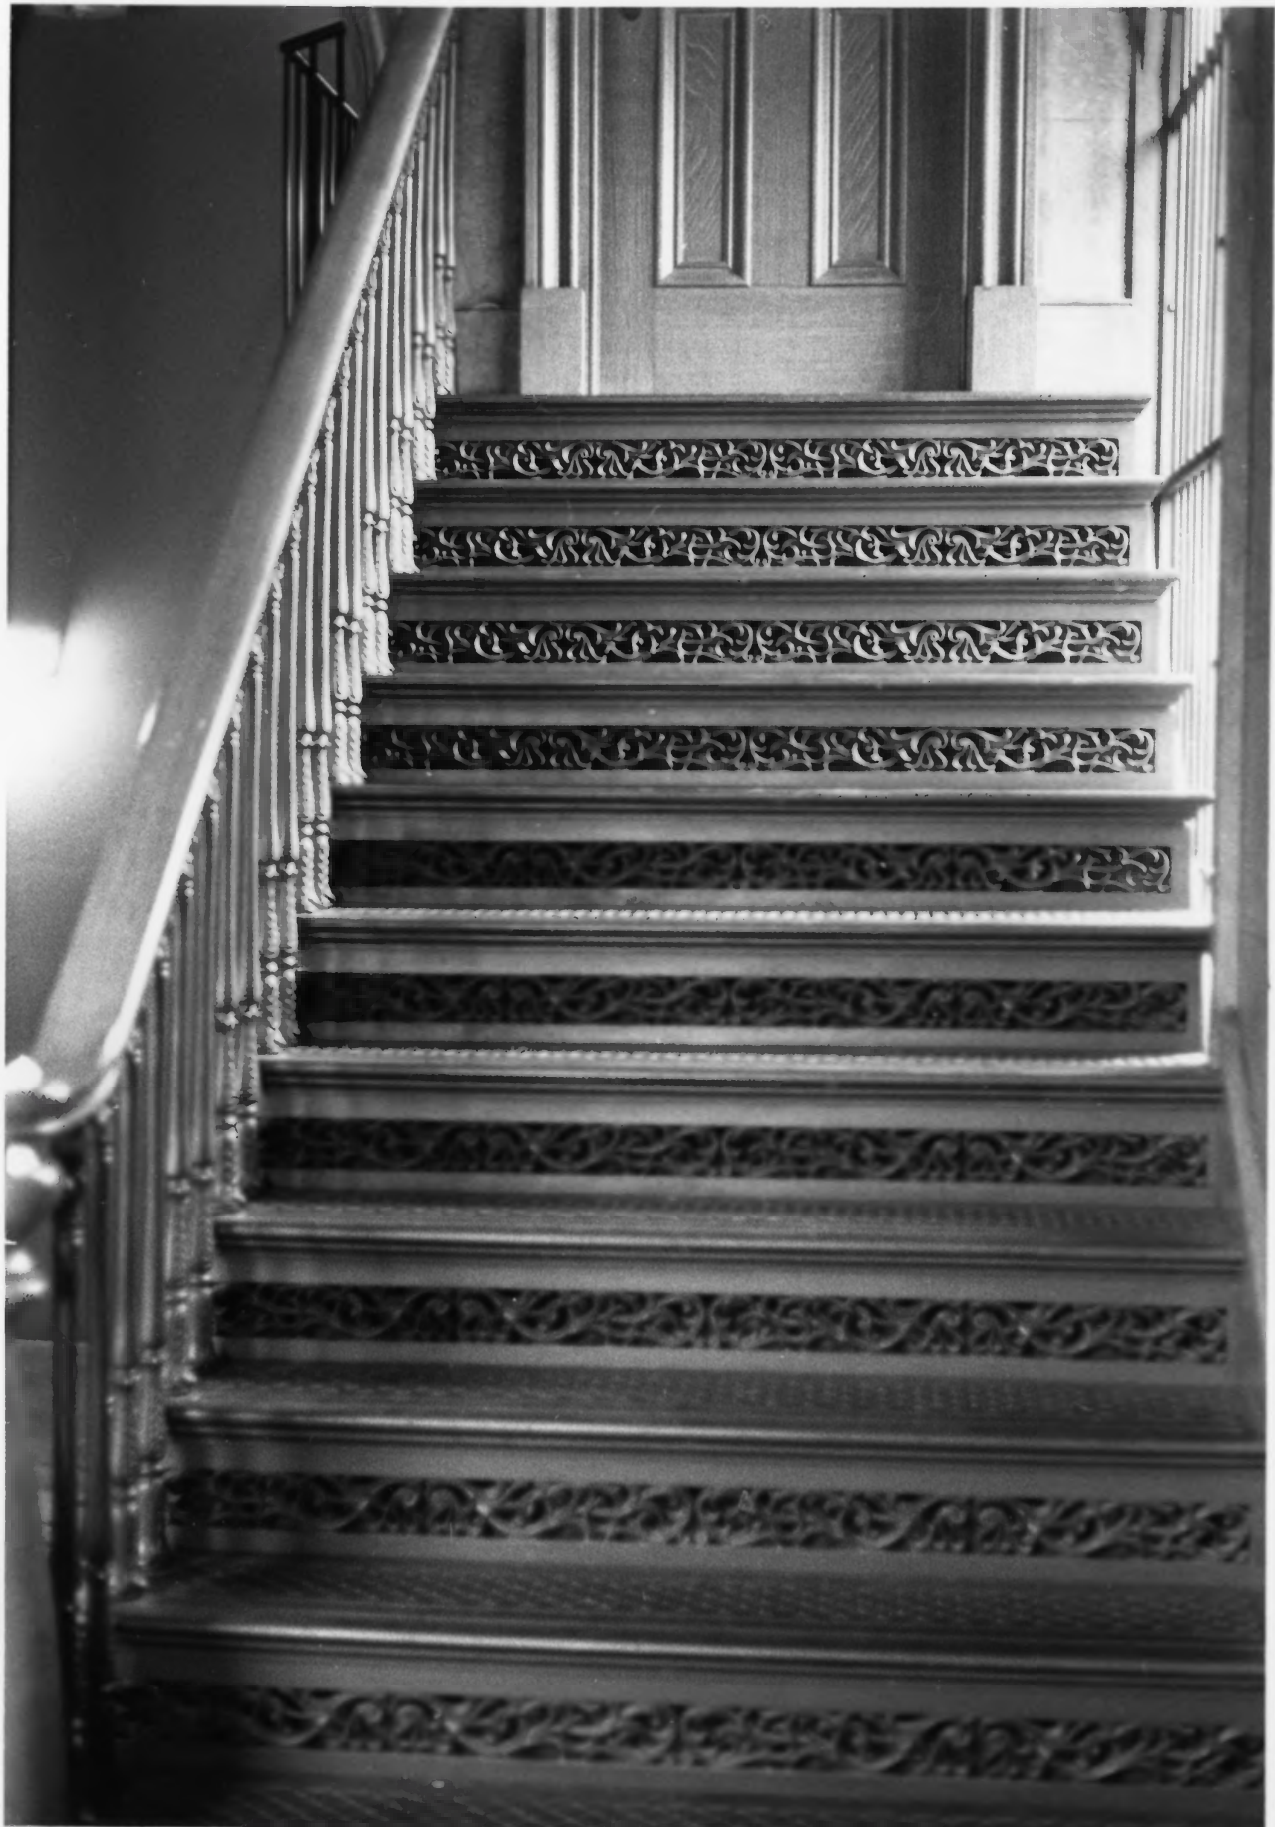
view: Stairway at south end of post
office vestibule that leads to 2nd
floor. Camera facing east.

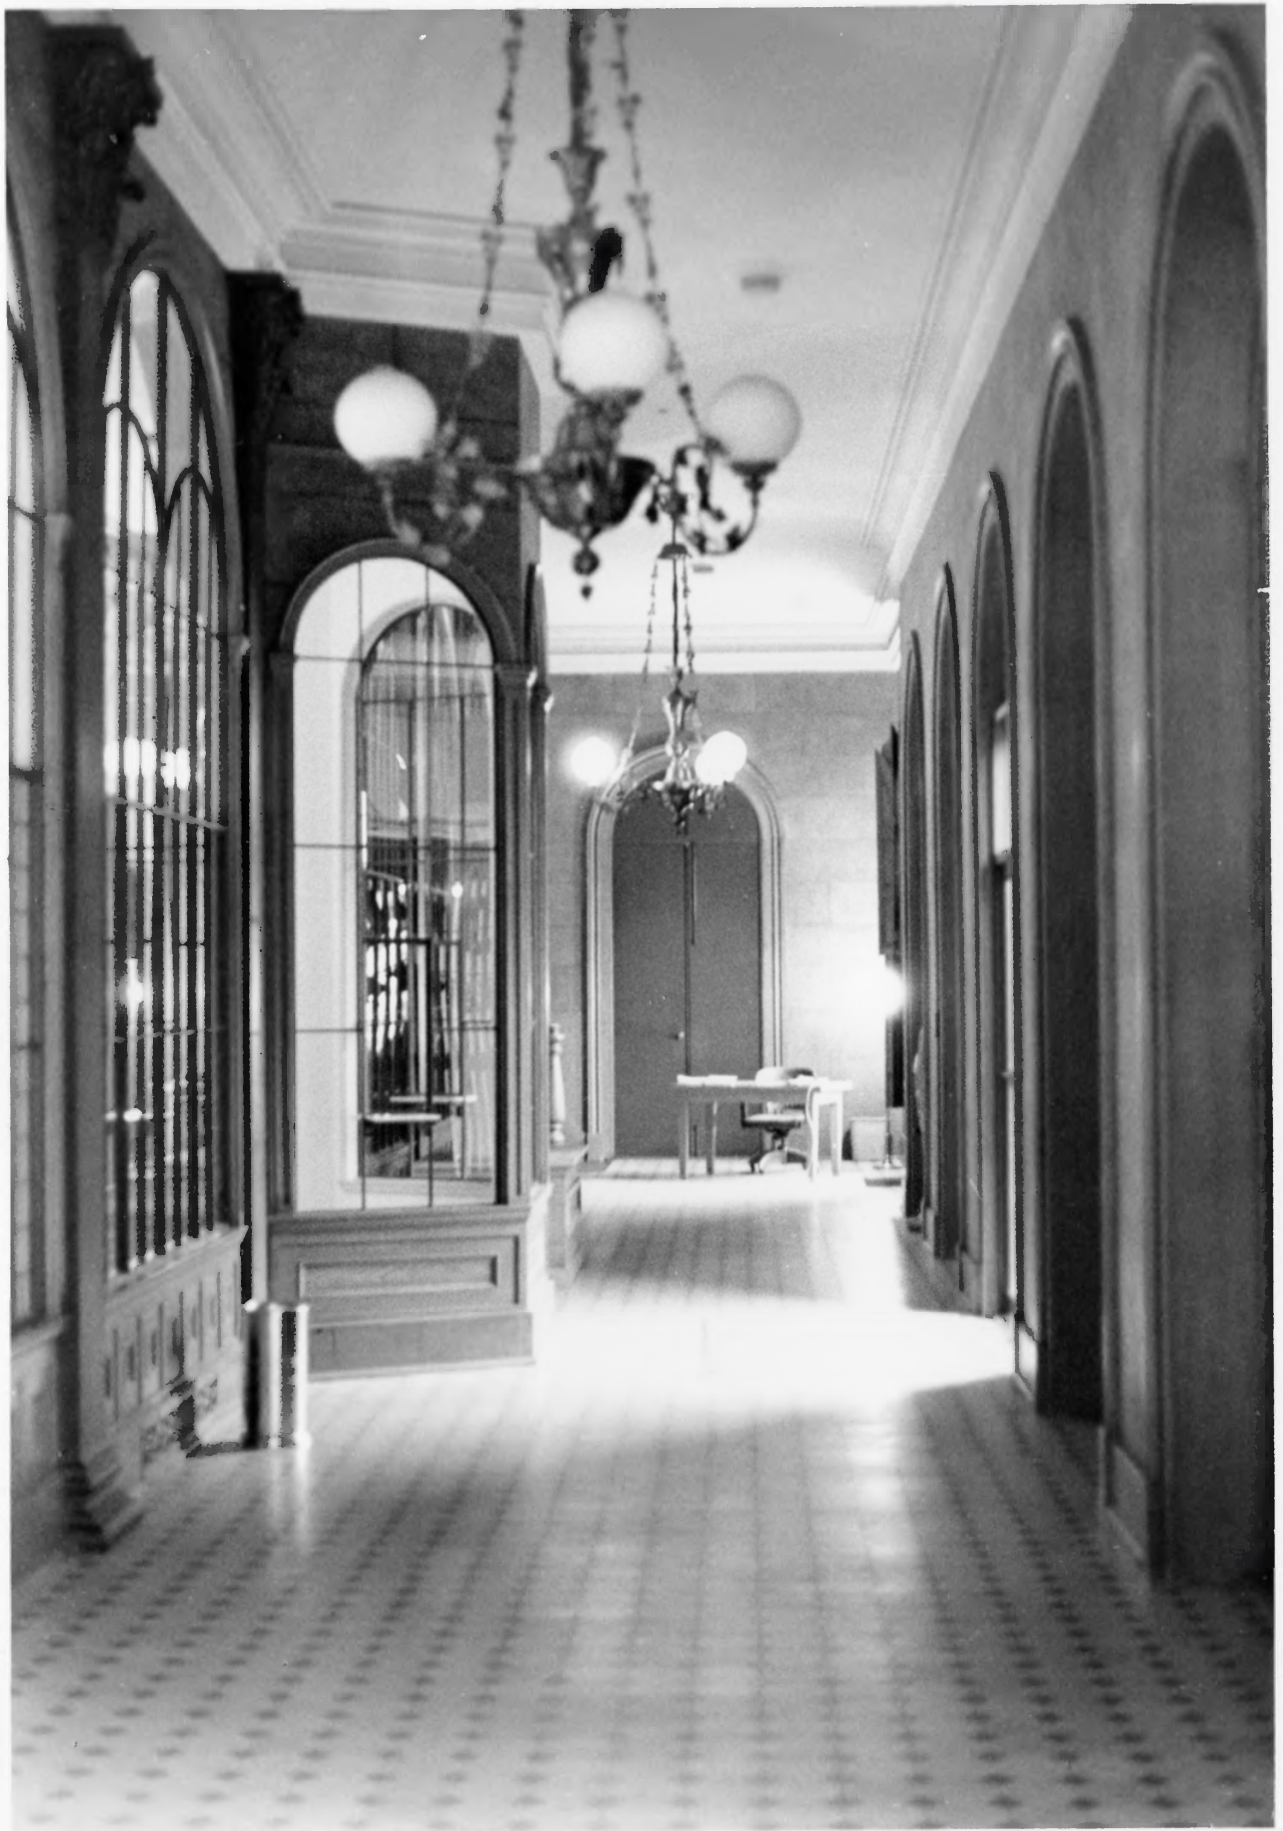
view: Post office vestibule with mail boxes/
Screen to left. Camera facing south.

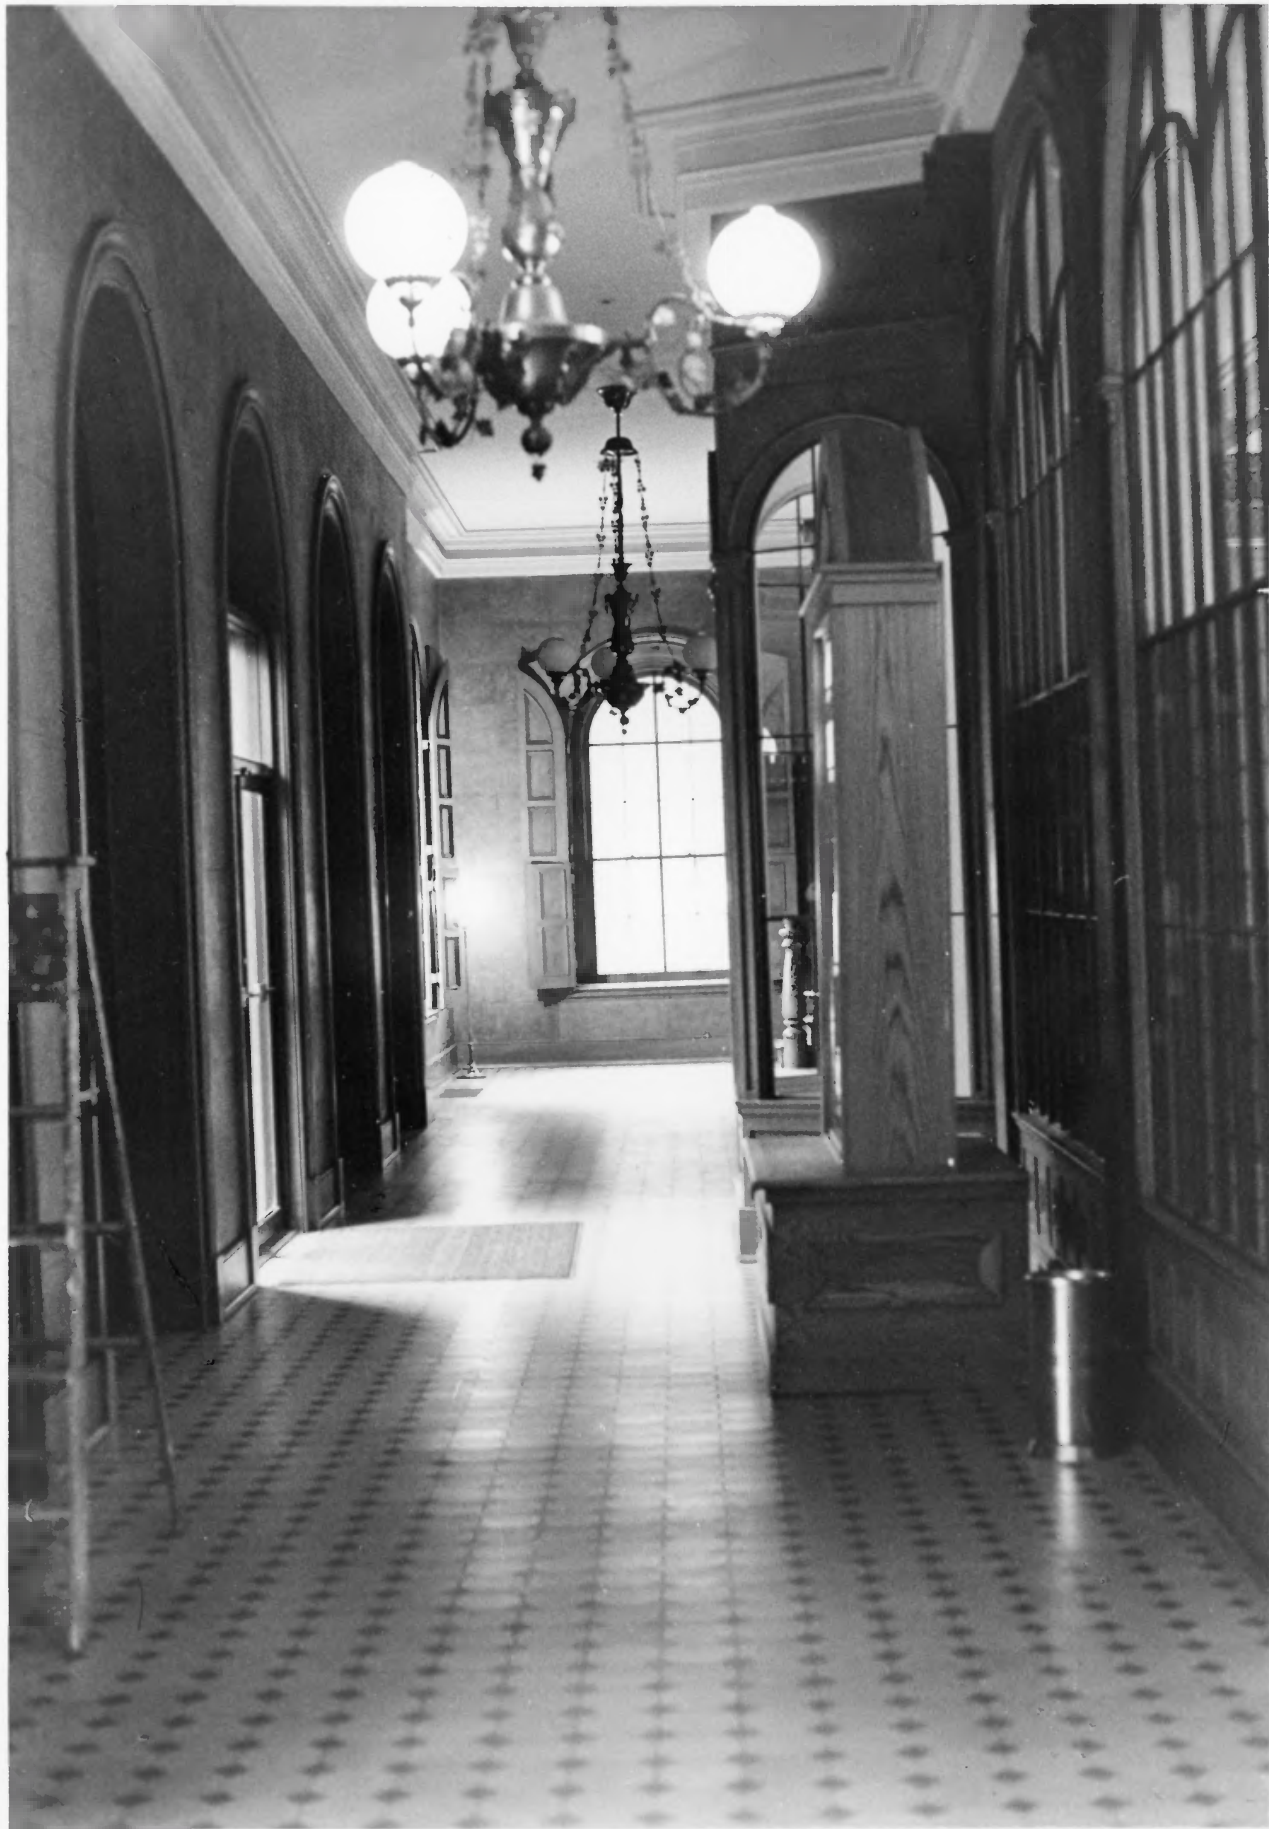
view: Post office vestibule with mail boxes / screen
to right. Camera facing north.

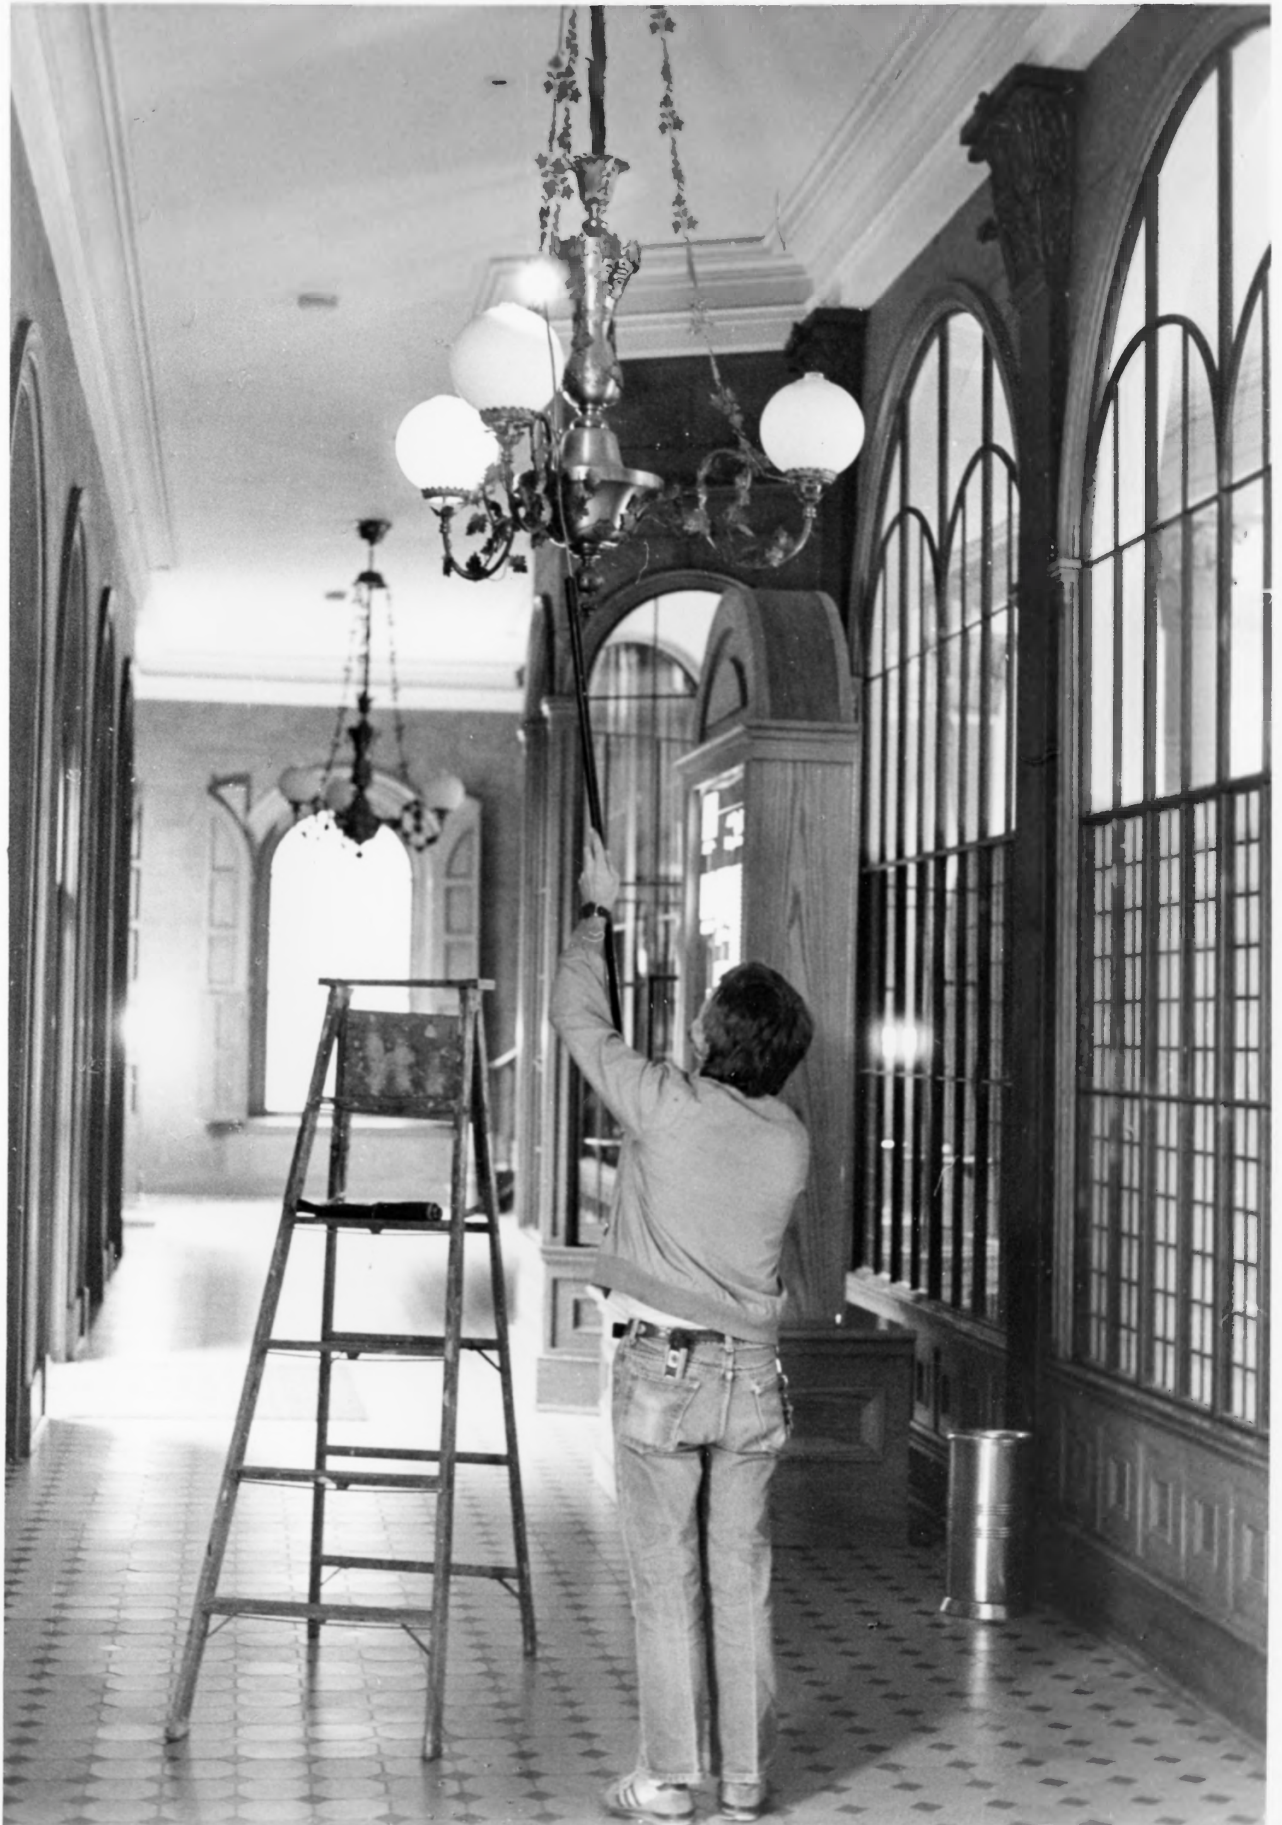
view: Post Office vestibule showing gas lamps
being lit. Camera facing north.

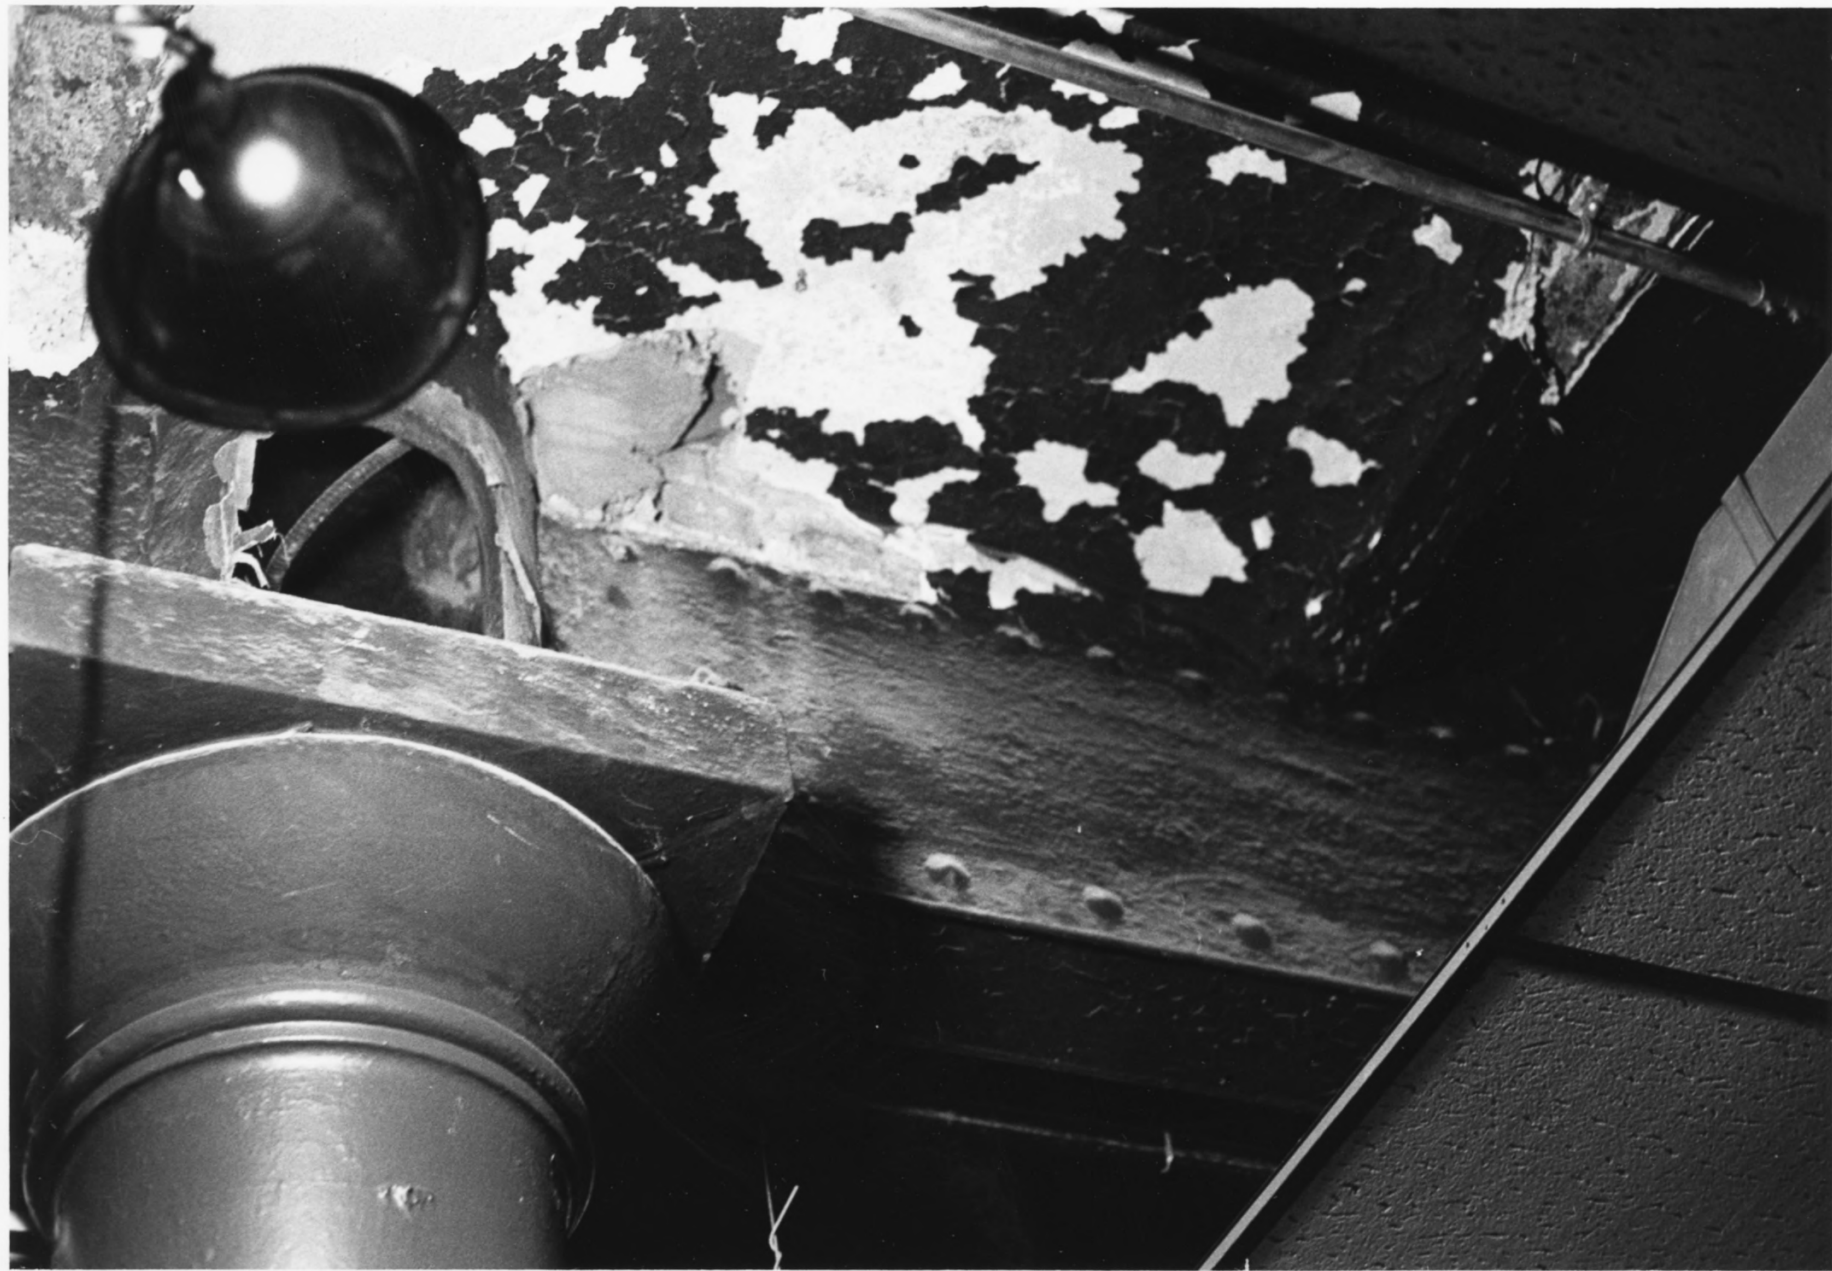
View: Framing system of building
left "unrestored" in basement
to expose rolled iron beams and
iron column and brick arches. Hole
in beam was used for hot air in
central heating system

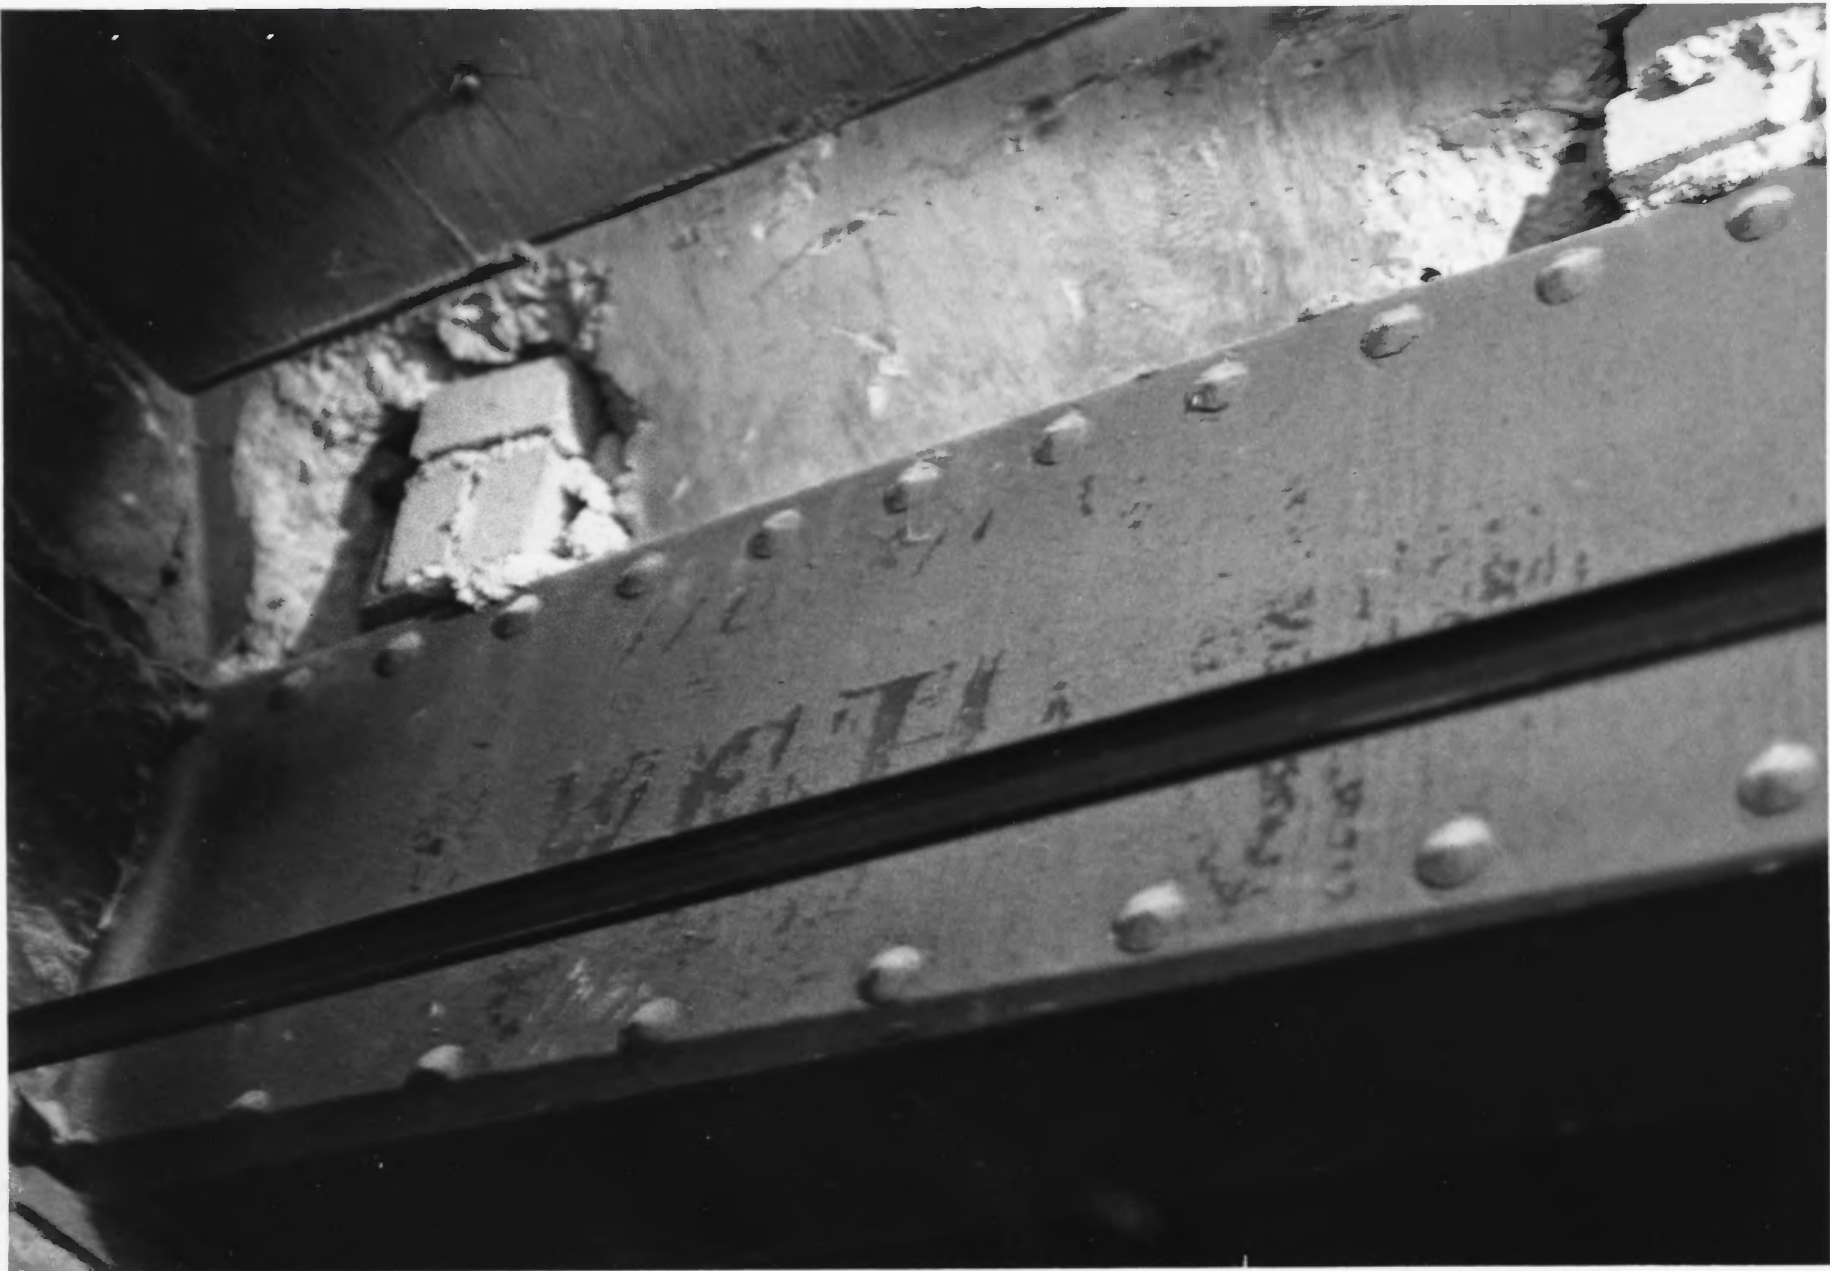
view: Rolled iron beam stamped "W.C.H." for
"Wheeling Custom House" in basement
