1) Wheeling Custom House

2) Wheeling, West Virginia

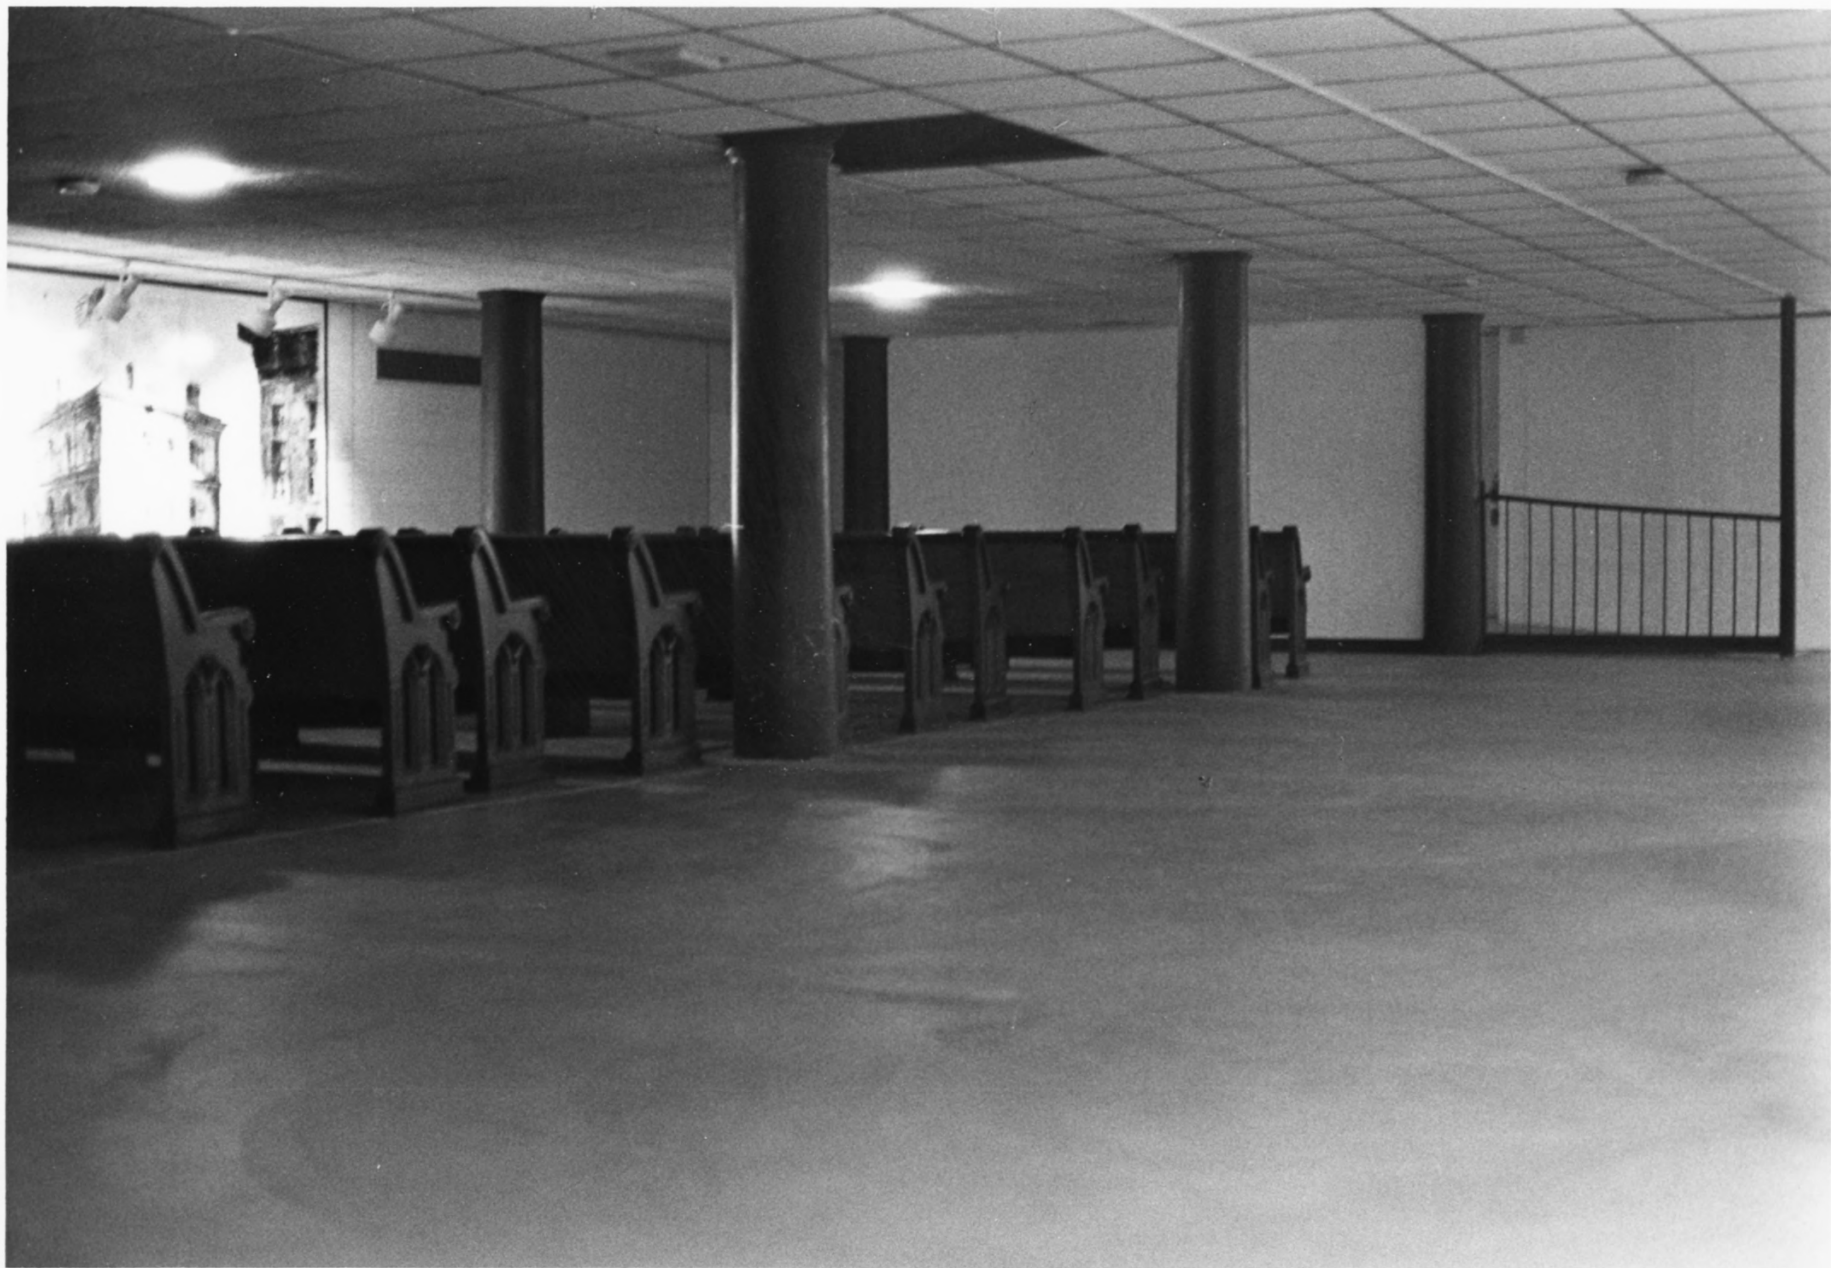
view: Basement showing movie screen in center, mechanical room at left, hole in ceiling to expose framing system.

Elevator is behind movie screen.

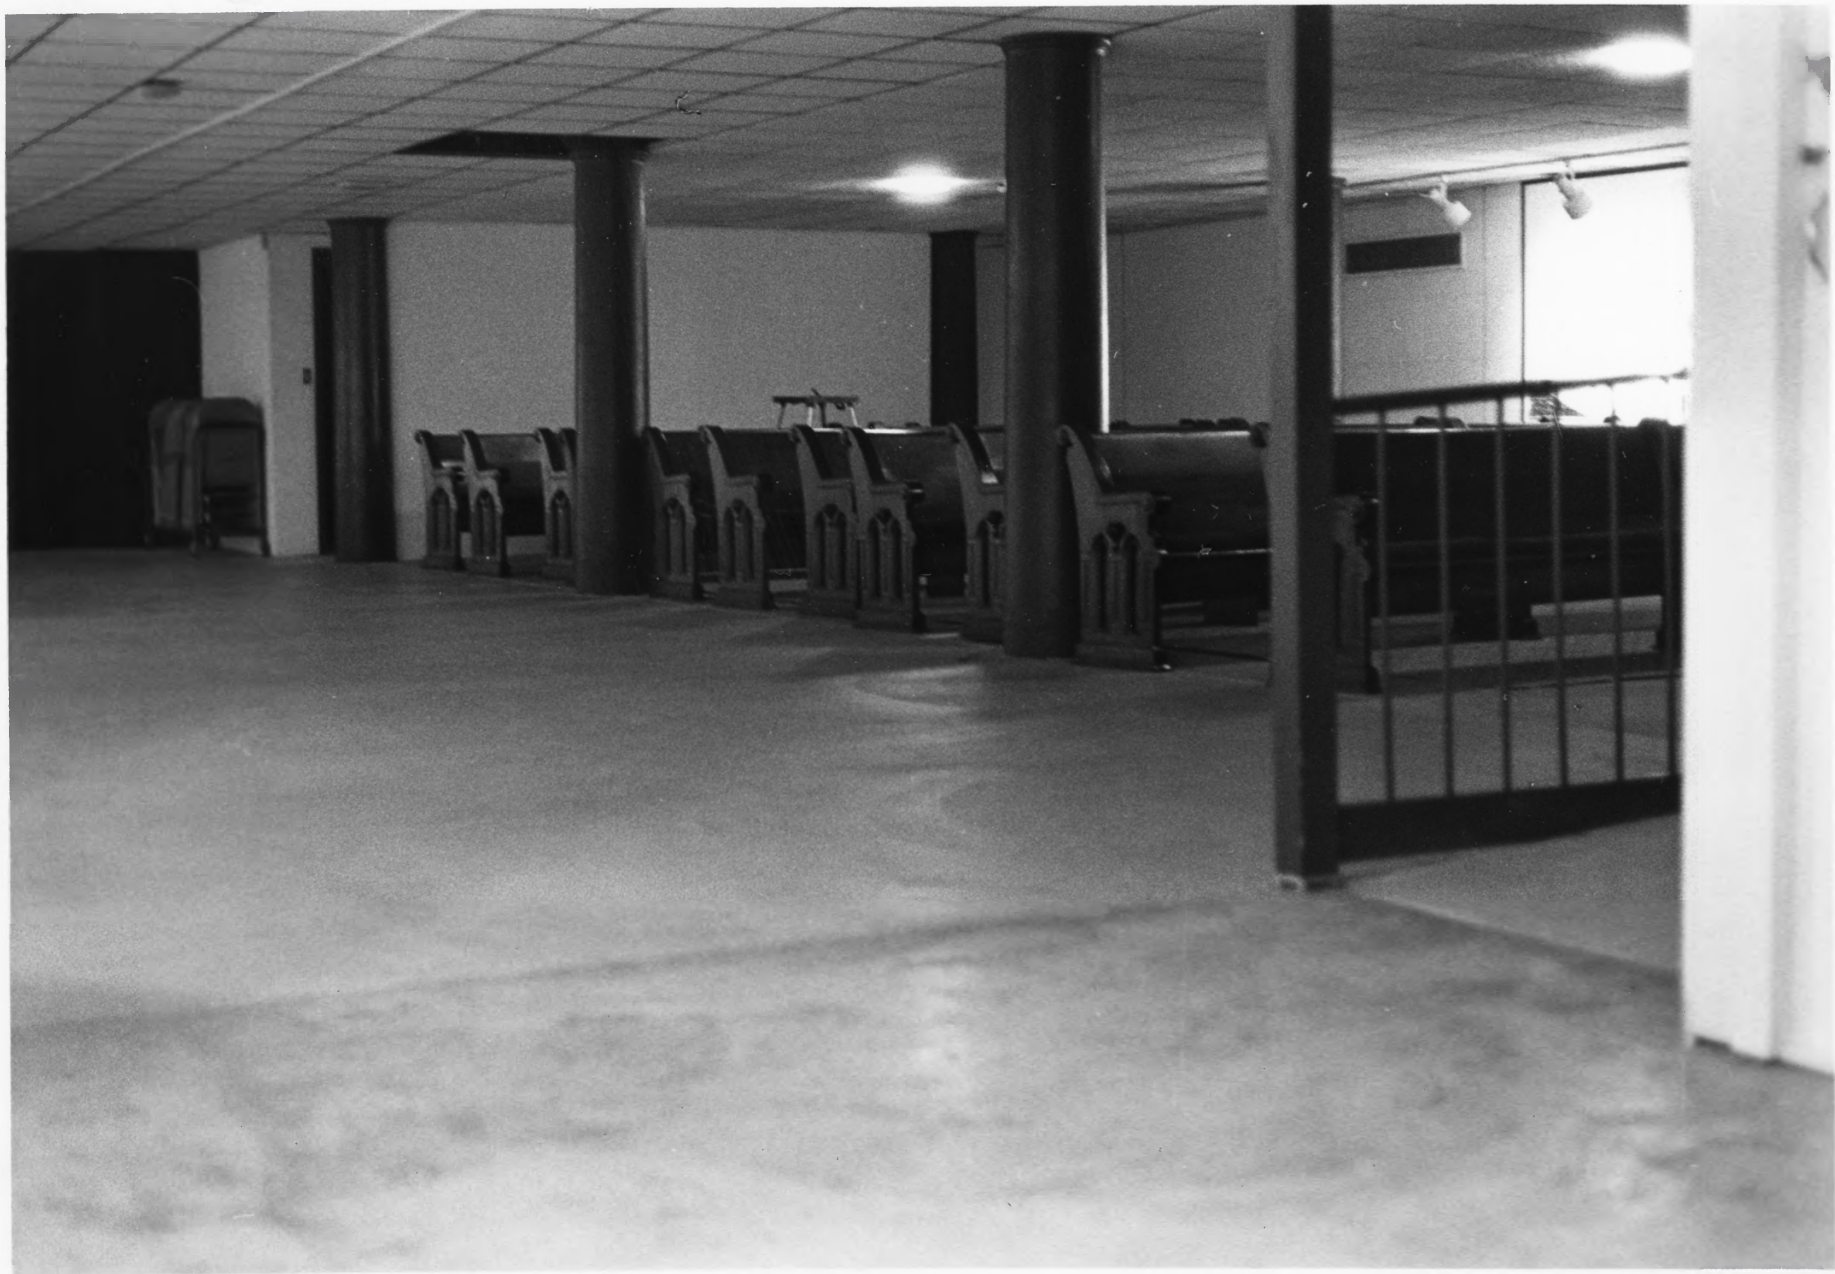
view: Basement showing mechanical room
at right. Restrooms are in wall behind
church pews. Camera facing north.

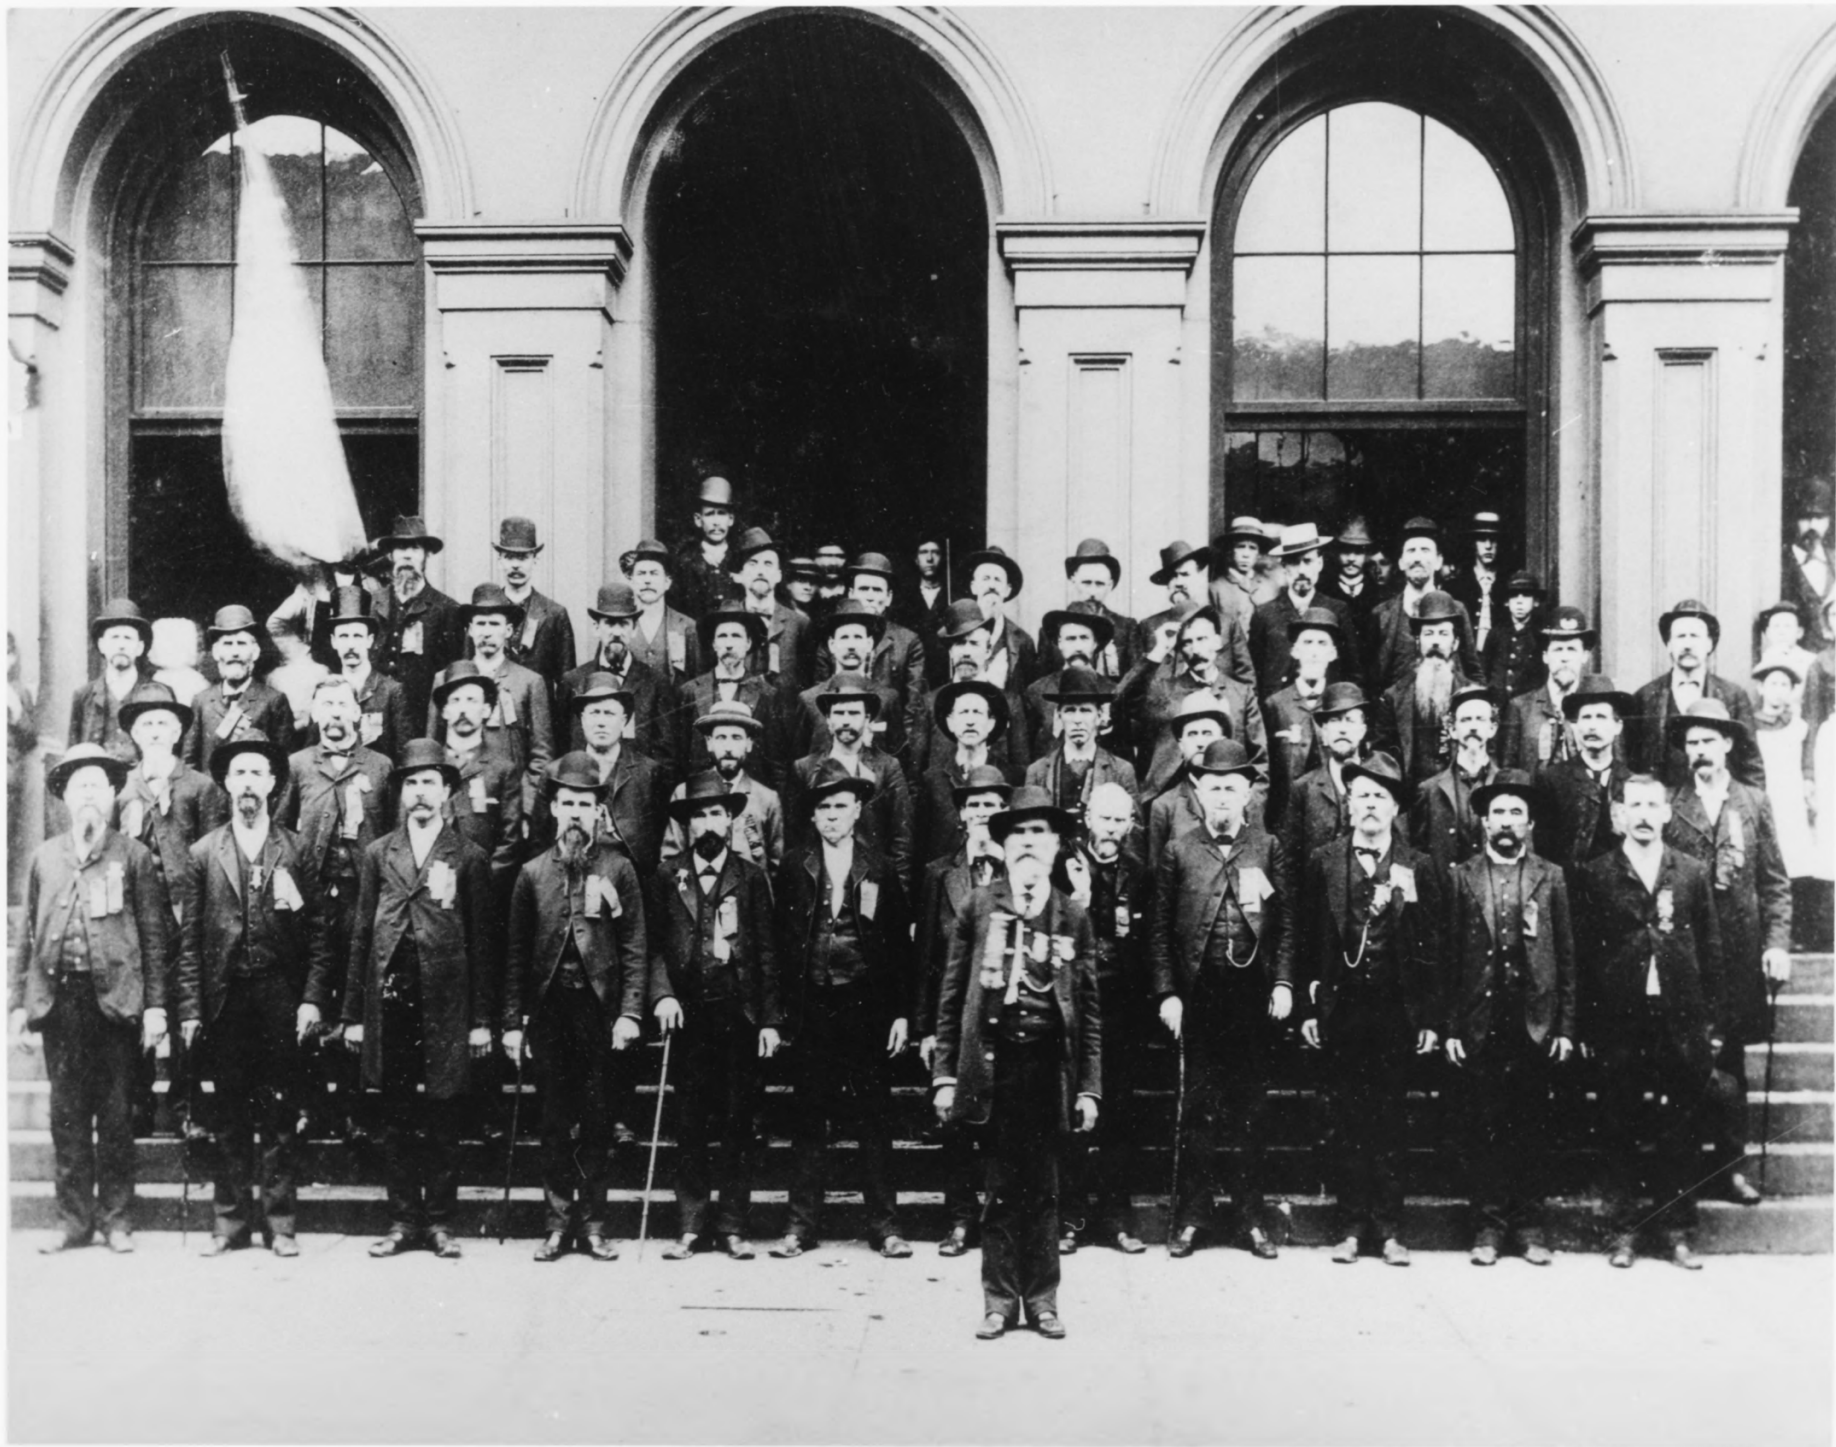
- 1) Wheeling Custom House
- 2) Wheeling, West Virginia
- 3) unknown
- 4) unknown
- 5) West Virginia Independence Hall Foundation
- 6) Group of (probably) Civil War veterans posed on west (front) steps; shows original front doors converted into windows; camera facing east

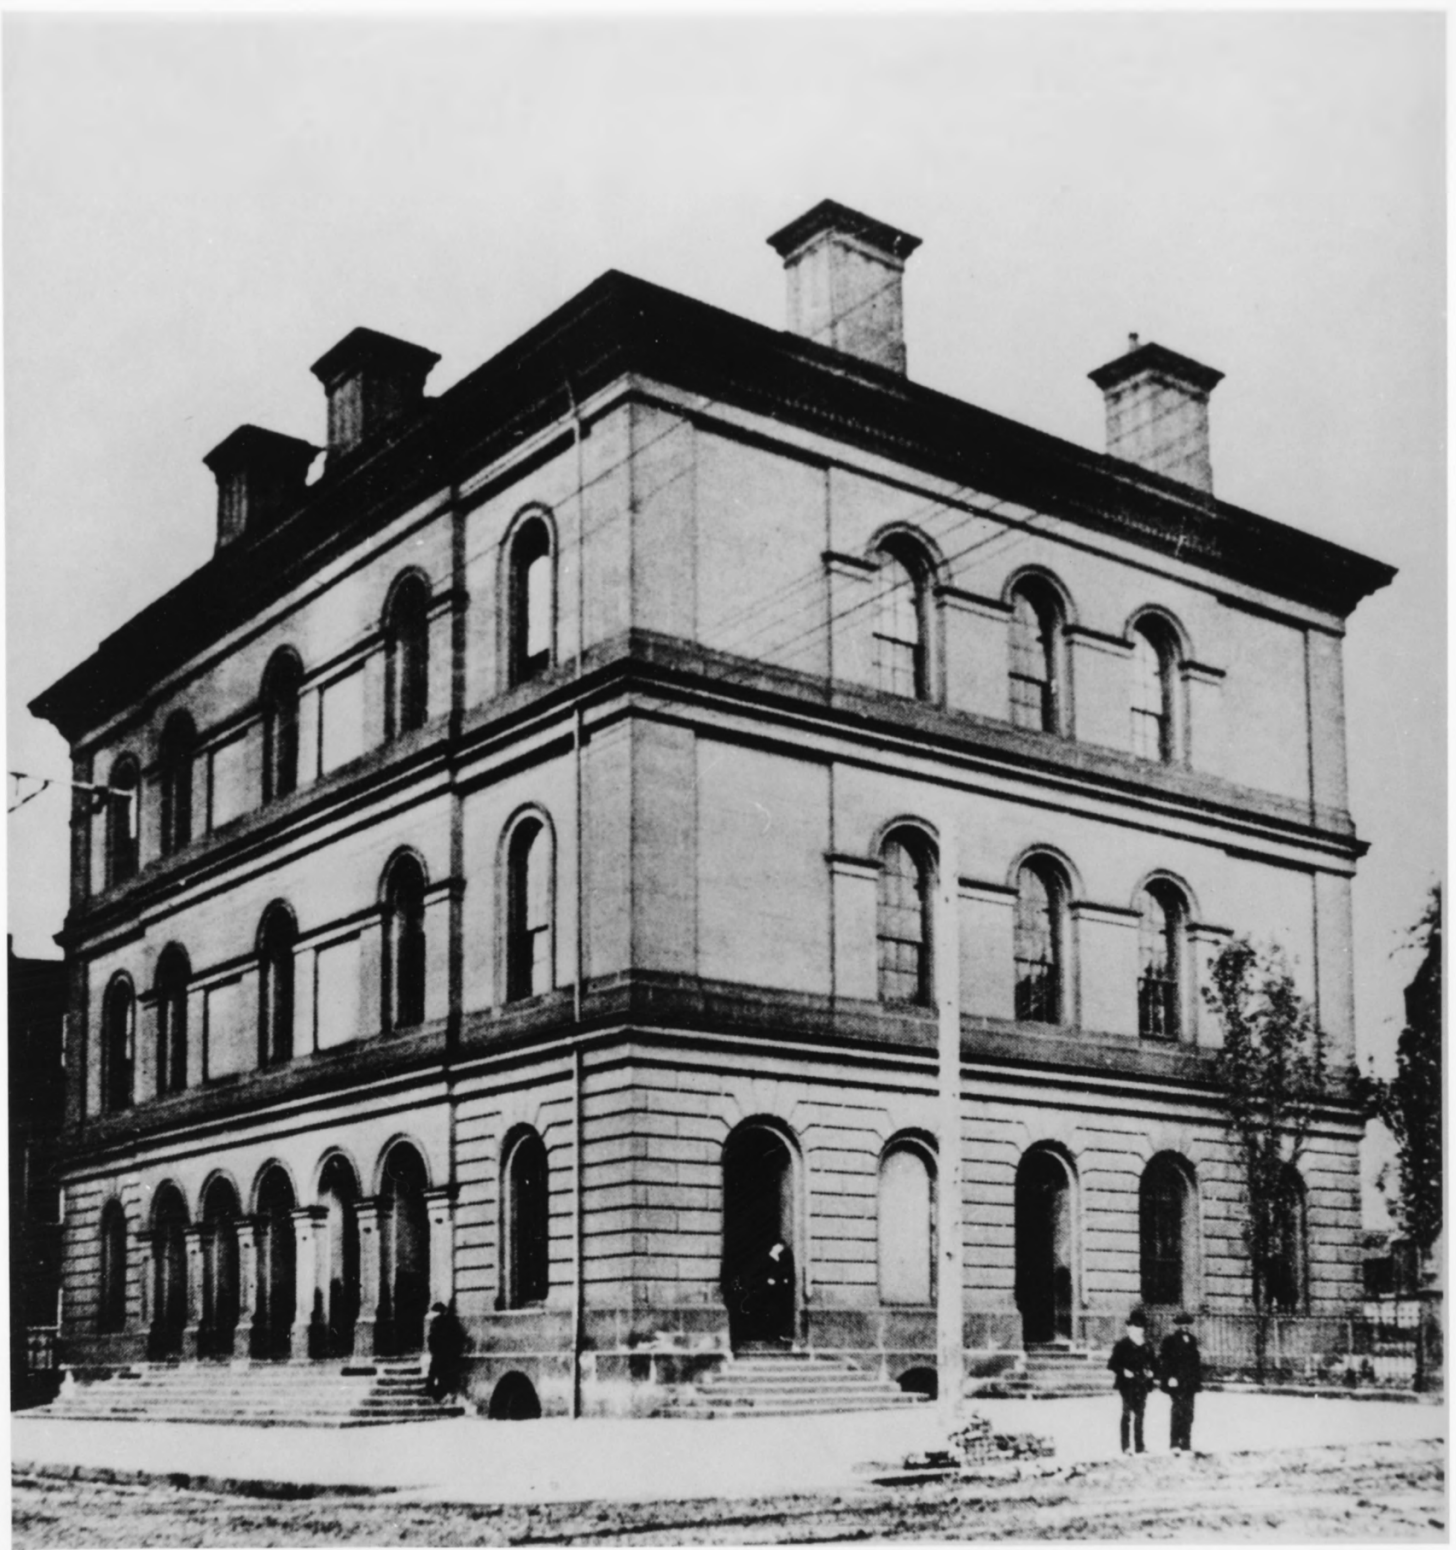
- 1) Wheeling Custom House
- 2) Wheeling, West Virginia
- 3) photographer: W. C. Brown
- 4) date: c. 1888
- 5) West Virginia Independence Hall Foundation, Wheeling
- 6) West and South elevations, camera facing northeast

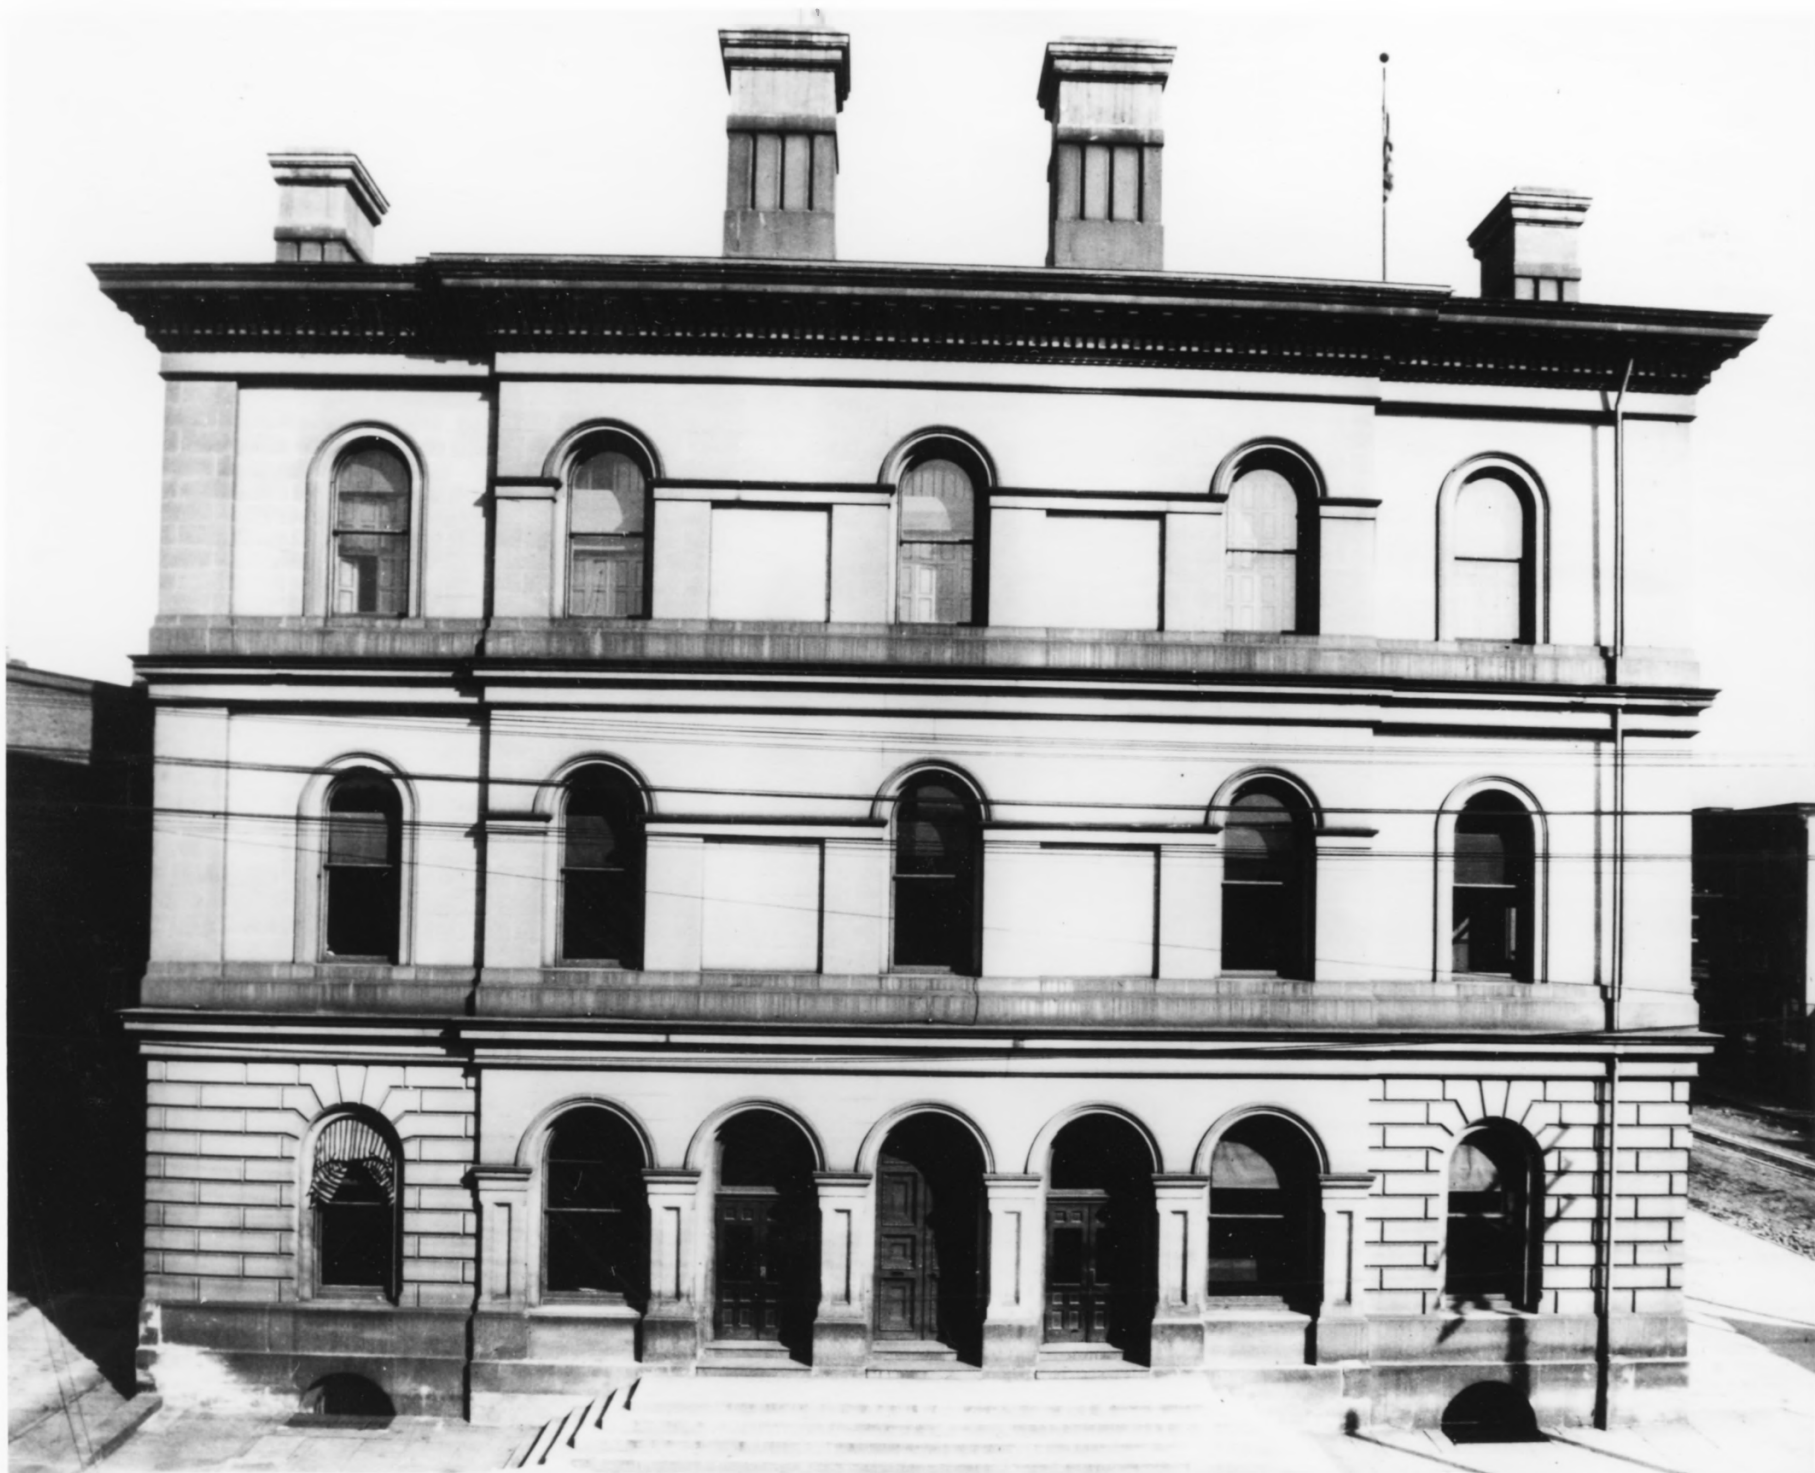
- 1) Wheeling Custom House
- 2) Wheeling, West Virginia
- 3) Unknown
- 4) unknown, c. 1890? pre-1909
- 5) West Virginia Independence Hall Foundations
- 6) West elevation, showing changes in doors and windows and chimneys after 1899 changes;
"Wart" probably on south side but not visible here; downspout not on original building;
Camera facing west

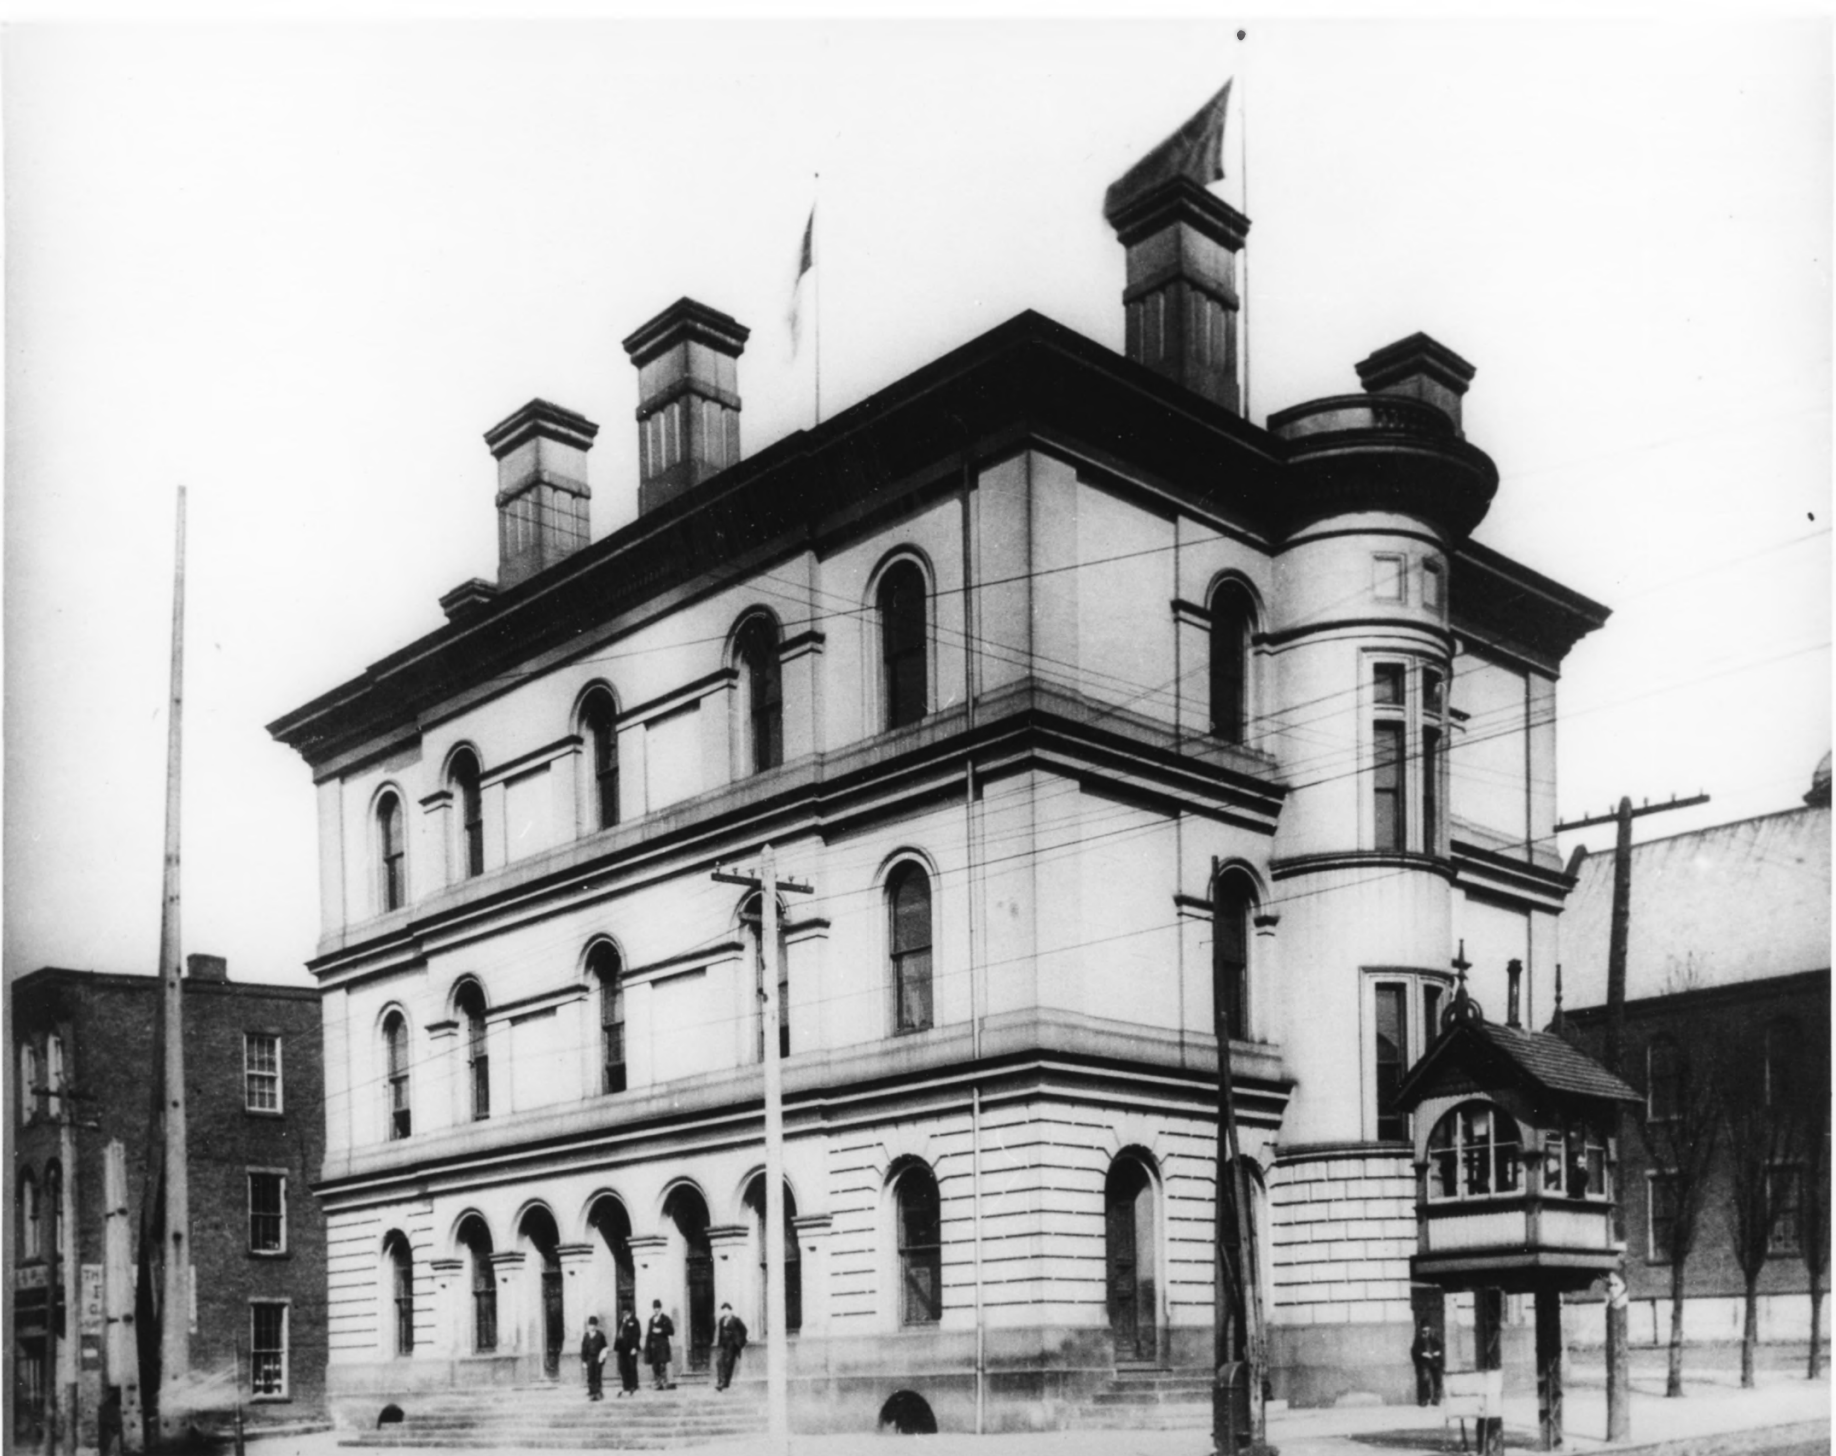
2

- 1) Wheeling Customs House
- 2) Wheeling, West Virginia
- 3) unknown
- 4) 1890 or later (pre-c. 1907)
- 5) West Virginia Independence Hall Foundation
- 6) West and south elevations, camera facing northeast

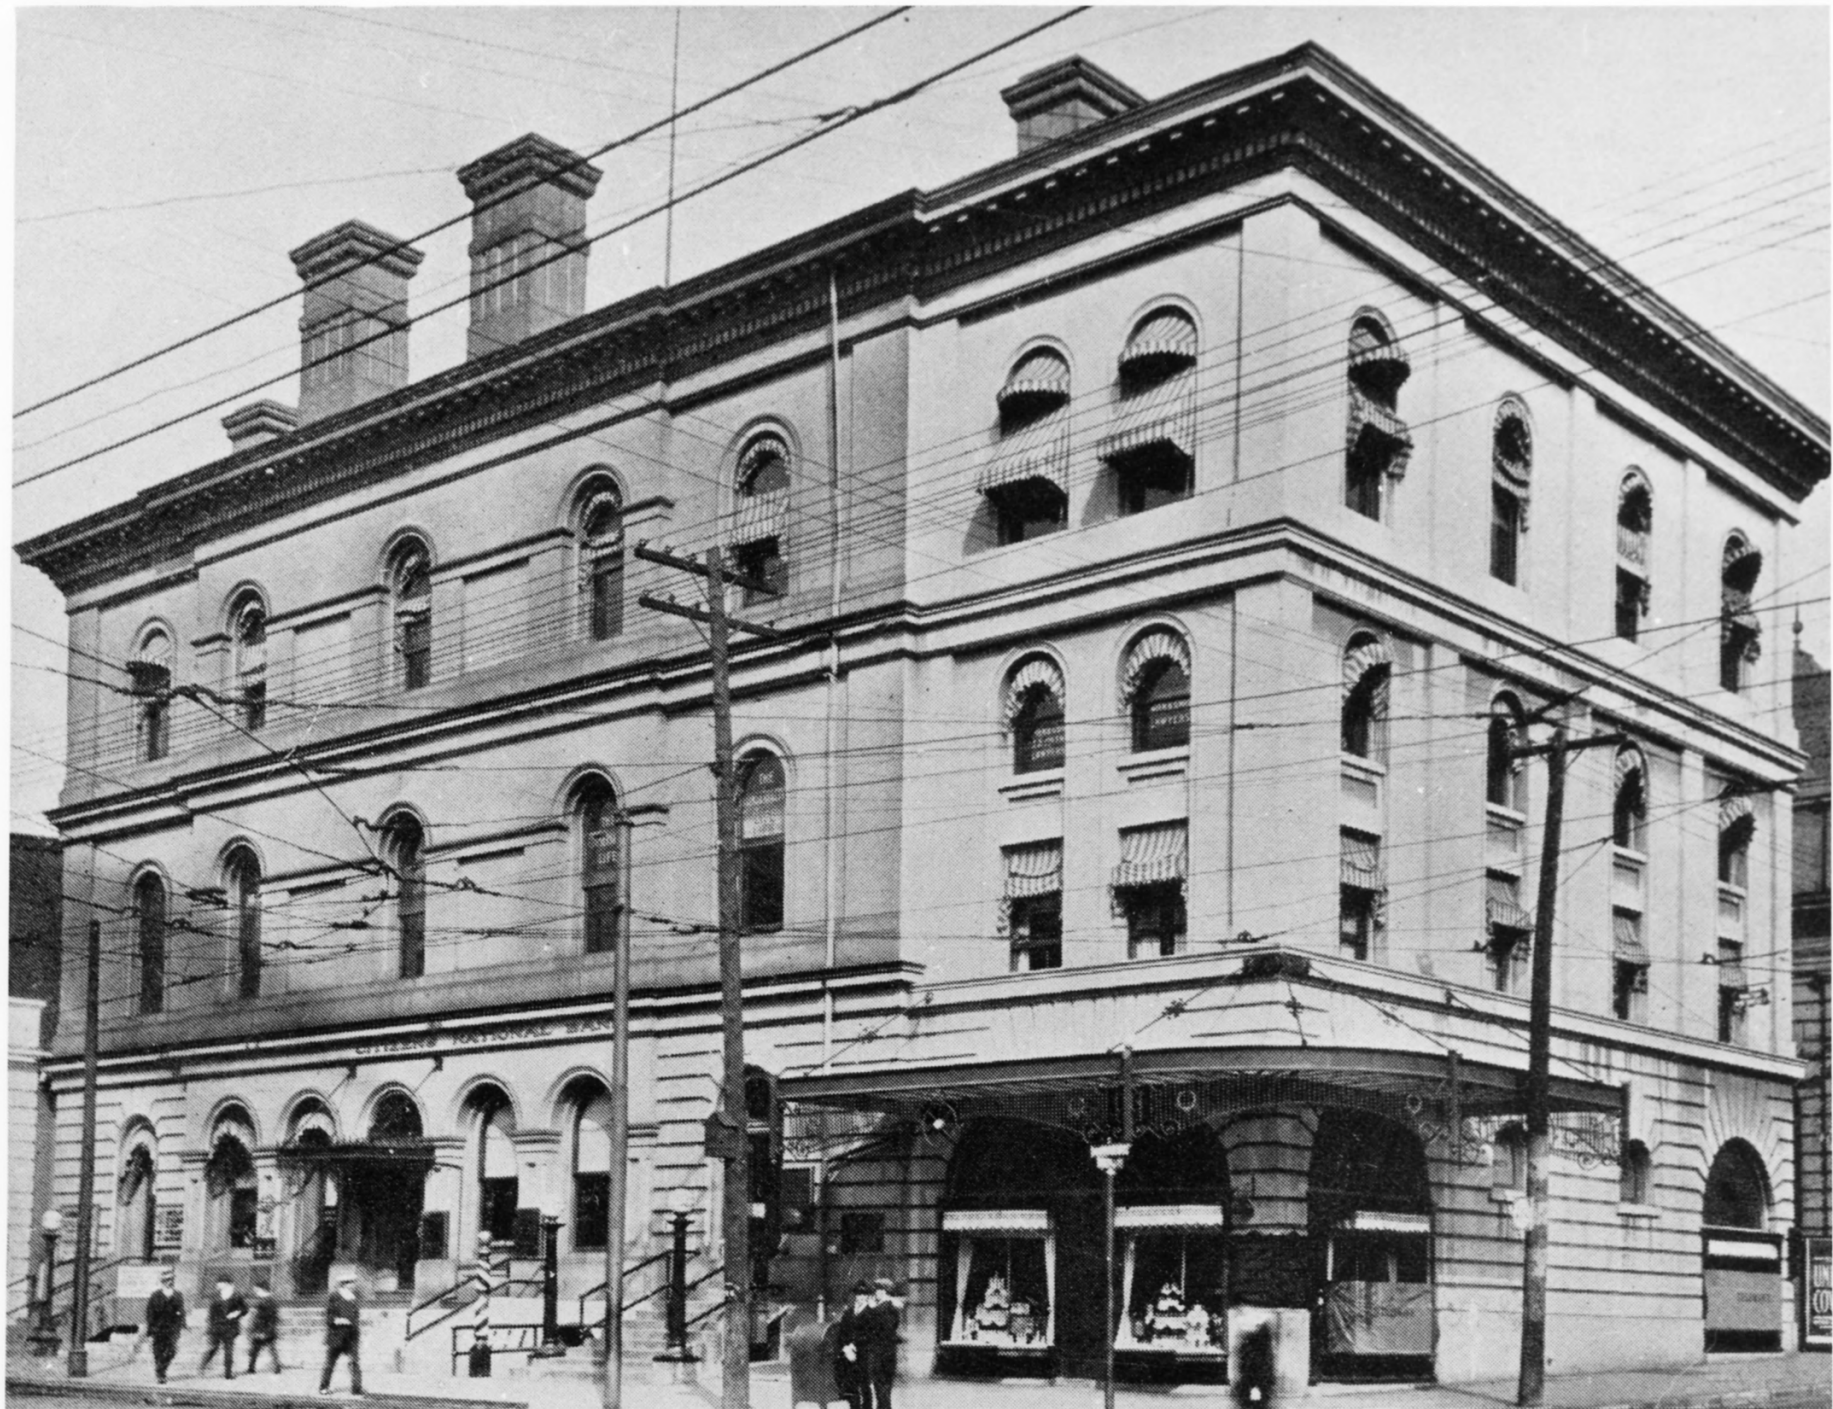
- 1) Wheeling Custom House
- 2) Wheeling, West Virginia
- 3) photographer unknown
- 4) 1915
- 5) West Virginia Independence Hall Foundation
- 6) West and south elevations, showing addition to south side; south bay designed by F.E. Farris

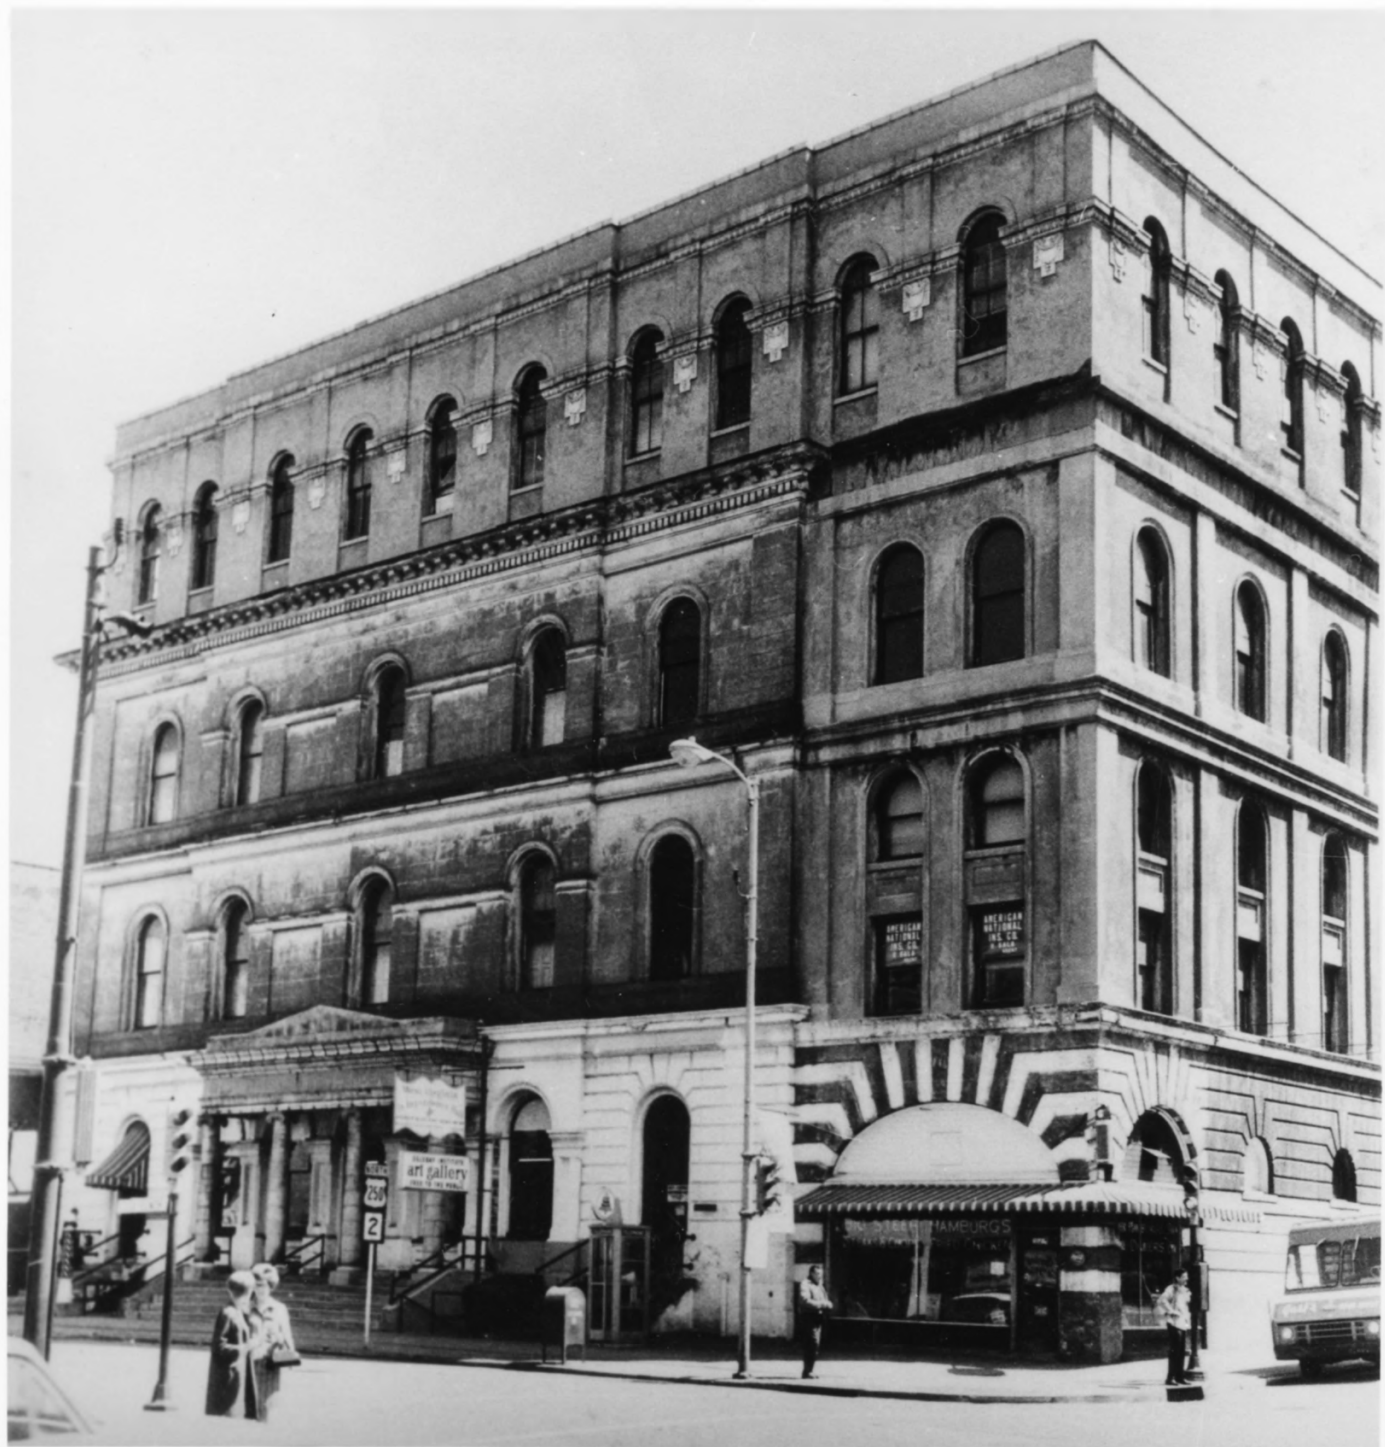
- 1) Wheeling Custom House
- 2) Wheeling, West Virginia
- 3) unknown
- 4) 1969
- 5) West Virginia Independence Hall Foundation
- 6) West and south sides of building, showing added 4th story, portico on west side
