National Register of Historic Places Registration Form

Historic name: St. Mary Peak Lookout

Name of related multiple property listing: L-4 Fire Lookouts in the USFS Northern Region (Region 1), 1932-1967

Other: “Readicut” L-4 Lookout House

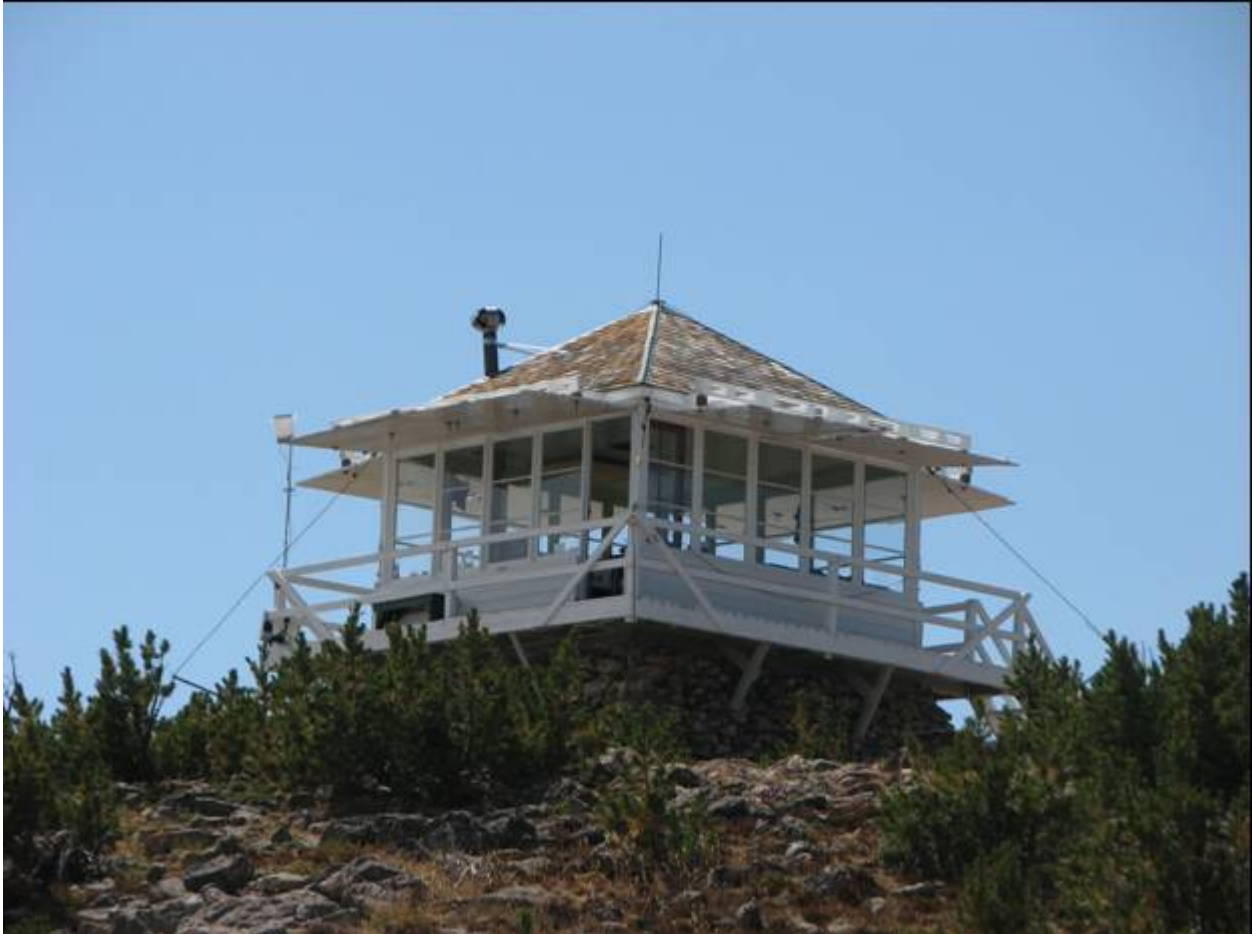
MT_RavalliCounty_StMaryPeakLookout_0001. Looking southwest to the east (front) and north walls of the lookout.

The lookout is a 1936-pattern L-4 lookout. The 14 ft. by 14 ft. wood frame house or cab has a pyramidal roof and sits atop an 8-foot-high mortared stone tower or base. An opening in its north wall provides access to the interior of the tower. Guy wires extend from each of the lookout's four corners securing the building to the ground. The catwalk is accessed by a single-flight stairway located at the north end of the west side. The stair stringers and treads are made with dimensional lumber and the base rests on a concrete footing. The catwalk safety railing consists of two horizontal rails with diagonal bracing at each corner. Dimensional lumber brackets, braced against the stone base, support the catwalk.

slope of the roof at its south end. The entry into the lookout cab is located at the north end of the east-facing wall. The entry contains a wood door with six lights above one panel. Four three-light windows are located in the wall south of the entry. The remaining three walls each contain five, three-light, wood windows. The central sash in each wall opens casement style for ventilation, while the remaining windows are fixed. The building retains its lightning protection. A radio antenna is attached to the northeast corner of the catwalk railing.

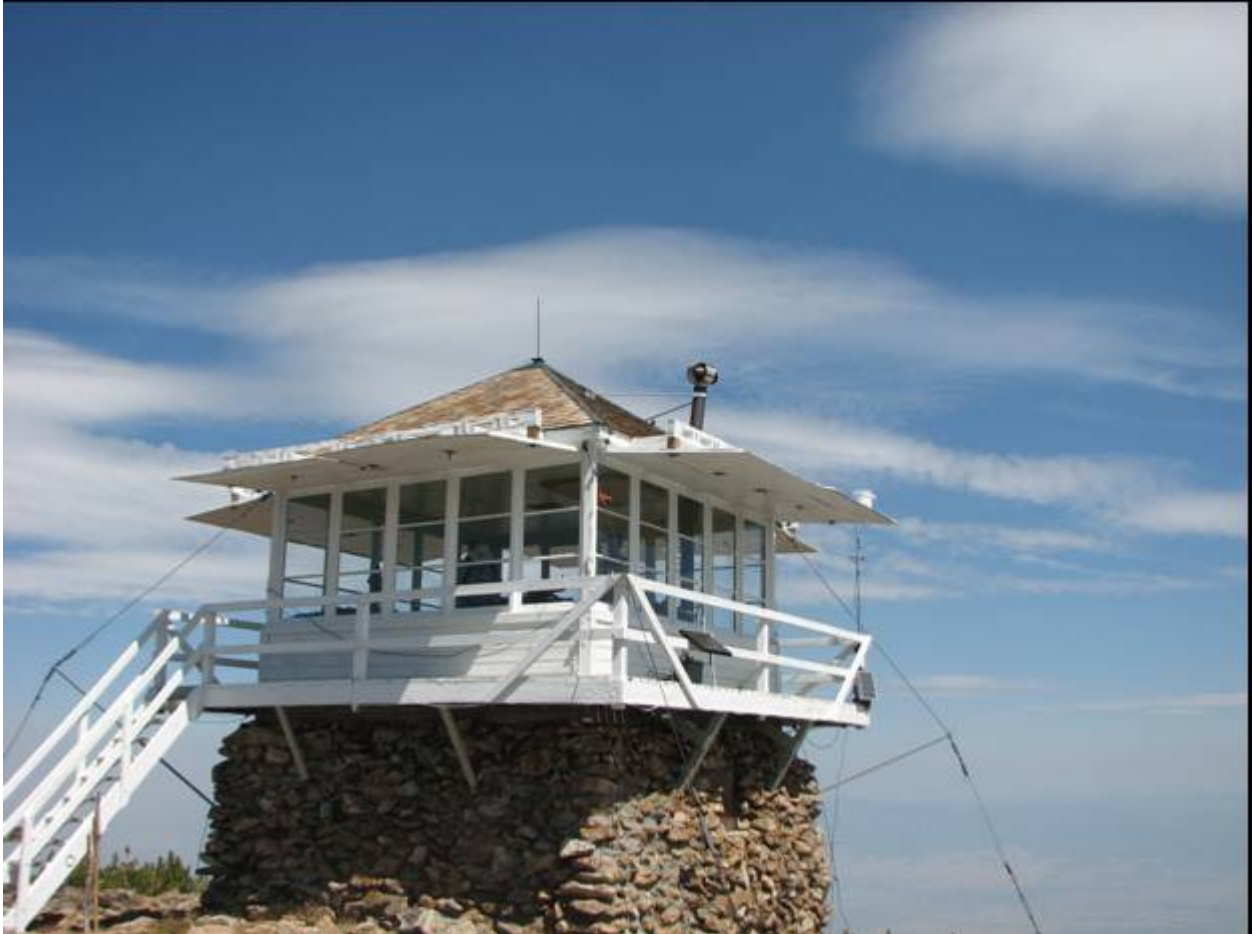
MT_RavalliCounty_StMaryPeakLookout_0002. Looking northeast to the west and south walls of the lookout.

Simple drop wood siding covers the lower portion of the cab's exterior walls, and the roof is covered with sawn cedar shingles with metal ridge finishes. A new stainless steel stove pipe extends above the west

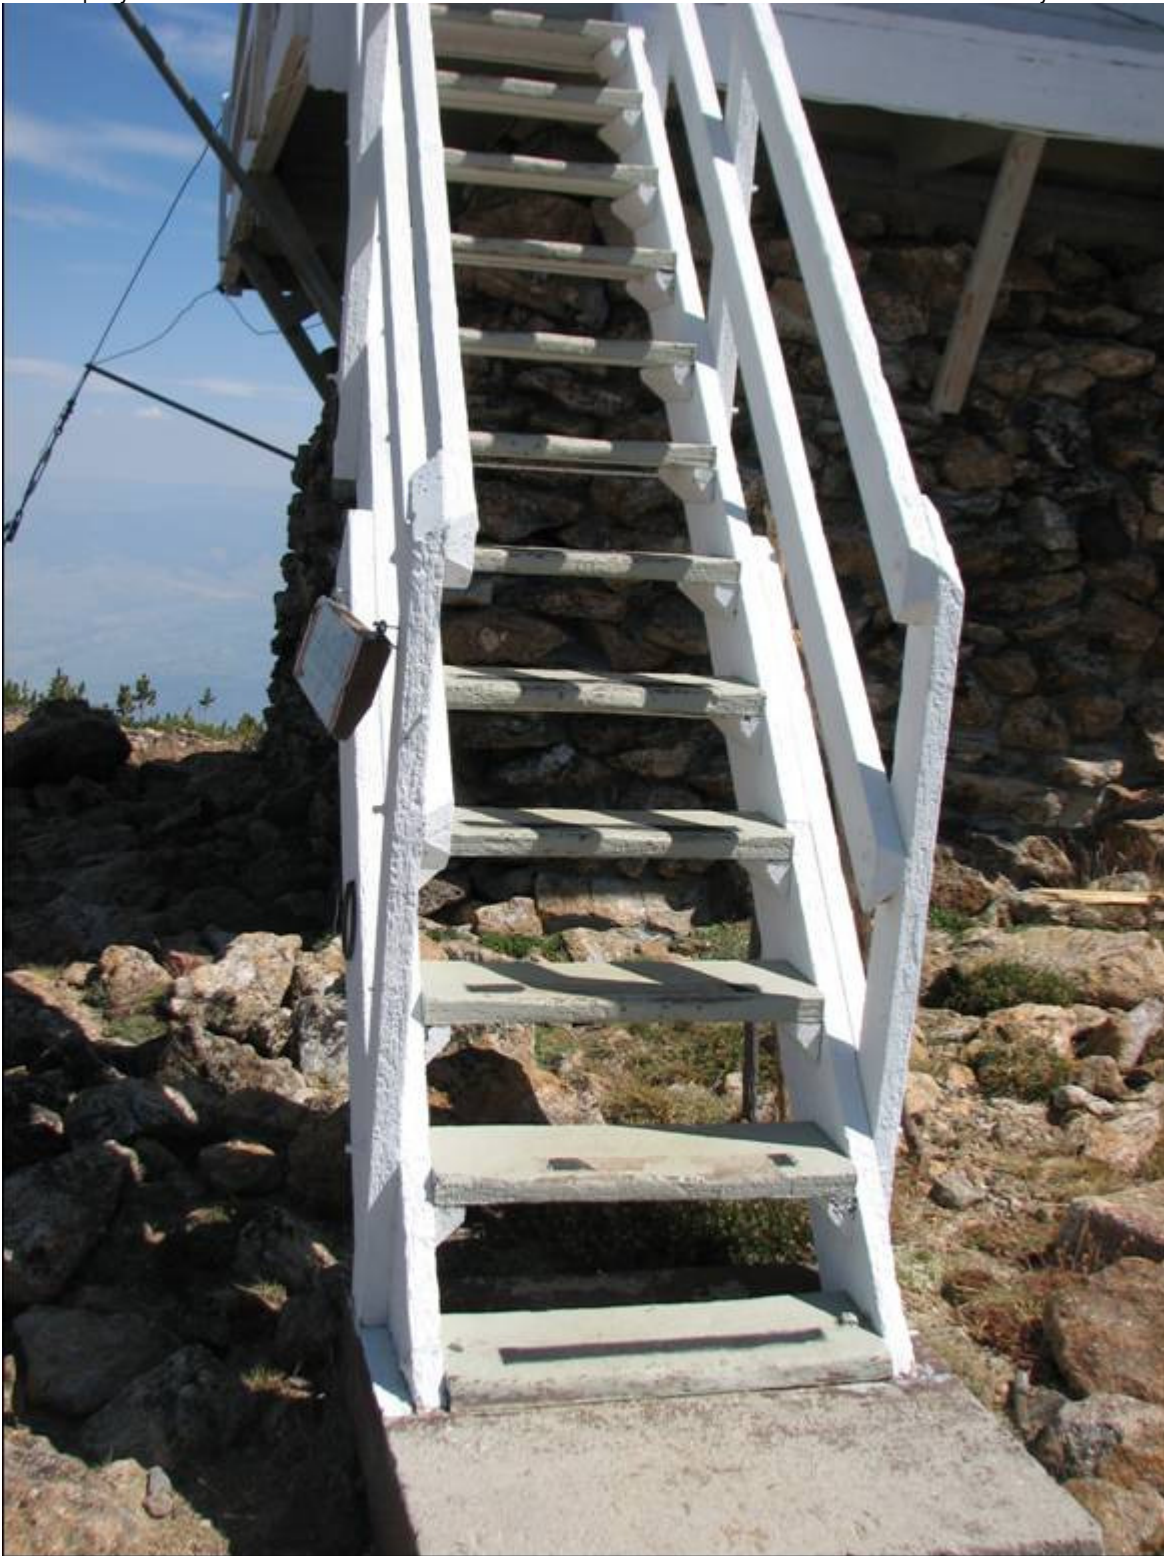
MT_ RavalliCounty_StMaryPeakLookout_0003. Looking east: detail of the stairway.

Lee also recommended modifications to the stairway leading to the lookout and its catwalk:

After thinking about the stairway at the St. Mary's Lookout, I believe we should install the standard safety gate at the head of the stairway. I also believe we can dispense with the heavy trap door in the catwalk by removing the hinges, cutting the door in two and fitting it to the opening one section at a time. We can provide for locking the catwalk at the seasons end by use of heavy hook-eye and chain arrangement.⁶

It appears that Lee's recommendations regarding the catwalk trap door were implemented, while the safety gate was never installed.

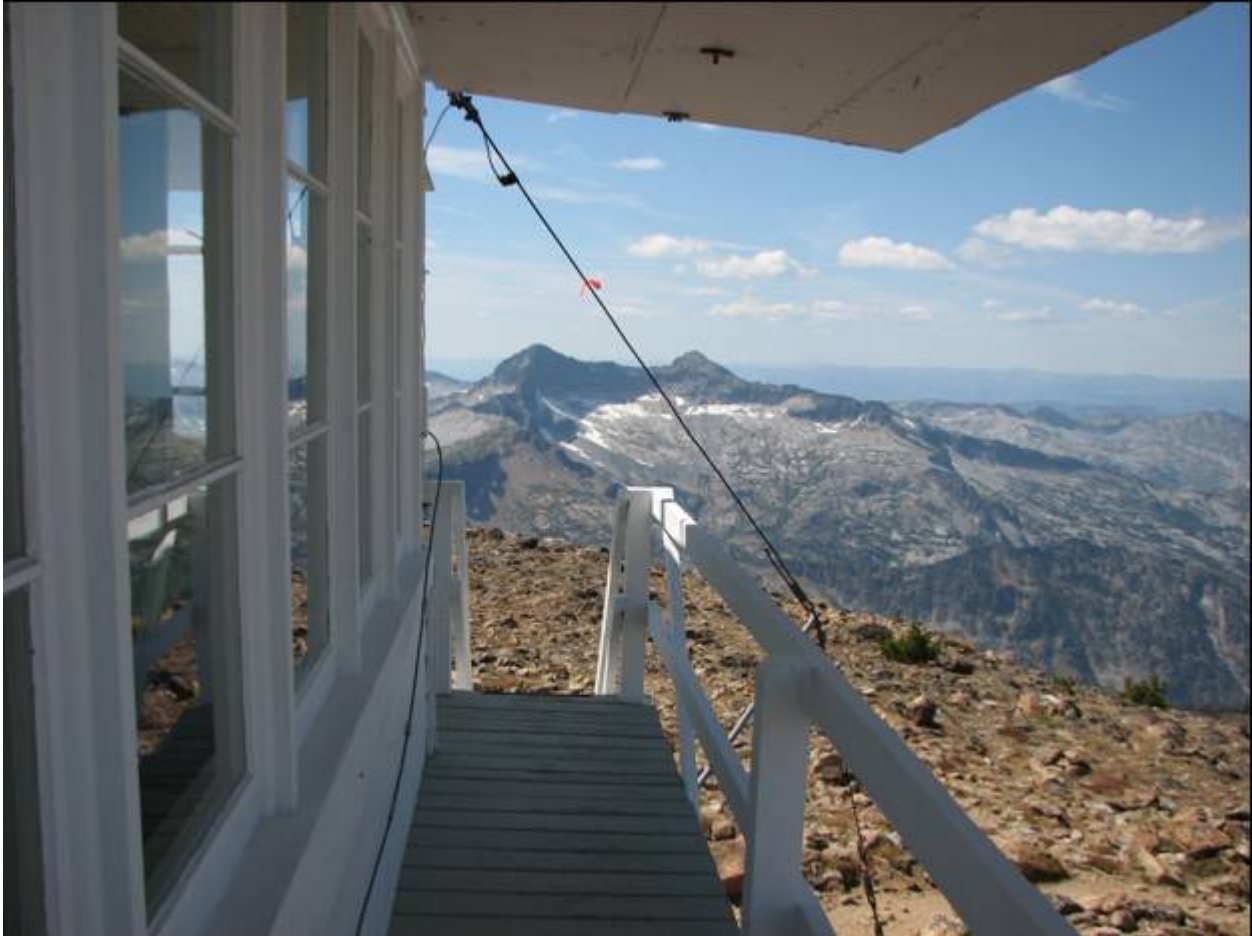
MT_RavalliCounty_StMaryPeakLookout_0004. Looking west along the north side of the catwalk to the stairway.

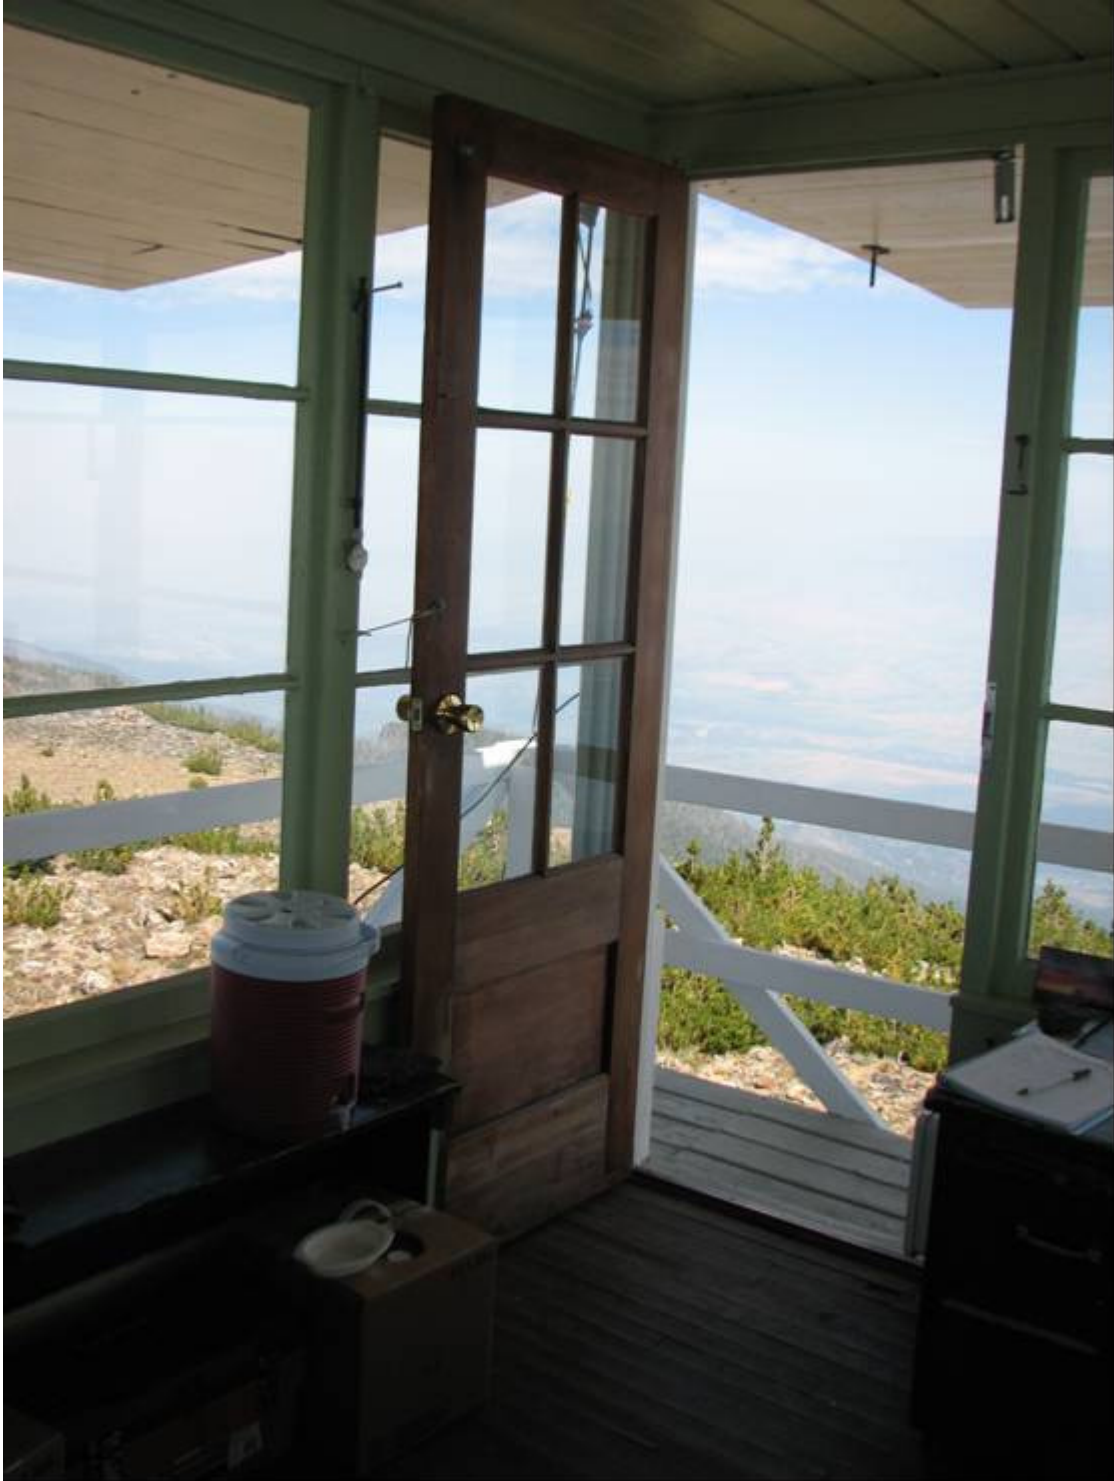
MT_ RavalliCounty_StMaryPeakLookout_0005. Looking northeast to the door and entry from the interior of the lookout cab.

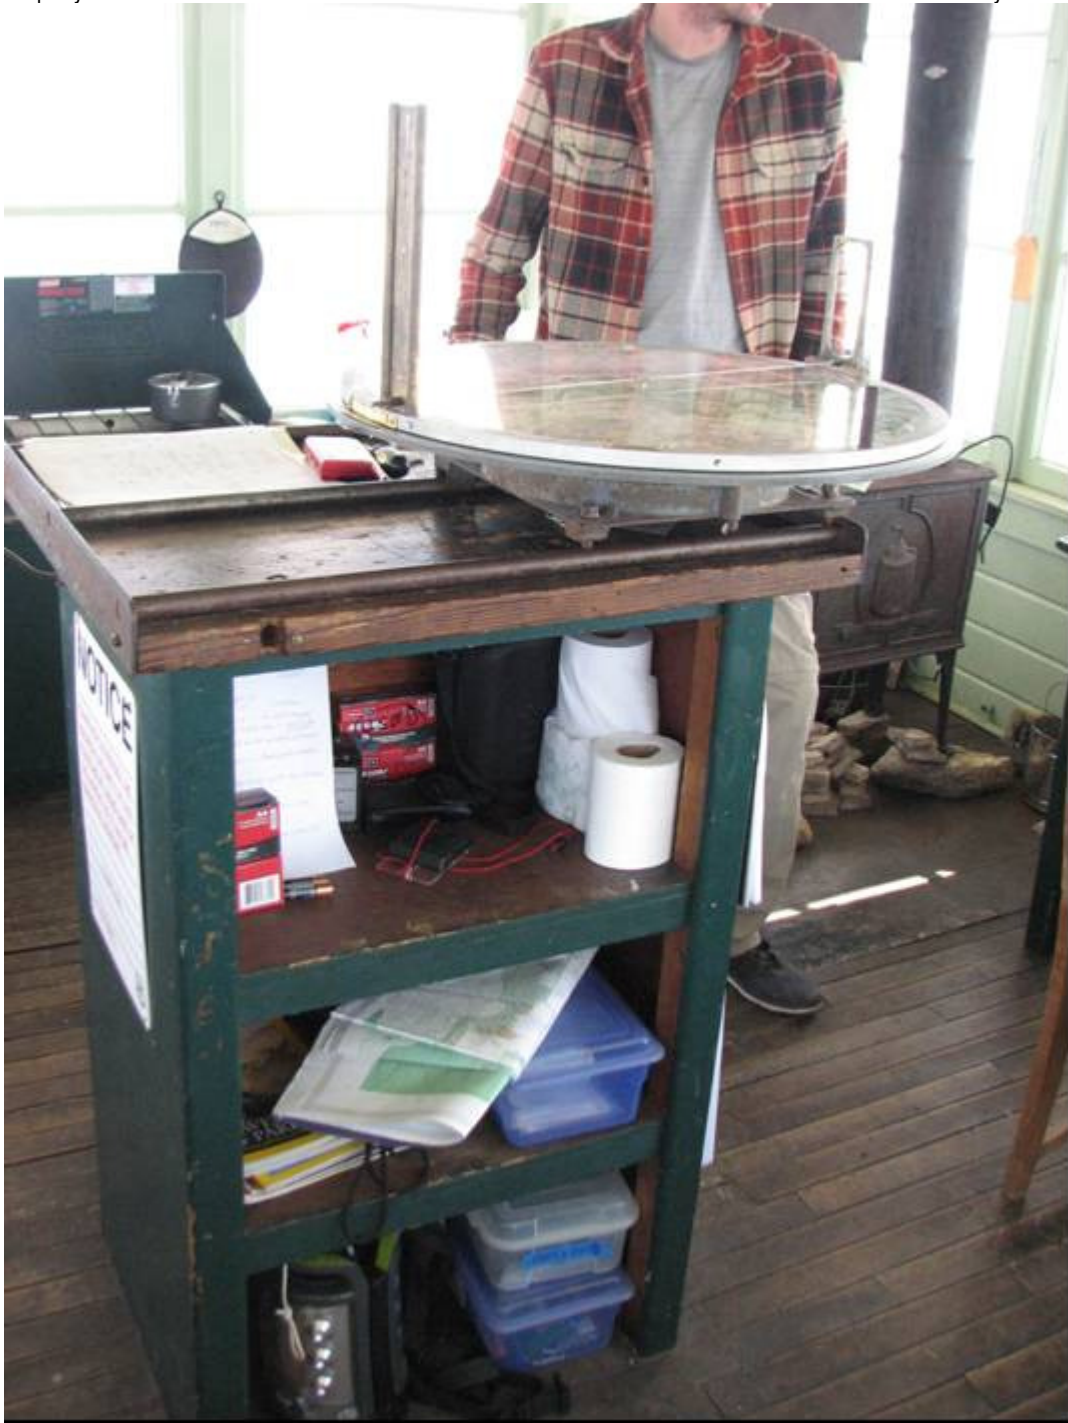
MT_ RavalliCounty_StMaryPeakLookout_0006. Interior: Osborn fire finder and stand.

In the one-room interior, the original maple floor is intact and in fair condition. The space is fitted with a stand for the Osborne fire-finder, a small wood-burning stove, a platform bed with drawers beneath for storage, and several tables, storage benches, and a wood box.

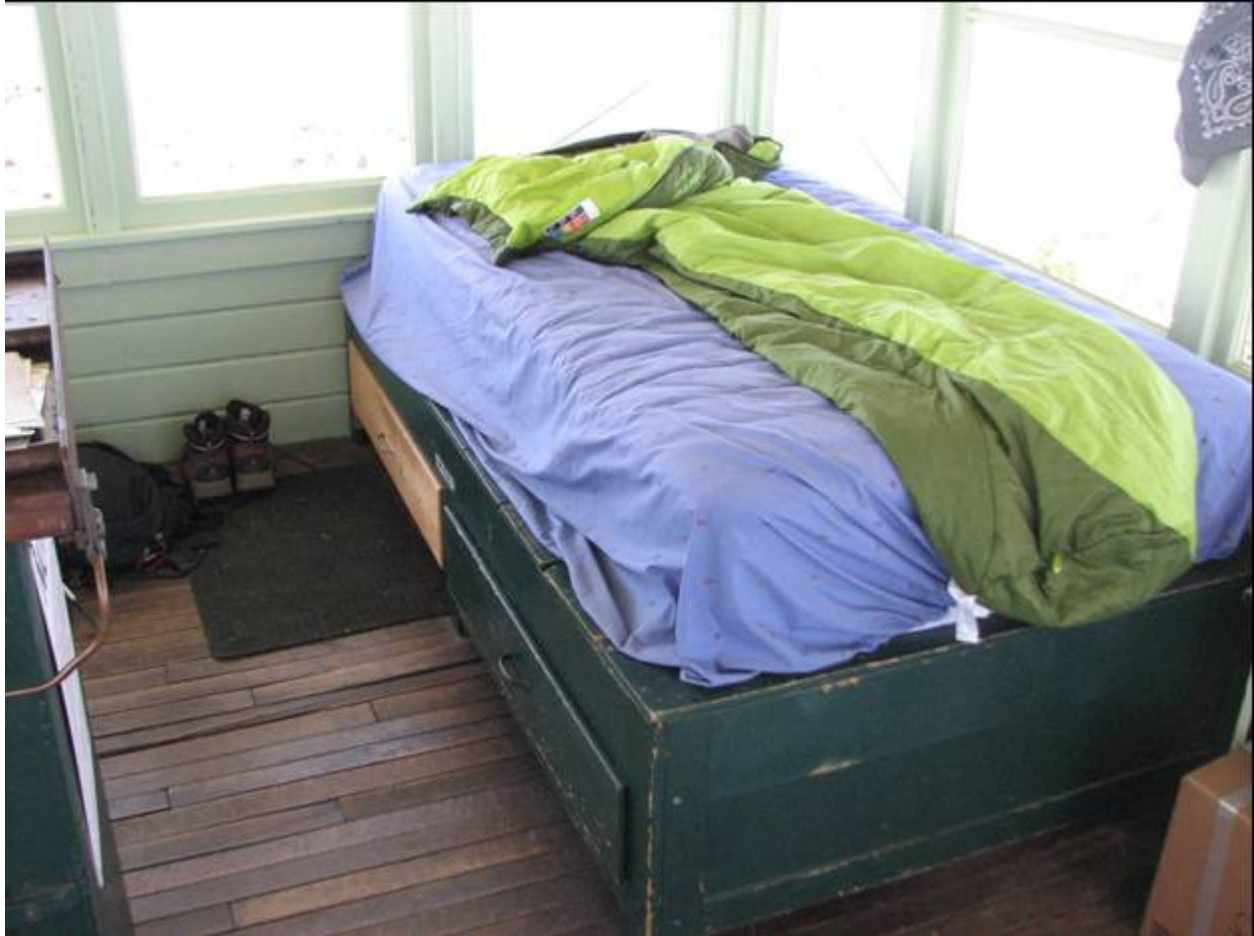
MT_ RavalliCounty_StMaryPeakLookout_0007. Interior platform bed with drawers.

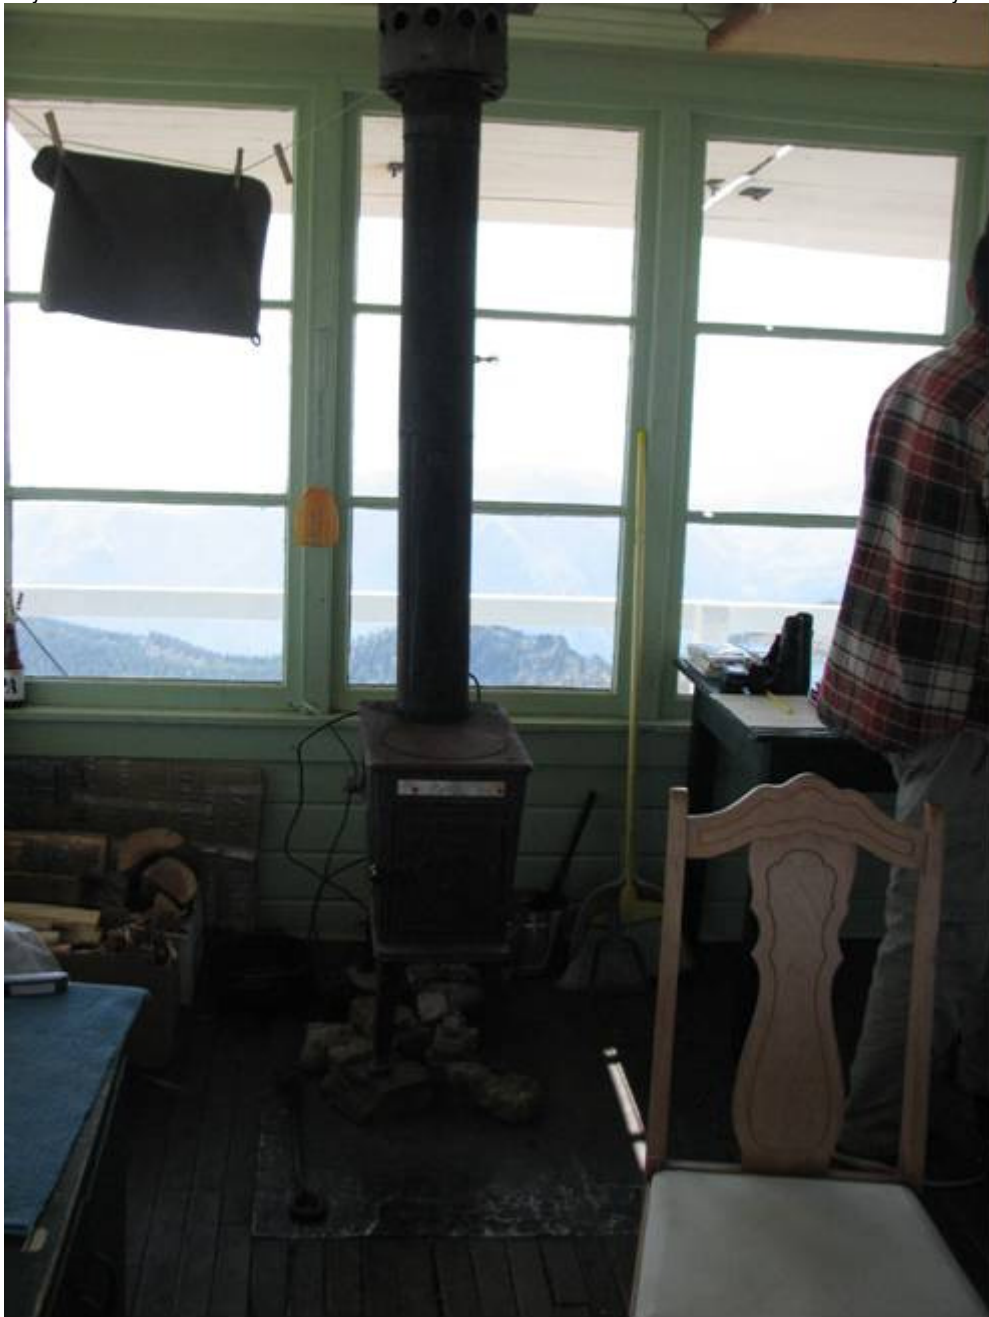
MT_ RavalliCounty_StMaryPeakLookout_0008. Interior wood stove.

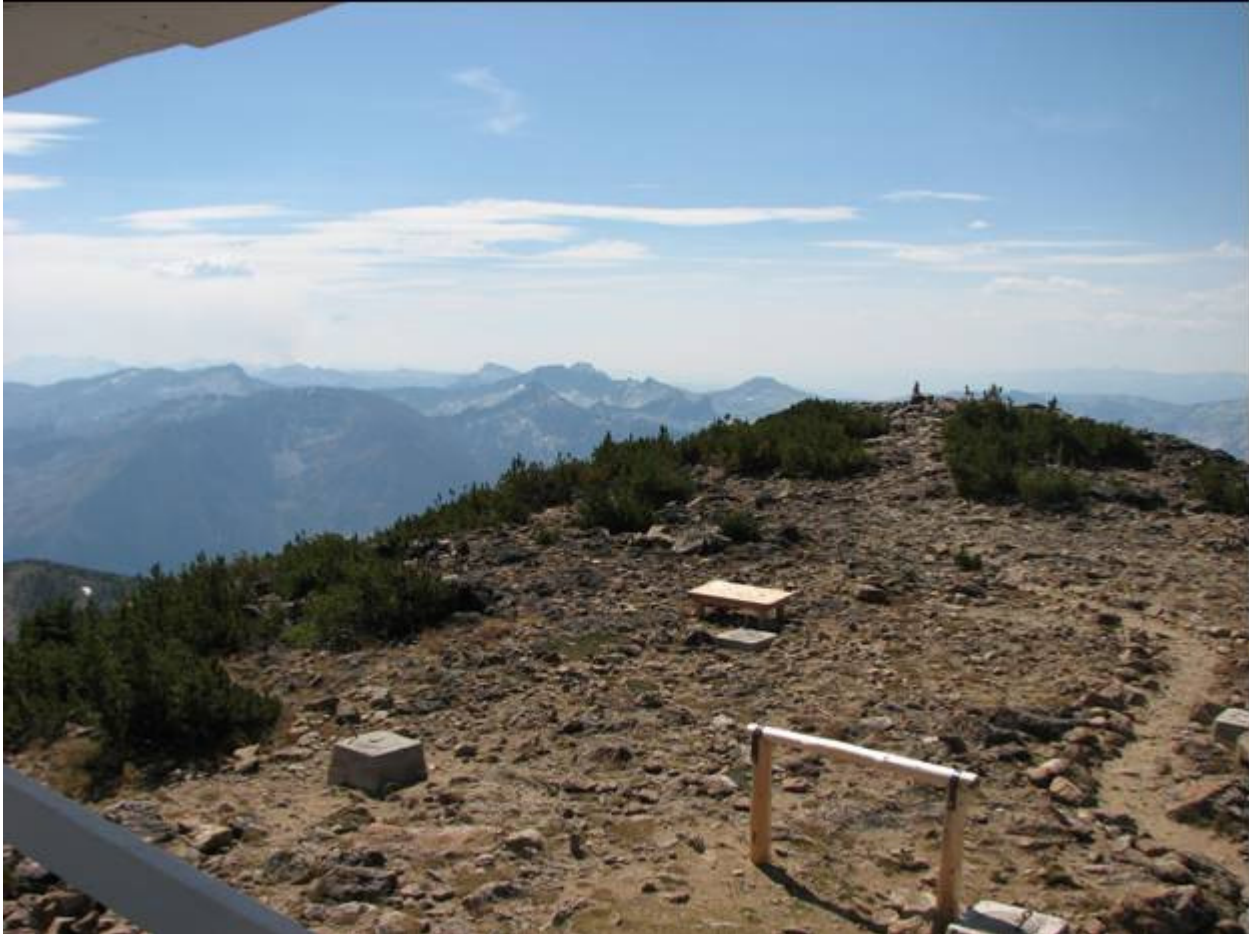
MT_ RavalliCounty_StMaryPeakLookout_0009. Looking west from the lookout catwalk over the concrete piers that mark the location of the earlier lookout. Note the modern hitching rail adjacent to the northeast pier.

Four concrete footings, marking the site of the original L-4 lookout erected at this location in 1934, are located 20 feet west of the current lookout.

A modern hitching rail is located adjacent to the northeast concrete footing. This small structure is made with two vertical peeled log posts with a horizontal rail affixed to the posts with a metal strap.

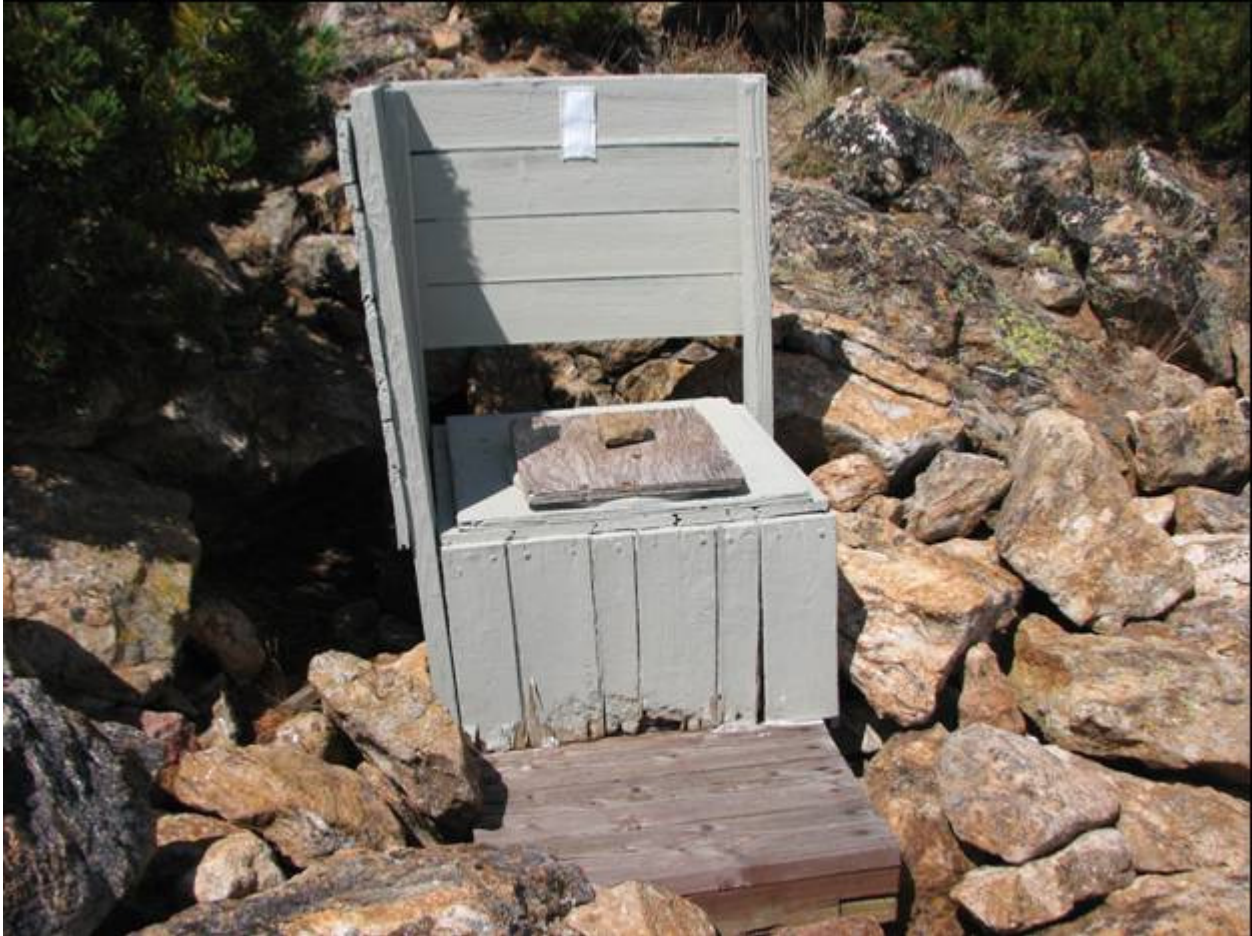
MT_RavalliCounty_StMaryPeakLookout_0010. Looking east to the toilet seat and step over the pit toilet.

A pit toilet is located about 80 feet west of the lookout. This simple open sided structure consists of a wood frame platform and a seat, accessed from a single wood step. It is set over a hole excavated in the talus.
