# National Register of Historic Places Registration Form

historic name Moser, Joseph Henry, Barn  
other names/site number N/A

street & number 507 South 3<sup>rd</sup> Street  not for publication  
city or town Silverton  vicinity  
state Oregon code OR county Marion code 047 zip code 97381

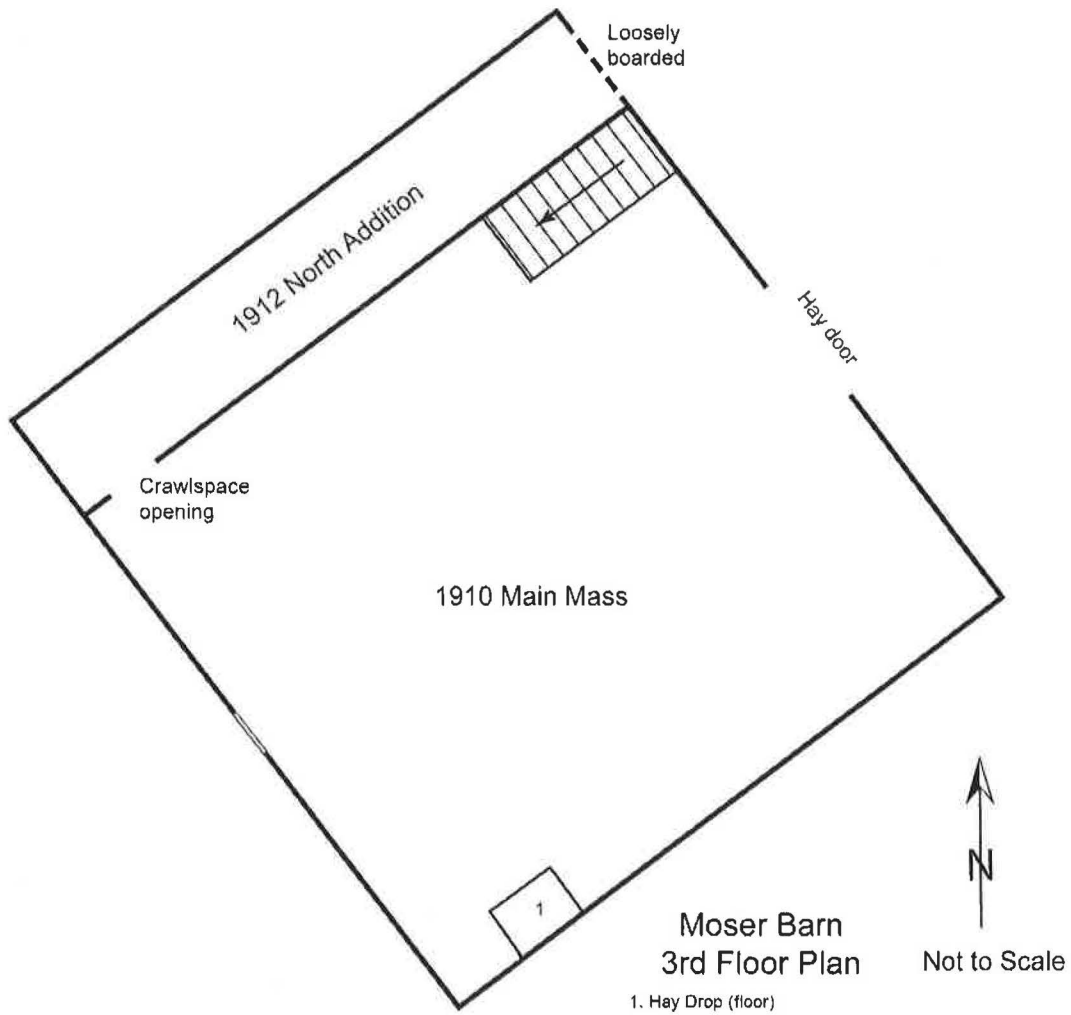
Figure 8: Third floor plan.

The upper level of the barn includes only the main massing. This is a 32'-2" x 24'4" open area with no interior divisions and no interior support framing beyond that supporting the walls (see photo 7). The upper level is accessed by the stair located in the northeast corner of this level. The west wall has a single, unglazed window opening below the gable peak, with boards nailed to the wall framing to create a ladder leading to it. The east wall has the third-story hayloft door opening and the hinged door below it, set at floor height. The upper ends of the north elevation attachment roof rafters are evident on the north wall, attached to the upper reaches of the wall framing. The wall framing on the north and south walls includes several members that do not reach the built-up plates in a single element—the western eight members on the south wall and the western nine members on the north wall are all between 1.5' and 0.5' short, and have an additional board nailed to them to bring them up to plate height. Diagonal cross-bracing is found on the east and west walls only. The roof framing described above, is clad on the south slope with corrugated sheet steel on spaced sheathing boards, while the roof on the north side has no decking, with the sheet steel attached directly to the spaced sheathing boards.

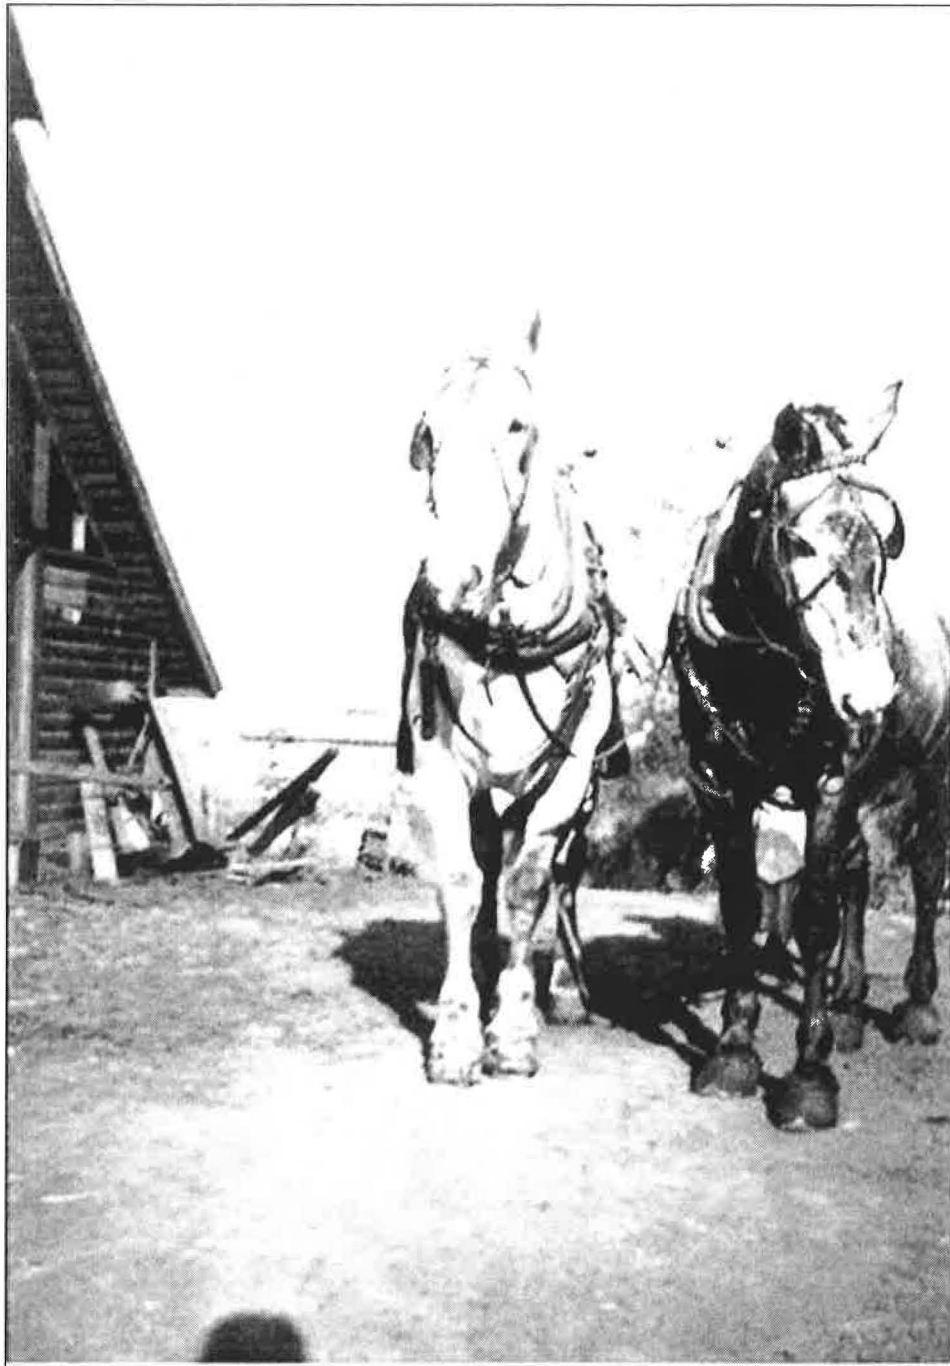
Figure 15: Horses in alley on northeast side of barn, unknown year; 1912 shed addition seen on left side of image.<sup>50</sup>
