United States Department of the Interior
National Park ServiceNational Register of Historic Places
Inventory—Nomination FormSee instructions in *How to Complete National Register Forms*
Type all entries—complete applicable sections

historic Mount Zion Missionary Baptist Church

street & number 409 South Main Street N/A not for publication

city, town Brinkley N/A vicinity of

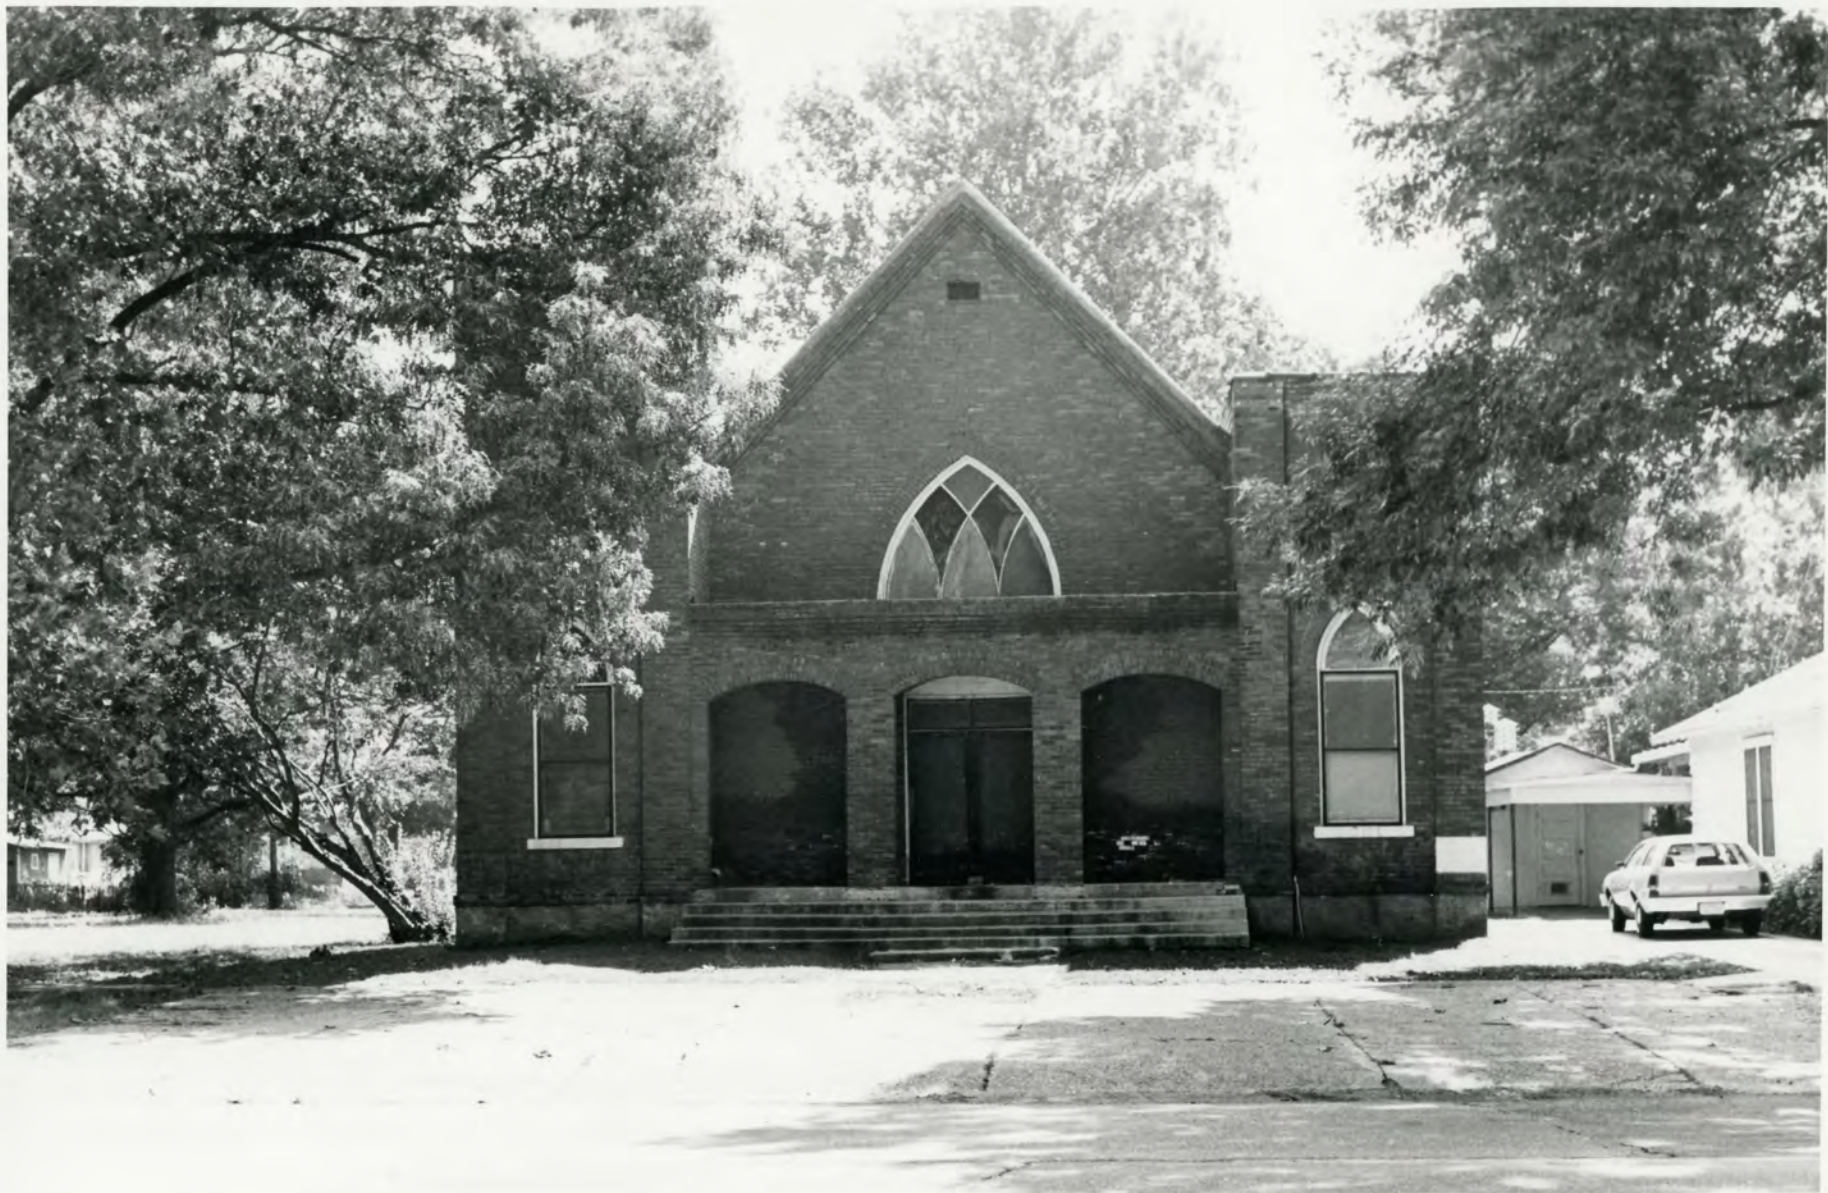
Front west facade

The principal elevation of Mount Zion Baptist Church faces west along one of Brinkley's major thoroughfares. The gabled facade is fronted by two square towers of different heights, each of which is accentuated with a one-over-one double-hung window with fixed arch sash above. The south tower rises to a height nearly equal to that of the gable peak while its counterpart is approximately ten feet shorter, giving the church an asymmetrical facade. Originally the north tower was taller, but deterioration of the belfry walls necessitated removal of the upper part of this tower in 1983. However, asymmetry was maintained by reduction of the north tower to an extent that it became the shorter of the two.

The two towers are connected by a covered porch with three flat-arched openings. Modest brick corbelling graces the cornice of the arcade as it does the edges of the front gable, which is dominated by a large painted-glass, pointed-arch window. The porch leads to a centered double door with transom and to doors right and left which give access to each of the two towers.

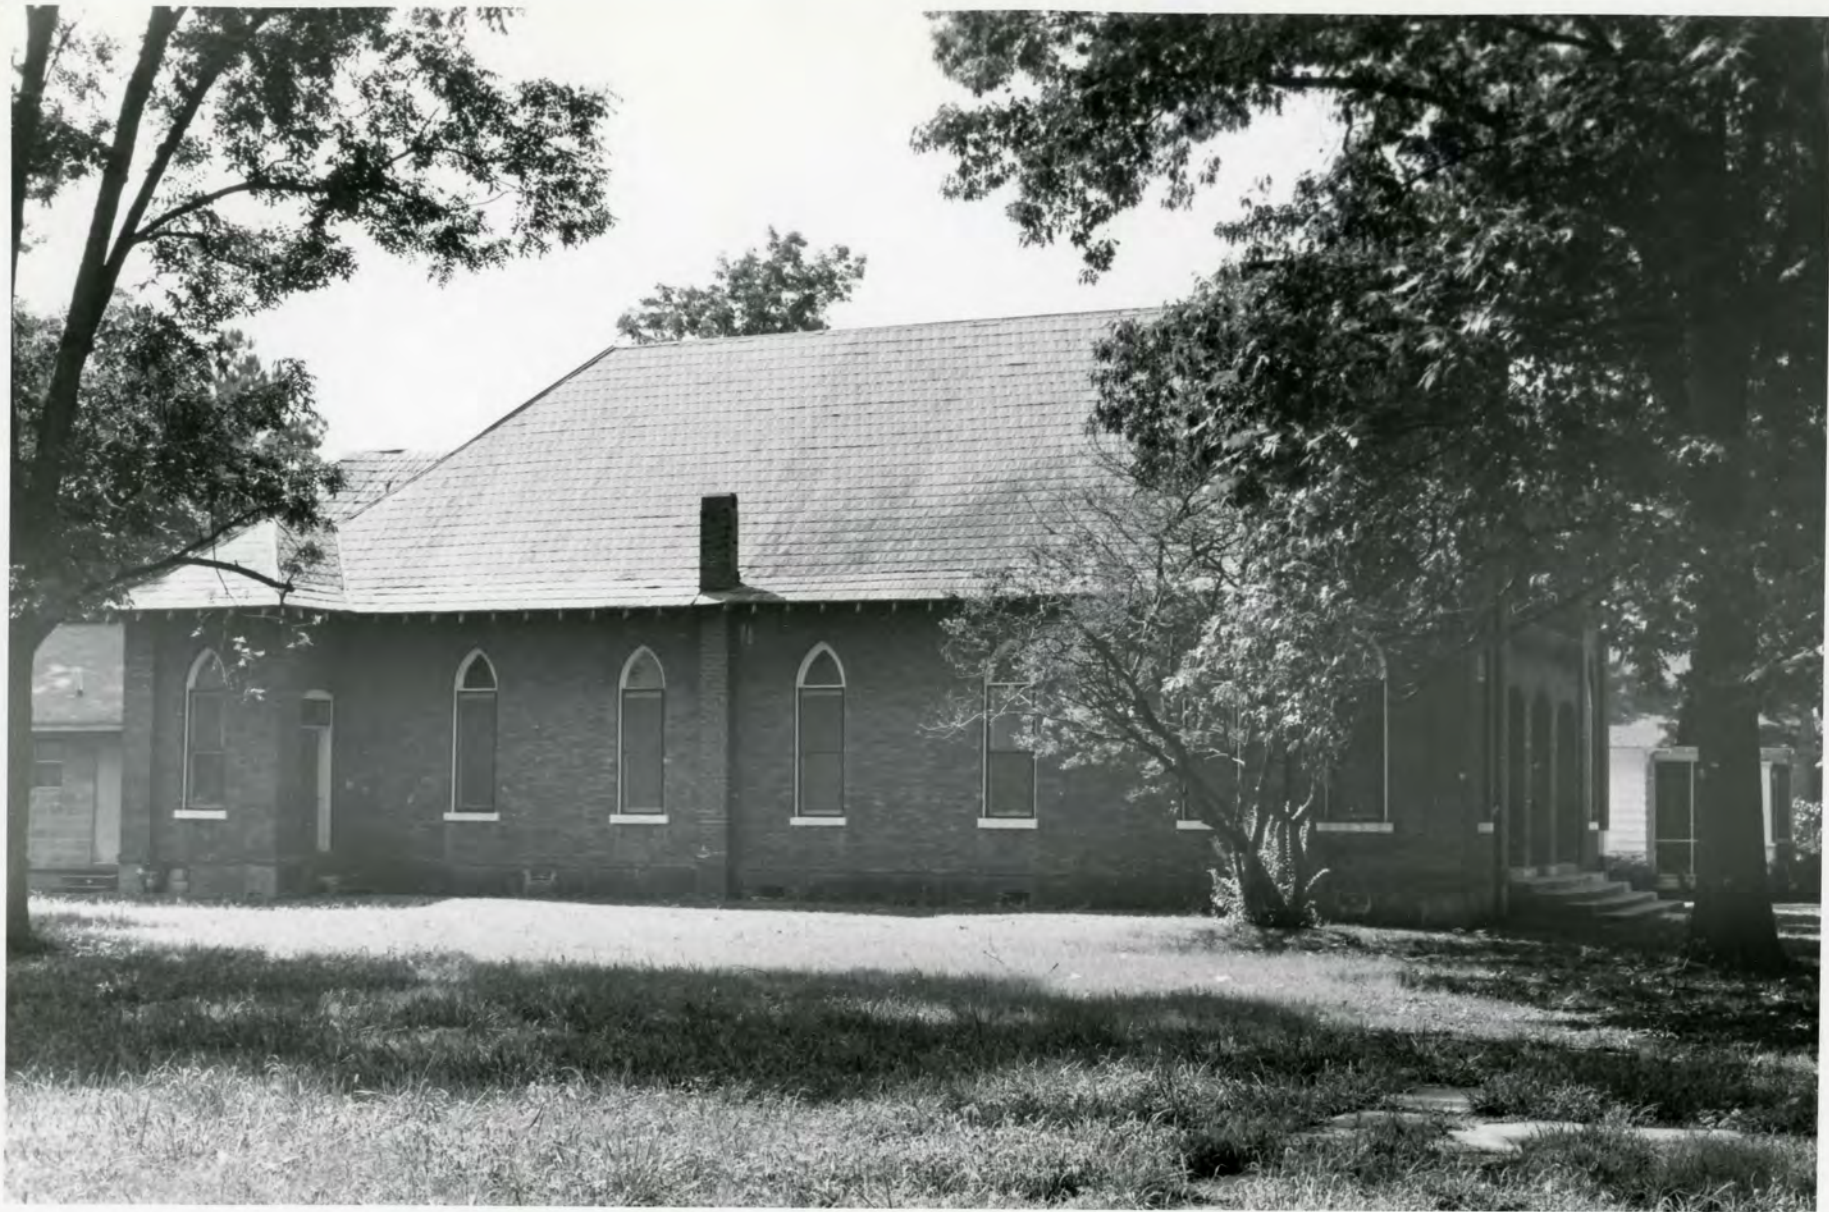
North side elevation

The north and south, or side, elevations of the church are identical. Each is lined with six one-over-one double-hung windows with fixed arch sash which are identical to the tower windows on the facade. At the back, or east, end of each side elevation is a small hipped-roof, ear-like projection with its own arched window and single door facing west.

The gabled roof of the church is covered with metal shingles, with exposed rafters visible under the eaves on the north and south.

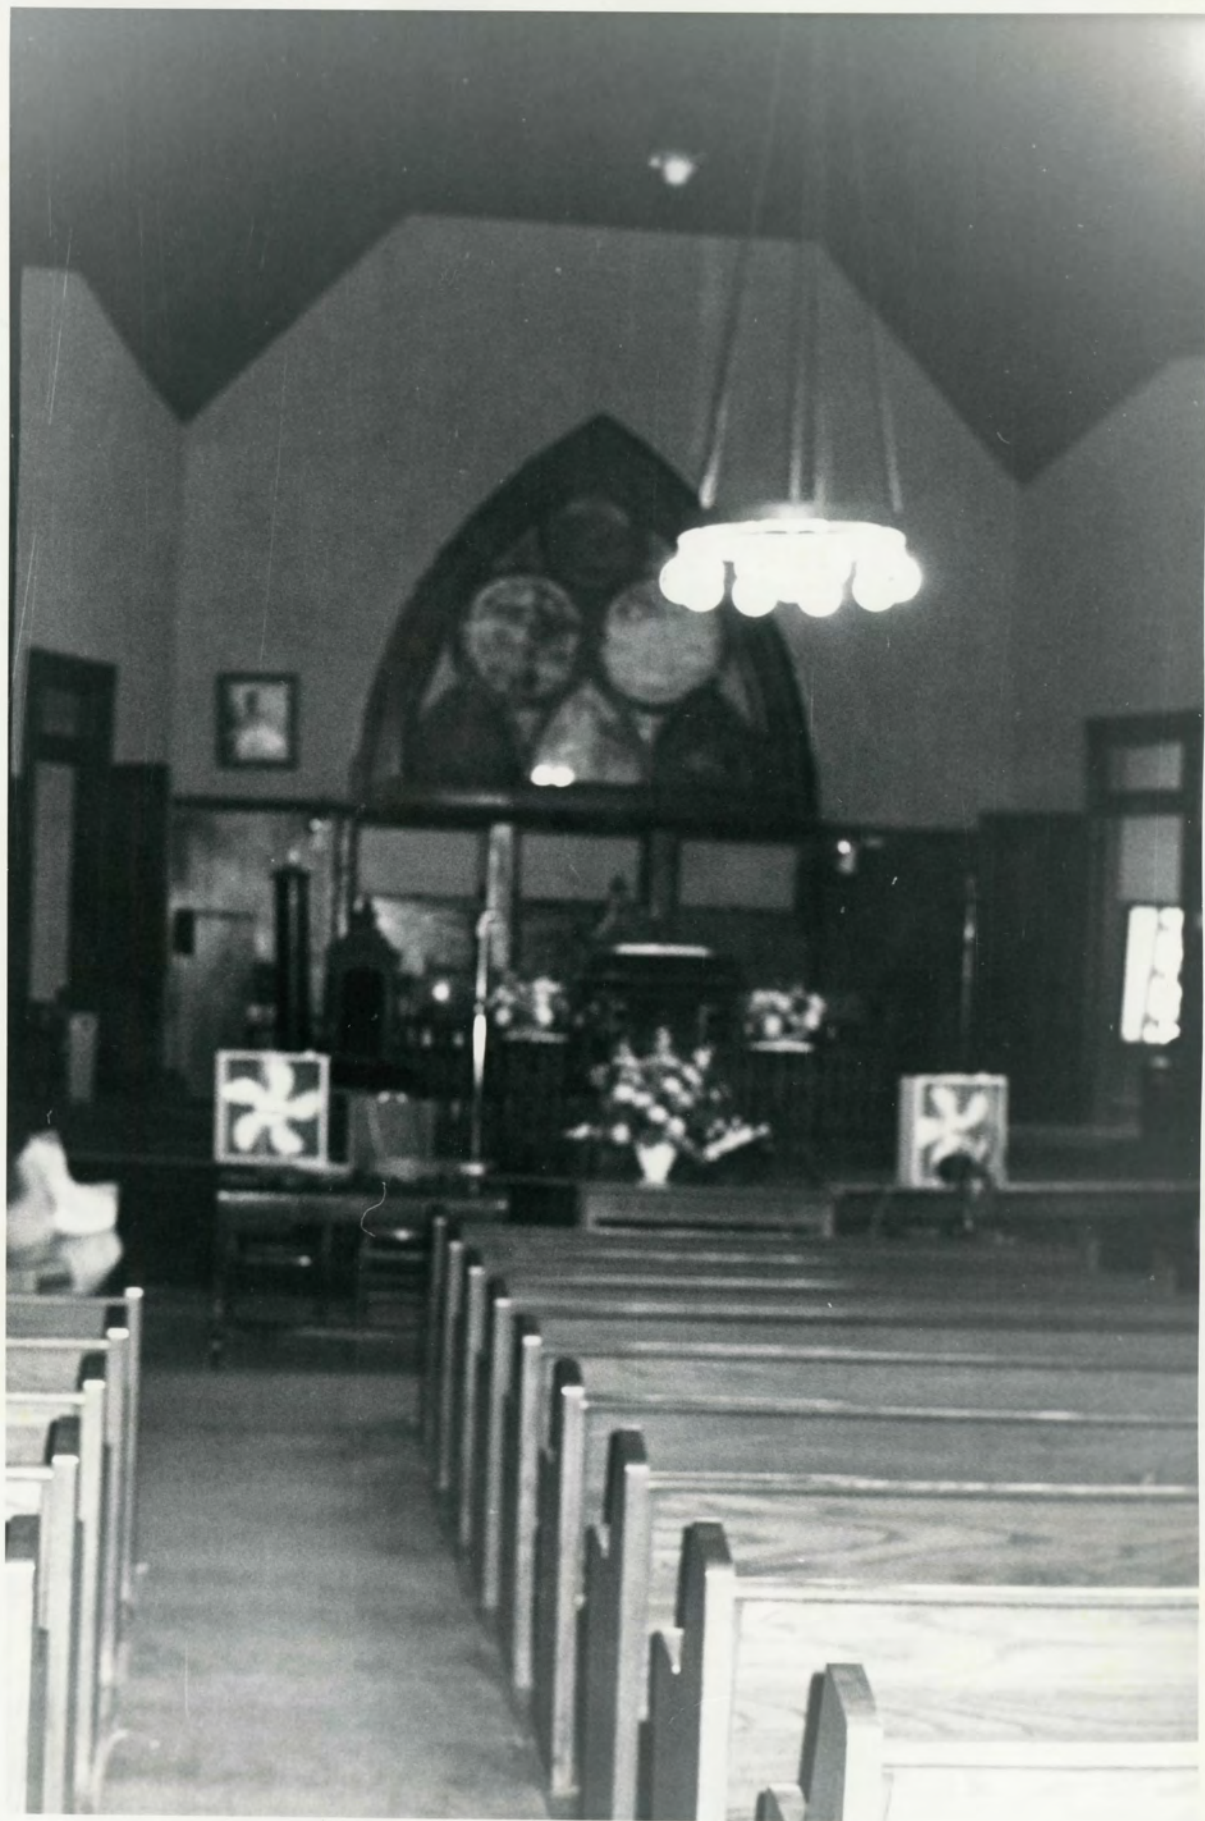
View of interior

The interior of Mount Zion Baptist Church is generally unaltered, with a rectangular sanctuary forming the basic plan. Entry is gained through the center exterior doors or from a single door which leads from the south tower. A main center aisle and two side aisles lead to the chancel at the west end of the sanctuary which is elevated approximately two feet above the nave. A large painted-glass pointed-arch window, identical to that on the west end which is visible from the facade, dominates the wall behind the pulpit. Doors at the northeast and southeast corners lead to a choir room

The ceiling reflects the gabled roofline, and is covered with beaded board applied in an unusual diagonal manner which echoes the Gothic suggestions of the church's window treatment. Walls are plaster, with a recent wainscoting of veneer paneling. Suspended globed chandeliers are original to the building, as is the pulpit furniture.

Access to a balcony at the west end of the sanctuary is facilitated by a staircase which is housed in the north tower. The balcony is supported by turned posts and its balustrade is covered with the same diagonal beaded board as the ceiling.
