### National Register of Historic Places Registration Form

historic name George Chamberlain House

street & number 315 Dover-Milton Road not for publication

state New Jersey code NJ county Morris code 027 zip code 07438

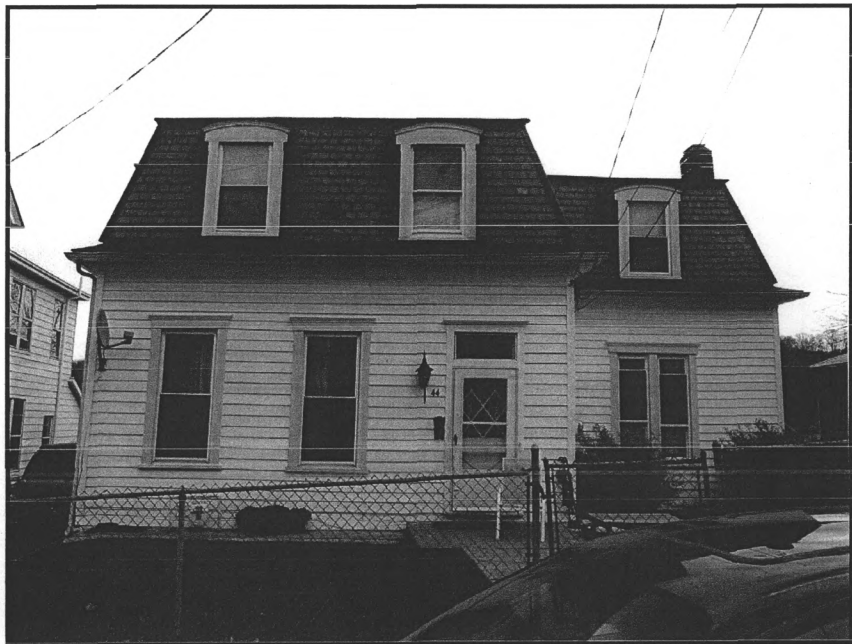
Comparative Photograph

Dover: Second Empire cottage in Dover, New Jersey. (Photographer: Kate Jefferson, Nov. 2008).

In Mine Hill, there is a group of three three-bay-wide mansard-roofed cottages that is unusual locally (Acroterion 1987:45). All three are set on raised basements and the upper roof slopes are steeper than those of other mansard-roofed houses. Two have full-width entry porches and one has a raised entry porch supported by square columns topped with brackets. One retains its pedimented window crowns with milled decorative sideboards and some double-hung two-over-one windows. Another mansard-roofed cottage is located on Hurd Street in Dover; it appears to have a taller first floor and corresponding taller first-floor windows and entry door, and a shorter lower roof than the George Chamberlain House (see photograph in accompanying

documentation section). It is also wider than the Second Empire cottages in Mine Hill. It has a wide extension on the right-hand side, set back from the front plane. There is a transom light above the door and the roof slate is coursed, without any decorative shingles.
