**NATIONAL REGISTER OF HISTORIC PLACES
REGISTRATION FORM**

historic name MORSE HARDWARE COMPANY BUILDING
other names/site number N/A

street & number 1023-1025 North State Street not for publication N/A
city or town Bellingham vicinity N/A
state Washington code WA county Whatcom code 073
zip code 98225

**MORSE HARDWARE COMPANY BUILDING
WHATCOM COUNTY, WASHINGTON**

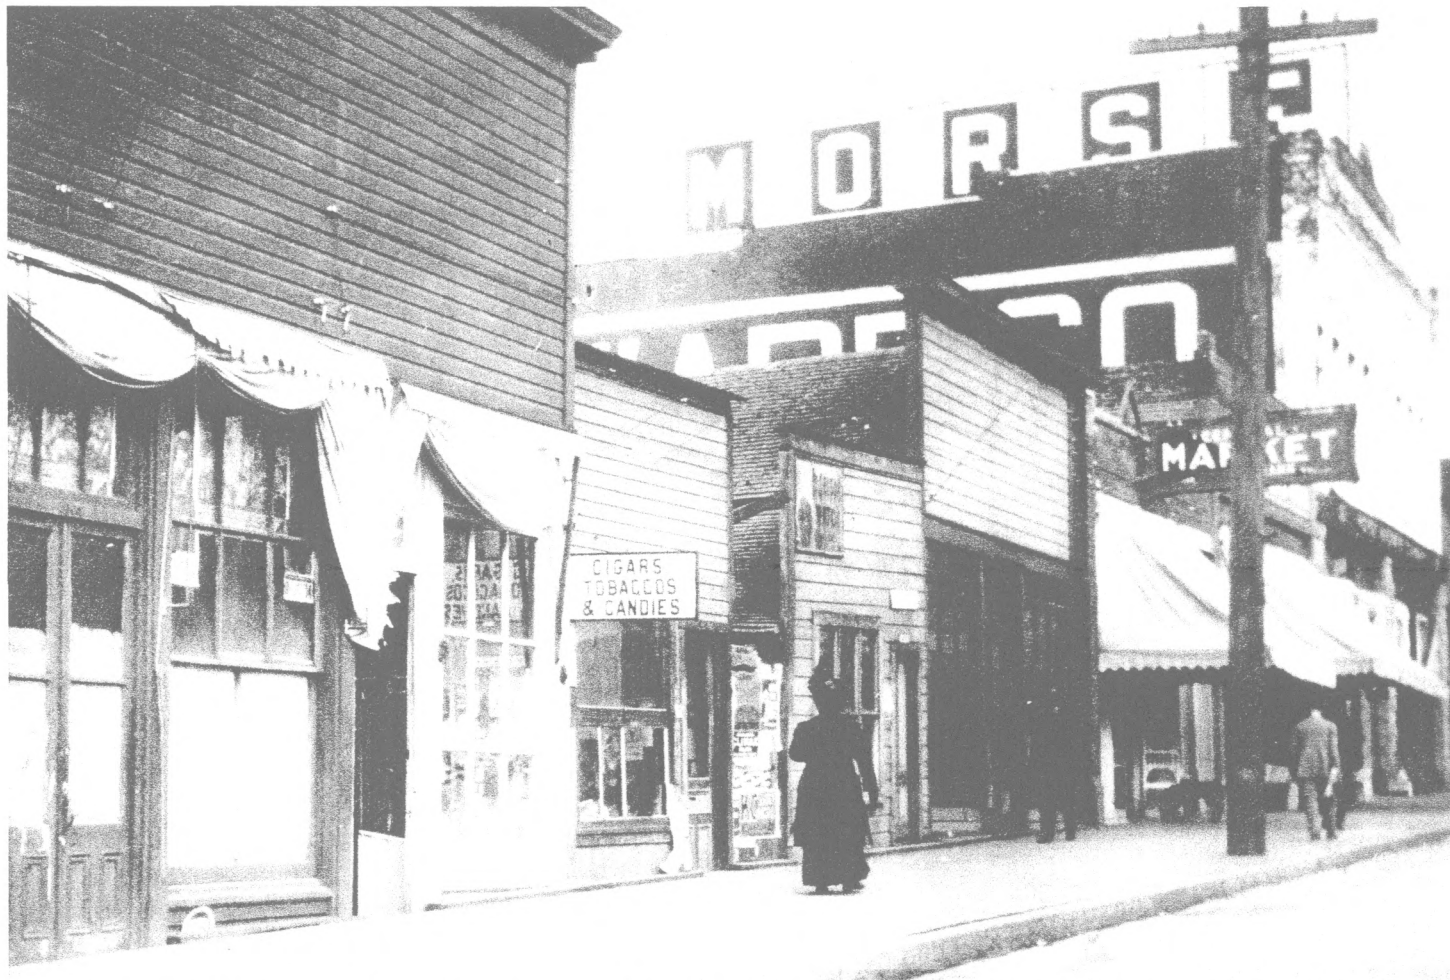
PHOTO No. 2—CA 1909 PHOTOGRAPH OF THE MORSE HARDWARE COMPANY BUILDING'S SOUTHWEST SIDE FACADE ABOVE THE ADJACENT SINGLE STORY BUILDINGS. SOURCE: GALEN BIERY COLLECTION, WHATCOM MUSEUM OF HISTORY AND ART, BELLINGHAM, WA, No. 1996.10.274.

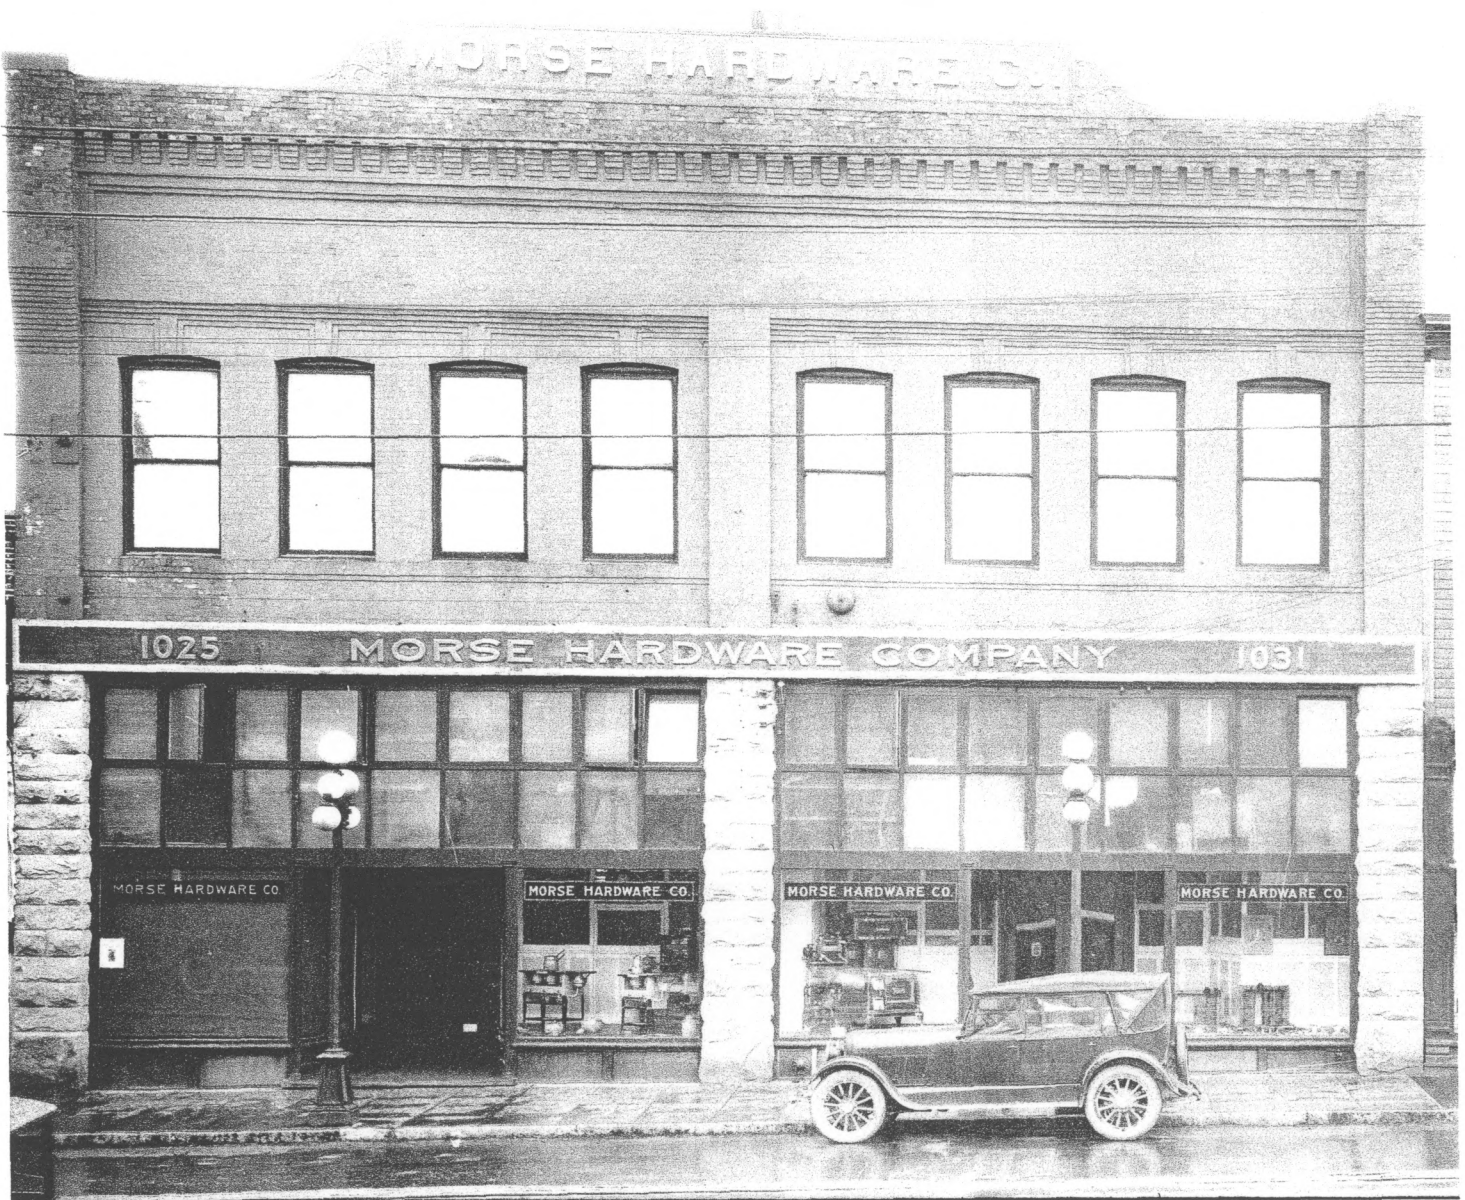
PHOTO No. 5—CA 1909 PHOTOGRAPH OF THE MORSE HARDWARE COMPANY BUILDING'S SOUTHEAST FRONT FACADE. SOURCE: SANDISON COLLECTION, WHATCOM MUSEUM OF HISTORY AND ART, BELLINGHAM, WA, No. 188.

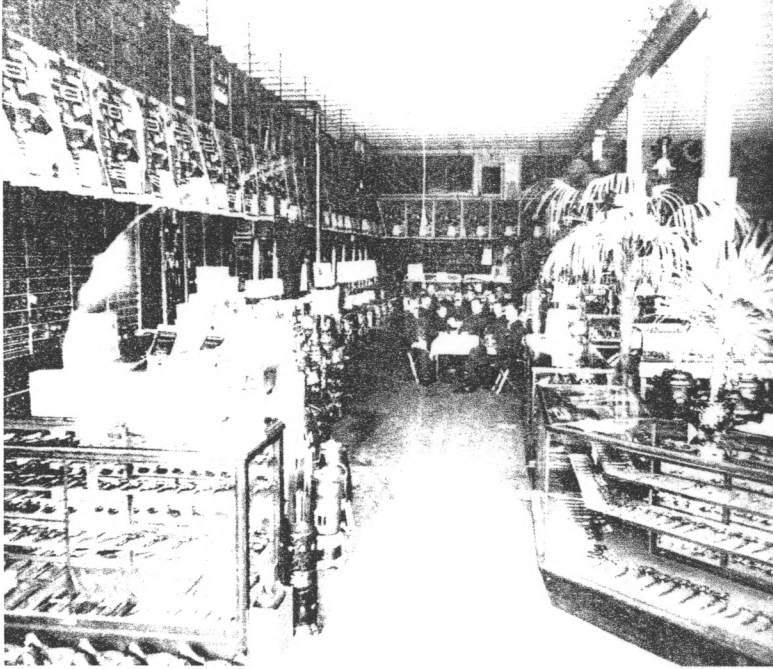
PHOTO No. 8—EARLY 1900S INTERIOR VIEW OF THE MORSE HARDWARE COMPANY BUILDING'S FIRST FLOOR RETAIL AREA. SOURCE: SELL'EM LOW—SEND AND GET MORE: A CENTENNIAL HISTORY OF THE MORSE HARDWARE COMPANY, 1884-1984: 42.

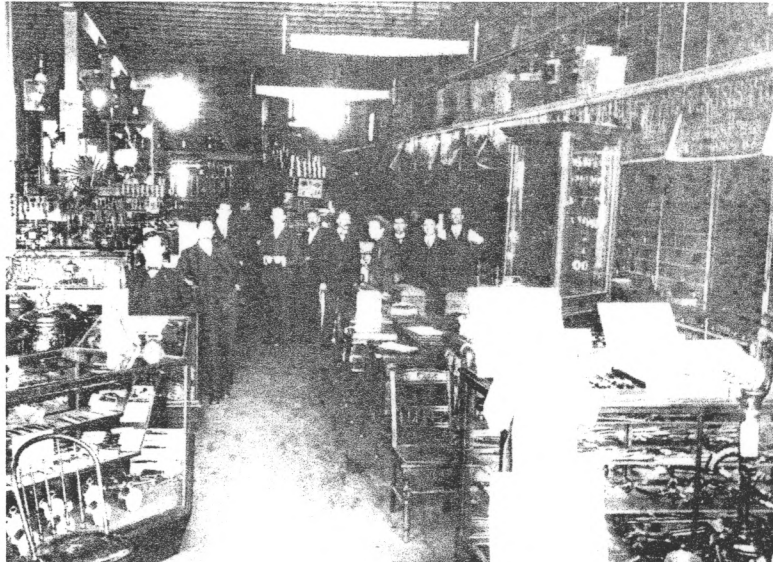
PHOTO No. 9—EARLY 1900S INTERIOR VIEW OF THE MORSE HARDWARE COMPANY BUILDING'S FIRST FLOOR RETAIL AREA. SOURCE: SELL'EM LOW—SEND AND GET MORE: A CENTENNIAL HISTORY OF THE MORSE HARDWARE COMPANY, 1884-1984: 43.

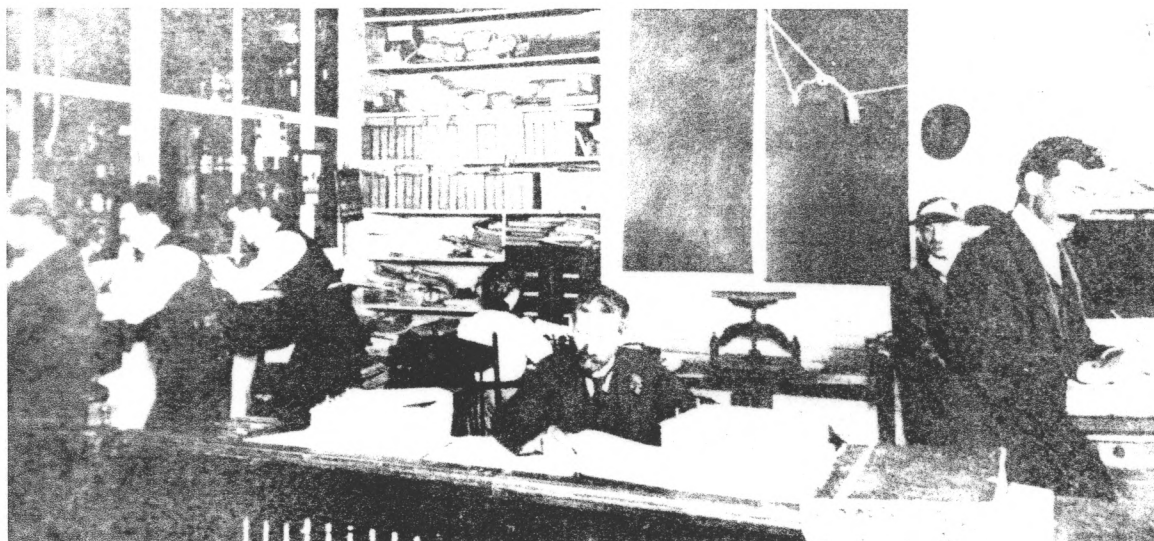
PHOTO No. 10—EARLY 1900S INTERIOR VIEW OF THE MORSE HARDWARE COMPANY BUILDING'S BOOKKEEPING OFFICE. SOURCE: SELL'EM LOW—SEND AND GET MORE: A CENTENNIAL HISTORY OF THE MORSE HARDWARE COMPANY, 1884-1984: 40.

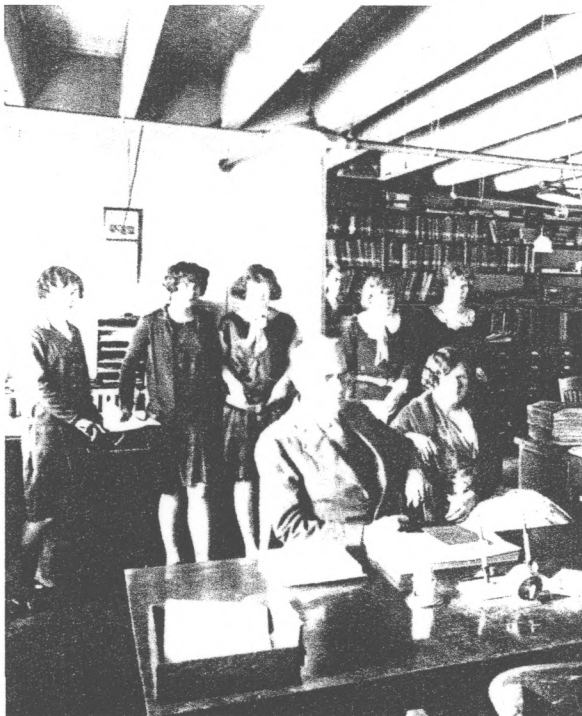
PHOTO No. 12—1920s PHOTOGRAPH OF PURCHASING AGENT ADOLPH L. RANK AND OTHER PURCHASING DEPARTMENT PERSONNEL IN THE MORSE HARDWARE COMPANY BUILDING. SOURCE: SELL'EM LOW—SEND AND GET MORE: A CENTENNIAL HISTORY OF THE MORSE HARDWARE COMPANY, 1884-1984: 57.

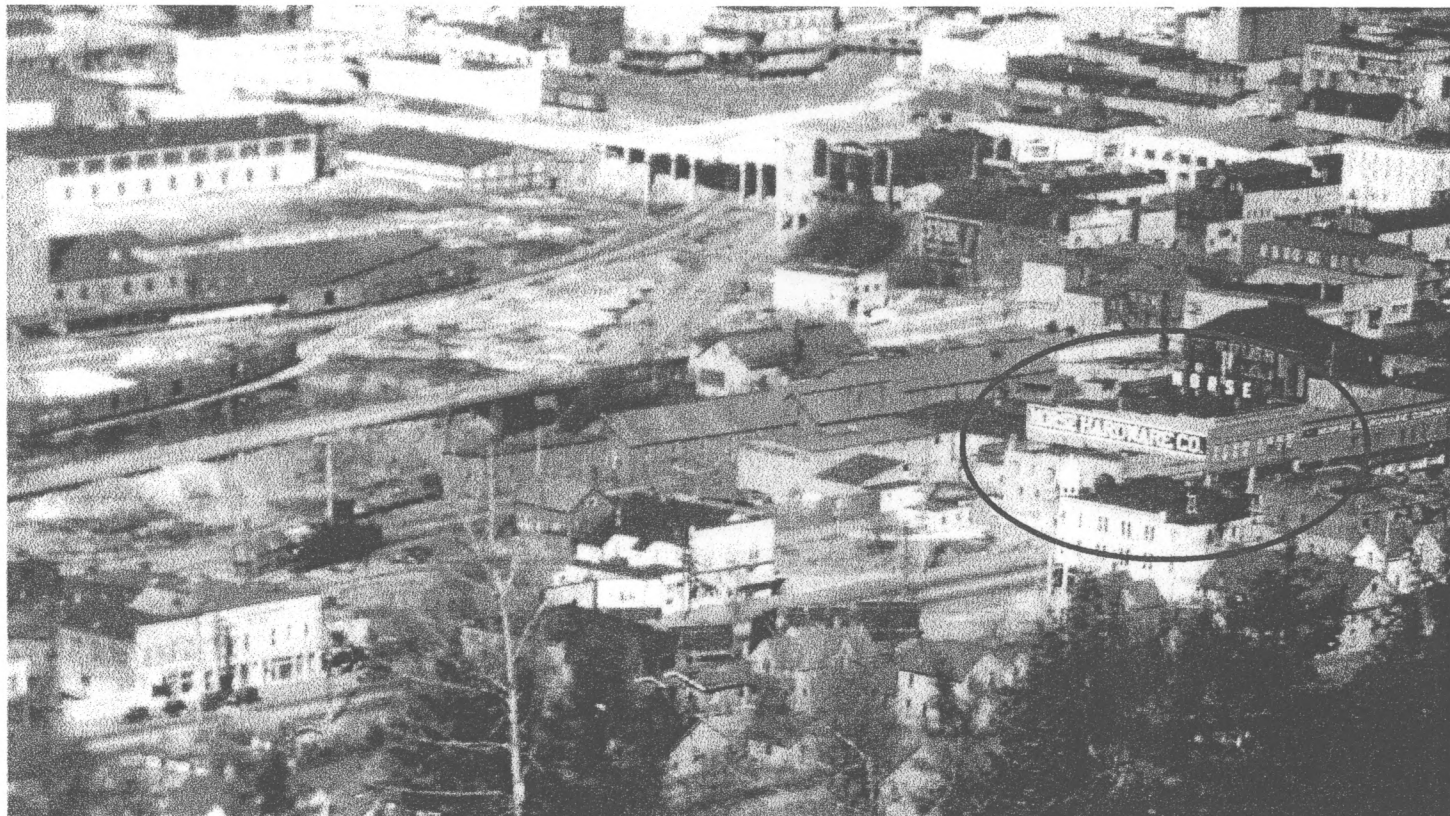
PHOTO NO. 14—CA 1930S PHOTOGRAPH SHOWING THE CONTEXTUAL SETTING OF THE MORSE HARDWARE COMPANY BUILDING. SOURCE: GORDON TWEIT.

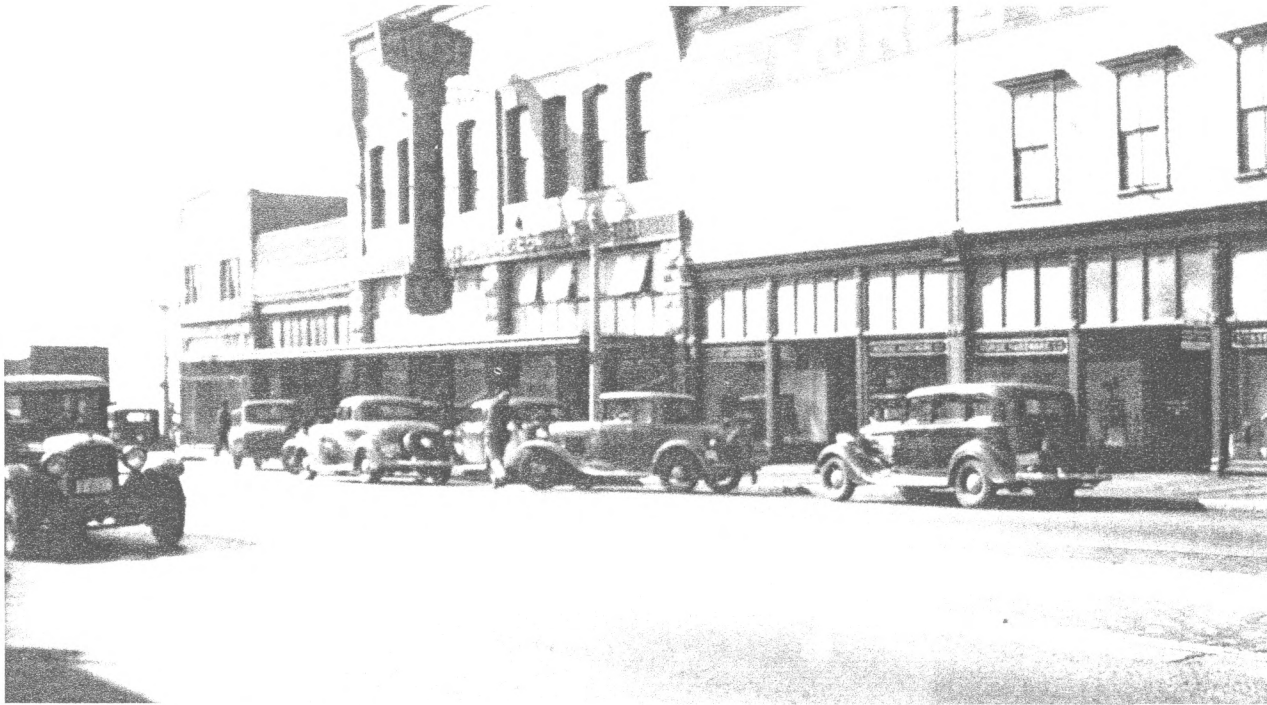
PHOTO No. 16—Spring 1938 view of the Morse Hardware Company Building. SOURCE: PHOTOGRAPH COURTESY OF GAYLORD LAUE. *SELL'EM LOW—SEND AND GET MORE: A CENTENNIAL HISTORY OF THE MORSE HARDWARE COMPANY, 1884-1984: 61.*

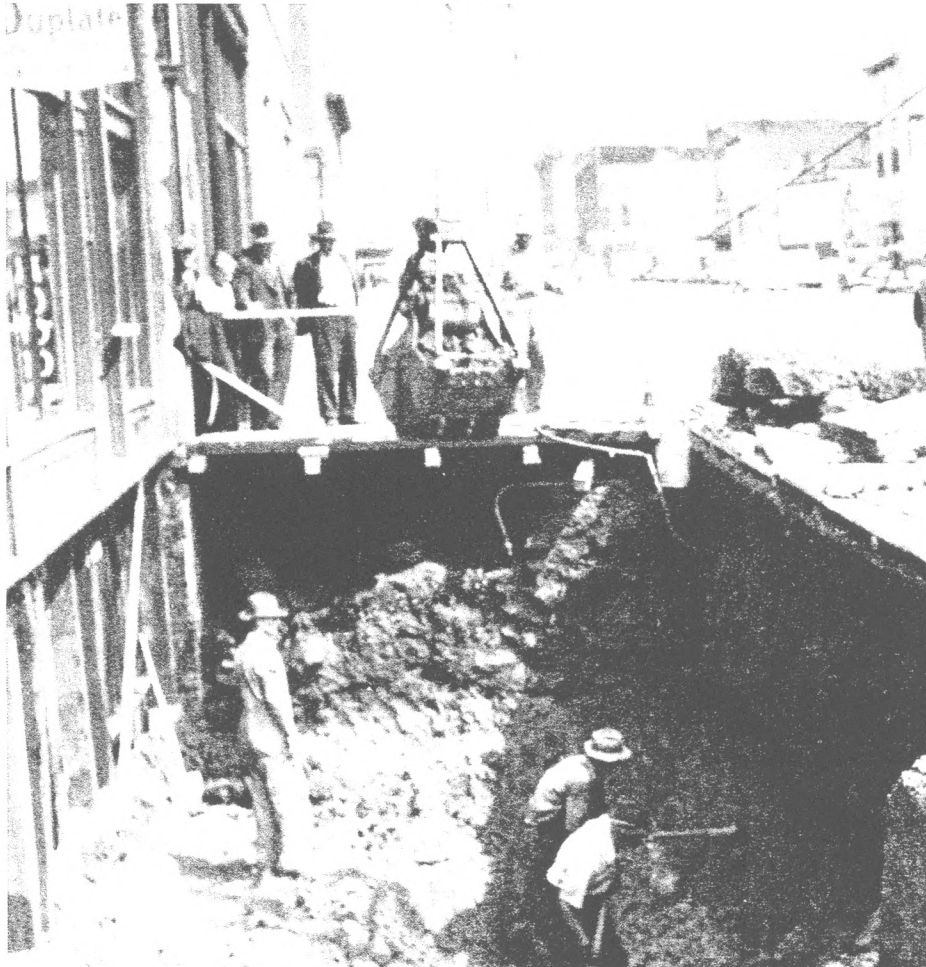
PHOTO No. 17—1937 PHOTOGRAPH OF EXCAVATION BELOW THE SIDEWALK IN FRONT OF THE MORSE HARDWARE COMPANY BUILDING TO EXTEND THE BASEMENT. SOURCE: *SELL'EM LOW—SEND AND GET MORE: A CENTENNIAL HISTORY OF THE MORSE HARDWARE COMPANY, 1884-1984: 59.*
