National Register of Historic Places Registration Form

1. Name of Property	
historic name Alexander House	
other names/site number Churcher House; Gloyd Hou	se; 5CF.2048
2. Location	
street & number 846 F Street	[N/A] not for publication
city or town Salida	[N/A] vicinity
state Colorado code CO county Chaffee	code <u>015</u> zip code <u>81201</u>

Alexander House Chaffee County, Colorado

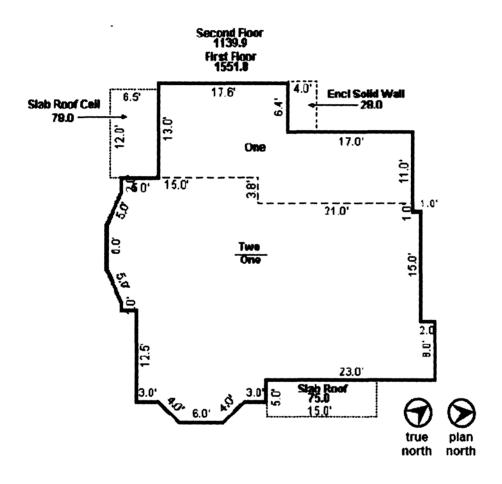
SKETCH PLAN 1: Footprint

Source/Note: This dimensioned foot print (Sketch Plan 1) of the Alexander House was acquired from the Chaffee County Assessor's Office located at the Salida courthouse. To create this footprint, measurements were taken along the exterior perimeter of the building. The two floor plan sketches (Sketch Plan 2 and 3) that follow were created with AutoCad and Illustrator by Lisa Schott. Interior photographs of the property and the dimensioned foot print were used as references. These highly simplified floor plans were created only to show the general layout of rooms and should not be considered a credible source for any other information.

The 1901 Alexander House is a two-story, Late Victorian Queen Anne style residence, with a rectangular (44' x 34') plan, a complex roof, and front and side porches. The walls are made of brick, the foundation of dark stone, and the roof of asphalt/composition shingles. The facade is asymmetrical. The interior of the house reflects the Victorian style. The house is located on a corner lot with the facade facing east onto F Street and a secondary elevation facing south onto 9th Street. The lot has a grass lawn and a concrete sidewalk in front, with a planting strip and large deciduous street trees. A chain-link fence on the south separates the side yard from a parking strip at the street's edge.
