National Register of Historic Places Registration Form

Historic name Oak Hill Farm

Street & Number: 1280 Keeling Road

City or town: Stanton State: TN County: Tipton & Haywood

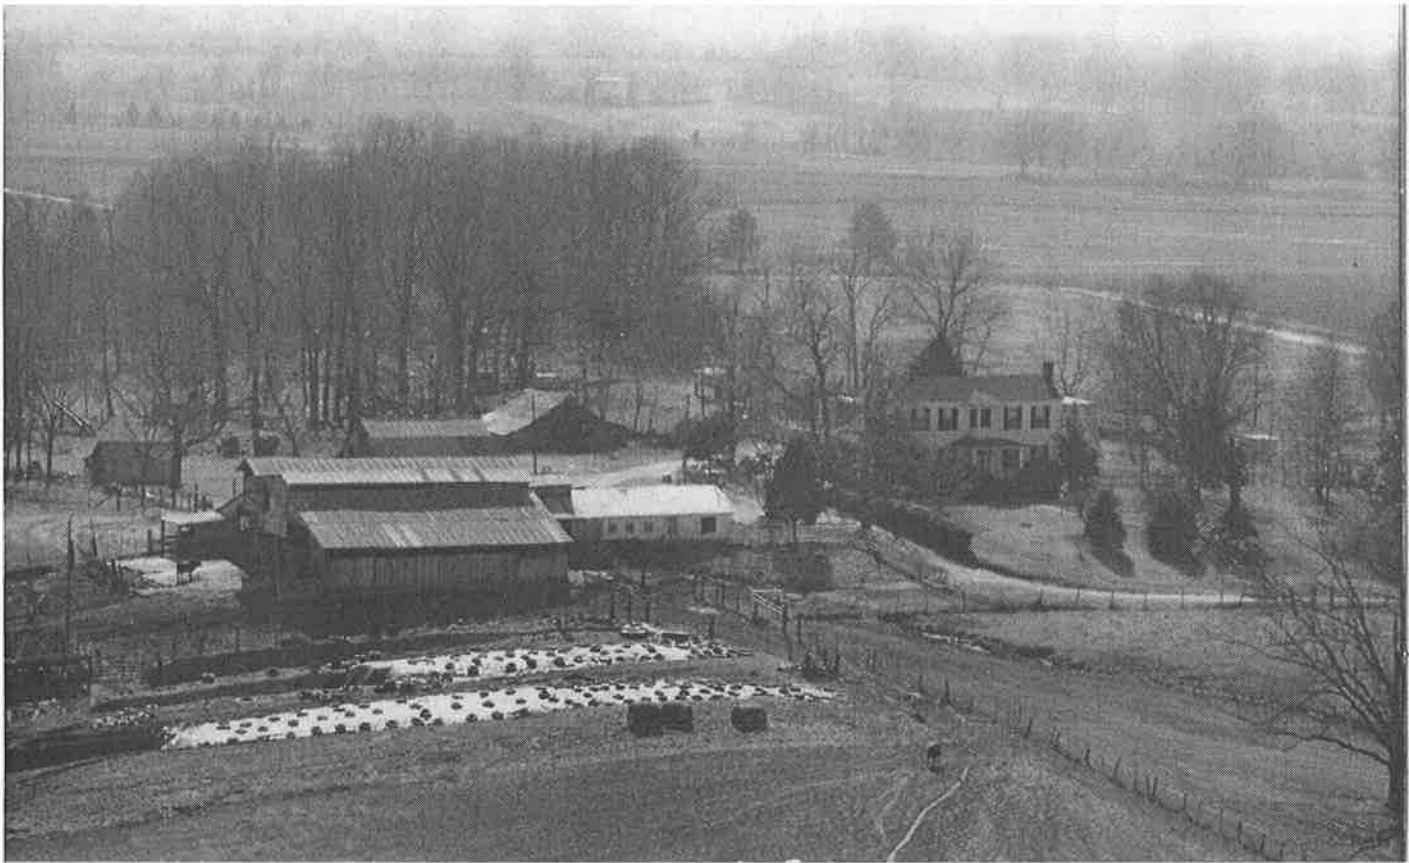
Figure 1. Aerial overview of the farm, c. 1980. Note the silage pits visible in the foreground, north of the barn.

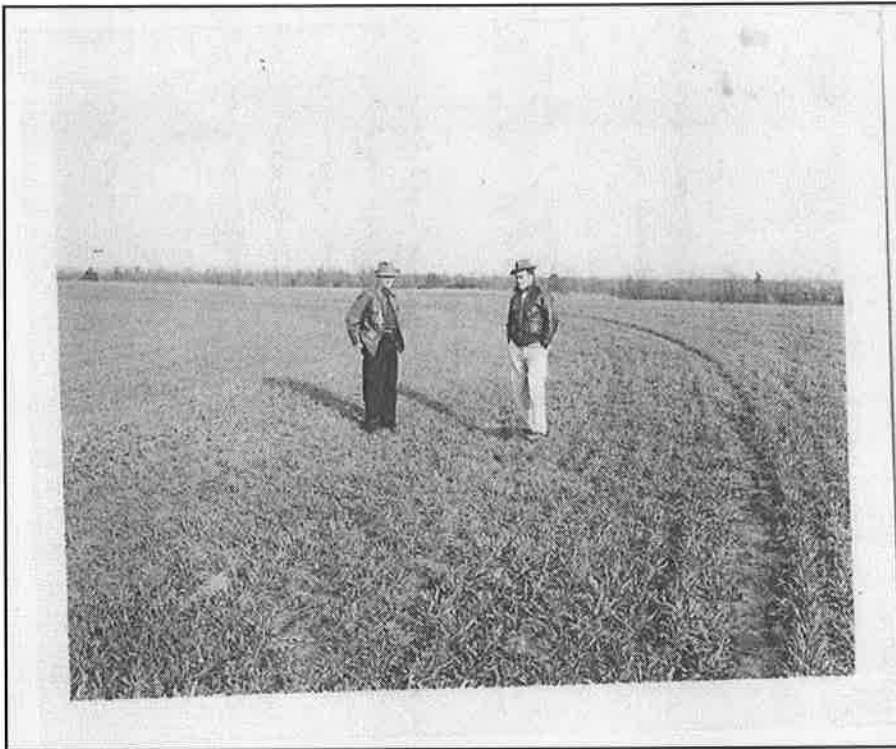
Figure 4. Caption reads: "2-2292-4
Tenn-Tipton-12-10-61 L.M. Maclin
Stanton, Tenn.

Oats on terraced land drilled on the contour.

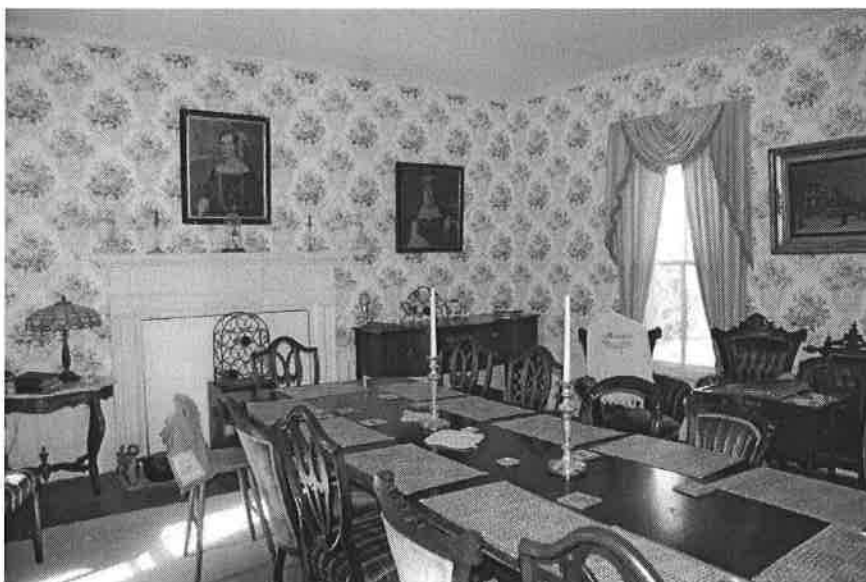
Additional Photo 1. Dining Room, Photographer Facing Northwest.

Accessible from the central hall, the dining room is a large room occupying the entire west end of the first floor (Photo 8).⁵ The walls and ceiling in this room have been replaced with drywall, but retain their historic wood-paneled wainscoting, baseboards, and crown molding. The west wall is dominated by a brick fireplace and hearth which includes what appears to be an original wood mantel and mantelshelf. The mantel is an excellent example of modest Federal-style vernacular detailing with its thin lines and formality. The sides of the mantel include pilasters with a stylized pedestal, stylized column shafts with channeling, a plain mantelpiece with central block and architrave detailing, and a molded cornice with implied capitals on which the mantelshelf rests (Photo 9).

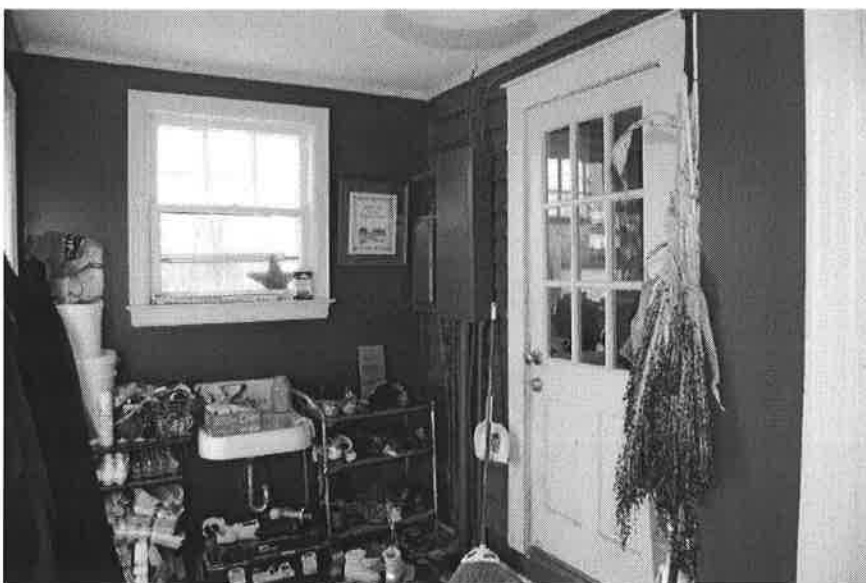
Additional Photo #2. Mudroom, Photographer Facing Southwest.

In 1945-1946, a shed roof addition was added to the south elevation of the house. A mudroom addition was made at the same time extending from the east elevation of the house and the south addition. The south elevation shed room addition introduced the first indoor plumbing to the home, and at the same time, electricity was added throughout the home. The south addition created a kitchen, an open area currently used as an office, a hallway with closets, and a full bathroom. Unless otherwise noted, these spaces have hardwood floors, drywall walls, plain four-inch baseboards, architrave trim on the window and doorframes, and crown molding.

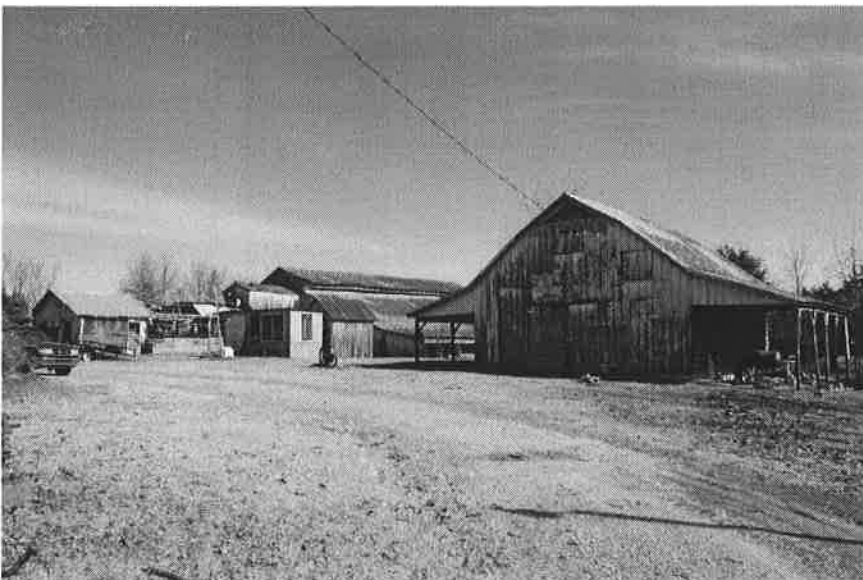
Additional Photo #6. Agricultural Complex (Granary, Barn, Dairy Parlor, Smoke House, and Well House), Photographer Facing Northeast.

The one-story dairy parlor was built in 1948 and is situated slightly northeast of the main house (Photo 28). It is attached to the barn (resource #3) via a connecting gabled roof hyphen, which would have been gated to feed the cows from the barn into the milking area. It sits on a poured concrete and concrete block foundation. The lower portion of the walls are brick, and the upper portion are board-and-batten. A raised seam metal gable roof extends from the barn west over the hyphen. Within the gable breezeway/hyphen are a series of wood chutes that allowed the cattle to move from the barn into the dairy parlor for milking. The dairy parlor is a center aisle structure with elevated concrete stalls where the cows stood to be milked, and the metal milking apparatuses remain (Photo 29). The north and south walls feature screened openings to allow light to enter the building. At the west end of the center aisle, a wood glazed door allows access to the storage area where the milk was kept until it could be transported for sale.

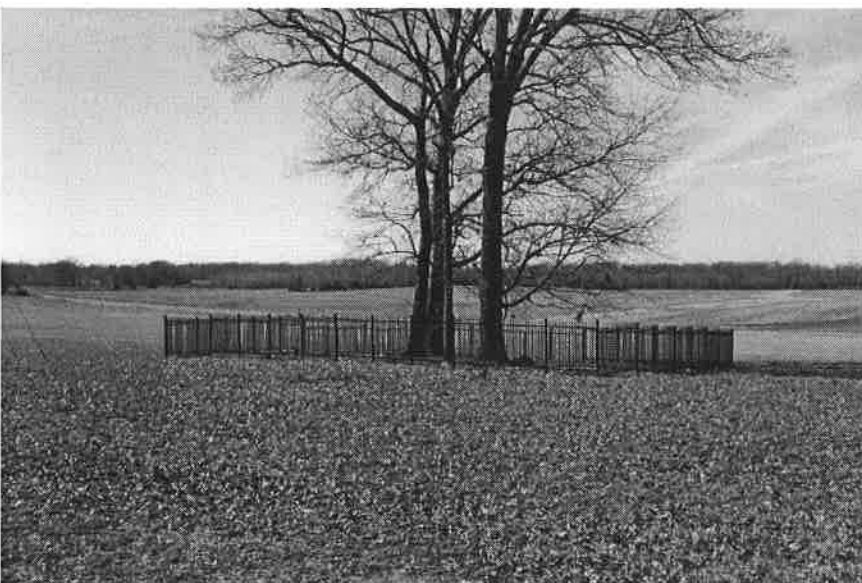
Additional Photo #8. View Toward Cemetery and Surrounding Setting, Photographer Facing Southwest.

The small historic cemetery at Oak Hill is situated to the west of the main house and farm complex and southeast of the 1979 secondary residence (resource #2) (Photo 41). It includes three marked graves: Lucy Lyne Maclin (buried 1869) (Photo 42), James Bullock Maclin (buried 1860) (Photo 43), and Charles Maclin (buried 1880). Lucy and James' graves are slightly more ornate. Lucy Maclin's tombstone includes a carved wreath and the phrase "OUR MOTHER" below. James Maclin's grave includes scrolling details at the top. The tombstones have suffered some damage from the root systems of the oak trees that shade the cemetery, but are not beyond repair. The burials appear to be arranged facing east. The cemetery is protected from the surrounding agricultural space by a metal fence erected in 2008, and the owners are not certain as to whether there may be other family members or farm residents buried in the vicinity, as no other graves were marked.
