United States Department of the Interior
National Park ServiceNational Register of Historic Places
Inventory—Nomination FormSee instructions in *How to Complete National Register Forms*
Type all entries—complete applicable sections

historic Bank of Malvern

street & number 212 South Main Street

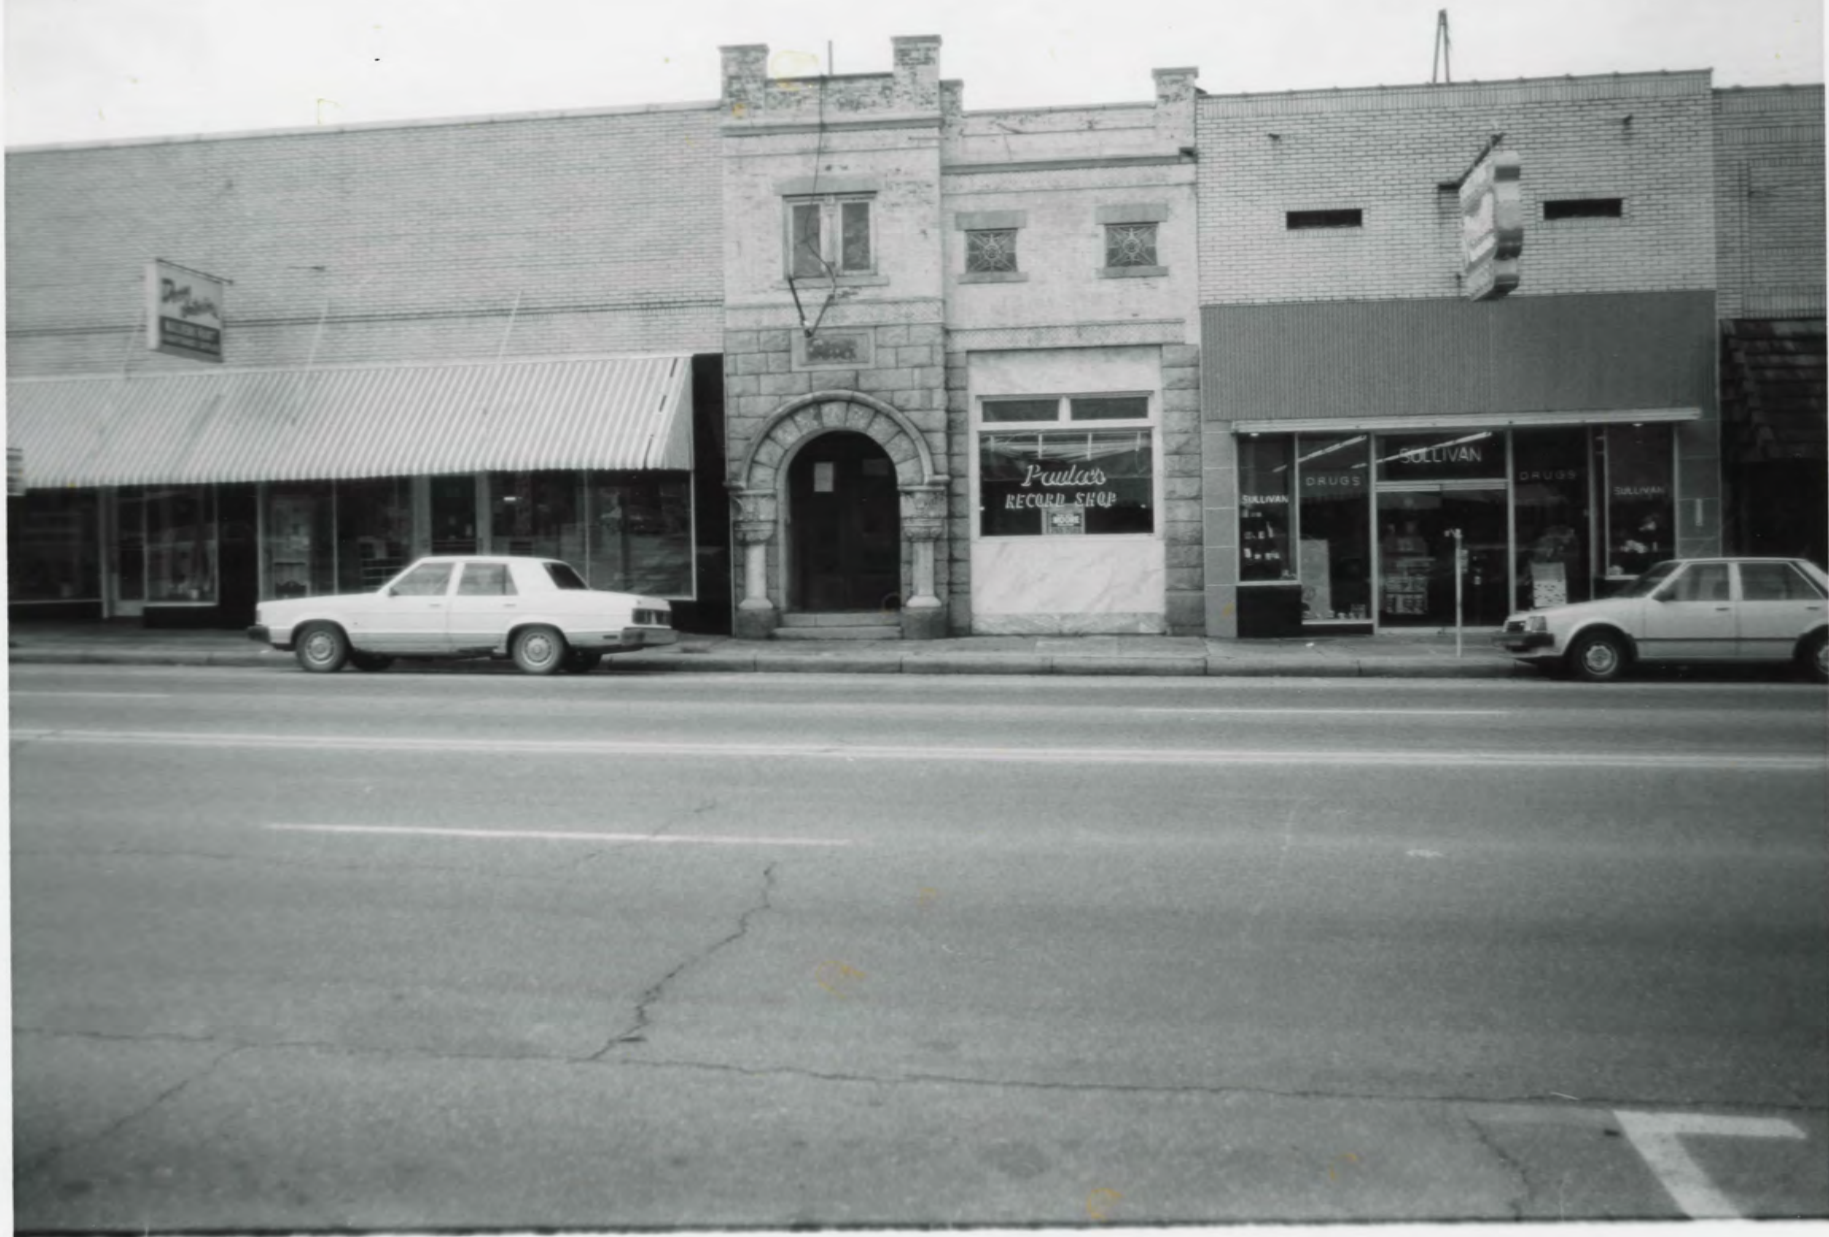
Bank of Malvern

Malvern, Hot Spring County

Front elevation

The facade consists of two bays which are asymmetrical in design. The entrance bay is emphasized by projecting slightly forward from and higher than the second bay. The ground floor, which remains from the original 1889 structure, is made of rough-cut granite. The entryway consists of a round arch supported by engaged squat columns with cushion capitals on rounded pedestals and a recessed double door. These features give the building a Richardsonian-Romanesque appearance. The second bay on the ground level contains a large window with a stationary pane and two transoms placed in a large marble panel, which is the result of a renovation at an undetermined date.

The second level, the product of reconstruction following the 1896 fire, is delineated by horizontal bands of terra cotta "trellis" and is made of brick. A pair of casement windows separated by a single colonette are centered above the entrance and there are two square windows with ornamental grillwork, rather than panes, in the second bay. All of the windows have lintel heads. A belt course or modified cornice runs above the upper terra cotta band and signifies the parapet, which has chimney-like extensions at each corner and completes the facade.

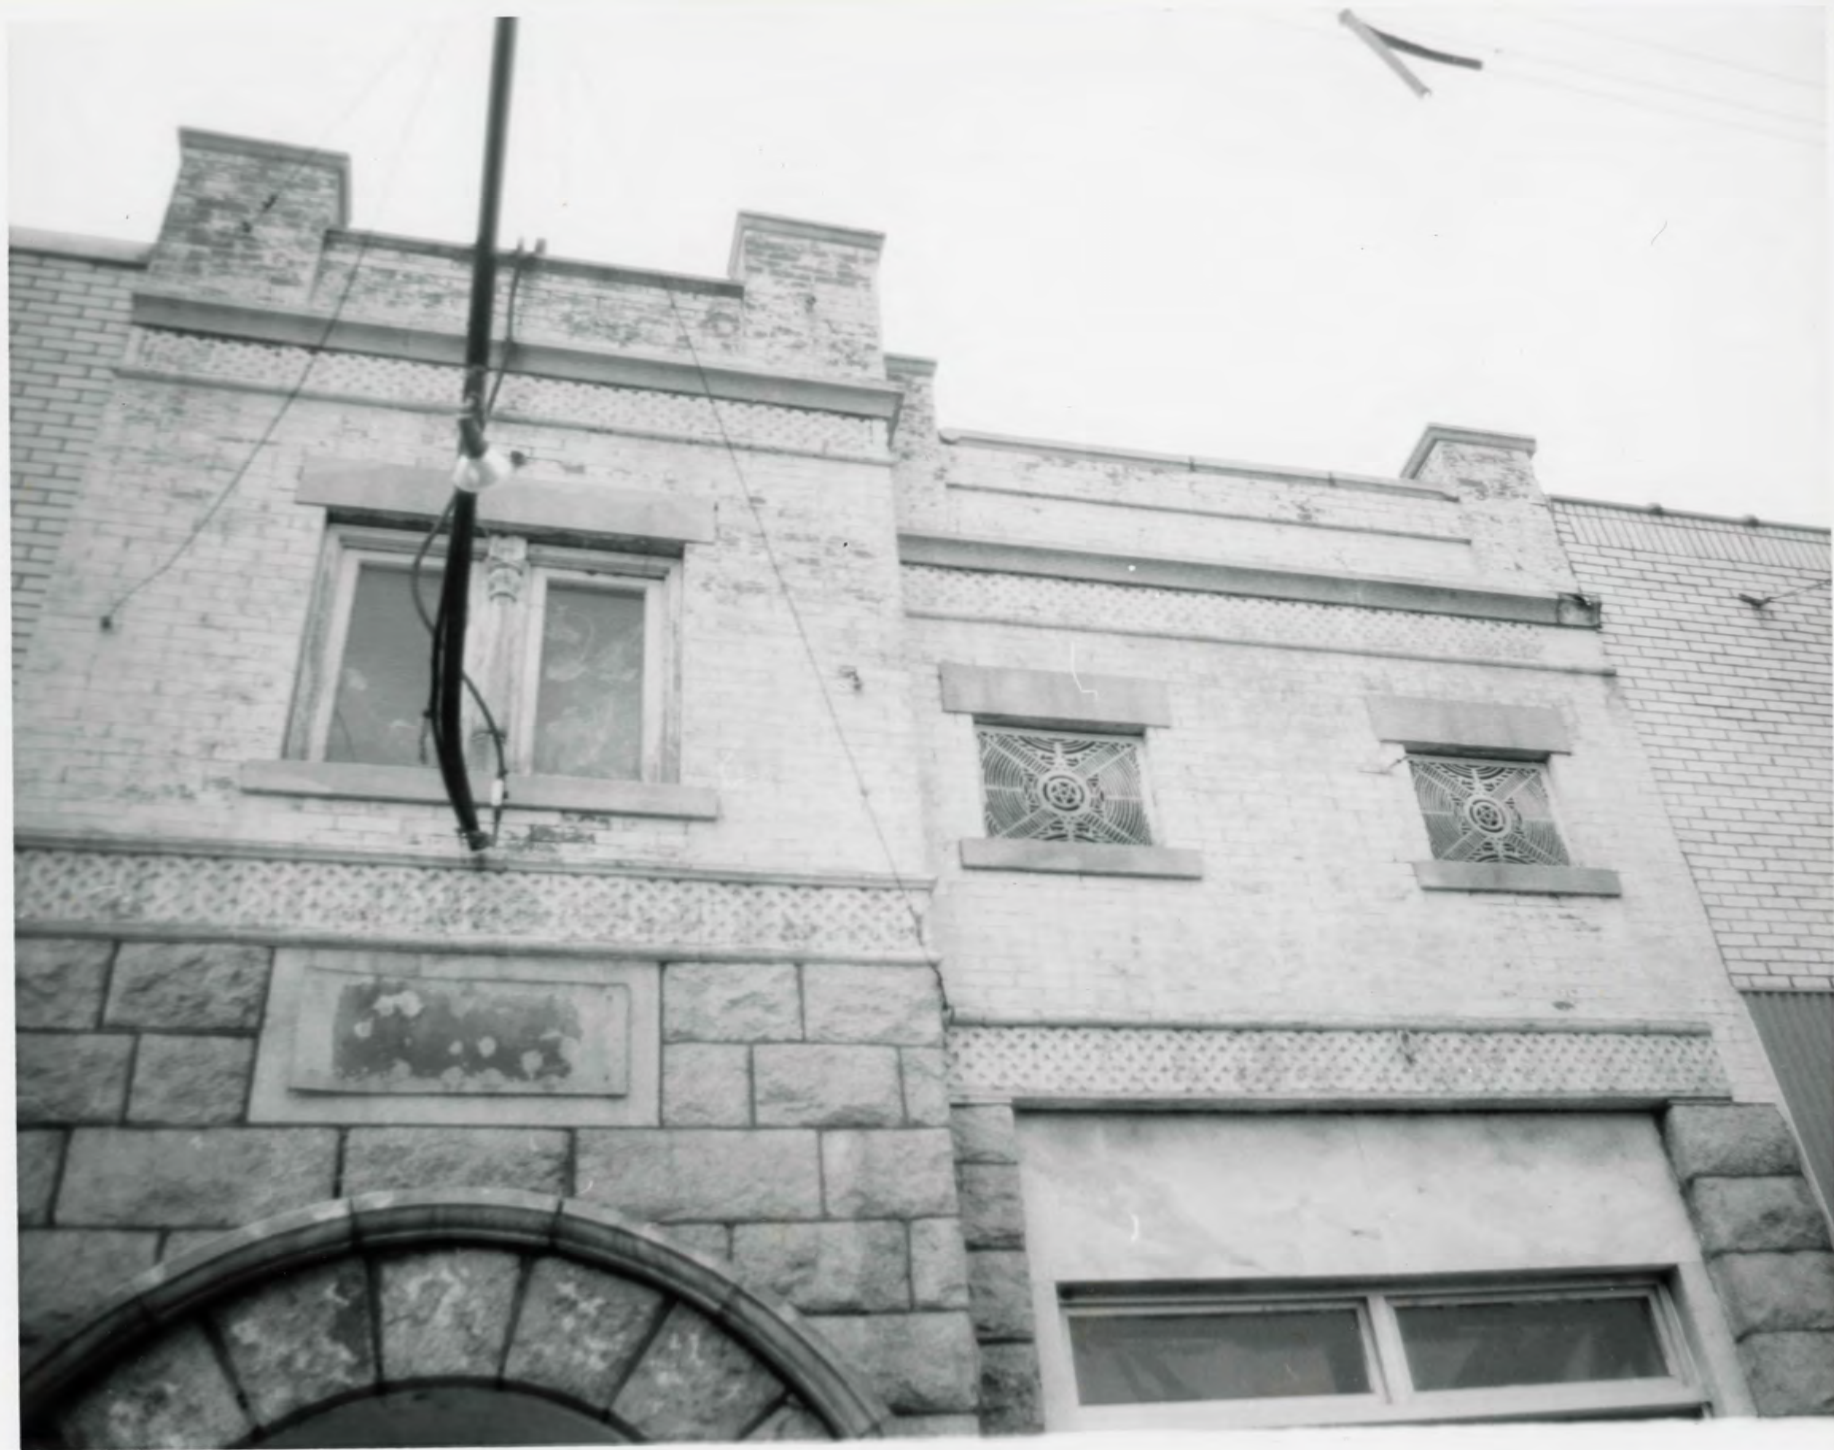
Bank of Malvern

Malvern, Hot Spring County

Exterior detail

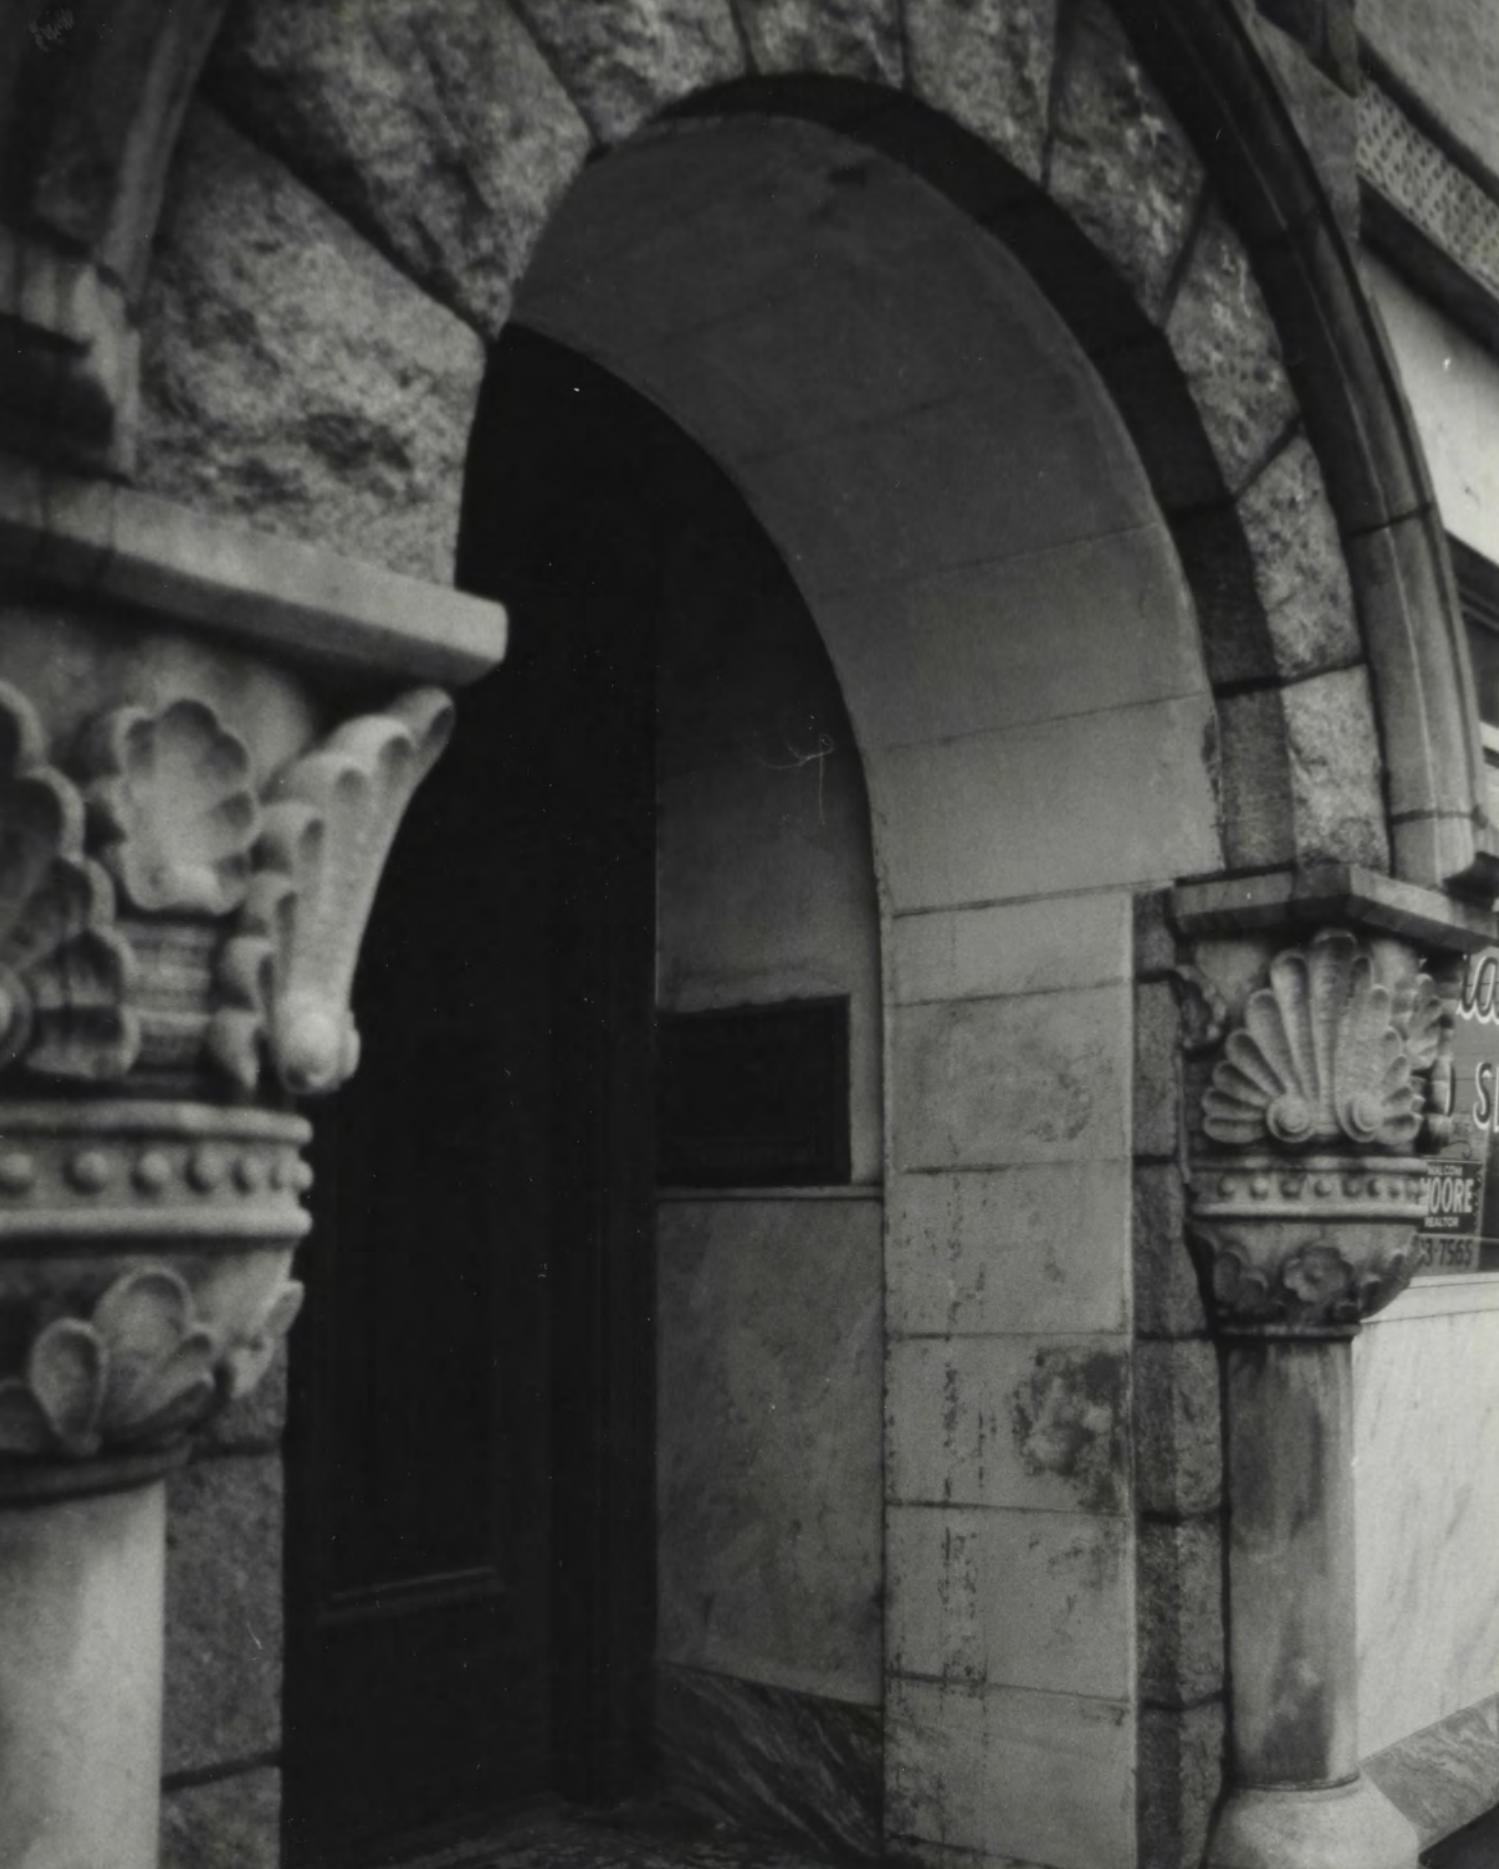
Bank of Malvern

Malvern, Hot Spring County

Exterior detail

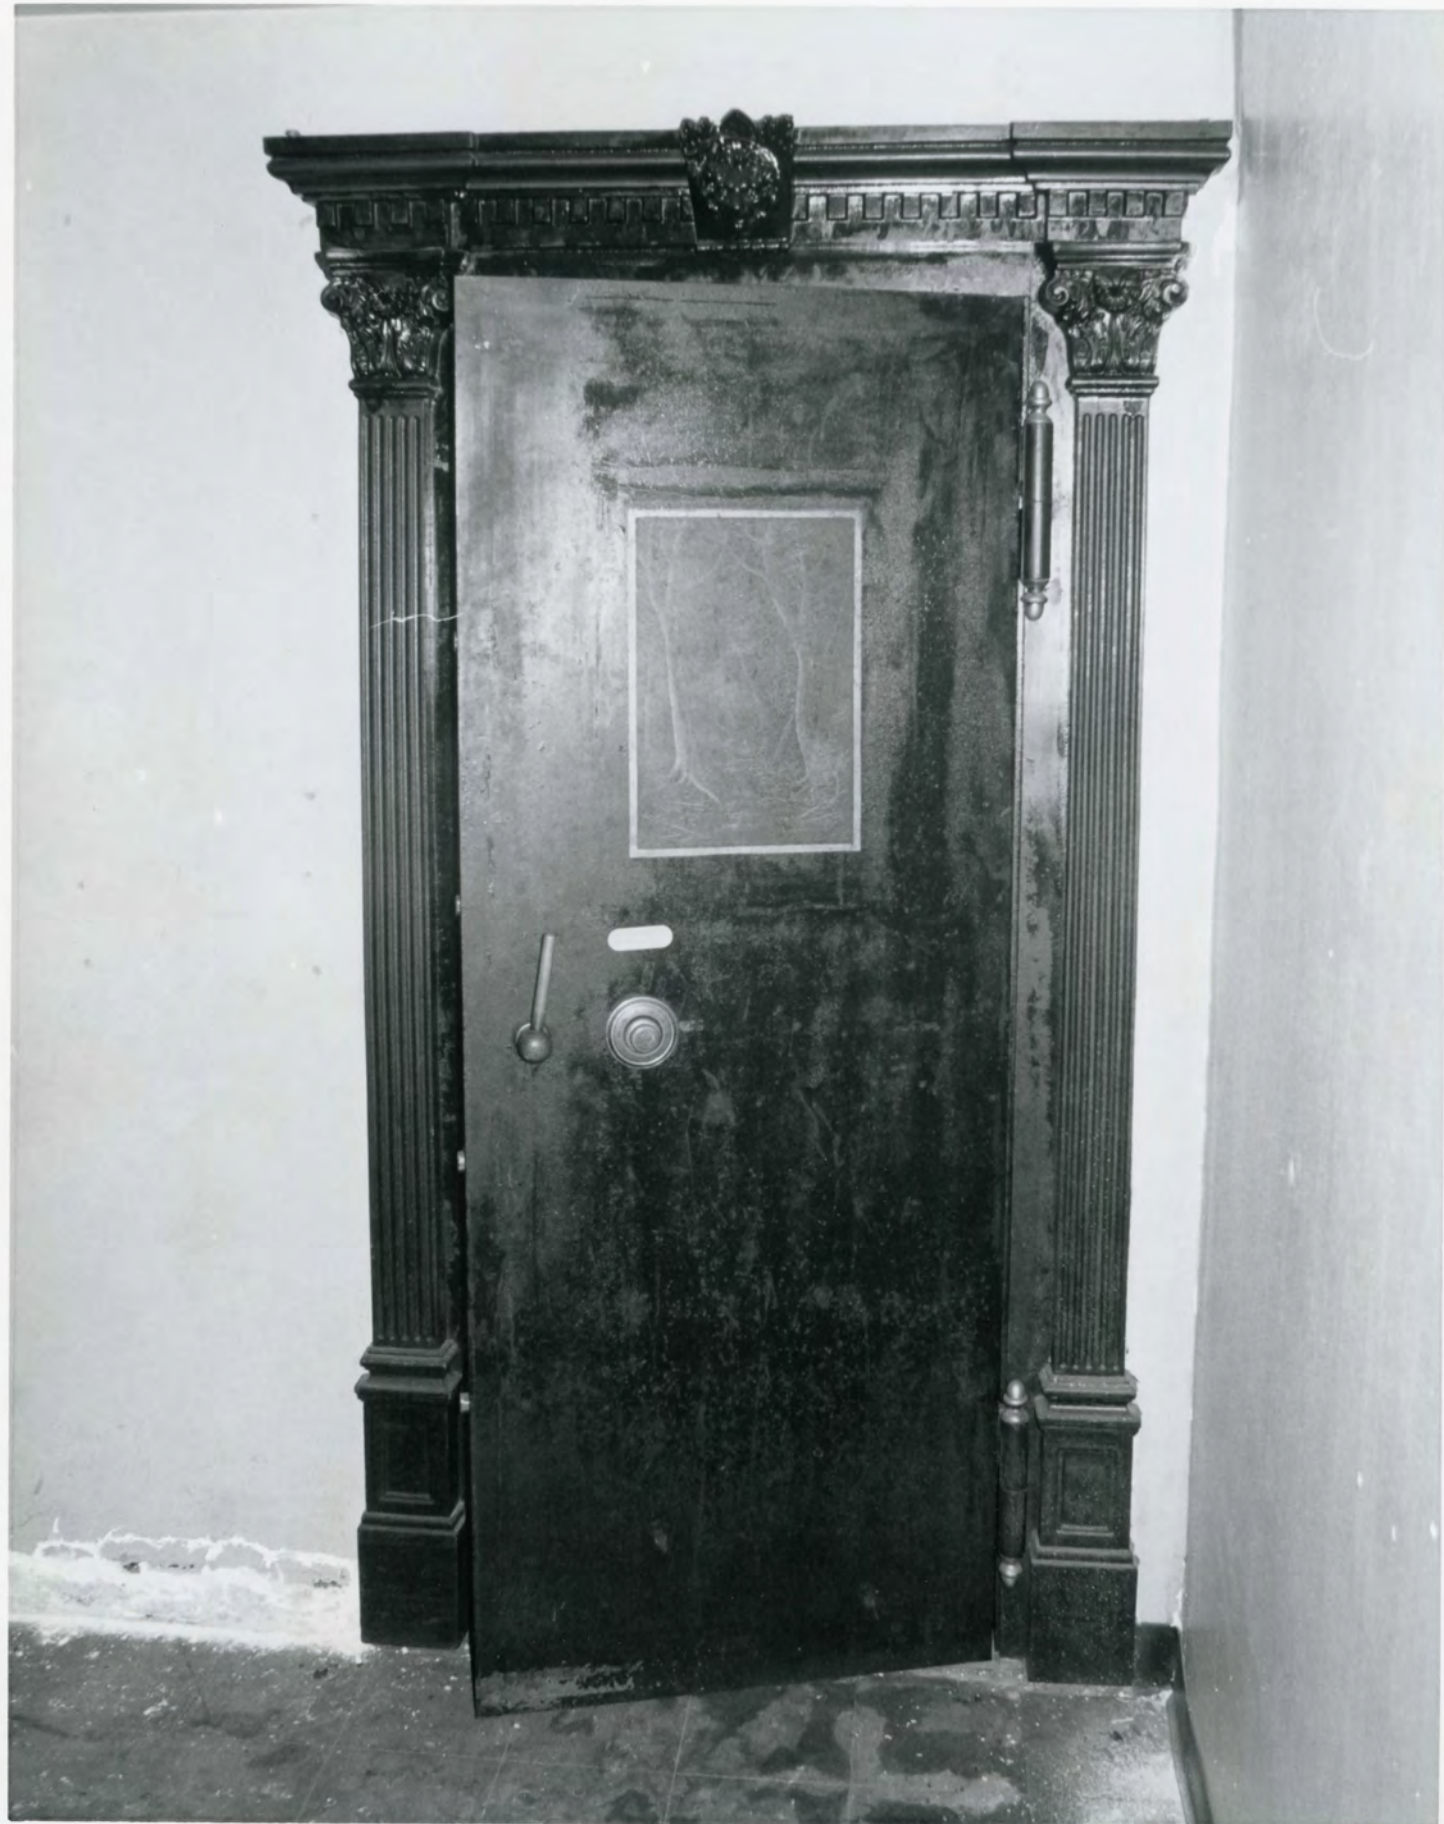
Bank of Malvern
Malvern, Hot Spring County
Interior detail

The interior of the structure reveals major alterations from the 1950 renovation; however, many of the original ornamental details remain intact. The entryway is floored with mosaic tiles. Beneath the present wall covering, the painted frieze is still visible and above the suspended ceiling the pressed-tin ceiling can still be found. The ornate door-surround of the vault is in excellent condition. It has fluted, composite pilasters at each side and an architrave and cornice with dentils, as well as a lions head keystone, above.

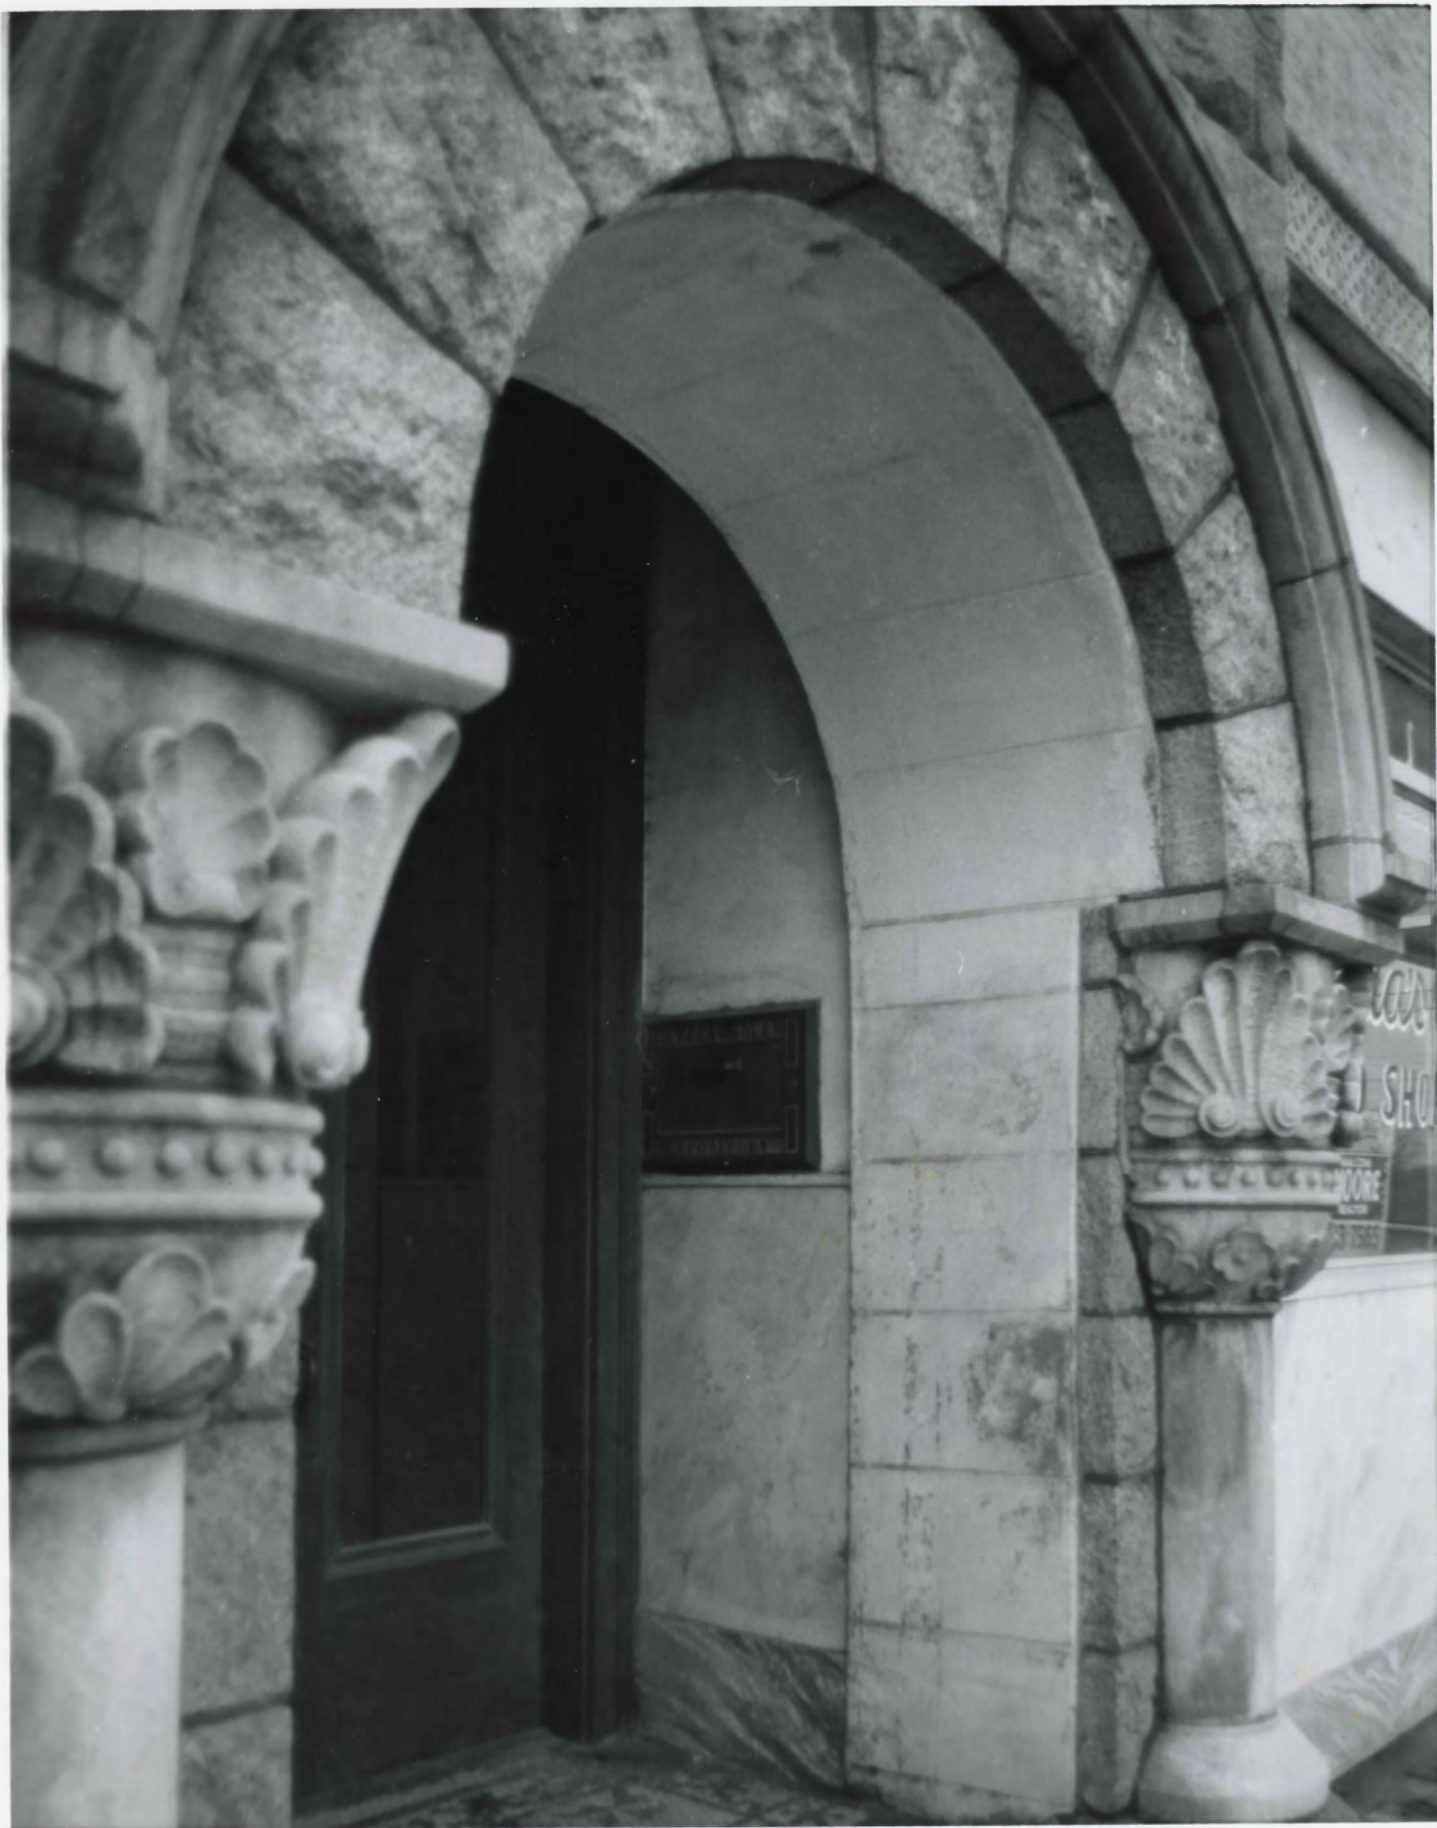
Bank of Malvern

Malvern, Hot Spring County

Exterior detail

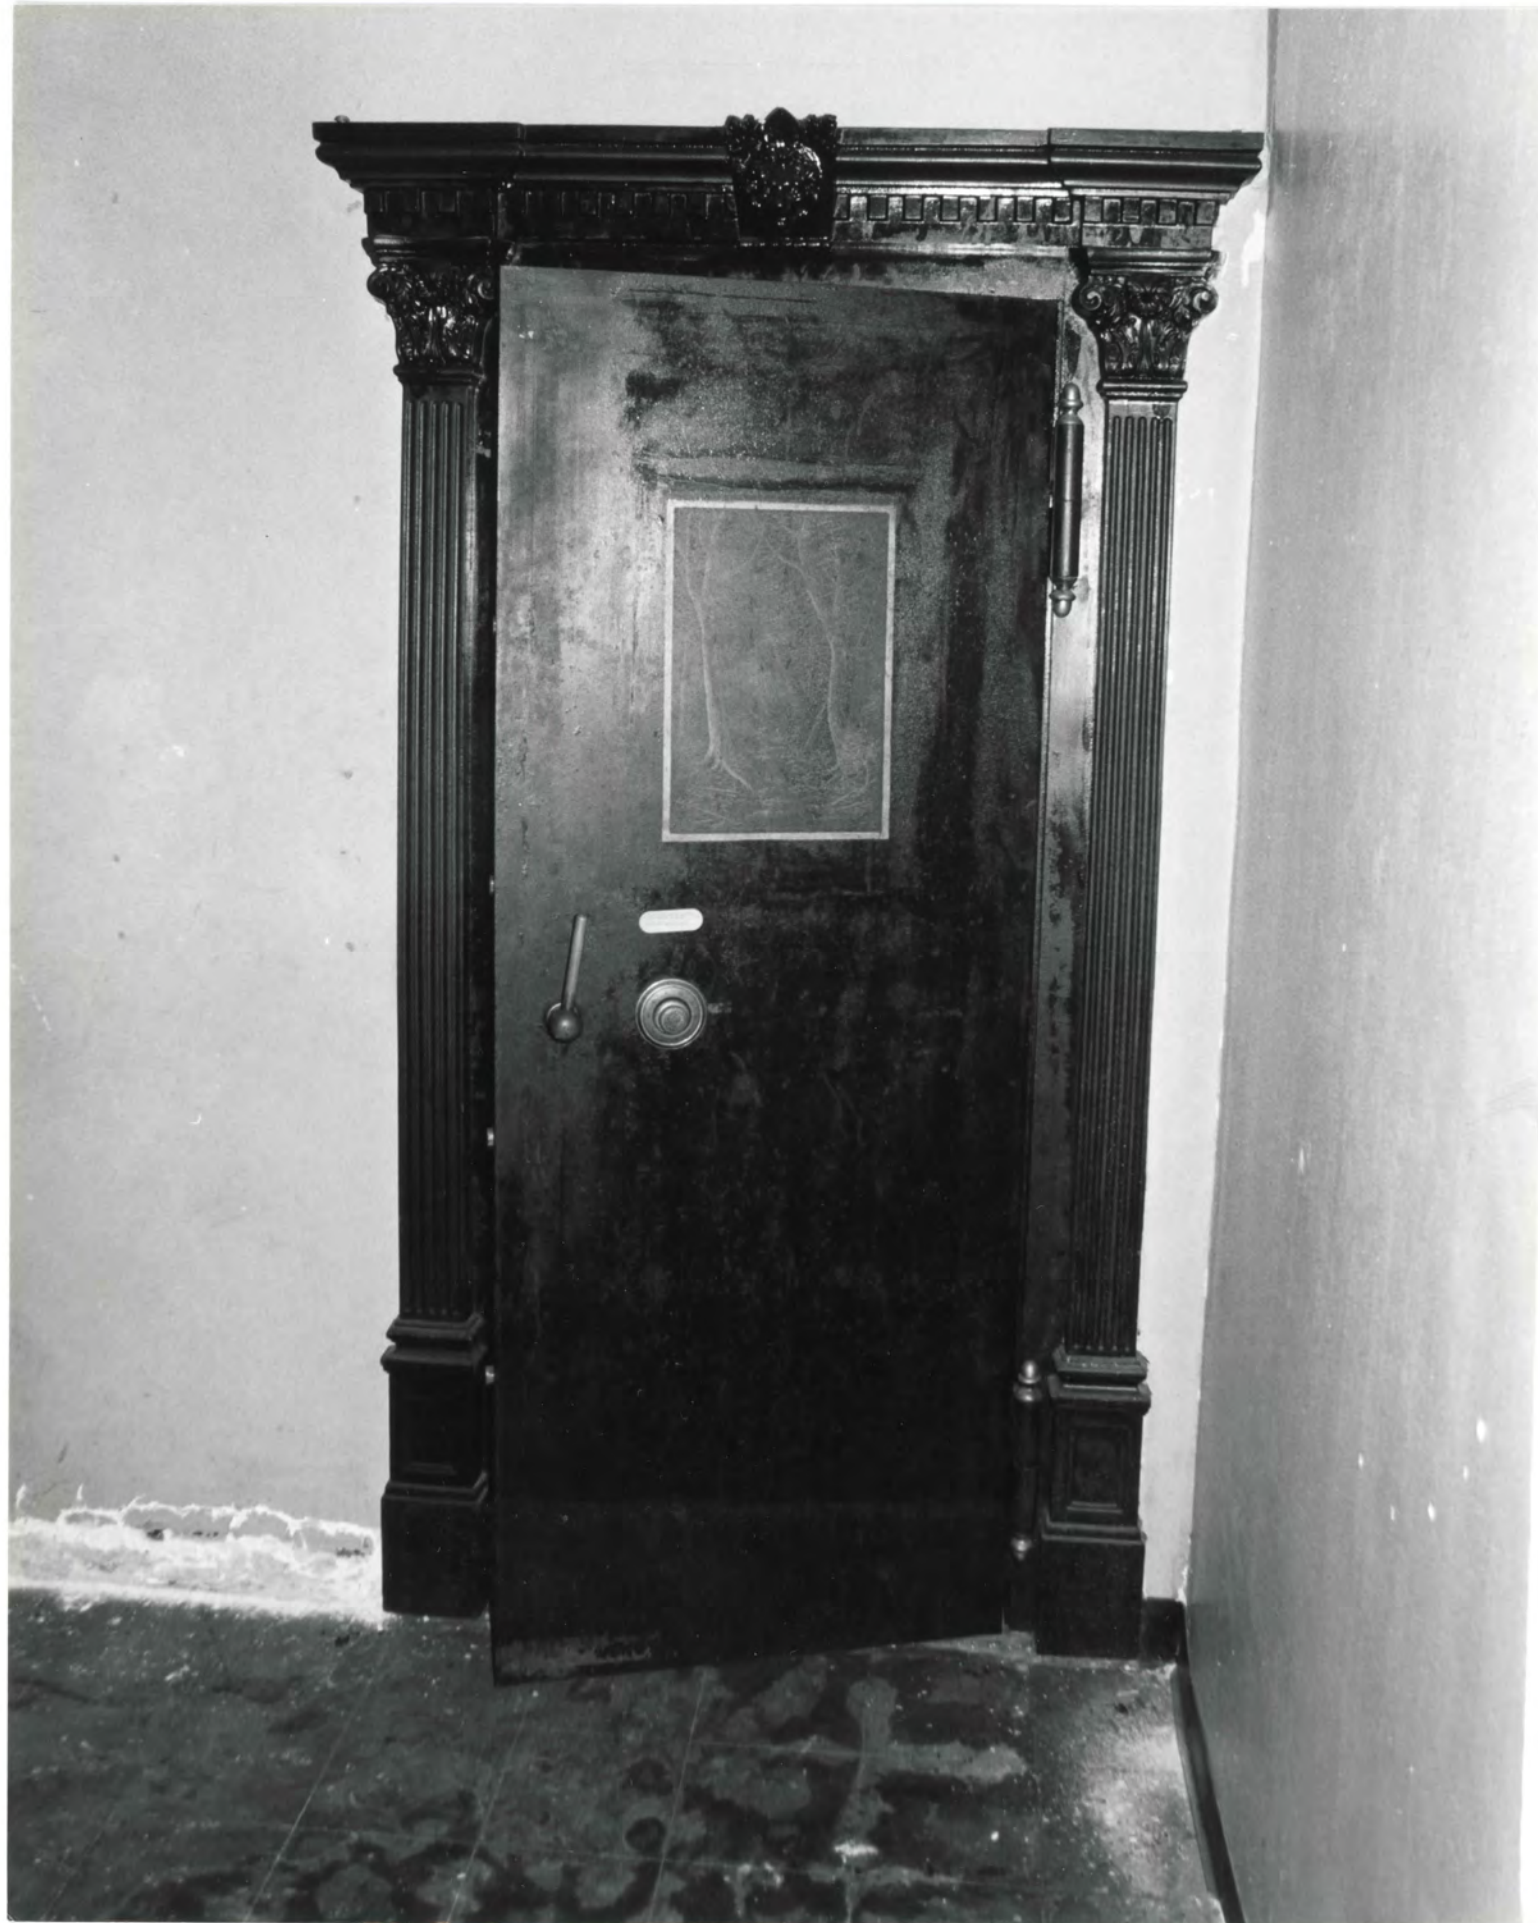
Bank of Malvern

Malvern, Hot Spring County

Interior detail
