KENTUCKY HISTORIC RESOURCES
Individual Inventory Form

Resource # BK-23
BRACKEN County

1. Name of Resource: Stroube House

5. Location: East side KY 616, 4/10 mile south of
KY 435, vicinity of Augusta

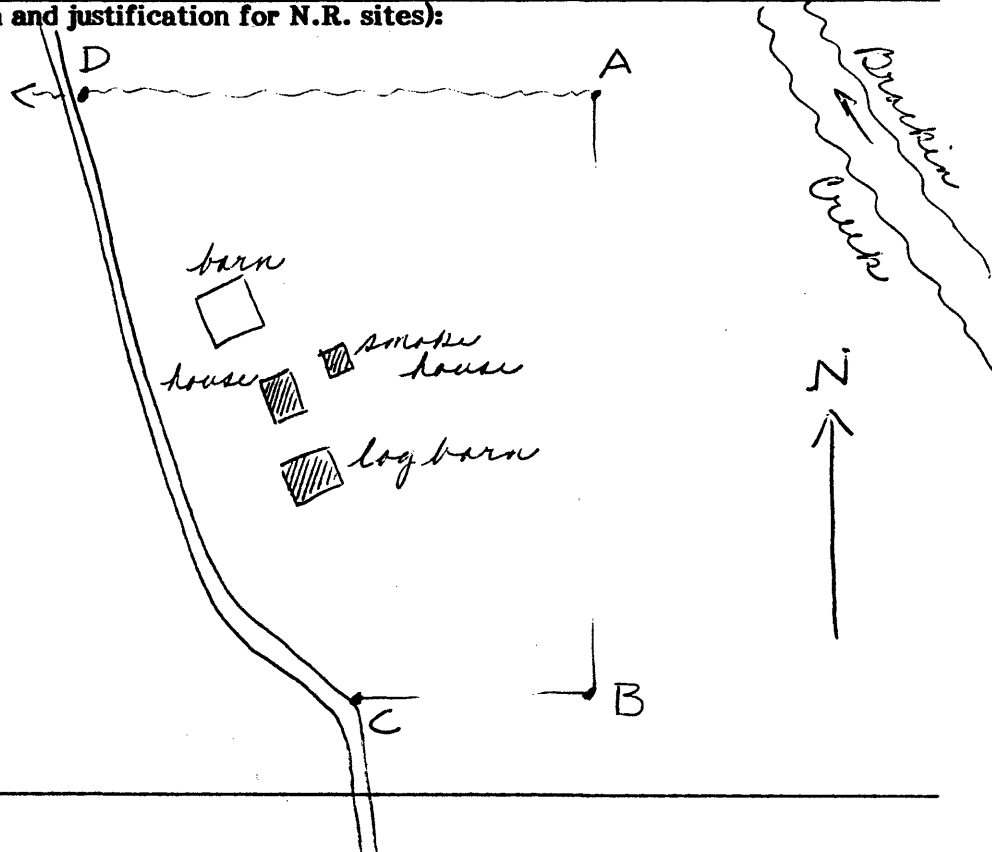
44. Site Plan (and boundary description and justification for N.R. sites):

Site enclosed by A-B-C-D as shown. C-D is on the road. Boundary includes stone house, smokehouse and log barn. D-A is with a creek.

The acreage included is a portion of the (original) farm and is visible from the house.

The barn on the north side of the complex is non-contributing.

3 contributing buildings

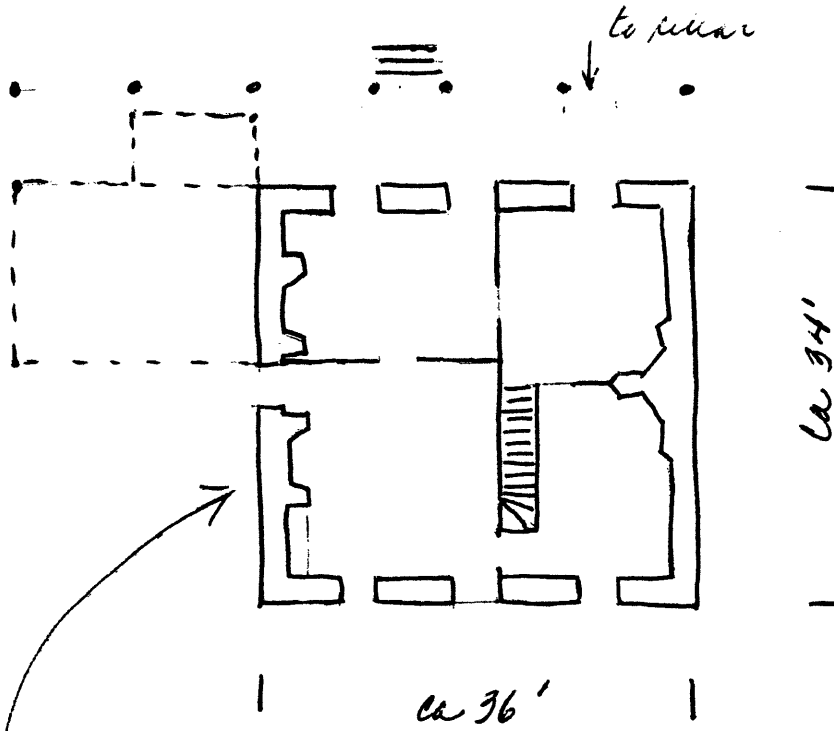
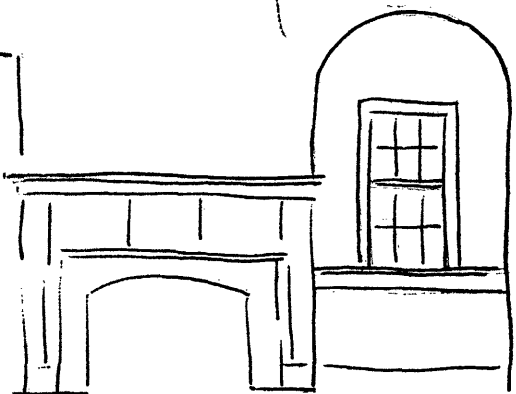
45. Description and House Plan:

Three-bay, one and one-half story, double-pile, dry-stone house. Upper Ordovician limestone, Fairview Formation. Stones tooled and coursed. Voussoirs. Pegged frames (some covered with aluminum). Plan is hall parlor at front, two-rooms deep, creating four-room plan. Interior chimney each gable end (top of south chimney removed). On north end of house fireboxes are parallel to wall, separated by one-half round arch above which they are joined. Window in arched space between fireplaces. Hall mantel of architrave trim; press to west of mantel; hall chamber (dining room) has shelf mantel. South chimney has diagonal fireplaces in southwest and southeast rooms. Enclosed corner stair arises from hall east of doorway to southwest room; space taken from southwest room; cellar stairway below the corner stair, descending from southeast room (straight flight). Log joists. Ovolo trim, chair rail throughout. No fireplaces upstairs or in cellar. Lift latch with brass knob on door to stairway. Double thickness front and rear doors are six panel outside, beaded-vertical boards inside.

Kitchen wing added on north end and porch across rear. Additional cellar access under porch may not be original. The kitchen is non-contributing; it does not seriously detract from the house.

House atypically situated on crest of ridge between Bracken Creek and Little Bracken Creek with vast views of creek valleys. Has hewn frame smokehouse and log-pen barn.

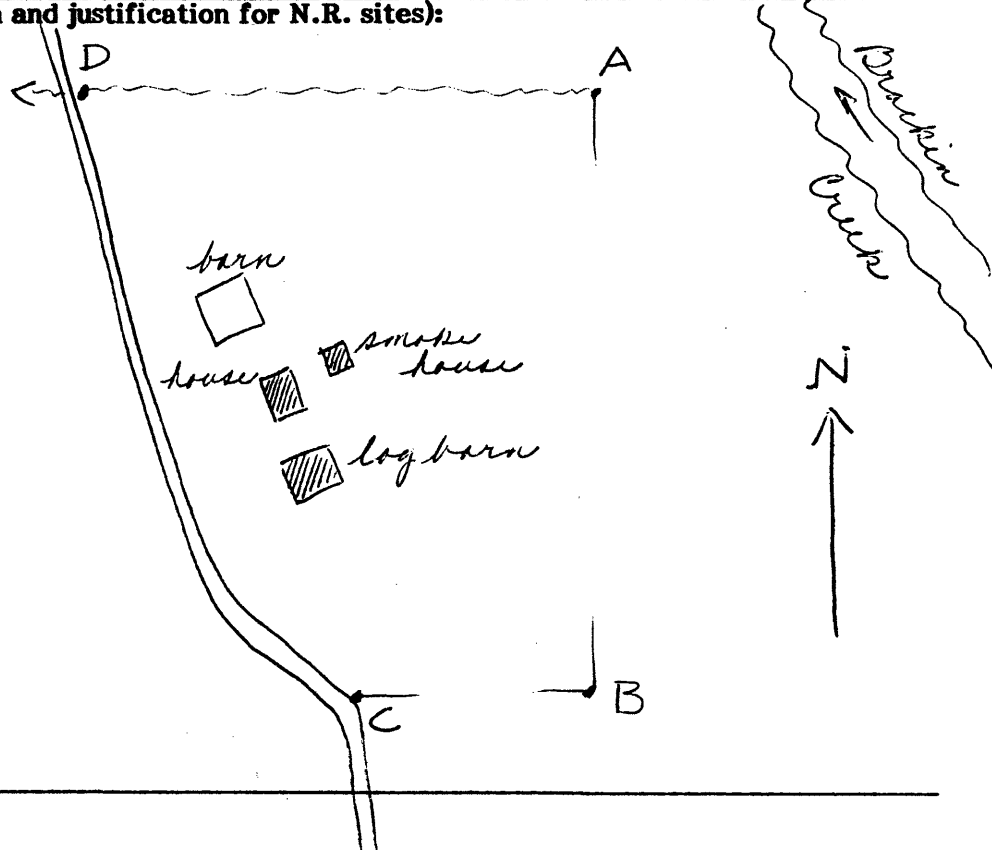
44. Site Plan (and boundary description and justification for N.R. sites):

Site enclosed by A-B-C-D as shown. C-D is on the road. Boundary includes stone house, smokehouse and log barn. D-A is with a creek.

The acreage included is a portion of the (original) farm and is visible from the house.

The barn on the north side of the complex is non-contributing.

3 contributing buildings

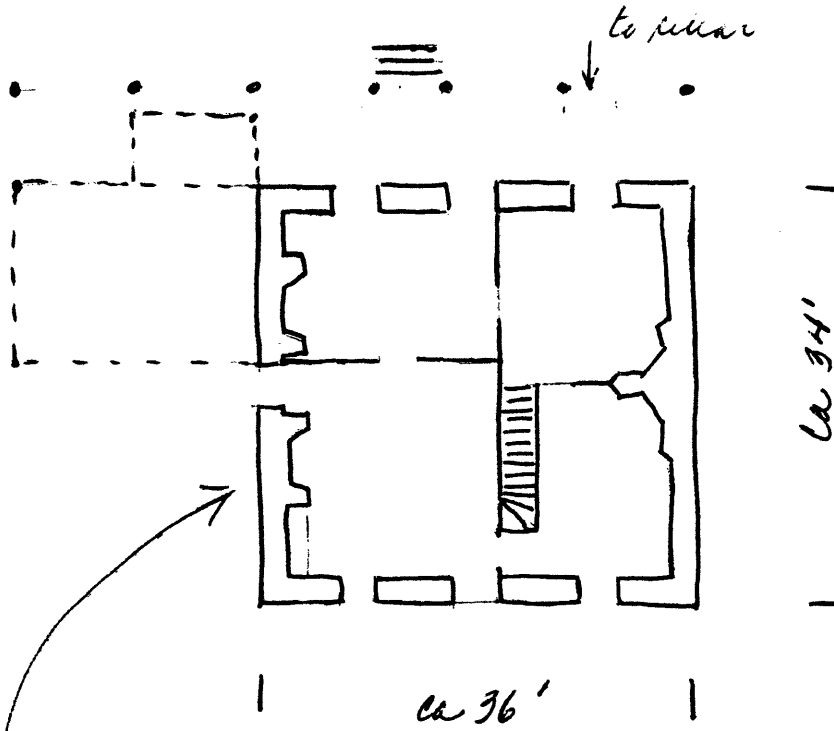
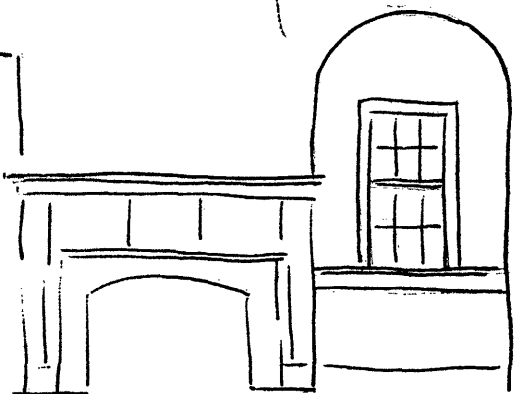
45. Description and House Plan:

Three-bay, one and one-half story, double-pile, dry-stone house. Upper Ordovician limestone, Fairview Formation. Stones tooled and coursed. Voussoirs. Pegged frames (some covered with aluminum). Plan is hall parlor at front, two-rooms deep, creating four-room plan. Interior chimney each gable end (top of south chimney removed). On north end of house fireboxes are parallel to wall, separated by one-half round arch above which they are joined. Window in arched space between fireplaces. Hall mantel of architrave trim; press to west of mantel; hall chamber (dining room) has shelf mantel. South chimney has diagonal fireplaces in southwest and southeast rooms. Enclosed corner stair arises from hall east of doorway to southwest room; space taken from southwest room; cellar stairway below the corner stair, descending from southeast room (straight flight). Log joists. Ovolo trim, chair rail throughout. No fireplaces upstairs or in cellar. Lift latch with brass knob on door to stairway. Double thickness front and rear doors are six panel outside, beaded-vertical boards inside.

Kitchen wing added on north end and porch across rear. Additional cellar access under porch may not be original. The kitchen is non-contributing; it does not seriously detract from the house.

House atypically situated on crest of ridge between Bracken Creek and Little Bracken Creek with vast views of creek valleys. Has hewn frame smokehouse and log-pen barn.
