ITEM #51
 1 BUILDING NAME (Common) Hartford & New Haven Railroad Depot
 2 TRN. CITY Windsor Center
 3 STREET AND NUMBER MAP 76, block 494, lot 5A; .36 acre
 4 CENTRAL STREET
 5 NAME Windsor Center
 6 COUNTY Hartford
 7 TYPE OF BUILDING
 8 IDENTIFICATION
 9 VACANT
 10 ACCESSIBILITY TO PUBLIC Yes No
 11 EXTERIOR LIGHTING FROM PUBLIC ROAD Yes No
 12 INTERIOR ACCESSIBLE IF YES EXPLAIN
 13 DATE OF CONSTRUCTION c. 1869-70
 14 TRAIN STATION
 15 PUBLIC Private

STATE OF CONNECTICUT
CONNECTICUT HISTORICAL COMMISSION
59 South Prospect Street, Hartford, Connecticut 06106
HISTORIC RESOURCES INVENTORY FORM
For Buildings and Structures

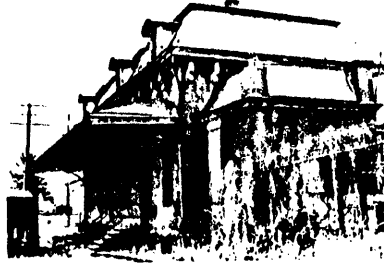
20 OTHER NOTABLE FEATURES OF BUILDING OR SITE (Include in description)
 2 story masonry building, 2 bays wide by 6 bays long, with mansard roof. The mansard has a pronounced curvilinear and is pierced by dormers with segmental arch hoods. Mansard is covered with slate tiles in fish-scale pattern. The roof ends in a molded cornice which is supported by paired brackets. These are scrolled type. The first floor has tall window openings with 6 x 6 sash in a simple wood frame (these have been removed and closed in with wood boards). Entries on the front and sides had paneled doors in a simple frame with transom overhead and cut-stone stoop below. Over the first floor extends a large canopy on east, west and south side. This canopy has a shallow pitched roof and molded board at eaves end. The canopy is supported by scrolled, metal braces which attach to the building walls. Around the building, extending to the length of the canopy was a wooden deck. This has since been removed. It had corner posts which helped support the canopy as well as a decorative rail with turned (see conf. sheet) BUTTERS

21 HISTORICAL OR ARCHITECTURAL IMPORTANCE
 Example of a mid 19th century railroad building, with rich detail in the French Second Empire style. This building is one of the finest in town, despite its present condition. Note the rich detail in cornice consoles, dormers, and canopy braces. The building used to have a deck with balustrade, giving it the style befitting a major transportation center. This station was built in 1869-70 by the Hartford and New Haven Railroad on land purchased from Elsworth N. Phelps. Soon after this time, residents of Hartford began moving to Windsor Center and using the train to commute to Hartford. The train stopped here, creating large scale residential development around Windsor Center in the 1870's and 1880's. Today the building stands vacant and in deteriorating condition, a major landmark threatened by neglect.
