National Register of Historic Places Registration Form

1. Name of Property	
Historic name Hilltop	
Other names/site number Hilltop Farm; Hill	Top Farm
Name of related multiple	Top Turin
property listing Knoxville-Knox C	ounty MPS
	operty is not part of a multiple property listing)
	operty is not part of a maniple property isting)

2. Location	
Street & Number:5617 Lyons View Pil	ke
	State: TN County: Knox
Not For Publication: N/A Vicinity:	N/A Zip: <u>37919</u>
3. State/Federal Agency Certification	
As the designated authority under the National Histo	ric Preservation Act, as amended,
	est for determination of eligibility meets the documentation egister of Historic Places and meets the procedural and professional
In my opinion, the property <u>X</u> meets does property be considered significant at the following le national	not meet the National Register Criteria. I recommend that this evel(s) of significance: statewide X local
Applicable National Register Criteria:	A B X C D
Signature of certifying official/Title:	2/2/16
Deputy State Historic Preservation Officer, T	
State or Federal agency/bureau or Tribal G	overnment
In my opinion, the property meets does no	ot meet the National

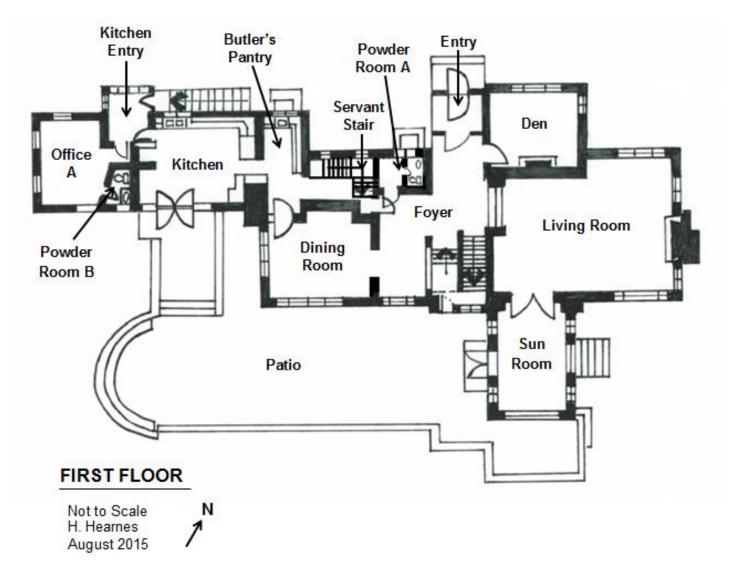
Hilltop House – First Floor

HILLTOP FLOOR PLANS

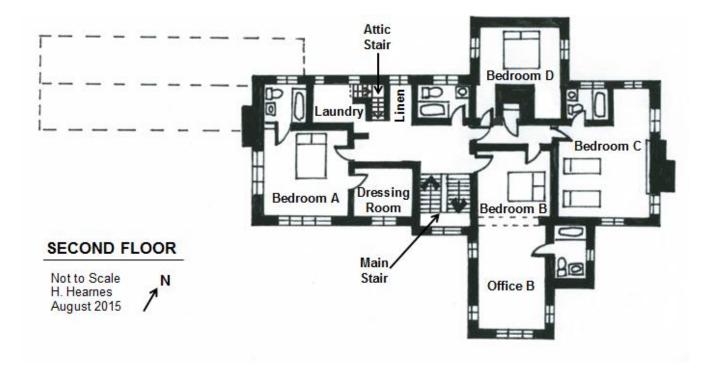
Hilltop House – Second Floor

HILLTOP FLOOR PLANS

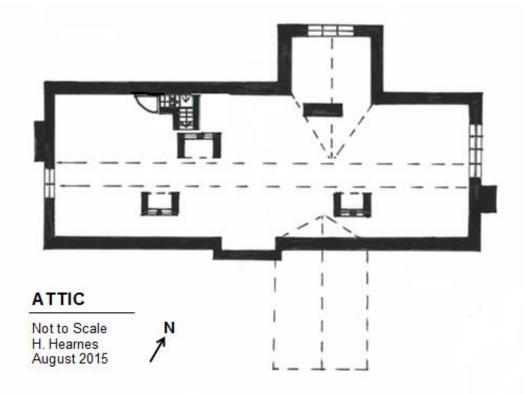
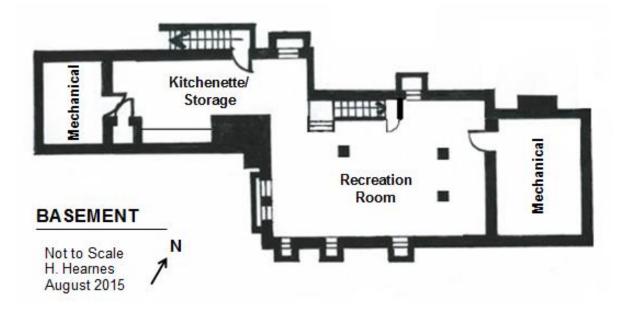
Hilltop House – Attic and Basement

HILLTOP FLOOR PLANS

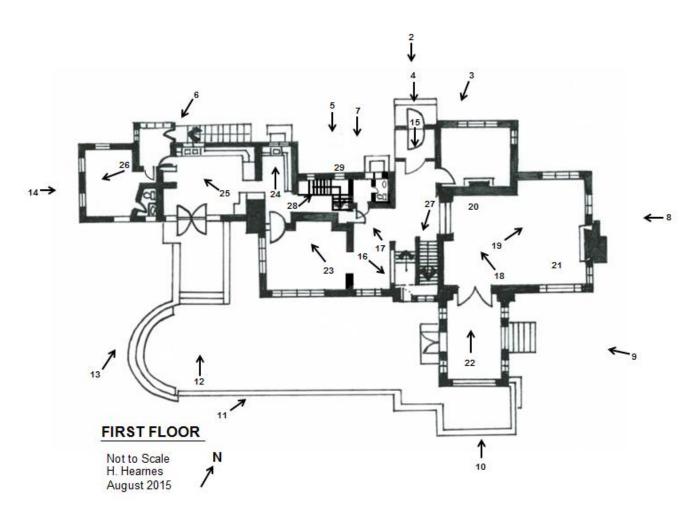
Hilltop House – First Floor

HILLTOP FLOOR PLANS WITH PHOTO KEYS

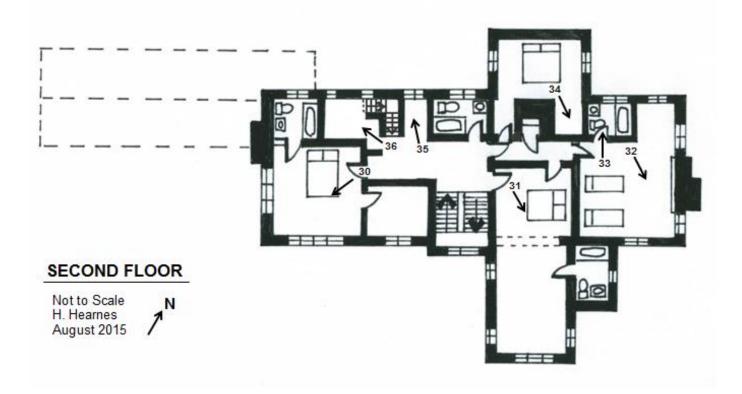
Hilltop House – Second Floor

HILLTOP FLOOR PLANS WITH PHOTO KEYS

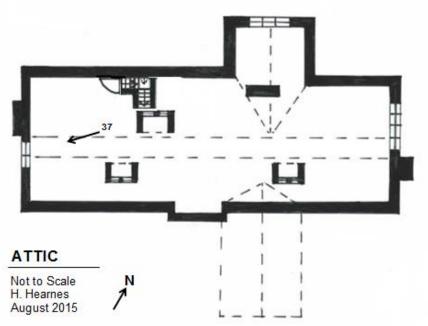
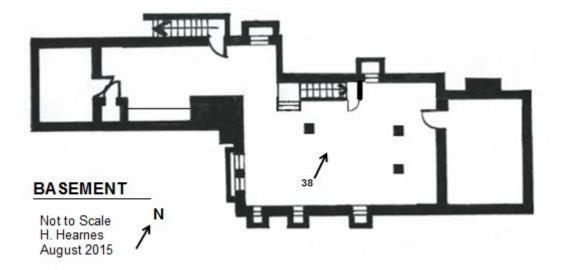
Hilltop House – Attic and Basement

HILLTOP FLOOR PLANS
