National Register of Historic Places Registration Form

Historic name Downtown Mangum Historic District

State Oklahoma code OK county Greer code 055 zip code 73554

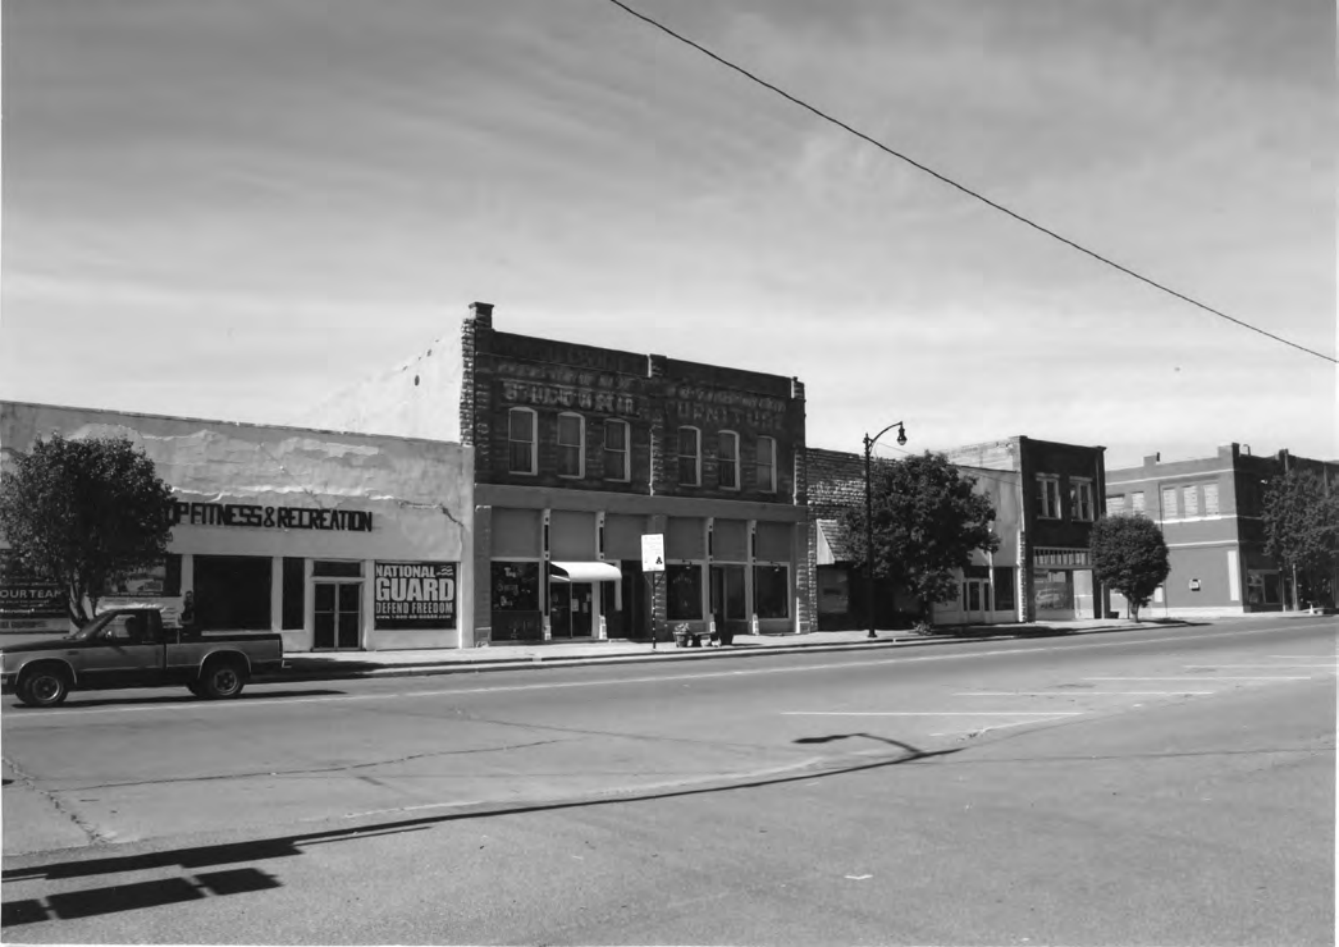
photograph # 0001

FITNESS & RECREATION

- 1) Fitness and Recreation, 124 East Lincoln. Ca. 1945 No distinctive style. This single-story flat-roofed building is constructed of brick and clad with stucco. Two of the four storefront windows have been in-filled, the remaining openings have replacement windows and modern metal frame glass doors. The entry has a transom window and sidelight. The east elevation has a stepped parapet, a stuccoed brick wall and a modern mural. Based on Sanborn Maps, the original building at this location burned between 1930 and 1941. The current one story building was constructed after 1941. Building materials indicate that this building was drastically altered after the period of significance.

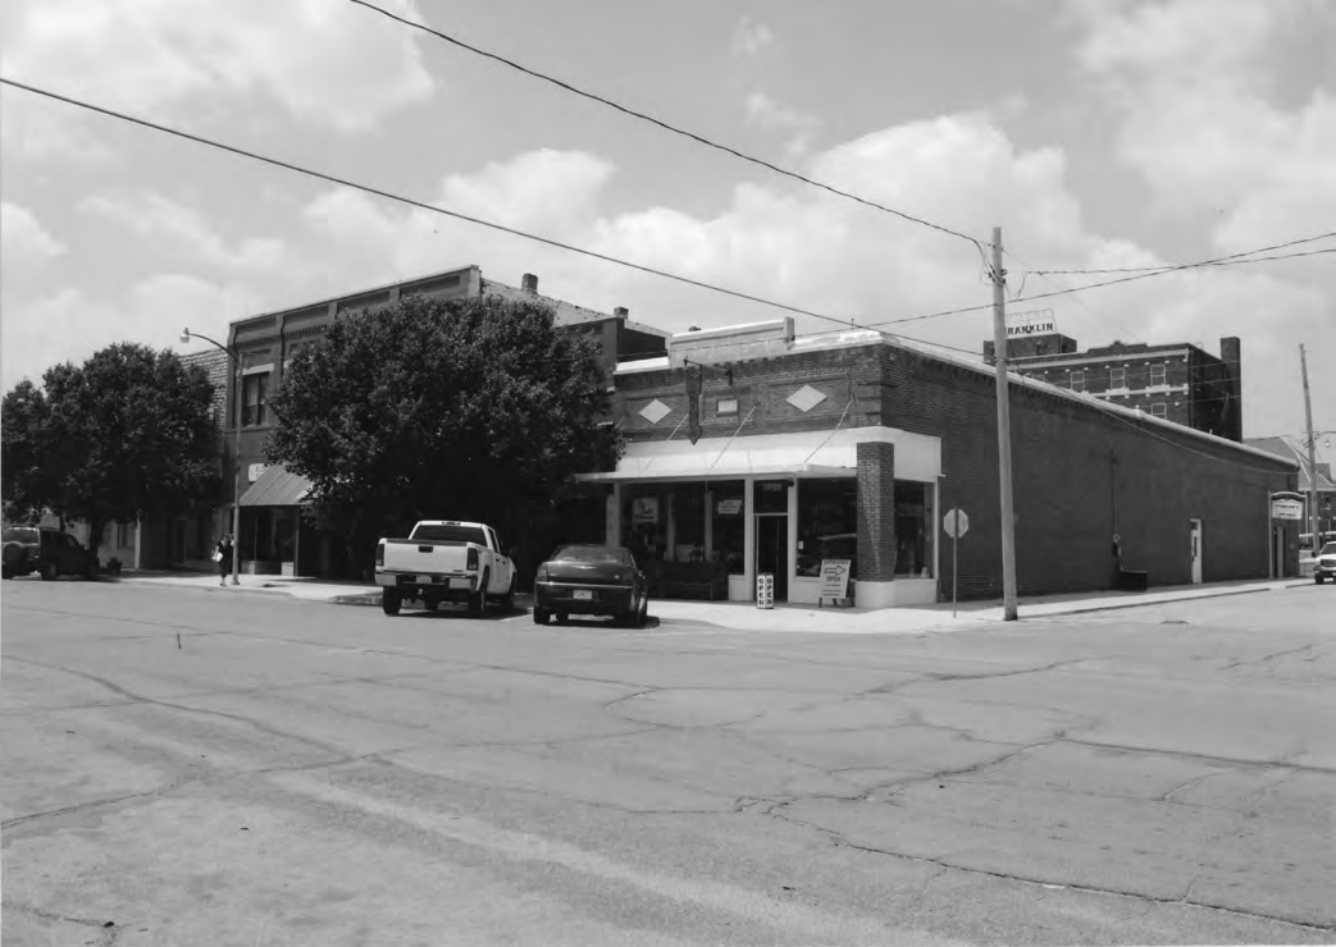
photograph # 0003

109-113 N Oklahoma

- 19) **109 North Oklahoma.** Ca. 1910. Two-part Commercial Block. This two-story brick building has three entrances on the first floor. The southeast entrance is recessed with display windows, a wood and glass panel door and a wood frame transom window. The central entry is recessed with display windows, a modern wood and glass panel door and a brick column in the center. The northeast entrance has a modern glass and metal frame door, metal frame display windows and a metal pent roof awning. All of the transom windows have been covered with wood panels. The second floor has four sets of two double hung windows; the upper sash is a Queen Anne window. The windows have stone lintels. Between each set of windows is a brick pilaster. The brick parapet has dentils and conceals the flat roof.

- 20) **111 North Oklahoma.** 1913. One-part Commercial Block. The entire entry has been enclosed with brick, glass block and a modern metal panel door. Located in the parapet is a decorative brick panel, brick dentils and stone copings.

- 21) **113 North Oklahoma.** 1913. One-part Commercial Block. This is a one-story brick building with a stone parapet that conceals a flat roof. The east elevation has a central entrance with display windows on either side of the door. The metal frame door has a metal frame fixed transom window. There is a brick column with a flared capitol at the northeast corner. The transom windows have been enclosed with wood panels. Decorative brick panels are located between the parapet and the transom windows. The north elevation has two wood and glass panel doors, each with a wood frame transom window. This elevation has two decorative bands of header bricks below the parapet.

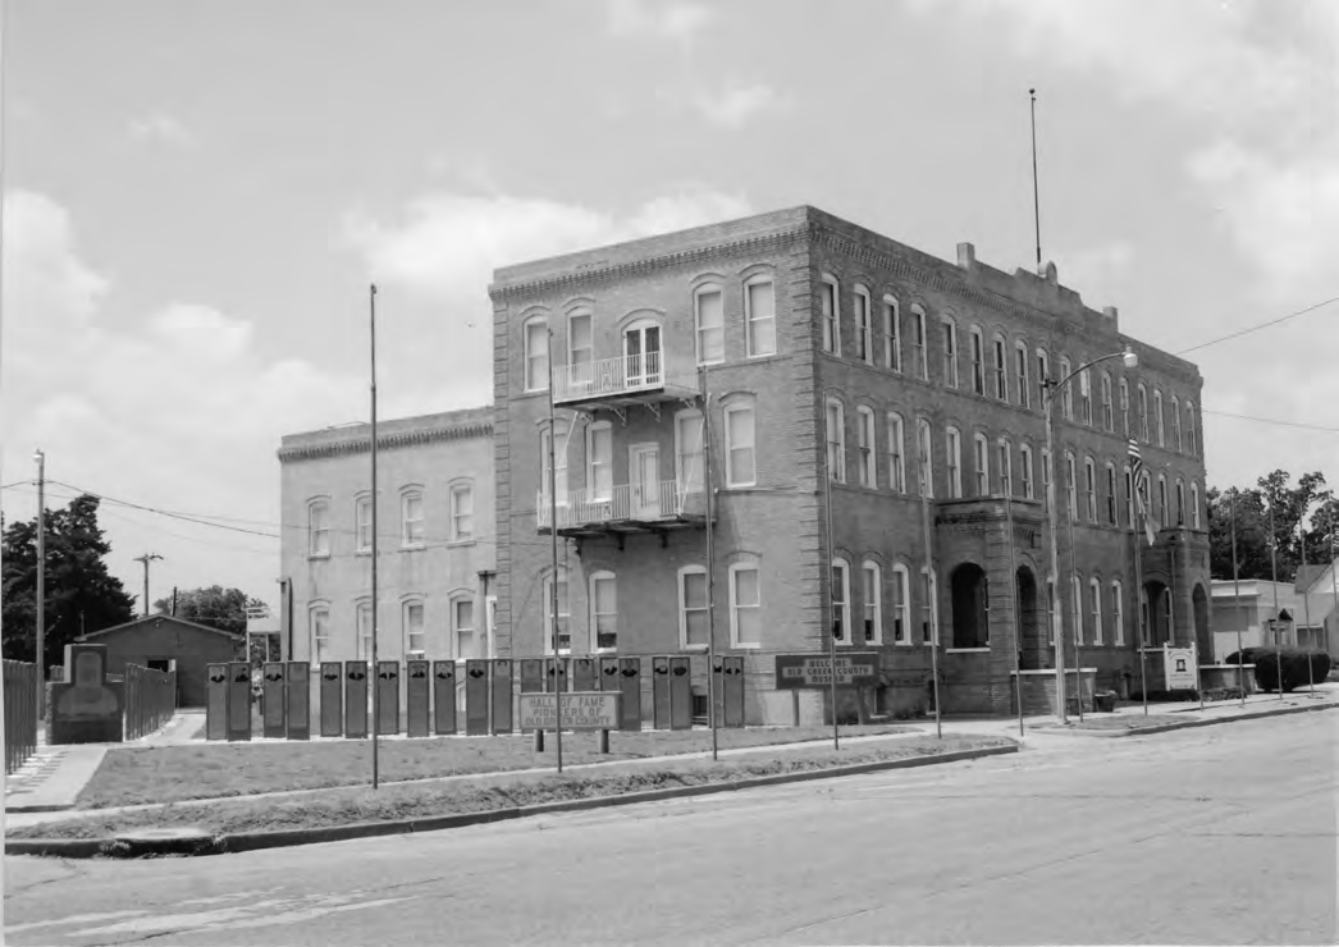
photograph # 0007

222 E Jefferson

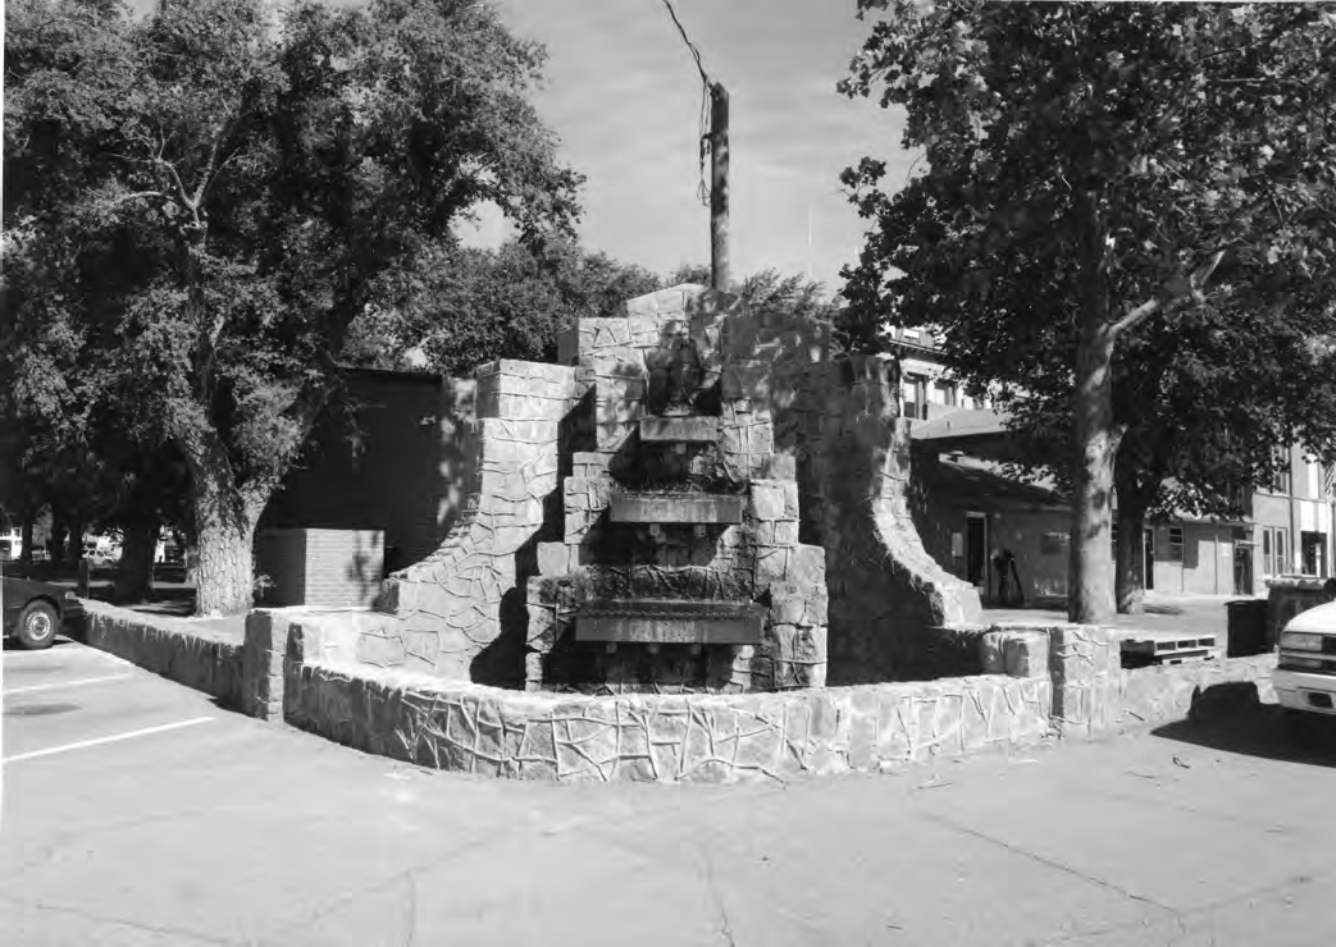
photograph #0008

Downtown Mangum Historic District
Fountain on Courthouse Square
Mangum, Greer County, Oklahoma

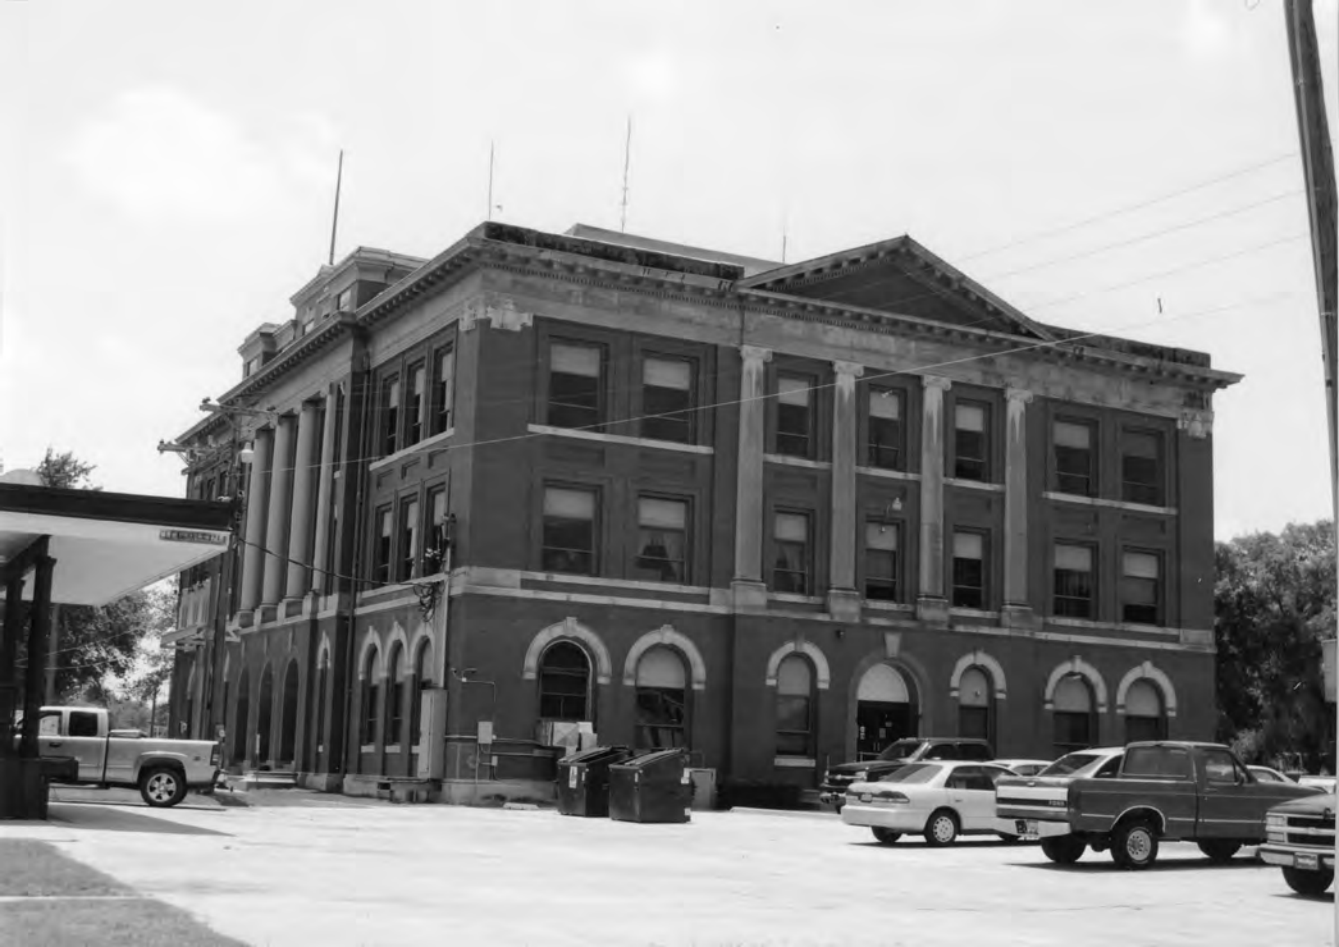
photograph #0009

Downtown Mangum Historic District
Greer County Courthouse
Mangum, Greer County, Oklahoma

- 70) **Greer County Courthouse. Courthouse Square.*** NR listed 1985, listing #85000682. 1906. Neoclassical. This three-story brick building has granite and limestone details. Designed by A.D. Campbell and Z.F. Lee/S.A. Layton, this courthouse originally had an elaborate copper covered dome which was removed in the 1940's due to its weight causing structural damage. Details of the courthouse include: engaged Doric columns on the north and south elevations on the second and third floors; Doric pilasters on the east and west elevations on the second and third floors; arched stone lintels with keystones above the first floor windows; a limestone beltcourse between the first and second floors; stone window sills; recessed brick panels between the second and third floors; and, a cartouche at the each corner of the third floor. The entablature has a banded architrave, dentils in the frieze and brackets in the cornice. The east and west elevation have a pediment projecting above the roof over the center three bays. It features dentils and brackets. The north and south elevations have a large dormer with five windows and stone copings. All original windows have been replaced with aluminum frame windows.
