CLASSIFIED STRUCTURE FIELD INVENTORY REPORT  
(Attach 4" x 5" Black and White Photograph)

STRUCTURE NAME Kirk's Cabin STRUCTURE NUMBER NEED - 28

# Kirk's Cabin Complex Canyonlands National Park

**National Register of Historic Places  
Continuation Sheet**

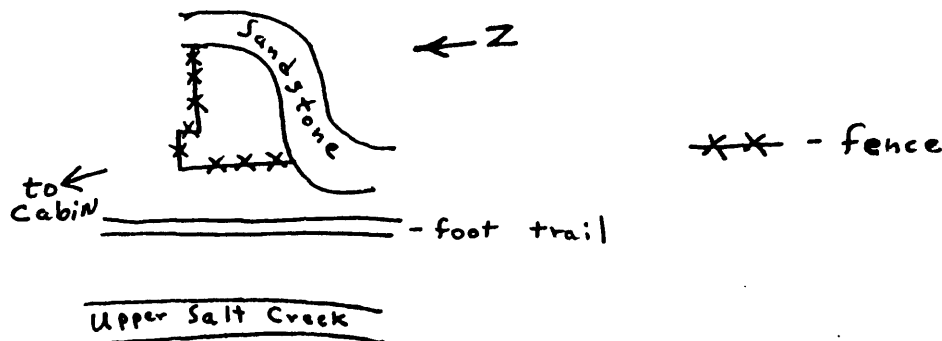
Evaluation of Structure: Historic Theme Contributing  Non-Contributing \_\_\_\_\_  
National Register Criteria:  B  C  D (Include integrity statement)  
The site retains integrity of location, but is badly deteriorated. Its function is only marginally apparent from the physical remains.

Type: FE  
 Materials: WD  
 Dimensions: 120'x150' approx.

The site is a corral built by constructing two post and pole fences and using natural sandstone walls for the other two sides. The posts are made of 2 poles pegged together and the fence was of horizontally laid poles.

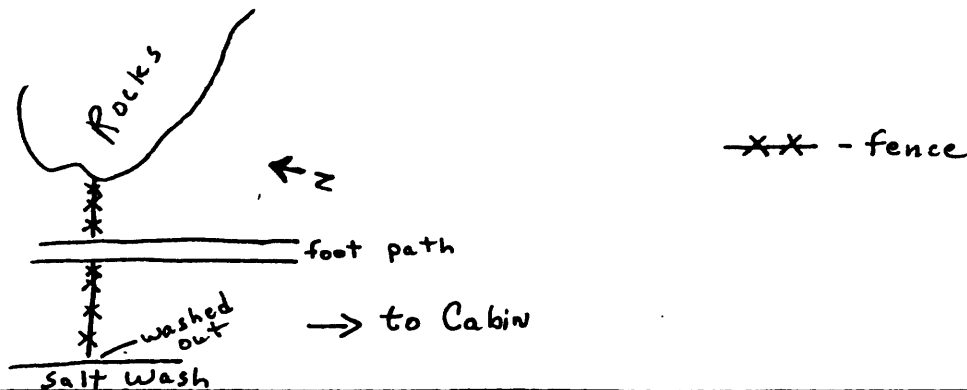
The fence, due to erosion, which has removed a portion of it, and later  
modifications by grazers, no longer has more than marginal physical  
integrity other than its location.

Type: FE  
 Materials: WD/MT  
 Dimensions: 1'x185' approximate

This is a fence built to denote the edge of Kirk's pasture in the same twin post and pole manner he built his corral (NEED - 29). It was later partially remade into a standard single post barbed wire fence.

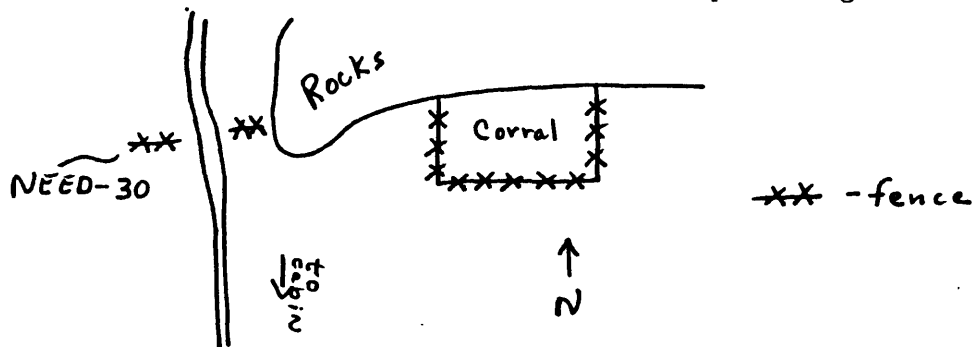
The structure retains locational integrity and enough physical integrity to  
make its function apparent. However, it appears to have been modified  
and expanded at various times.

Type: FE  
 Materials: WD/MT  
 Dimensions: 45' x 110' (approx.)

This is a twin post and pole corral with fences on three sides and a rock wall for the fourth. Its construction is similar to the other Kirk's corral and Kirk's fence, except that no pegs were used. Instead, wire held the posts together.
