National Register of Historic Places Registration Form

Historic name: St. Nicholas Ukrainian Catholic Church
Other names/site number: New Calvary Baptist Church; St. Nicholas Ruthenian Greek Catholic Church; St. Michael's United Greek Catholic Ruthenian Church; DE CRS# N03124
Name of related multiple property listing:
N/A
(Enter "N/A" if property is not part of a multiple property listing)

Street & number: 610 South Heald Street
City or town: Wilmington State: Delaware County: New Castle
Not For Publication: Vicinity:

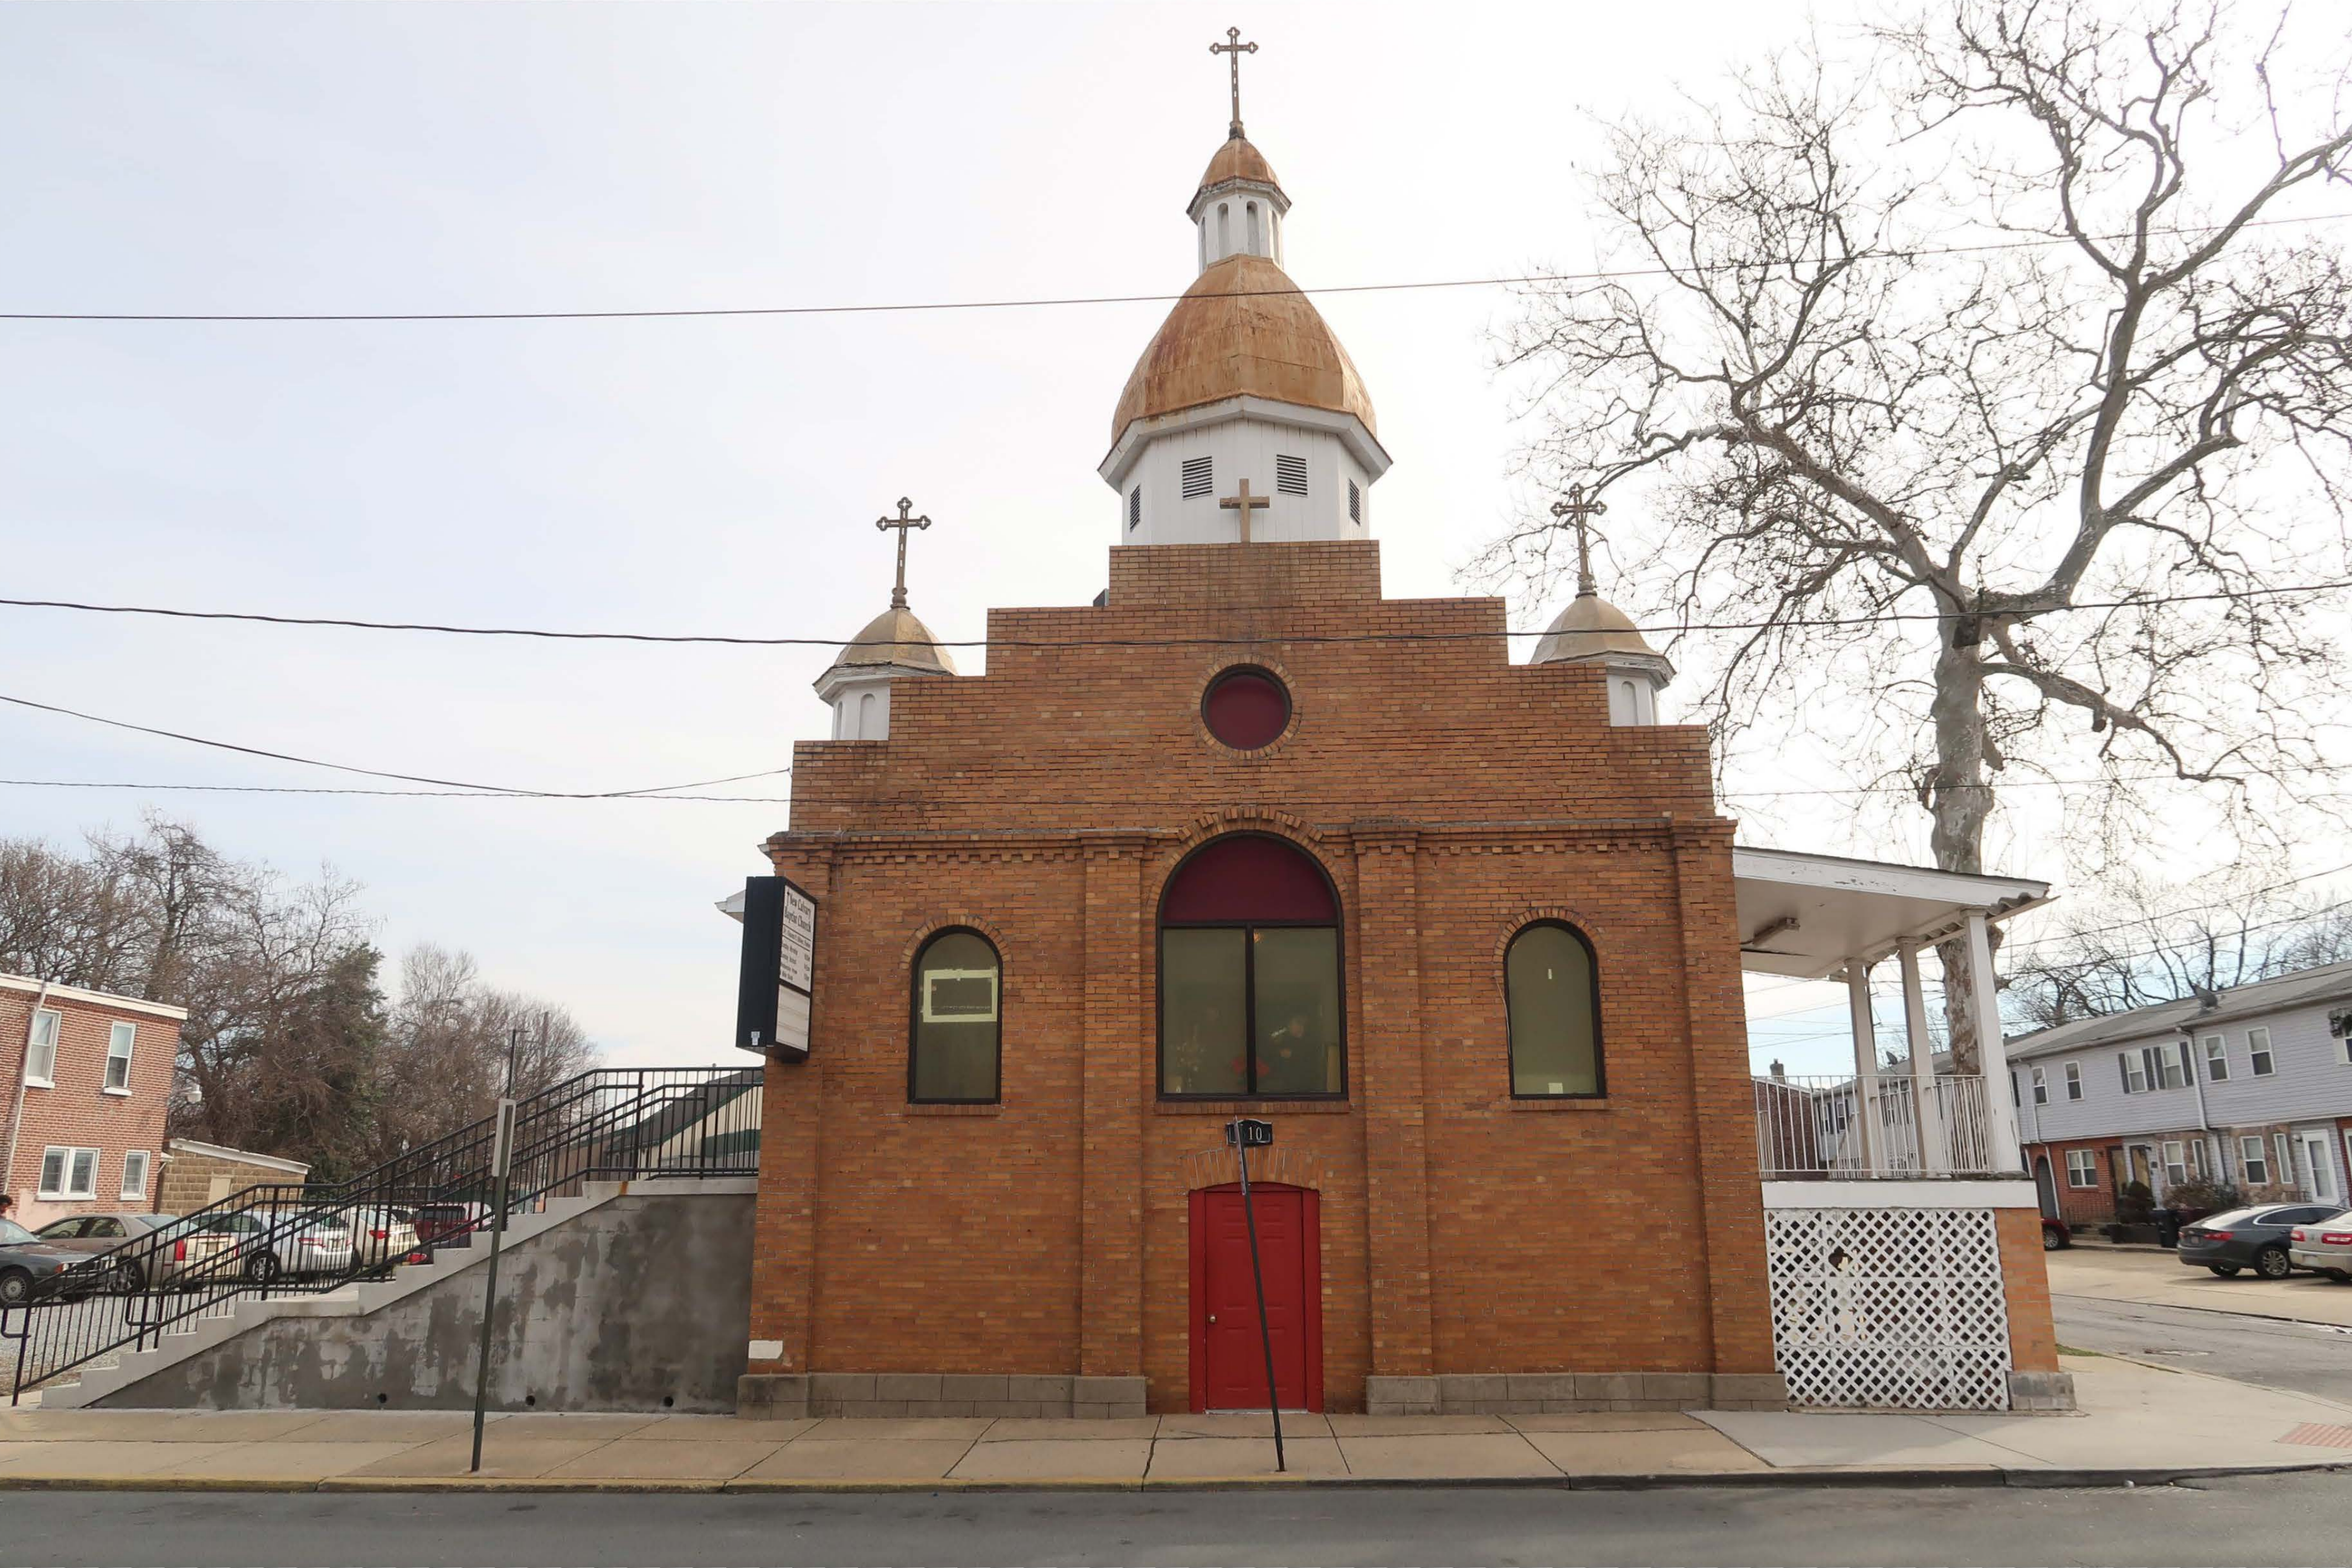
19 of 21 (DE_New Castle County_ St. Nicholas Ukrainian Catholic Church _019)
View of interior of basement from southeast corner, showing social space, pastor's office, hallway, and kitchen, looking north.

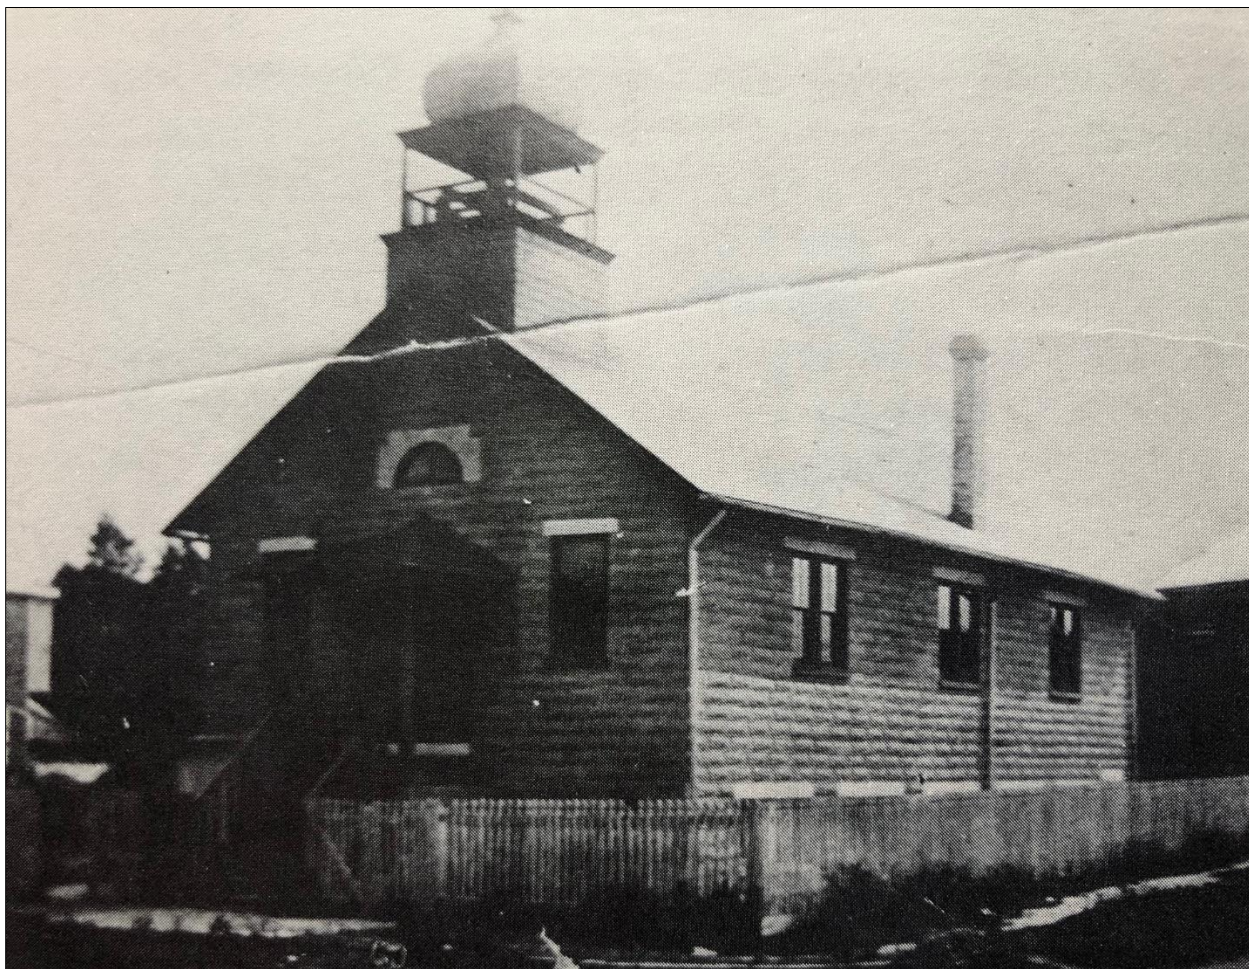
Figure 5: St. Michael's United Greek Catholic Ruthenian Church, later St. Nicholas Ukrainian Catholic Church, view of northwest and southwest elevations as originally constructed, 1909. From Lushnycky, *75 Jubilee*, 115.

Historical images of the building—one taken just after construction was completed in 1910, another from just after 1917, and others from 1936 and 1958—show changes in the building's appearance over time. The photo taken around 1910 depicts the church as originally constructed. In its earliest manifestation, it was a relatively plain building of rusticated, rockface concrete block with embellishment in the form of contrasting door and window elements. The raised entrance of the gable-front, three-bay building was accessed from the street via stairs to a small, covered porch with hipped roof. Sash windows with contrasting, thick, cement lintels flank the central door. In the gable above the porch is a semi-circular window framed by light-colored voussoirs. At the apex of the roof and set slightly back from the edge is a square bell tower. Its base is built up of blocks, it has an open, metal-framed middle section, and it is topped by a four-segment onion dome. A low wood fence surrounds the property.

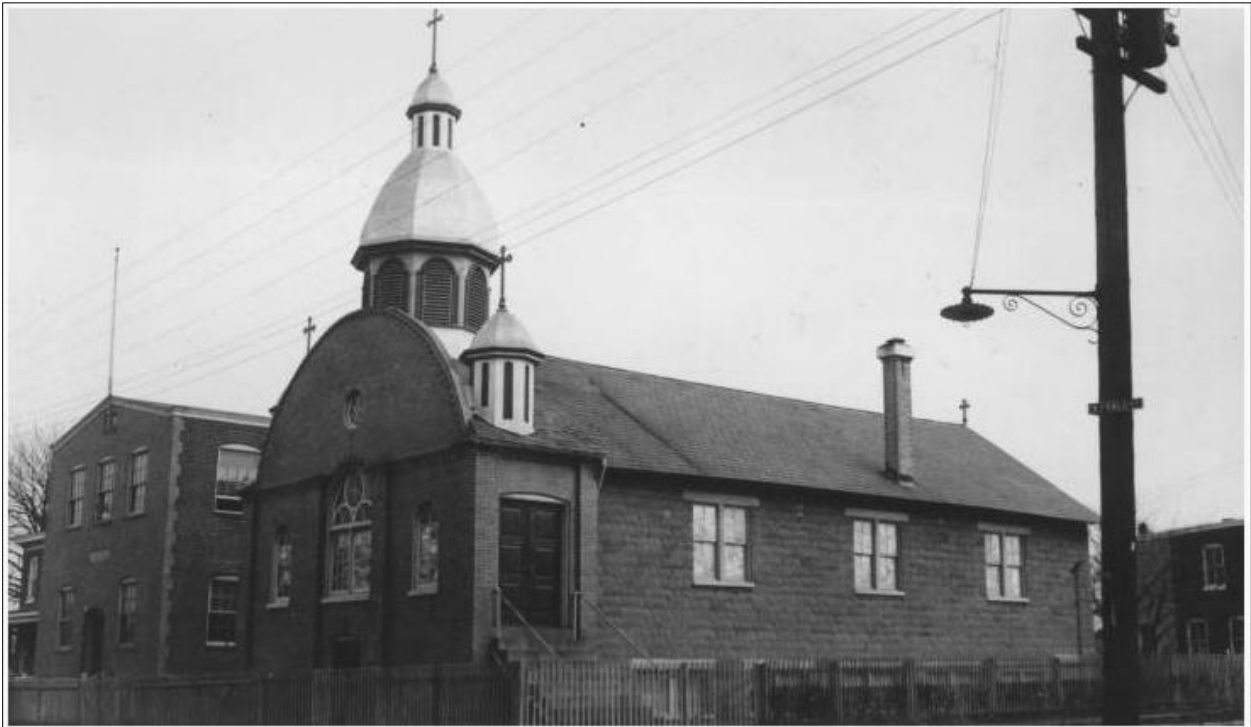
Figure 7: St. Nicholas Ukrainian Catholic Church, view of northwest and southwest elevations, 1936. Delaware Public Archives, Frank R. Zebley Collection, Churches of Delaware Photograph Collection, no. RG 9015-001-002.

Between photos taken in 1936 and 1958, the shape of the building’s brick façade was altered from the arched-gable to the stepped-gable seen today. This change to the building might be referenced in a 1946 entry in the church timeline as, “[e]xterior repairs made on Church and Hall,” and perhaps suggests that the arch was deteriorating.² It is apparent that much of the pediment wall was preserved, as the circular window remains in place, but that bricks along the curved edge were removed and new bricks woven in. In 1947, a low metal fence was erected around the church and education buildings. This was in place until the latter was demolished in 2005.³

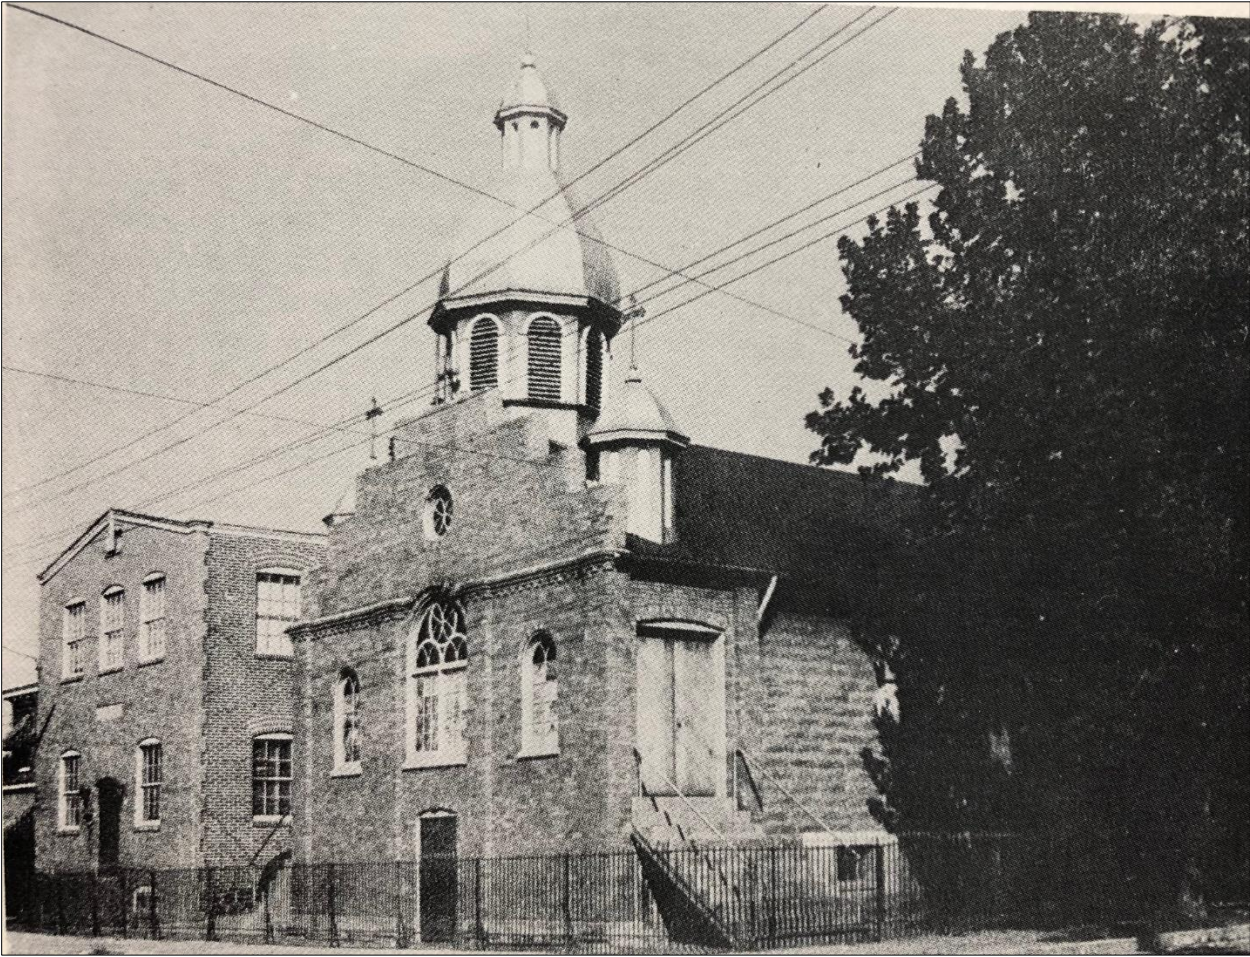
Figure 8: St. Nicholas Ukrainian Catholic Church, view of northwest and southwest elevations with stepped pediment, 1958. From Lushnycky, *75 Jubilee*, 43.

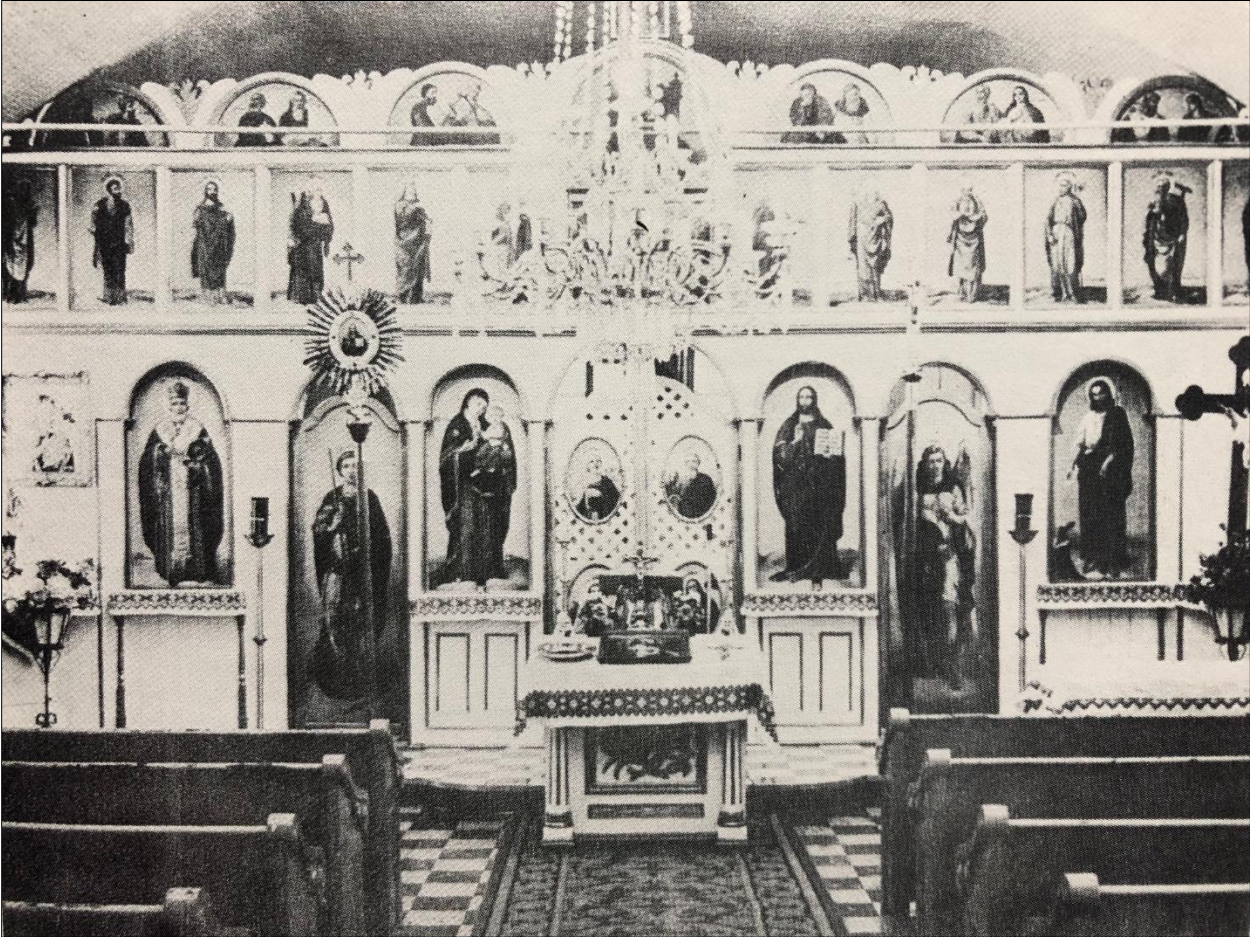
Figure 9: St. Nicholas Ukrainian Catholic Church, view of interior with iconostasis and chandelier, date unknown. From Lushnycky, *75 Jubilee*, 43.

when they moved to their newly built church but did not install it there.⁹ An offering table stood in front of the iconostasis and platform. Black and white checkerboard tiling covered the floor and a long runner rug was laid in the central aisle. Pictures also show that the hammered ceiling is original to the building, as is the crystal chandelier. Additional light fixtures have been replaced.

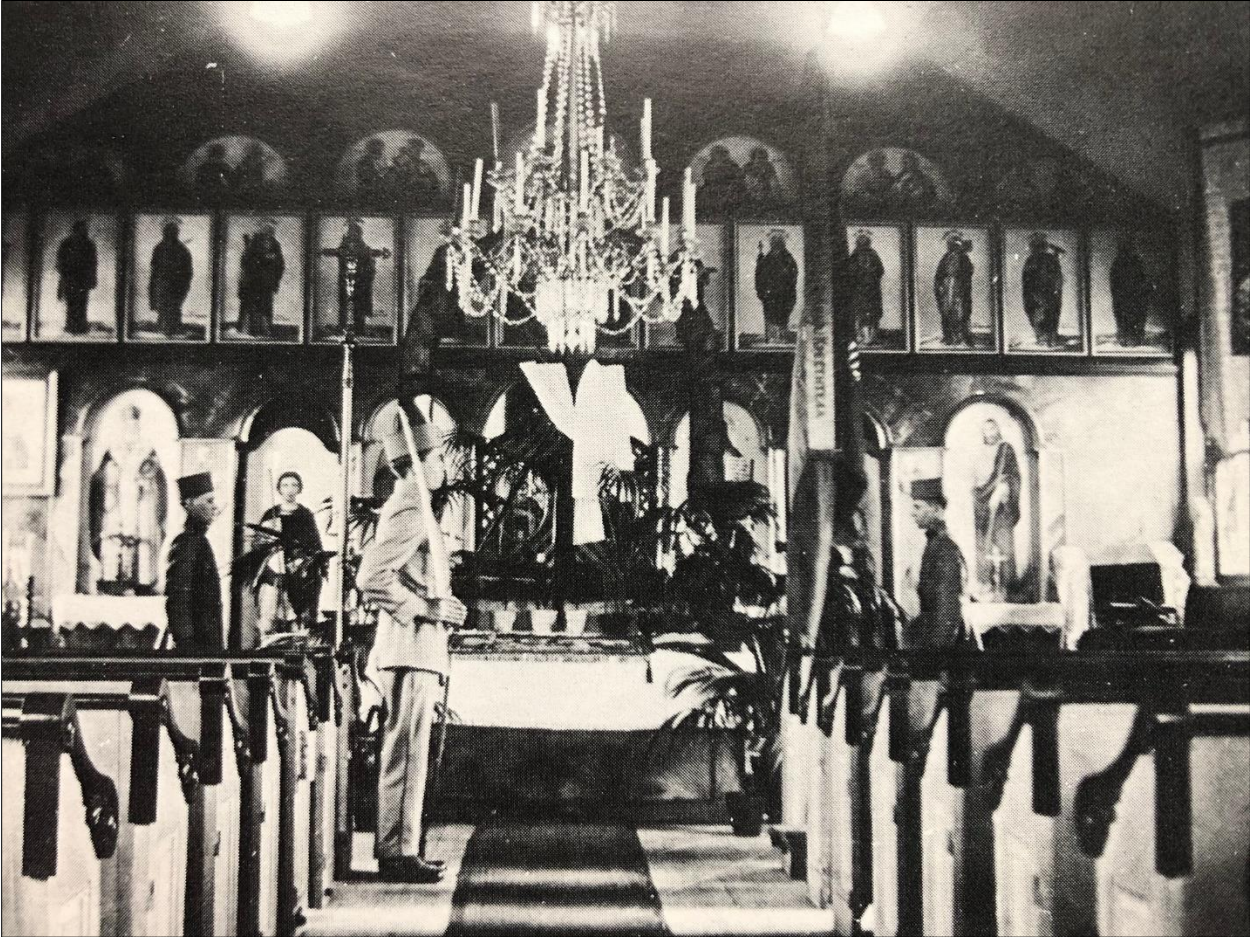
Figure 10: St. Nicholas Ukrainian Catholic Church, view of interior with iconostasis and chandelier, date unknown. From Lushnycky, *75 Jubilee*, 49.

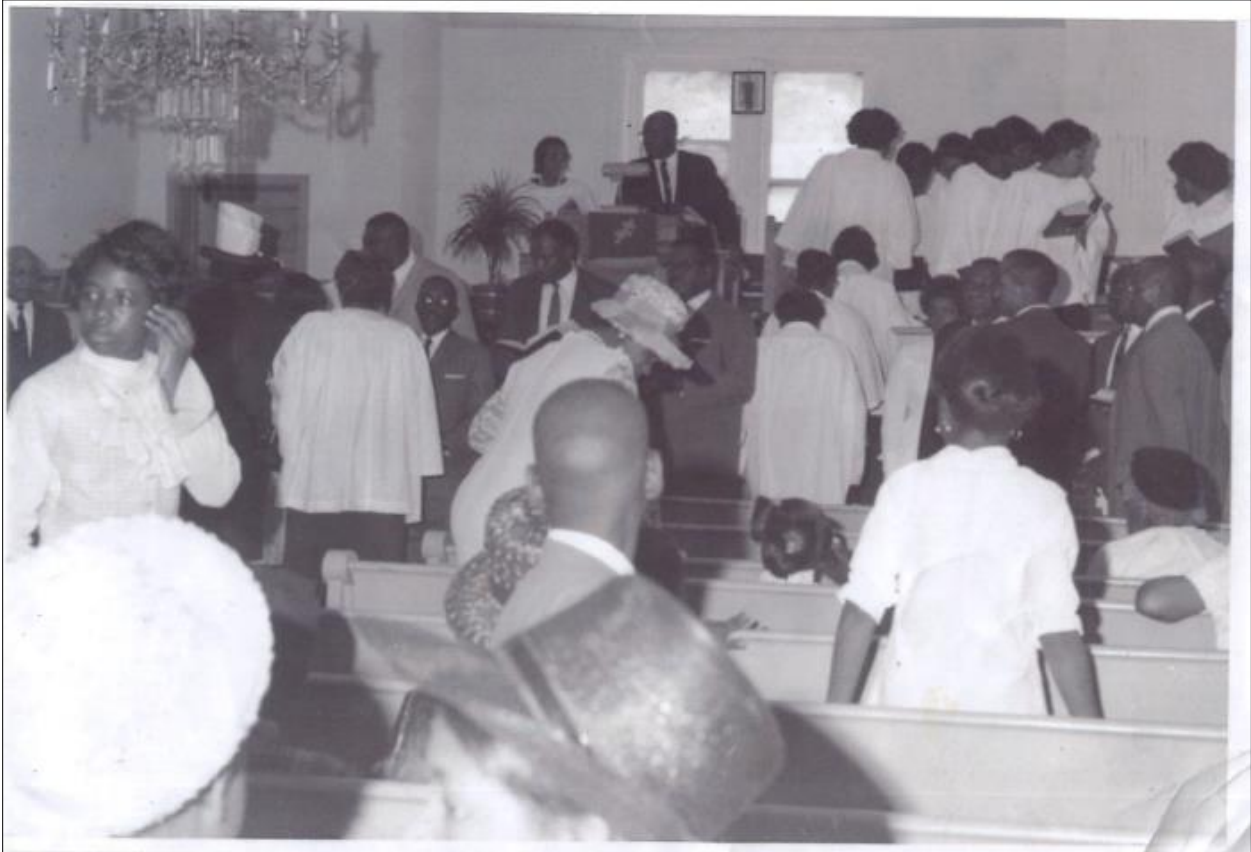
Figure 21: St. Nicholas Ukrainian Catholic Church after acquisition by the New Calvary Baptist Church, view of interior showing wood paneling and windows. Wedding of LaVerne Adderley, 1974, private collection. Photo provided by congregation.

- Figure 21 St. Nicholas Ukrainian Catholic Church after acquisition by the New Calvary Baptist Church, view of interior showing wood paneling and windows. Wedding of LaVerne Adderley, 1974, private collection. Photo provided by congregation.

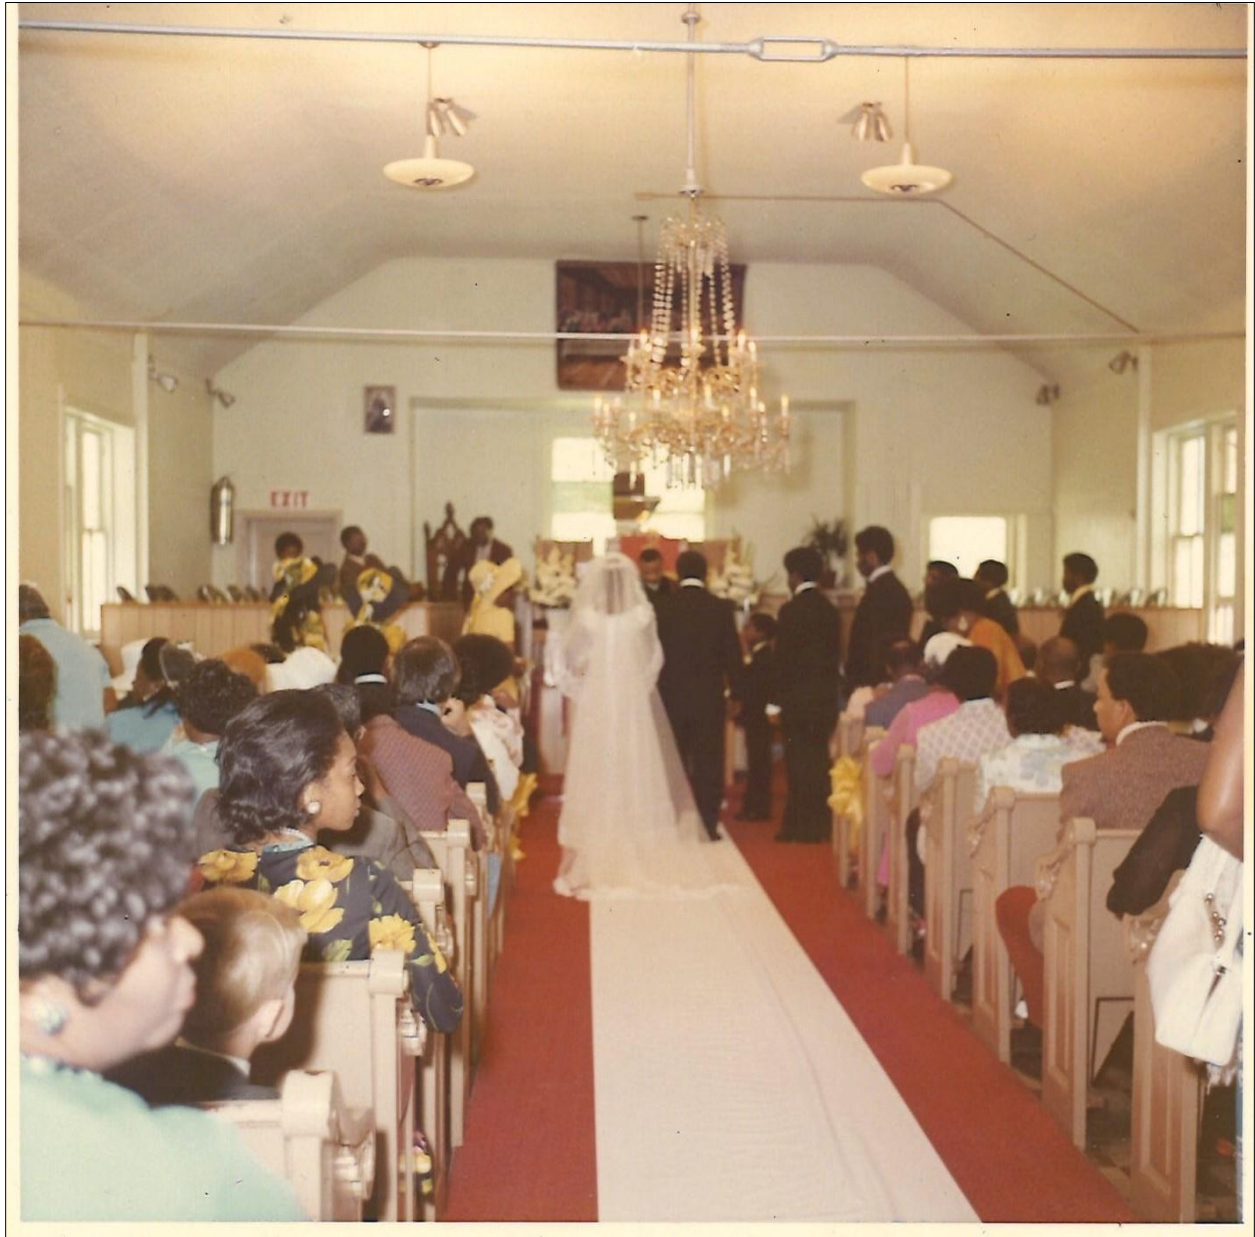
Figure 22: St. Nicholas Ukrainian Catholic Church after acquisition by the New Calvary Baptist Church, view of interior showing choir box, light fixtures, and window glazing. Wedding of LaVerne Adderley, 1974, private collection. Photo provided by congregation.

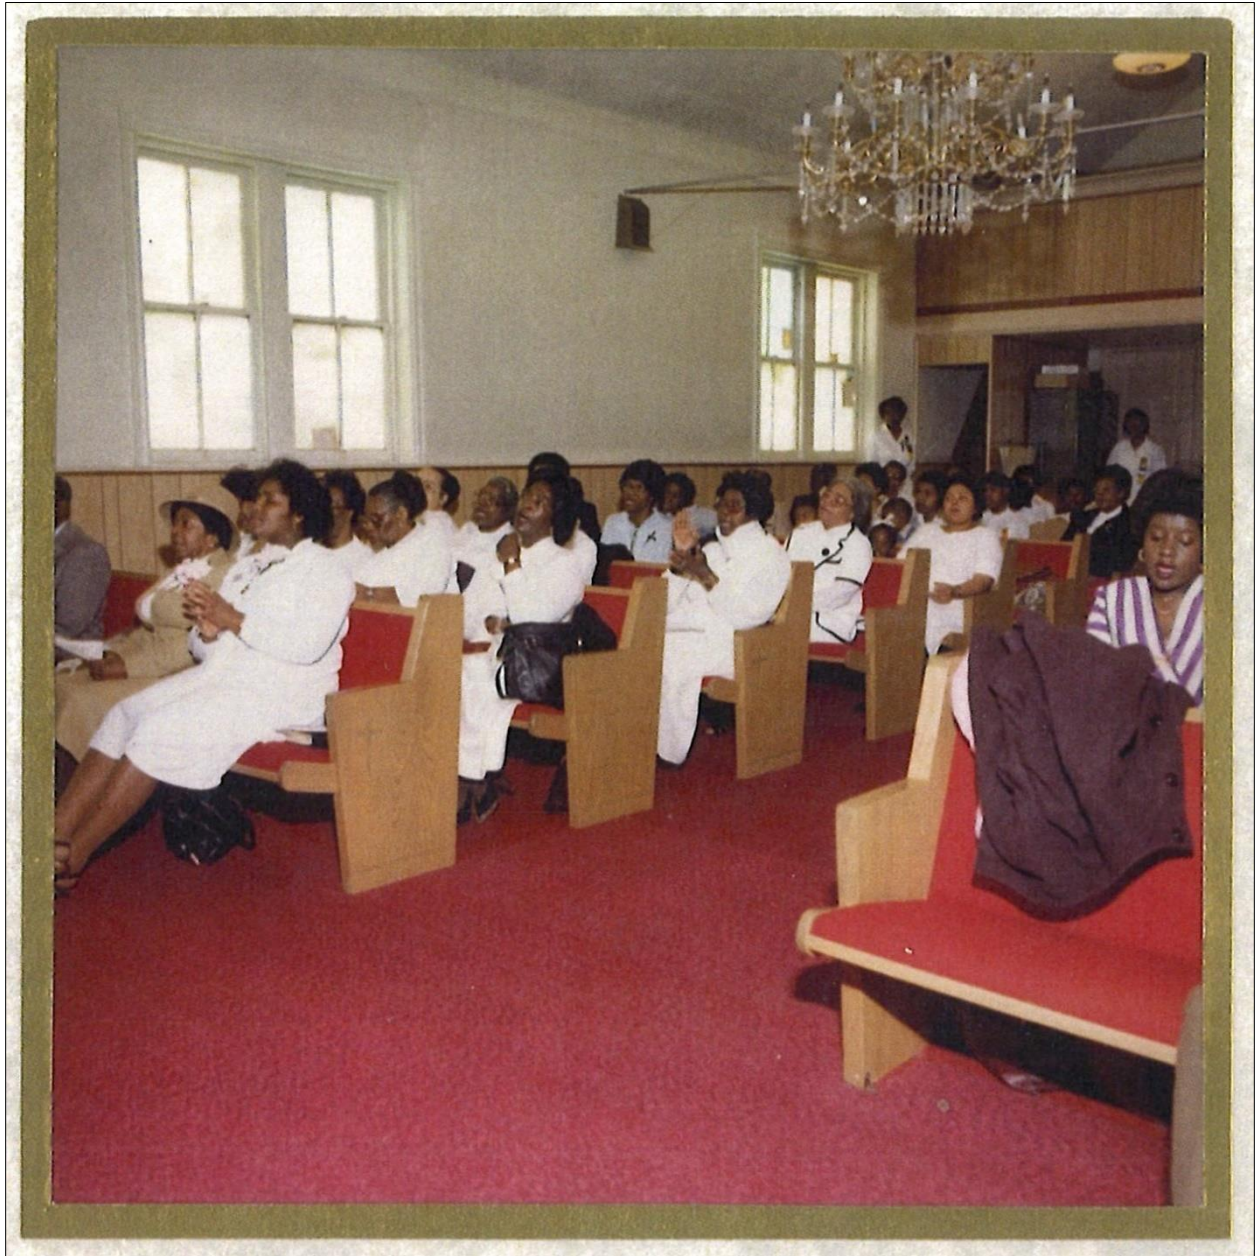
Figure 23: St. Nicholas Ukrainian Catholic Church after acquisition by the New Calvary Baptist Church, interior view showing the congregation, the current pews, the chandelier, wood paneling, and windows. Photo provided by Reverend Raymond Fisher, 1980, private collection.
