National Register of Historic Places Registration Form

Historic name: Fuksa, John and Mary, Farm

Street & number: 1228 E0580 Road

City or town: Bison State: OK County: Garfield

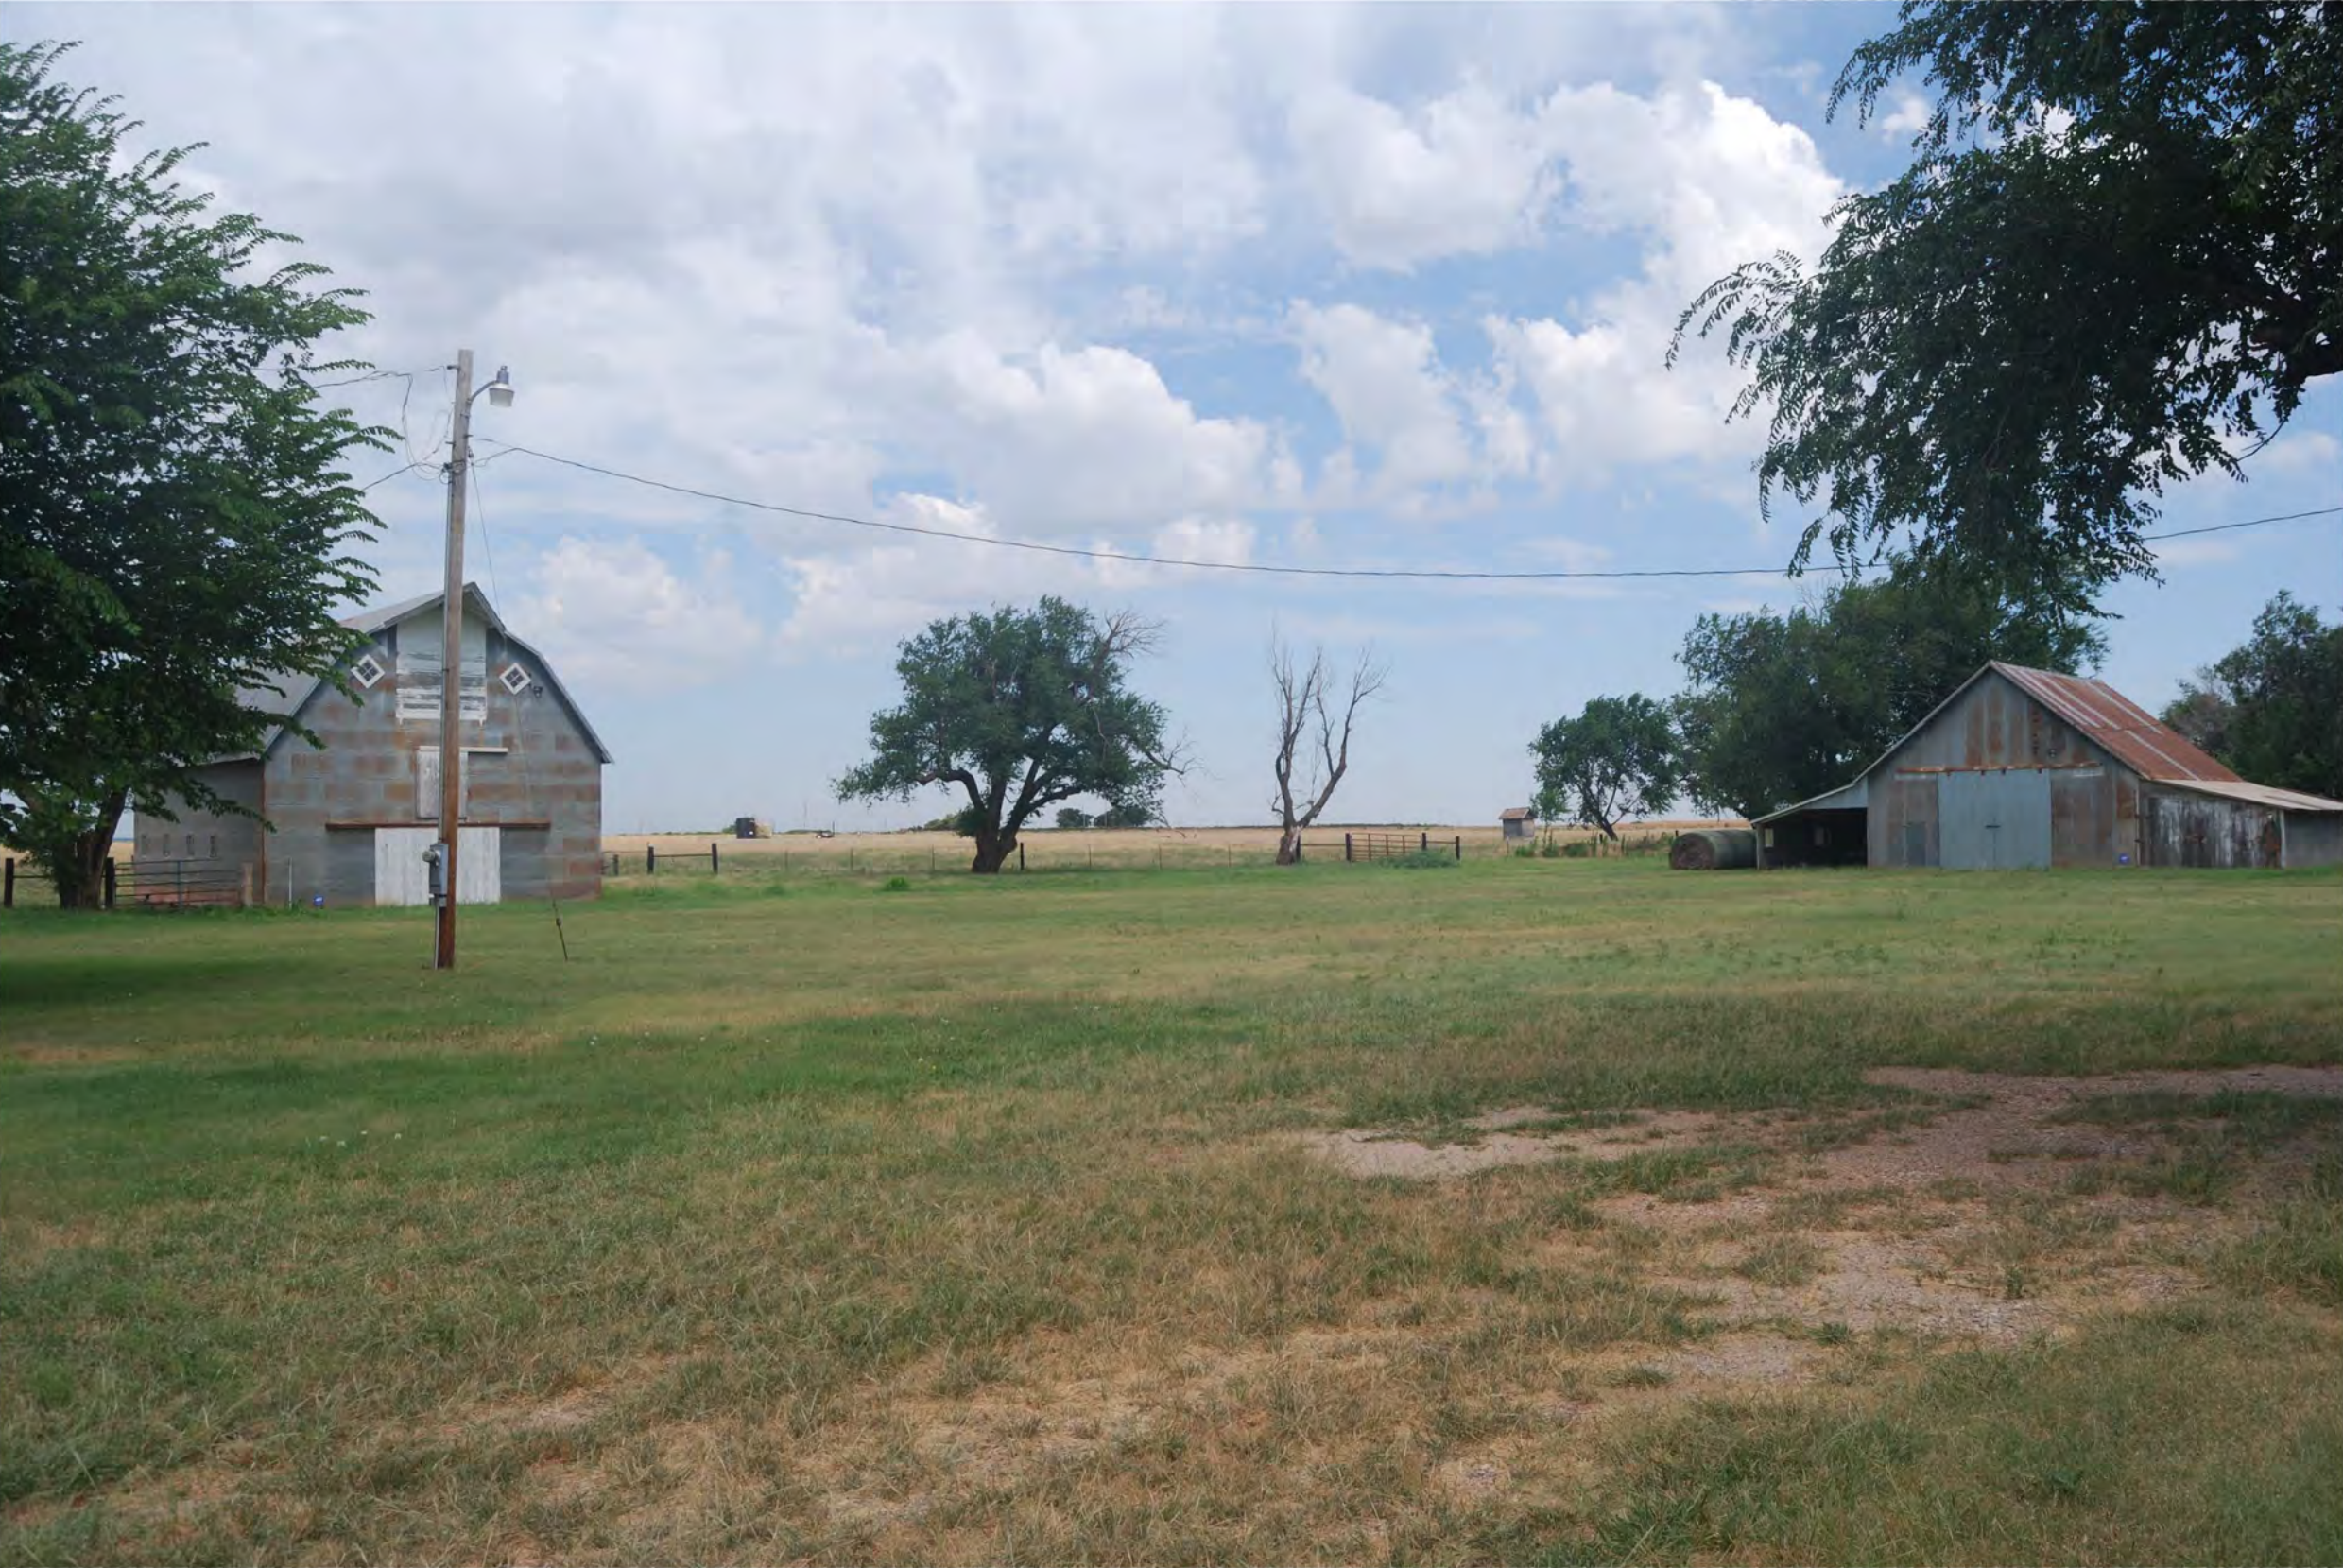
Barn, 1940, contributing: This is a two-story metal clad gambrel roof barn with a concrete foundation. The building is clad in a brick-patterned metal siding. The south elevation has four four-pane wood windows. The west elevation has two sliding shed doors as well as two diamond pane fixed sash windows in the gambrel peak. The north elevation has three single four pane wood windows. The east façade has two central sliding shed doors as well as a smaller hay loft hinged, drop-down, door above for the hay hook trolley access which is extant. There are two diamond pane fixed sash windows in the gambrel peak. The interior features stalls and milking areas on the first floor with a full hay loft on the second floor. (photograph 0001, 0005)

Granary, 1927, contributing: This is a one-story front gable building with a shed roof wing on the east and west elevations. It is clad in metal and has a concrete foundation. The south elevation has two sliding shed doors in the gable front portion and hinged doors in the shed roof wing on the east side. The west shed roof wing is open. The west elevation has no openings. The north elevation has a sliding metal door in the center and two wooden doors on the west extension. The east elevation has no openings. (photograph 0001, 0002)

Photograph Number	Subject	Direction
0001	Barn and Granary	Northwest
0002	Chicken House and Granary	Northeast
0003	House	Northwest
0004	Storm Shelter	North
0005	Barn	Southwest
0006	Well and Windmill	West
0007	Pigeon House	West

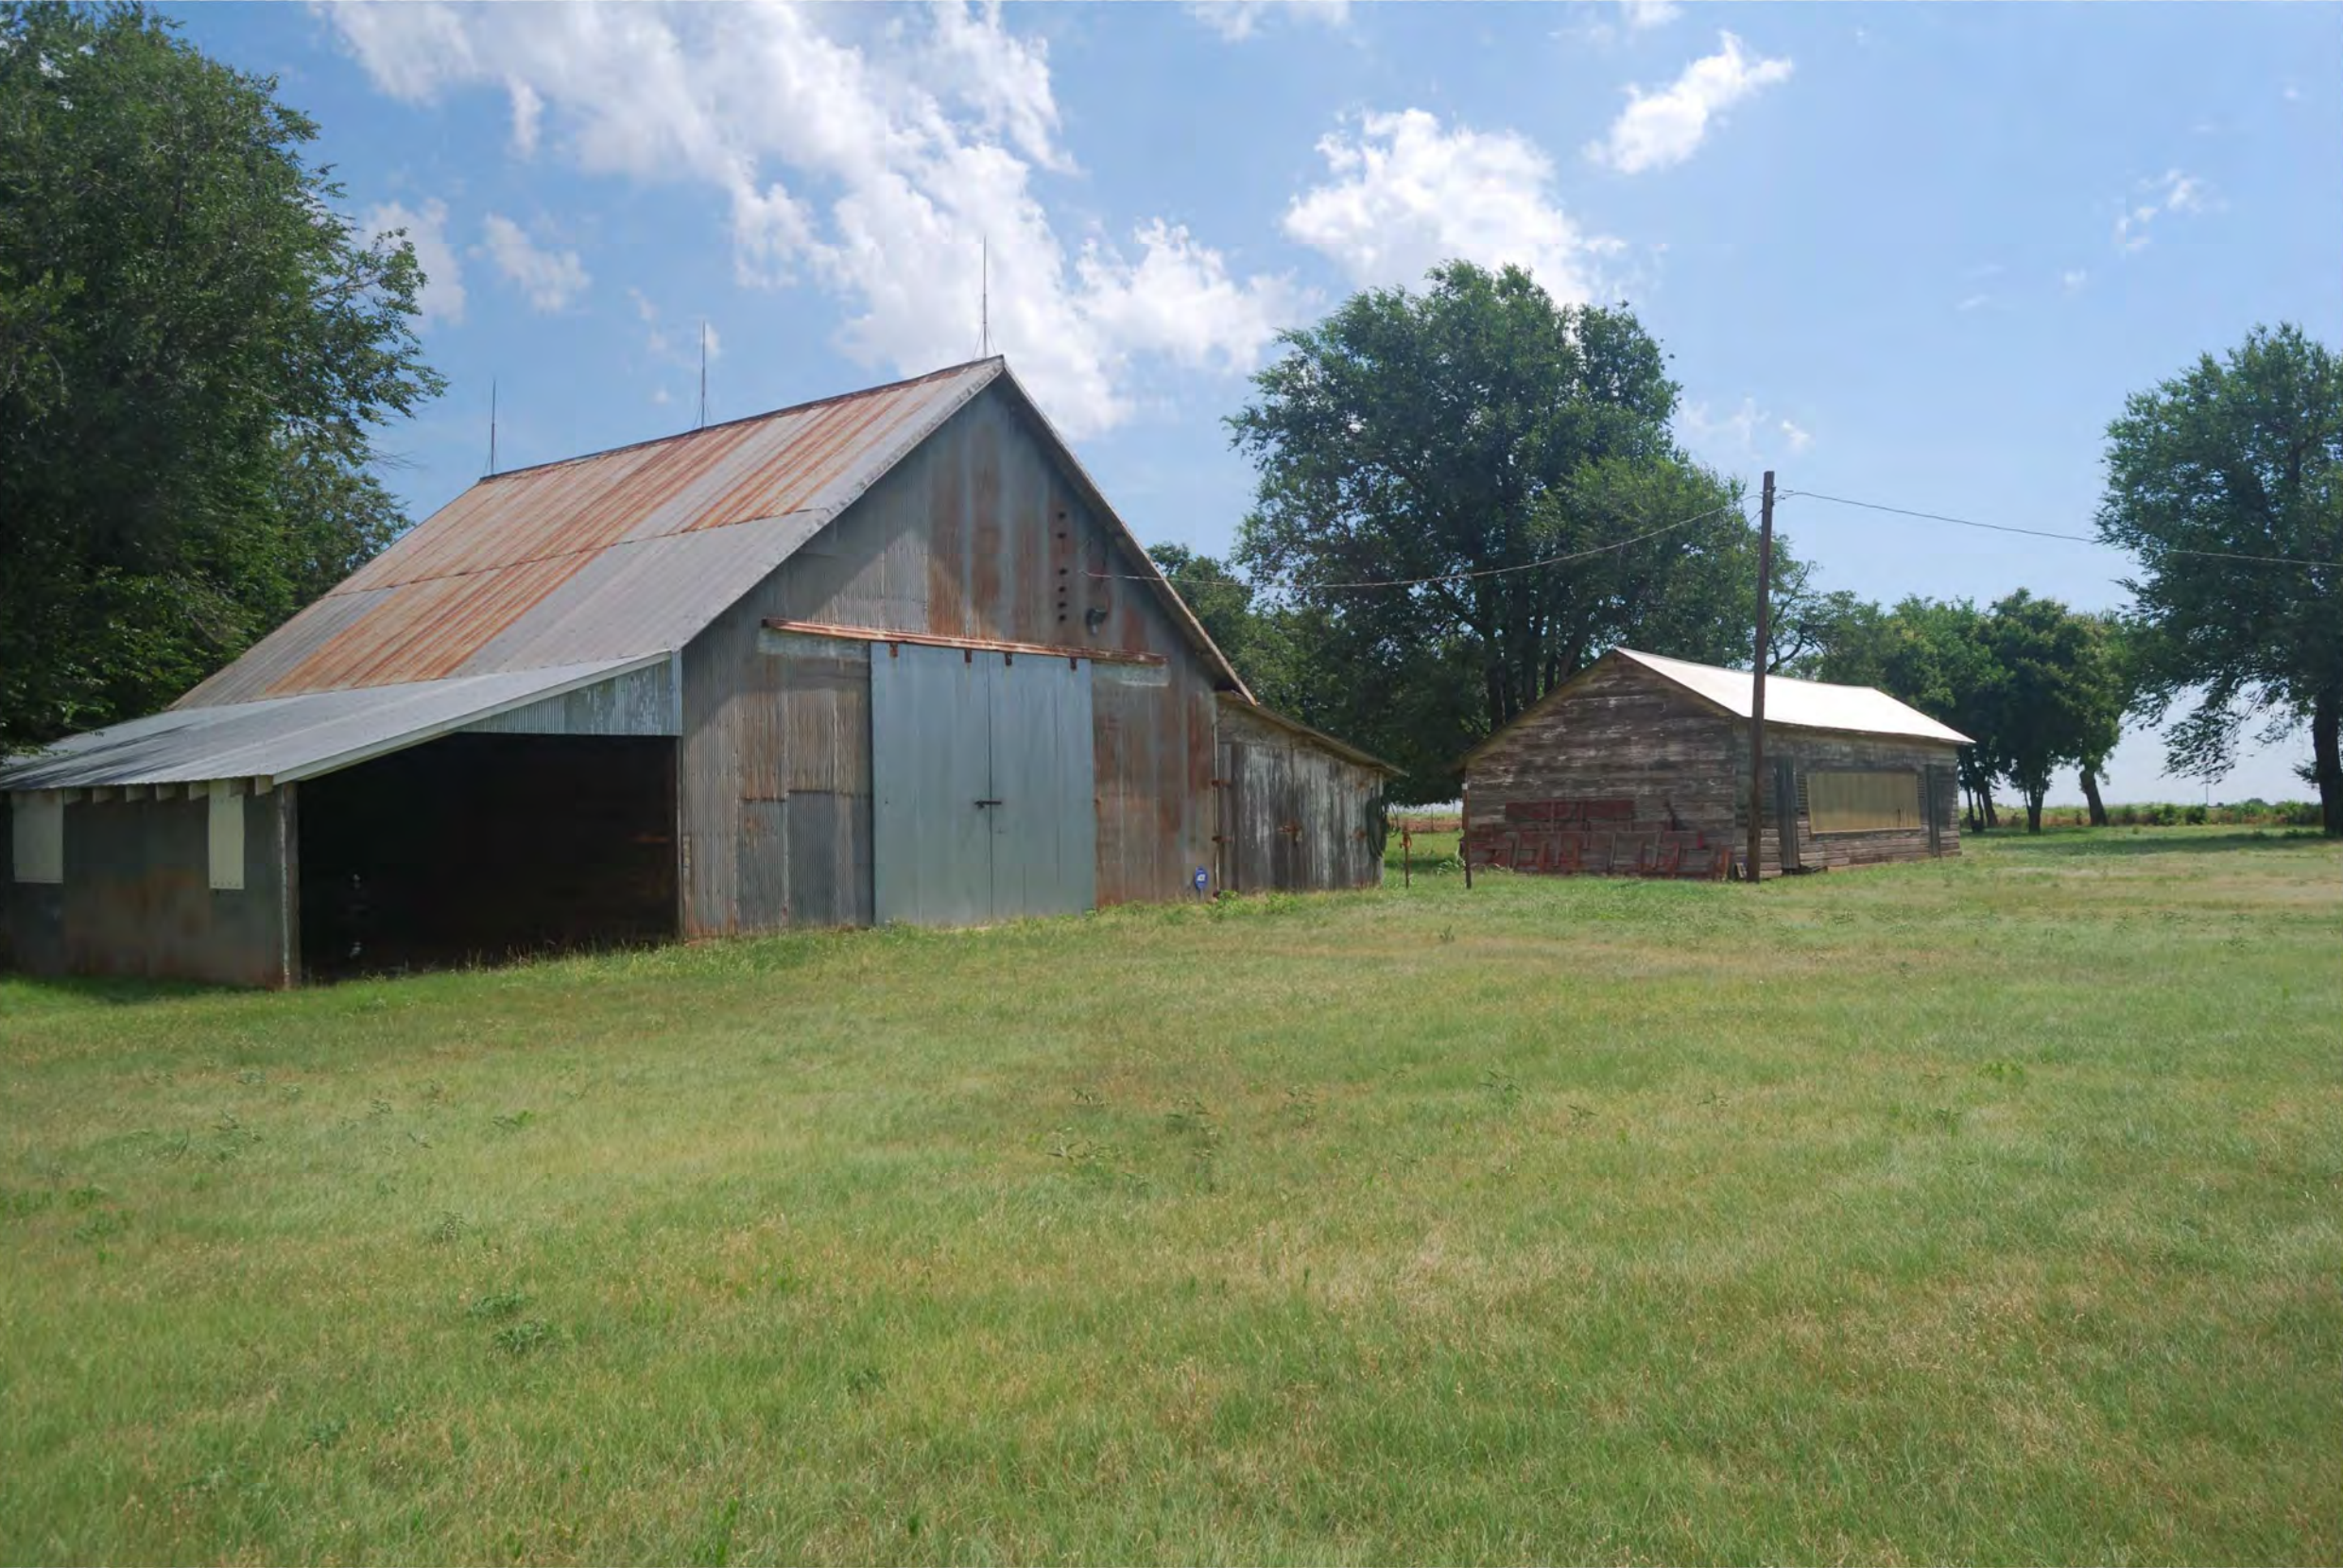
Chicken House, 1926, contributing: This is a one-story side gable building with a concrete foundation. The building is clad in horizontal wood siding. The roof is clad in metal. The south elevation has two wooden paneled doors on both ends and a centralized band of ten single pane wood window openings that have been covered with green fiberglass. The west elevation has no openings. There are two sections of the exterior wall with a top hinge that allows the wall to open outwards to provide ventilation on the north elevation. The east elevation has two wood frame hung windows. (photograph 0002)

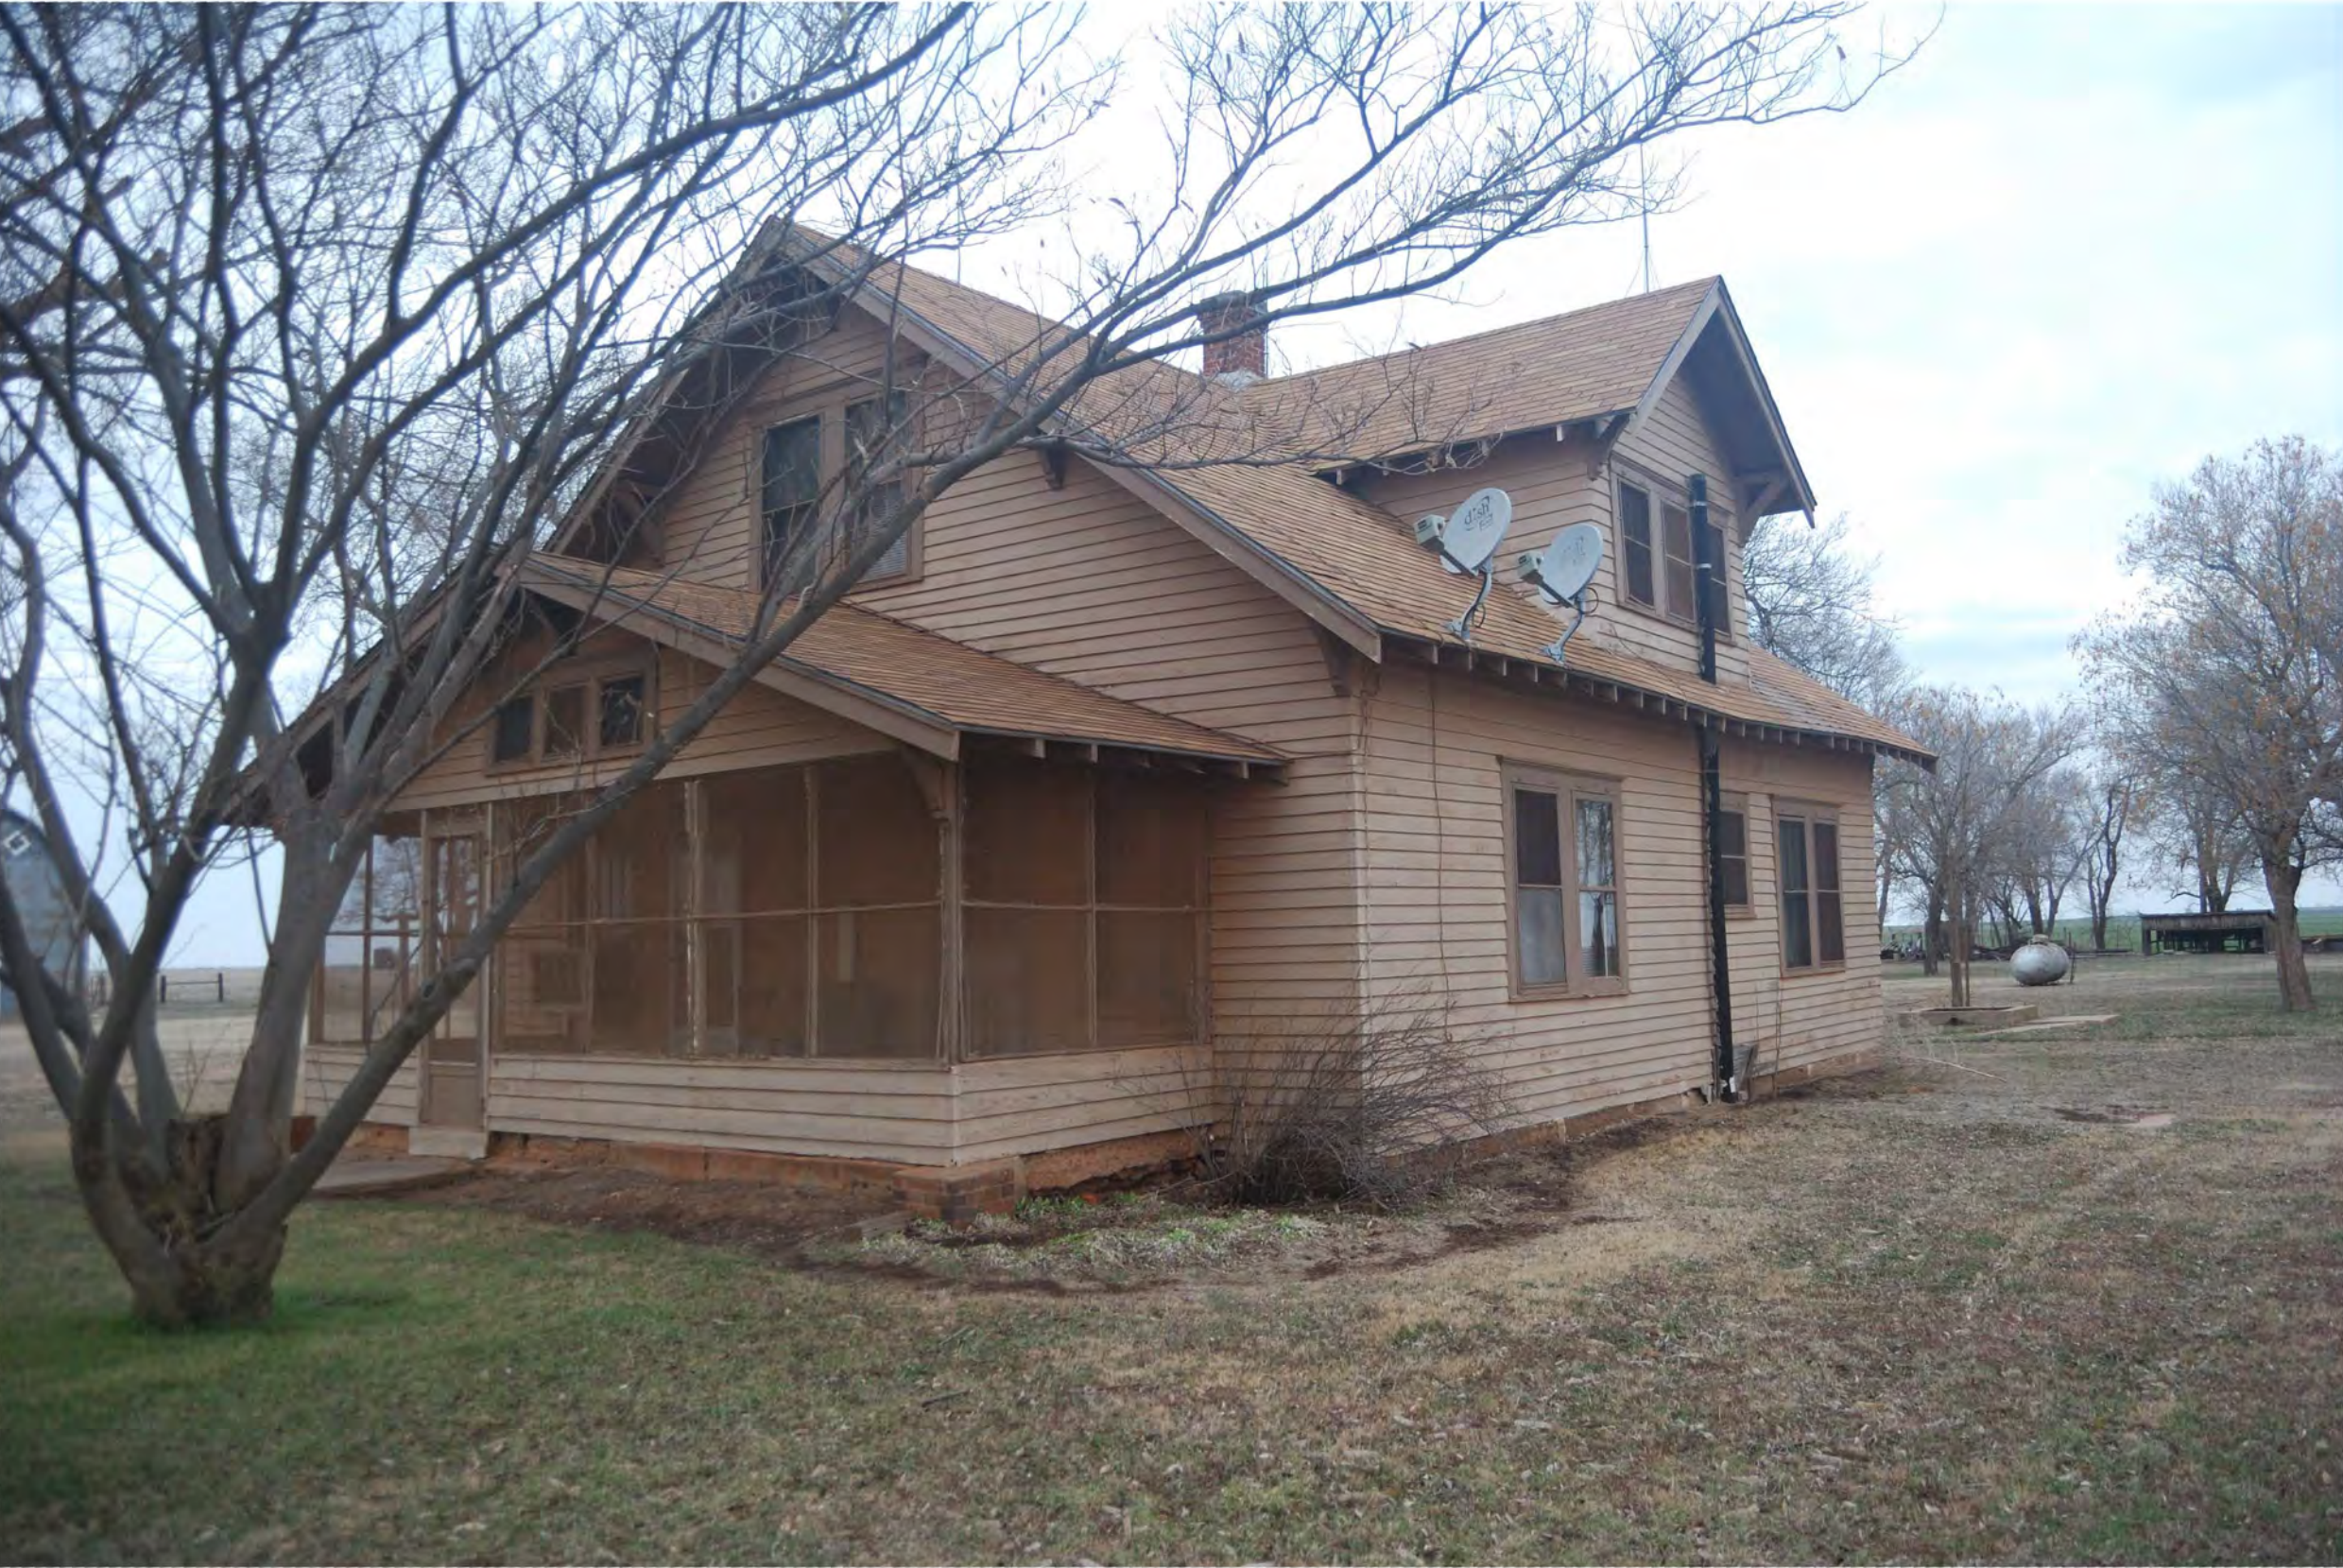
House, 1926, contributing: This is a one-and-a-half story front gable building clad with wood clapboards and asphalt shingles on the roof. The foundation is concrete. The façade, which faces south, has a front-gable porch with one three-pane, fixed window. The first floor has two pane and panel wood doors and two, four-over-one hung wood windows. The half-story gable end has two, four-over-one wood hung windows. The west elevation has a front gable extension with a sliding window on the south and north elevation and two sliding windows and a wood pane and panel door on the west elevation. Located in the gable end of the west elevation are

three, three-pane fixed windows. The north elevation has two pair of four-over-one wood hung windows on the first floor. The half-story has two four-over-one hung wood windows in the gable end. The east elevation also has five, four-over-one wood hung windows. The side gable roof has a gable front dormer with three four-over-one wood hung windows. There is a brick chimney in the center of the roof. The roof also has exposed rafter tails on the side gables and brackets on the gable ends. (photograph 0003)

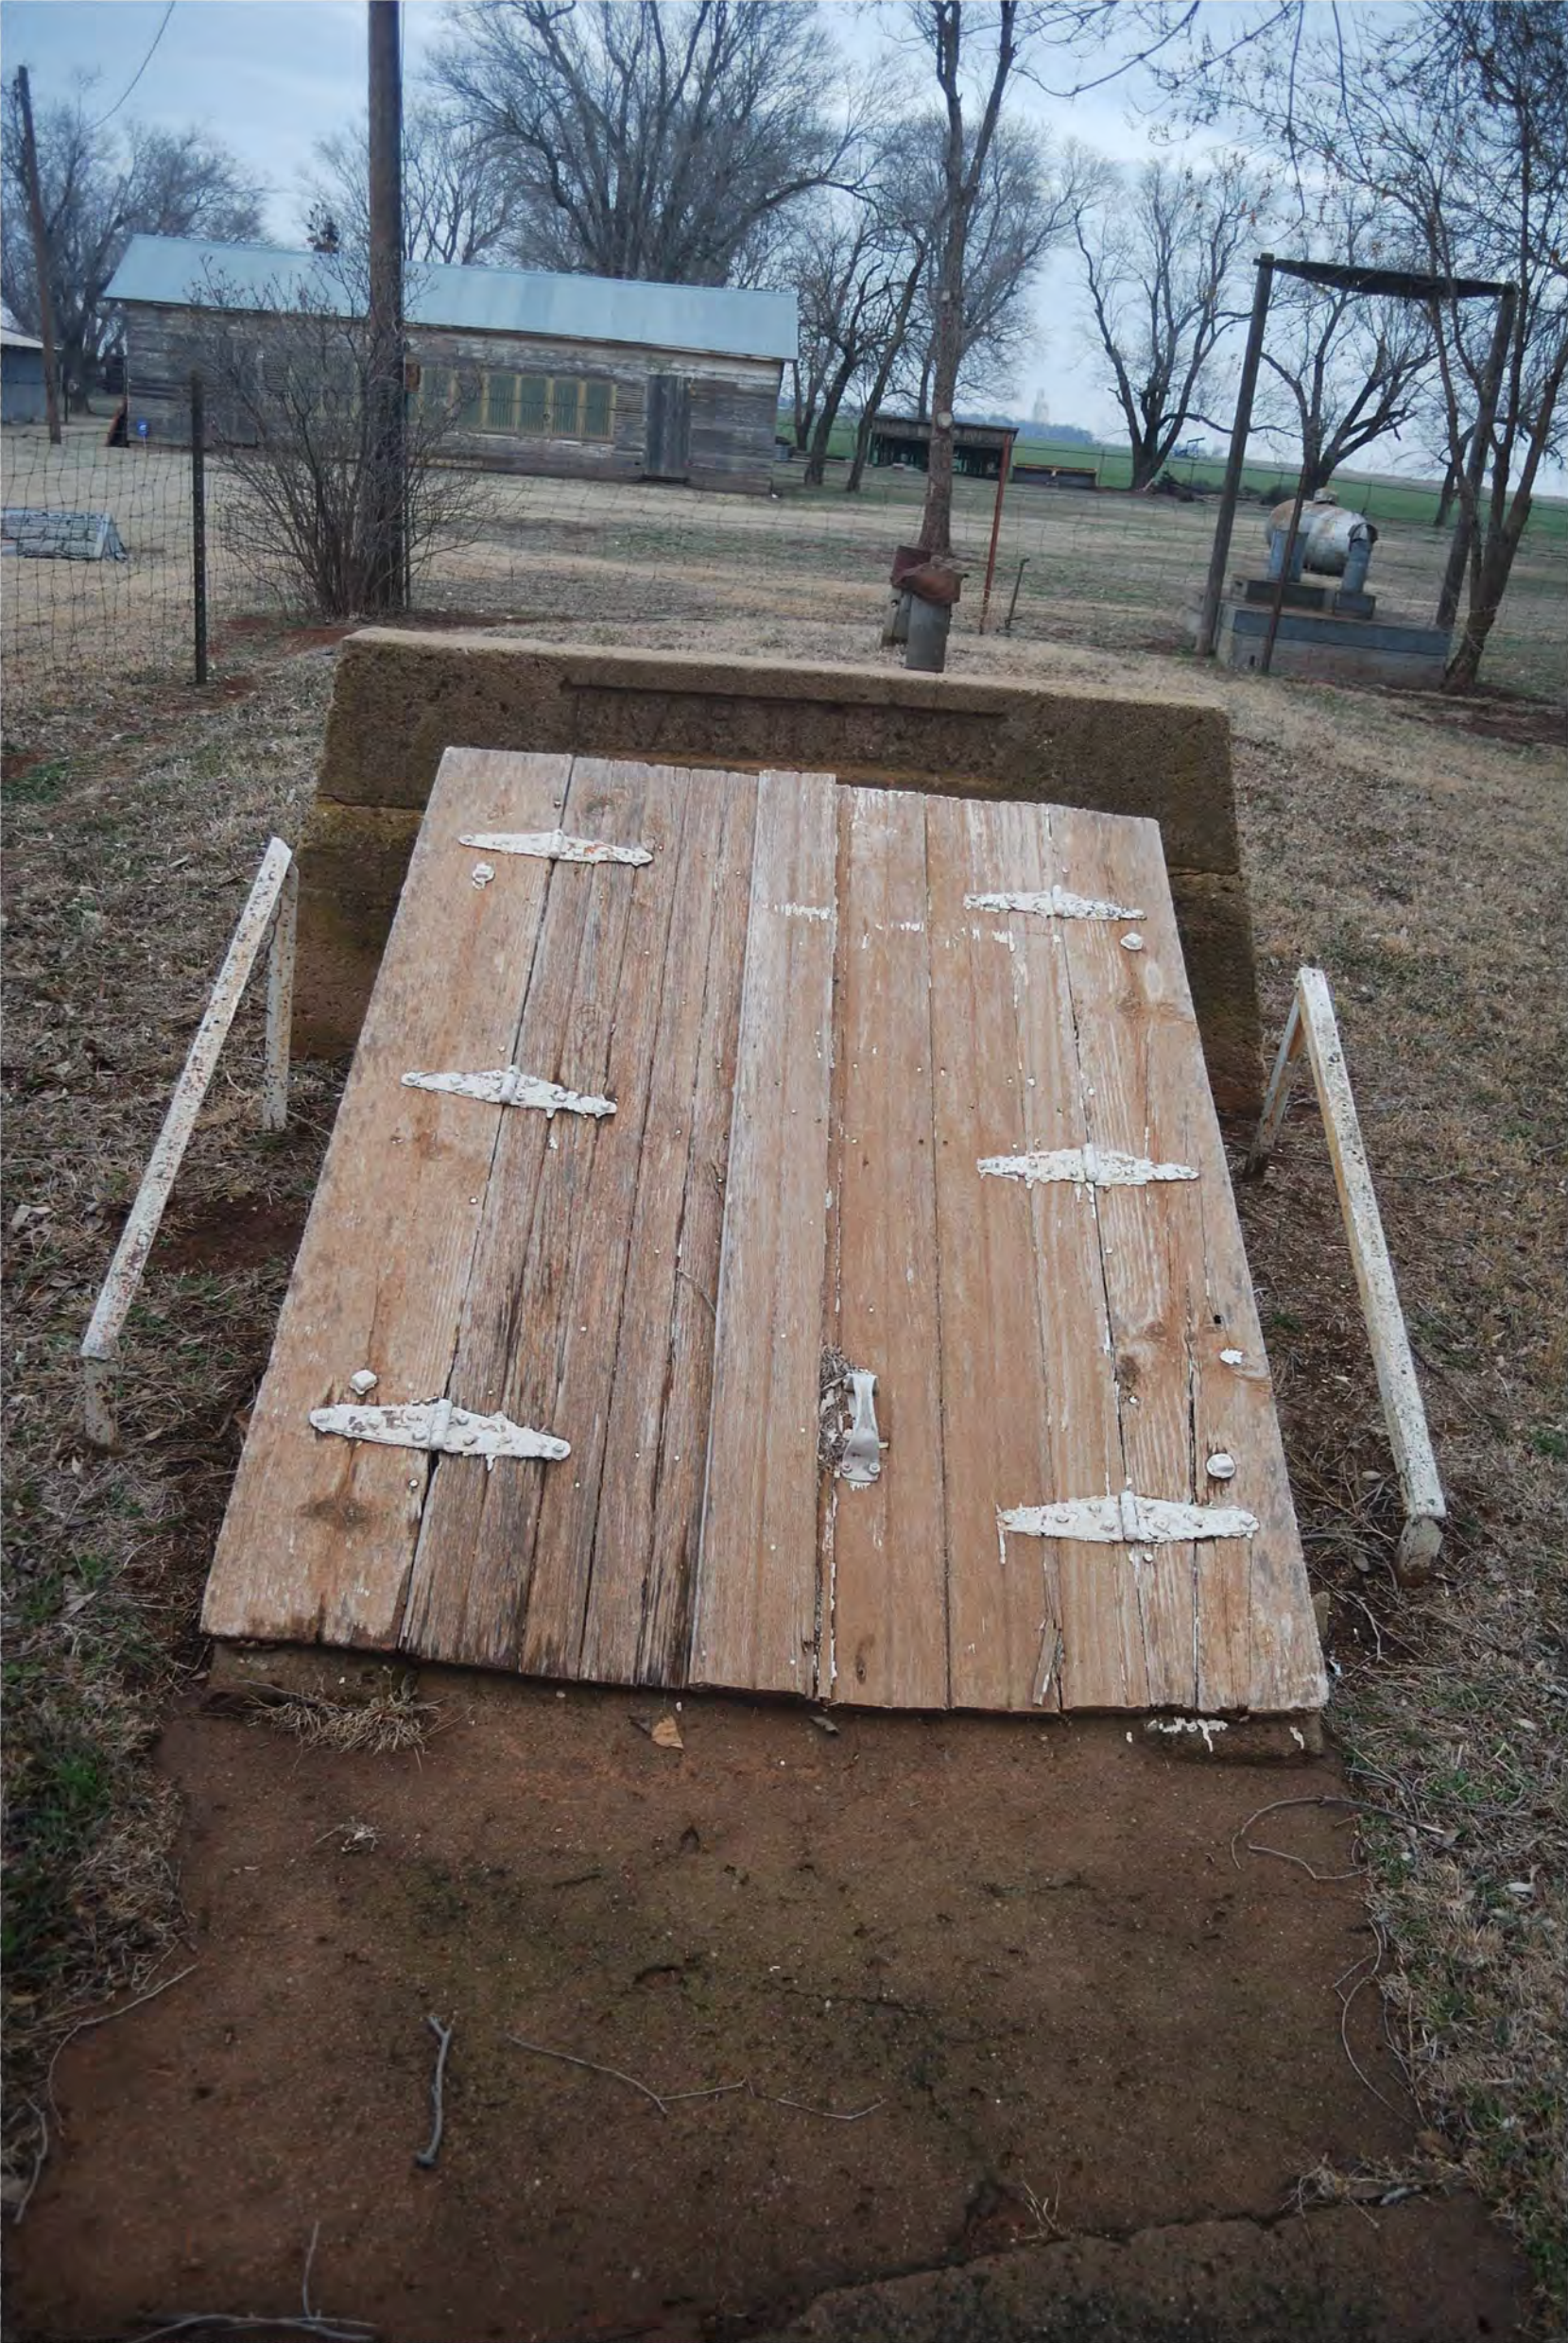
Storm Shelter, 1930, contributing: This is a concrete underground storm shelter. The south façade has two wood-paneled doors which open outward. There is a metal railing on the east and west sides of the doors. Visible from the south elevation written in the concrete is Mar 11, 1930. (photograph 0004)

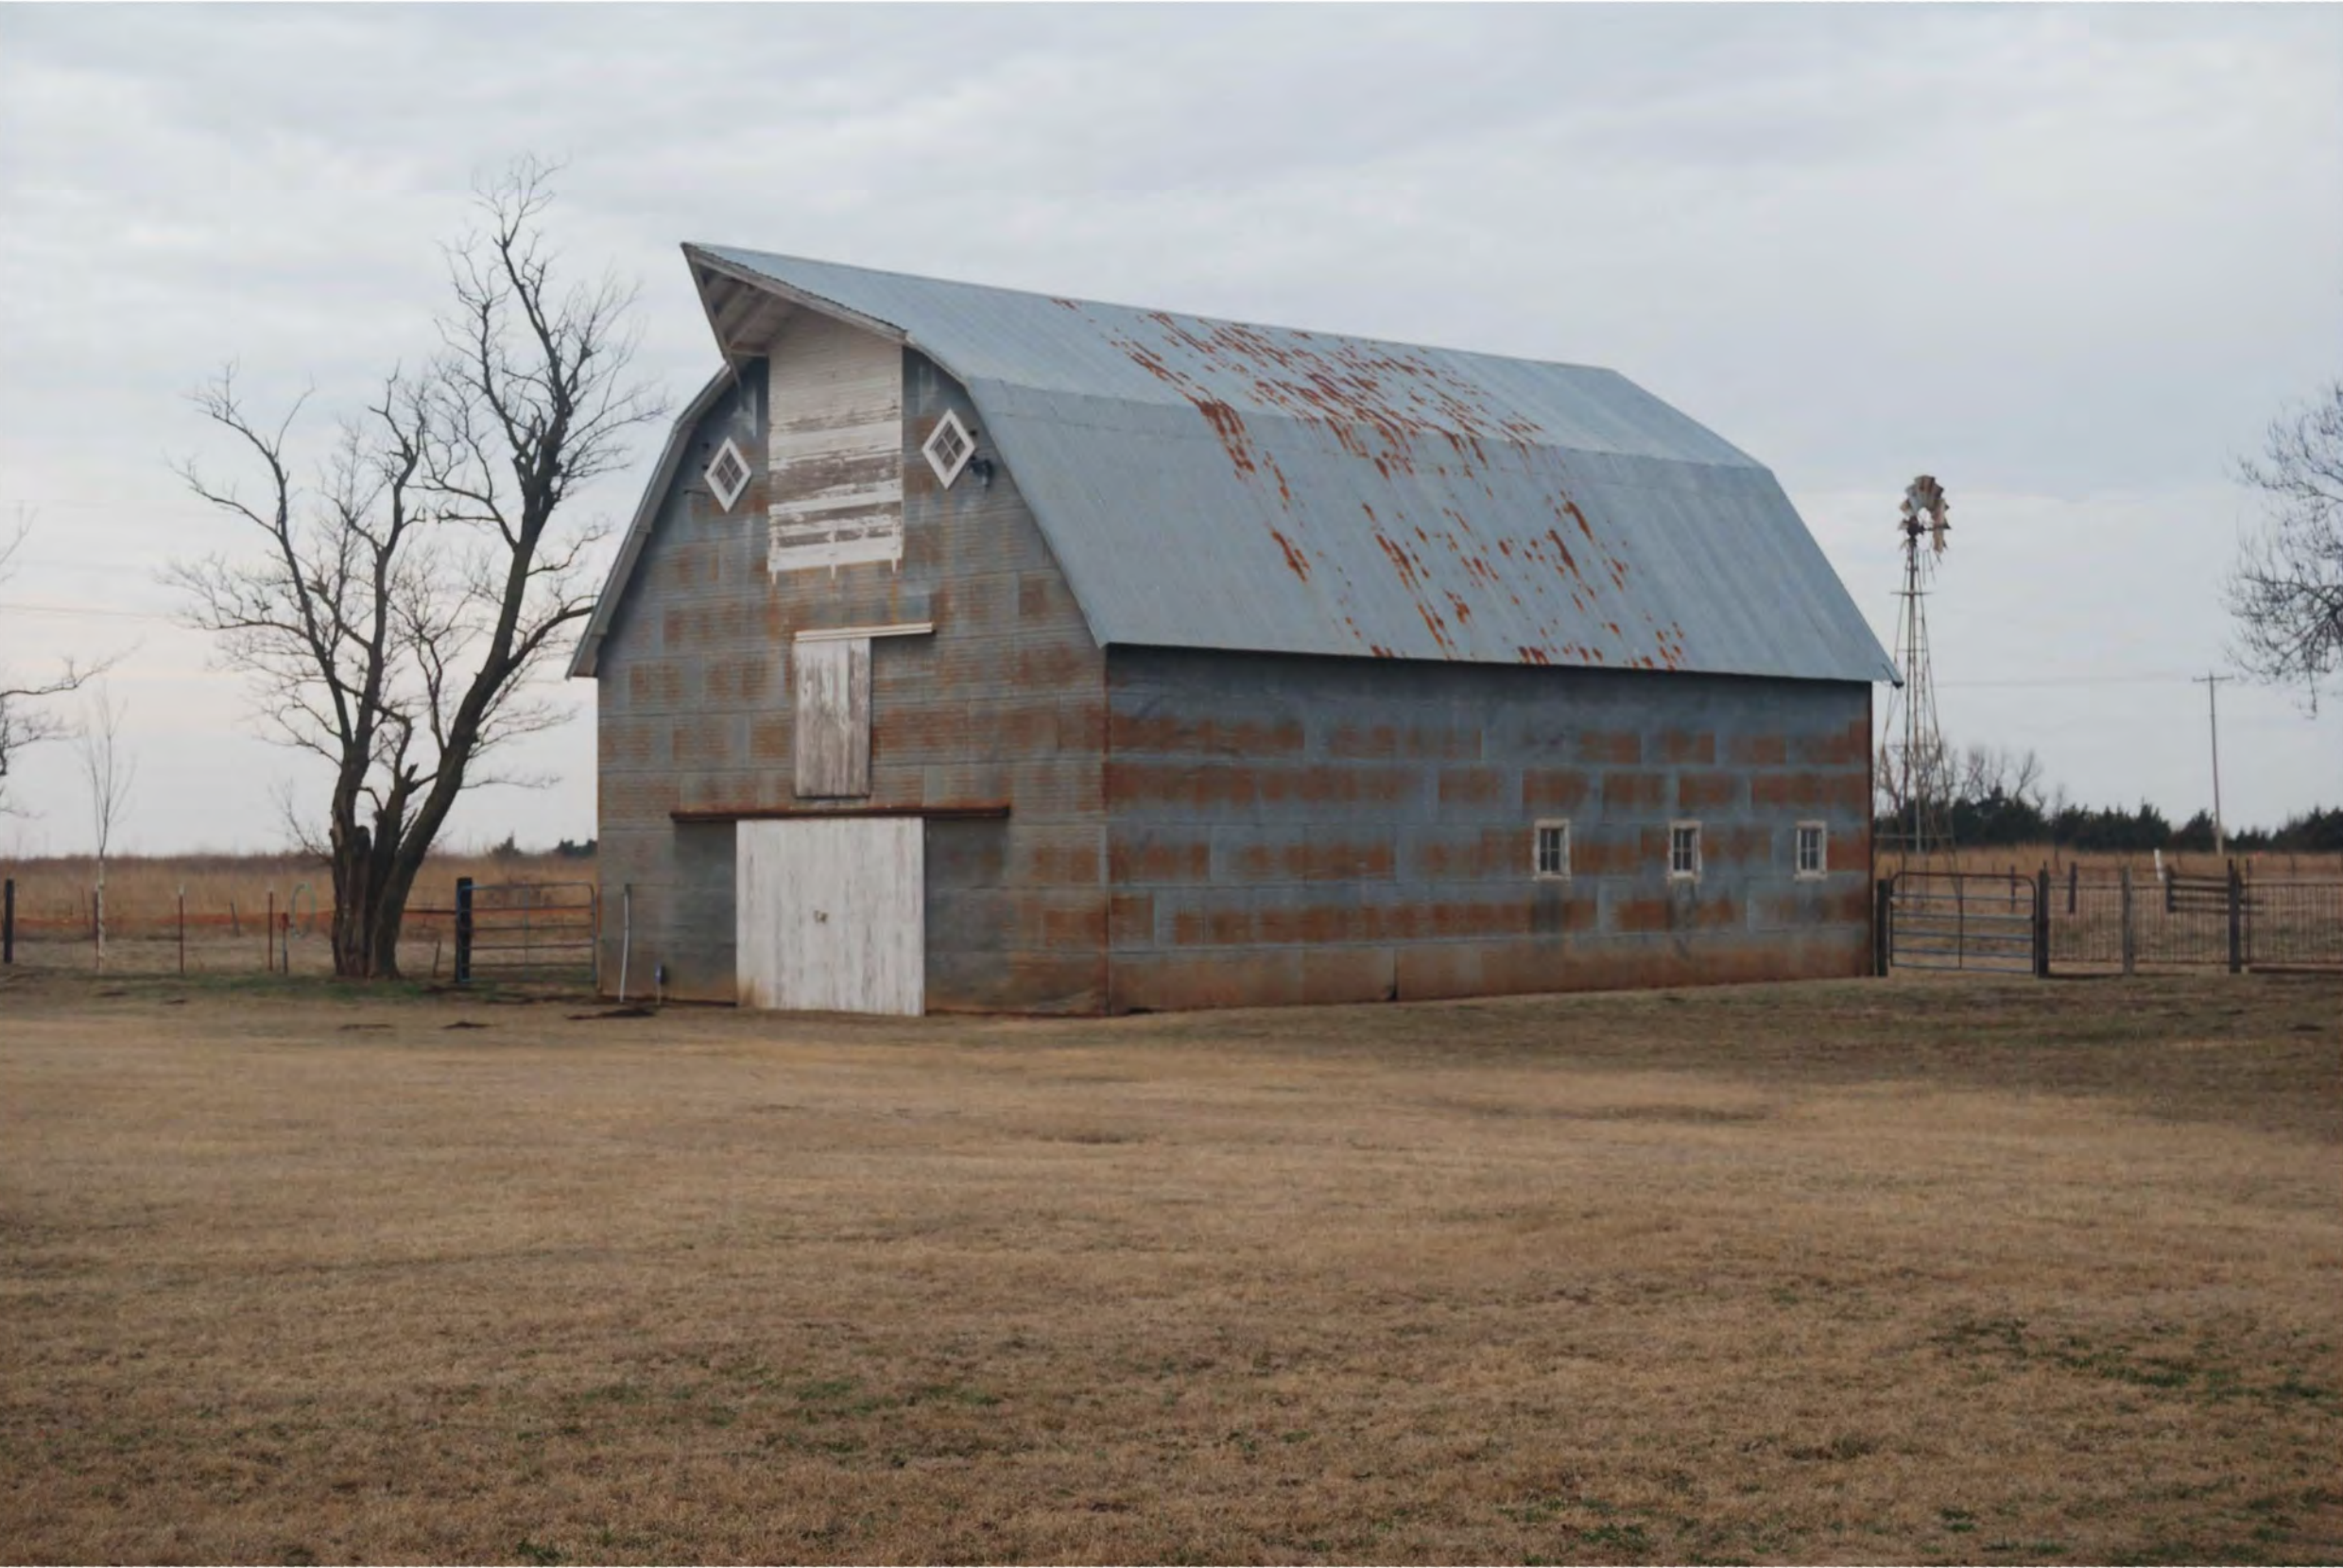
The barn, built in 1940, was an important aspect to the farming practices of the family. The barn is a classical dairy barn. It has a shallow pitched gambrel roof and the row of small windows on the side elevations. The first floor was utilized for cattle and horses while the second floor was used as hay storage with a hay door on the east elevation. As is common on most farms, the barn was the most important building. It was important to provide shelter for the animals due to the harsh climates in Oklahoma.
