National Register of Historic Places Registration Form

Historic name: Fuksa, John and Mary, Farm

Street & number: 1228 E0580 Road

City or town: Bison State: OK County: Garfield

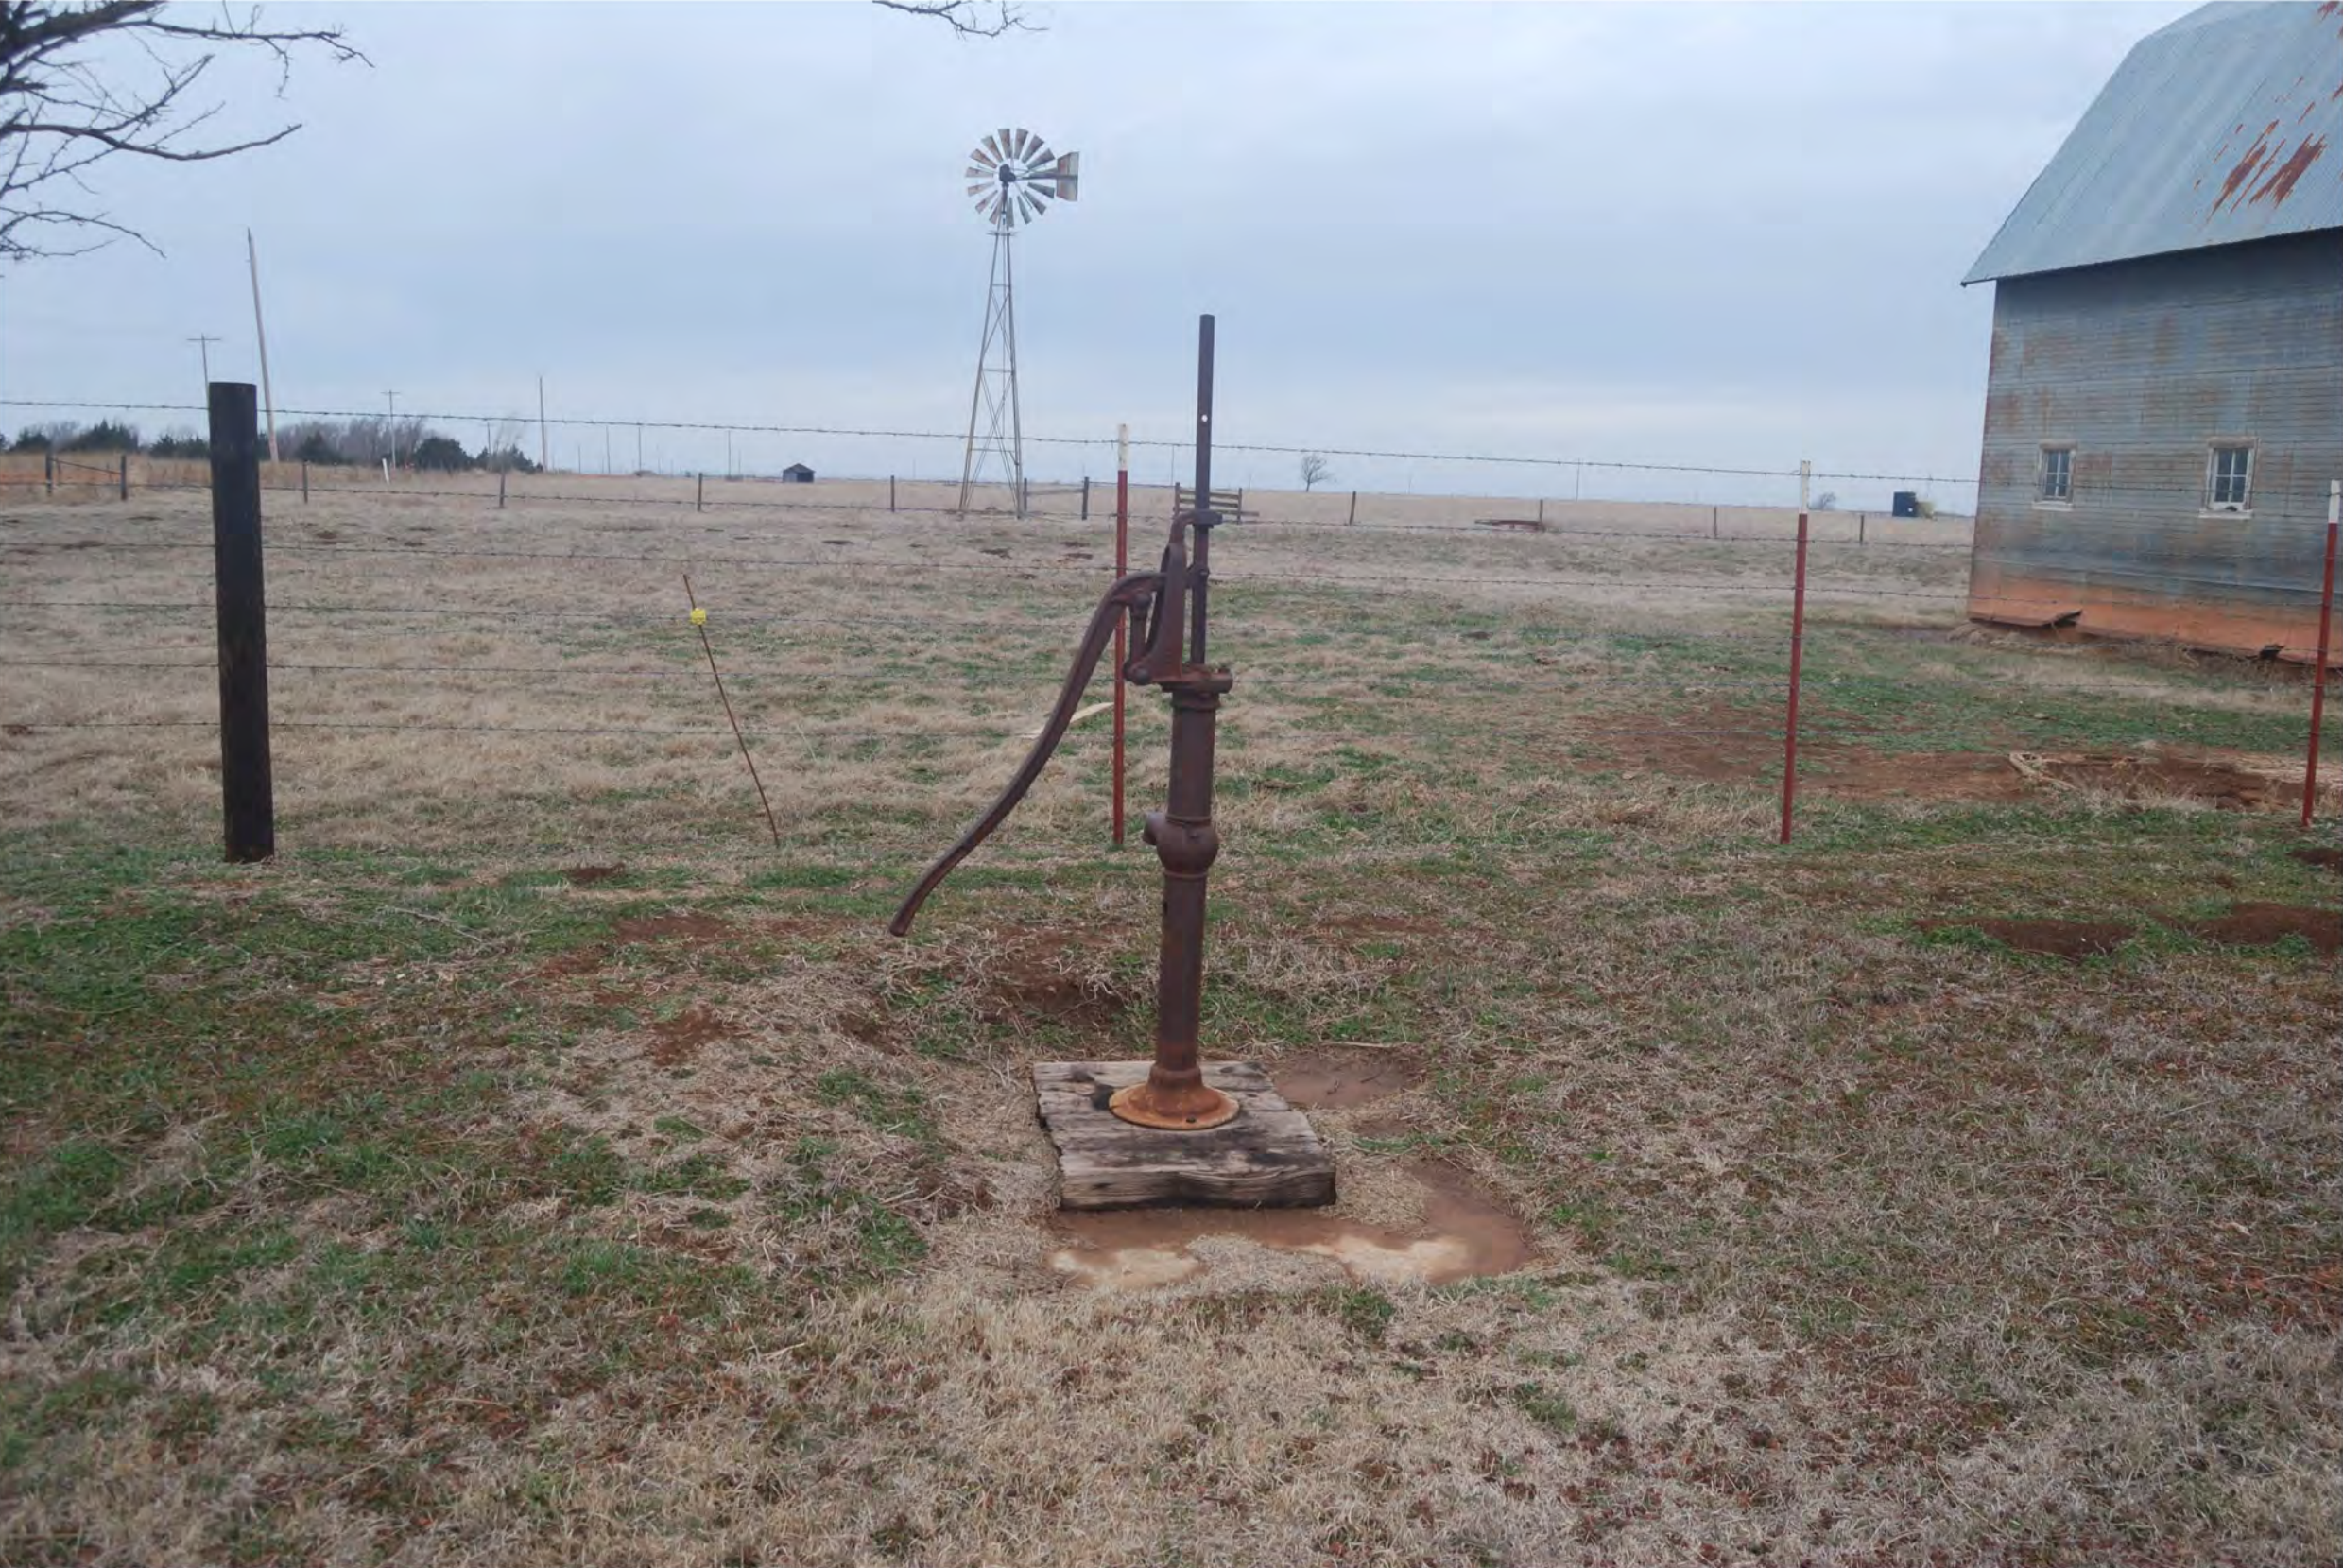
Windmill, ca. 1930, contributing: Metal windmill, functioning. No foundation. (photograph 0006)

Hand Pump, 1930s, contributing: South of barn. Hand Pump manufactured in Beatrice, Nebraska was shot and has a hole in the south side; water comes out of hole during pumping. (photograph 0006)

Photograph Number	Subject	Direction
0001	Barn and Granary	Northwest
0002	Chicken House and Granary	Northeast
0003	House	Northwest
0004	Storm Shelter	North
0005	Barn	Southwest
0006	Well and Windmill	West
0007	Pigeon House	West

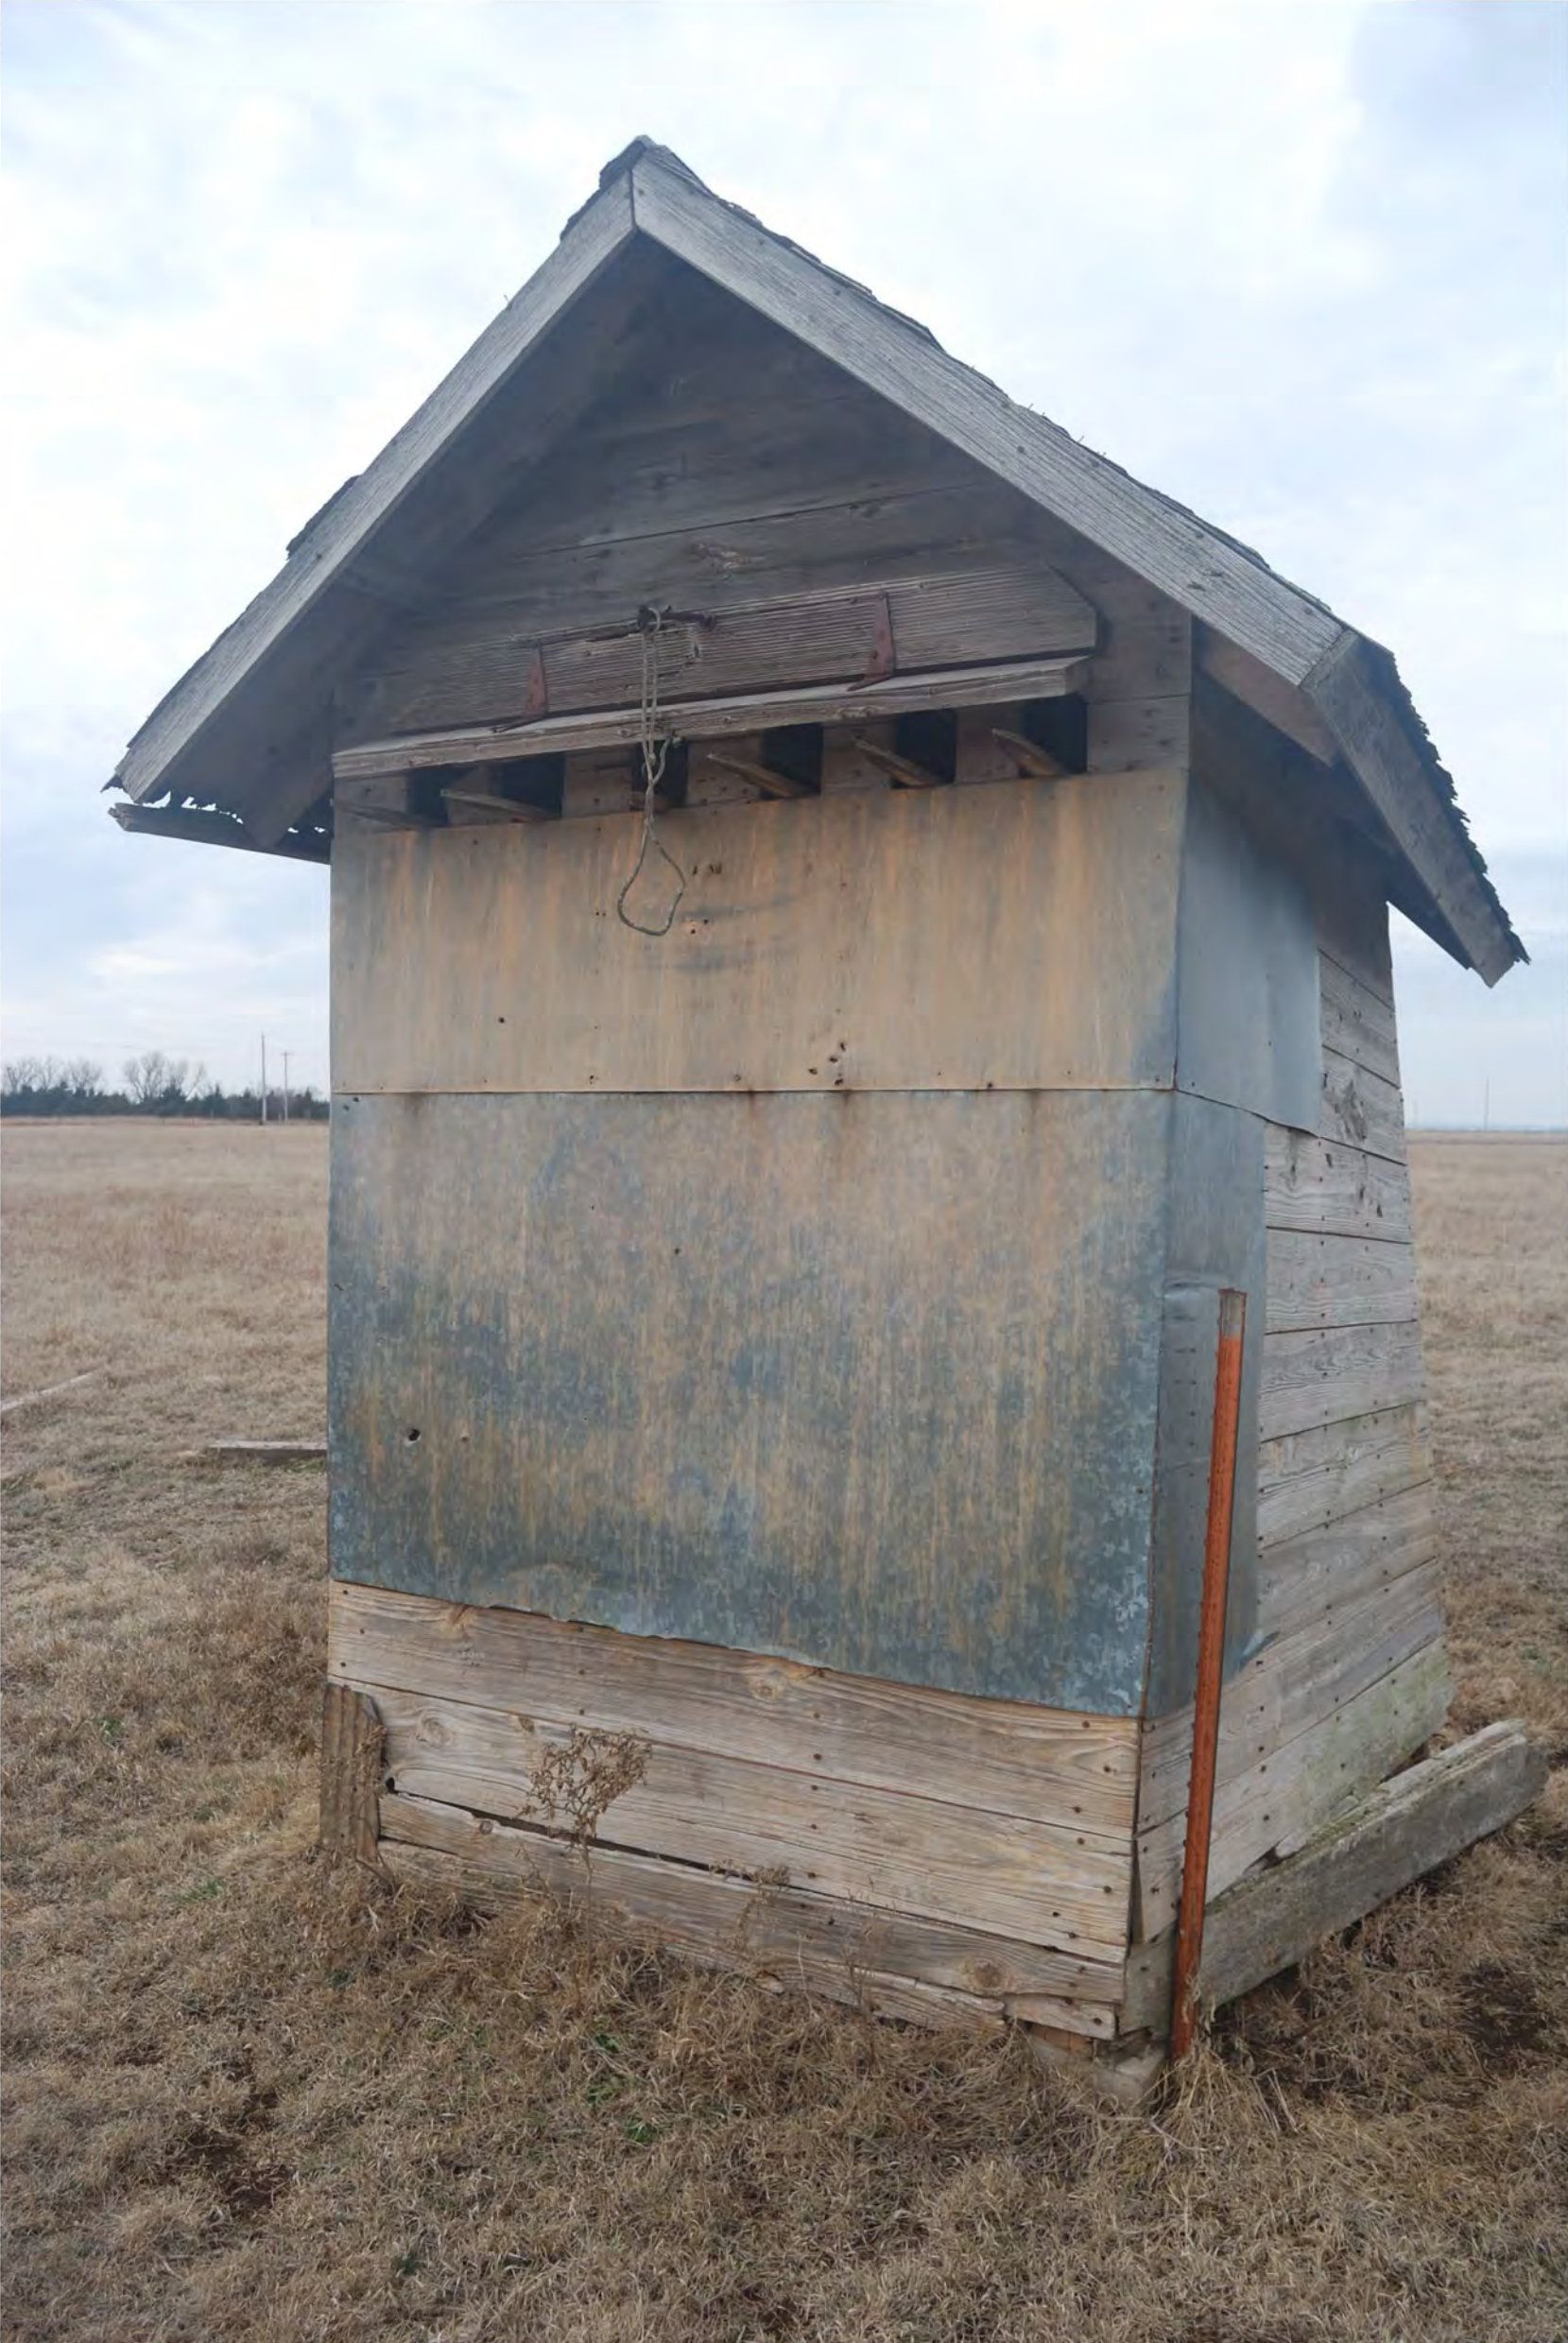
Pigeon House, ca. 1930s, non-contributing: The pigeon house is a one-story front gable building clad with wooden siding and asphalt shingles. The original foundation is unknown; the current foundation is concrete blocks. This building is no longer in its original location. Originally located on the northeast portion of the farmstead, it was relocated to the pasture. The south elevation has no openings. The west elevation is completely open, exposing the pigeon roosting boxes, laid out in a checkerboard pattern. The north elevation has no openings. The east elevation consists of the egress planks for the pigeons to enter the house. A hinged board is

attached above the pigeon entrances to close when necessary to contain the birds. (photograph 0007)
