National Register of Historic Places Registration Form

Historic name: Sligo

Other names/site number: VA DHR # 111-0097

Street & number: 1100 Dixon Street

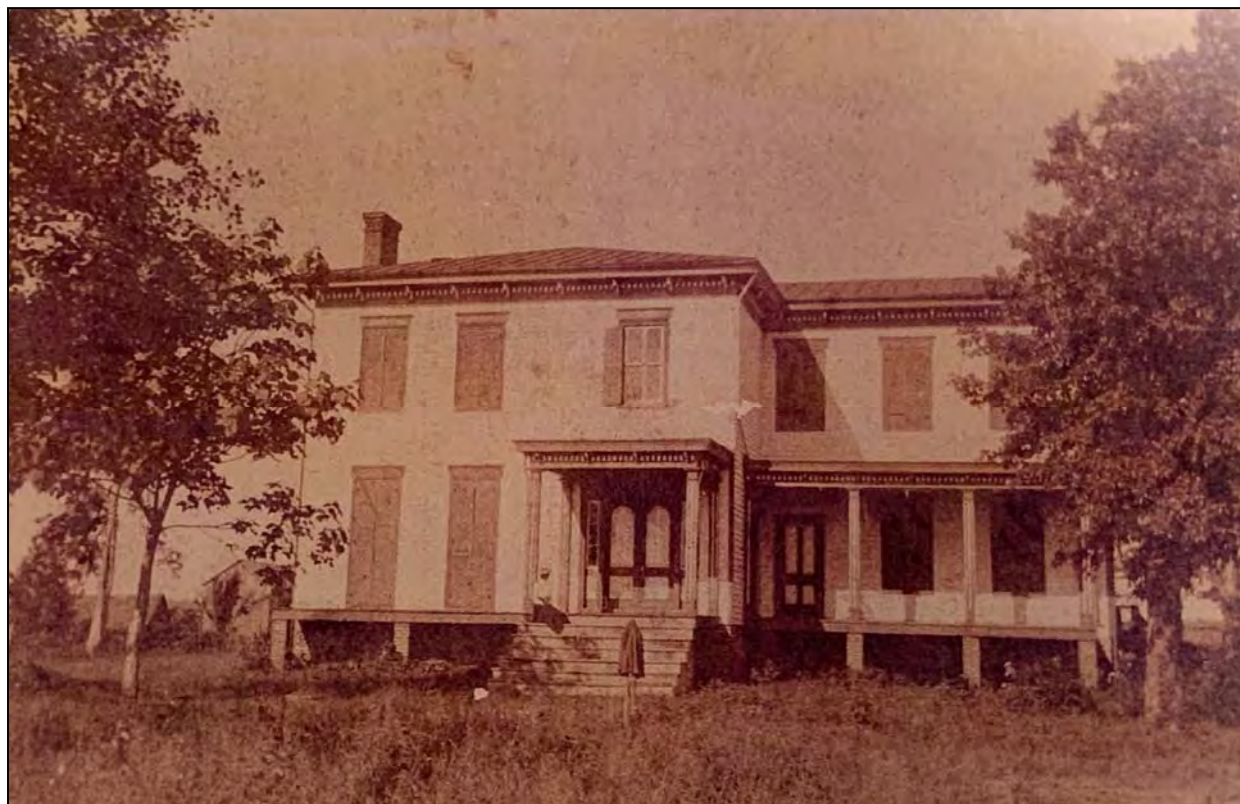
Undated early 20th century view of Sligo shows the no-longer-present secondary entrance and the front porch prior to its expansion.

original one-story, full-length, hipped-roof porch along the ell's façade, that was expanded around 1950 with a flat-roofed porch to create a wrap-around to the south elevation. Historic photos indicate the extended porch was enclosed at this time, but it was opened up again during the 1980s. The foundation underneath the porch, along the west and south elevations of the house, has been red washed and penciled to resemble an all-stretcher bond, rather than the 5:1 common bond that it actually is. An original one-story, one-bay, entry porch matching the one on the façade is located on the rear of the house (east elevation). Also located along the rear elevation is a one-story, one-bay, hipped-roof, pre-1919 addition similar in size to the rear entry porch (Sanborn Map Company 1919).
