1. Independence Prairie Ranger Station.
2. Vicinity - Marion Forks, Oregon.
3. Photographer: Melissa Carlson.
4. Date: 4/3/79.
5. Negative Location: Detroit Ranger District Office,
Detroit, Oregon.
6. Looking north, south gable end of south building
in right foreground, main gable facade of north
building to left in background.
7. Photograph #1.

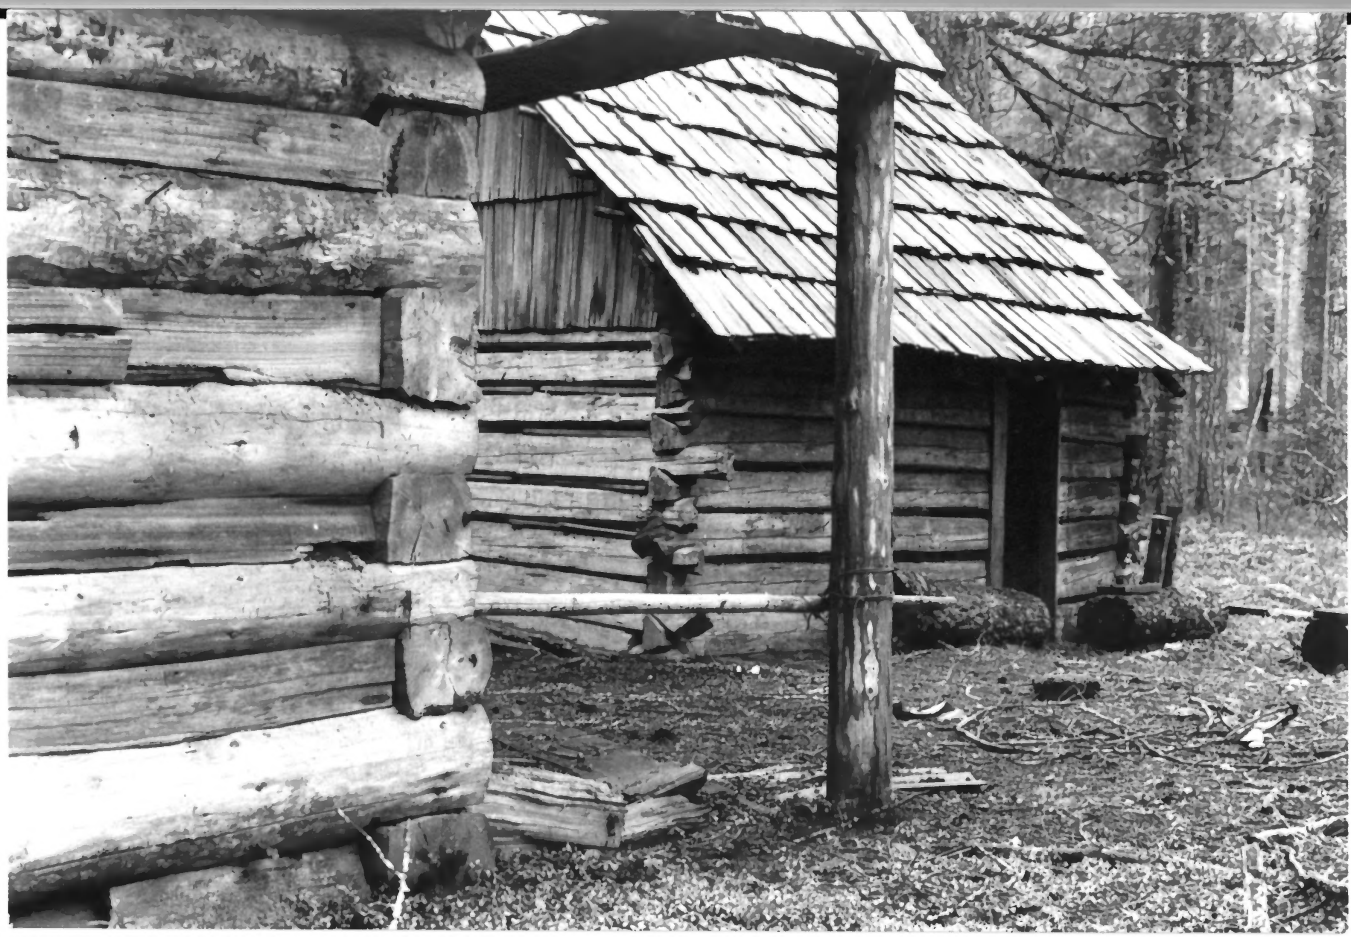
1. Independence Prairie Range Station, North Building.
2. Vicinity-Marion Forks, Oregon.
3. Photographer: Melissa Carlson.
4. Date: 4/3/79.
5. Negative Location: Detroit Ranger District Office, Detroit, Oregon.
6. Southwest corner of north building is in left foreground.
7. Photograph #2.

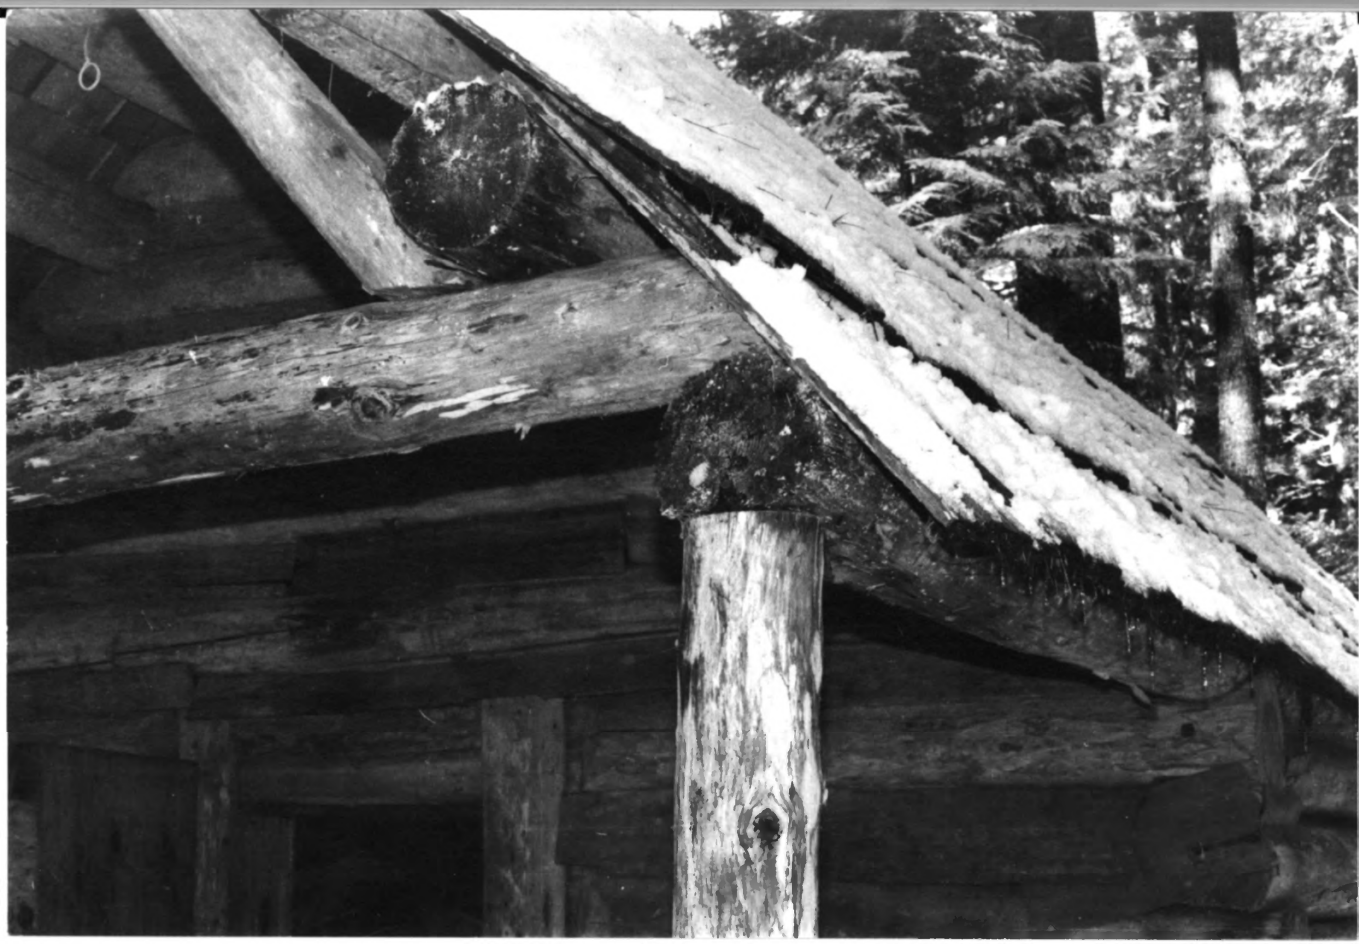
1. Independence Prairie Ranger Station, North Building.
2. Vicinity - Marion Forks, Oregon.
3. Photographer: Melissa Carlson.
4. Date: 3/2/79.
5. Negative Location: Detroit Ranger District Office, Detroit, Oregon.
6. Looking northwest at southeast corner detail of roof overhang forming open porch.
7. Photograph #3.

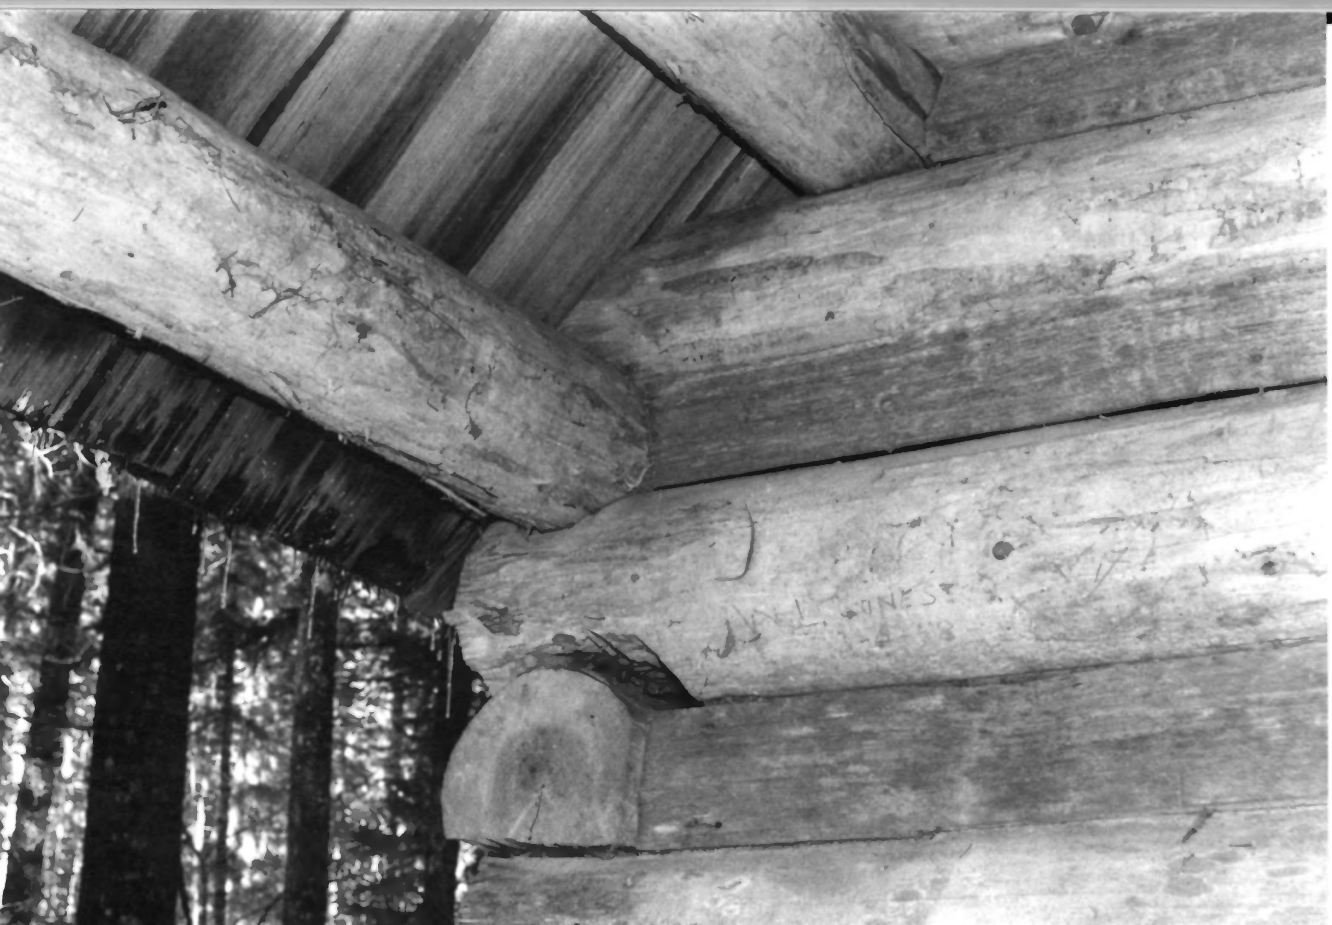
1. Independence Prairie Ranger Station, North Building.
2. Vicinity - Marion Forks, Oregon.
3. Photographer: Melissa Carlson.
4. Date: 3/2/79.
5. Negative Location: Detroit Ranger District Office, Detroit, Oregon.
6. Looking northwest at intersection of wall and roof of southwest corner of open porch.
7. Photograph #4.

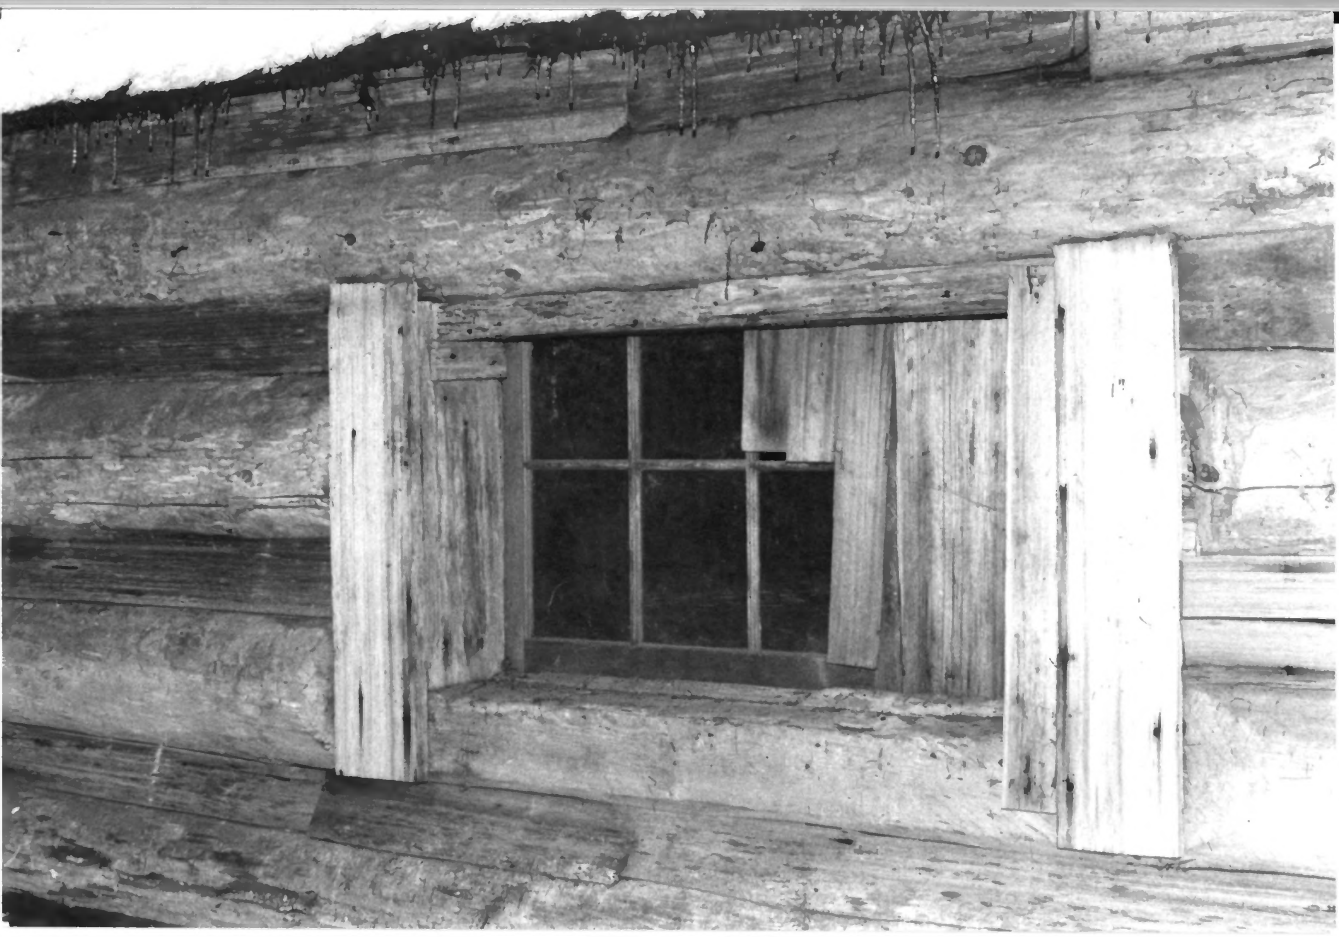
1. Independence Prairie Ranger Station, North Building.
2. Vicinity-Marion Forks, Oregon.
3. Photographer: Melissa Carlson.
4. Date: 3/2/79.
5. Negative Location: Detroit Ranger District Office, Detroit, Oregon.
6. West window detail.
7. Photograph #5.

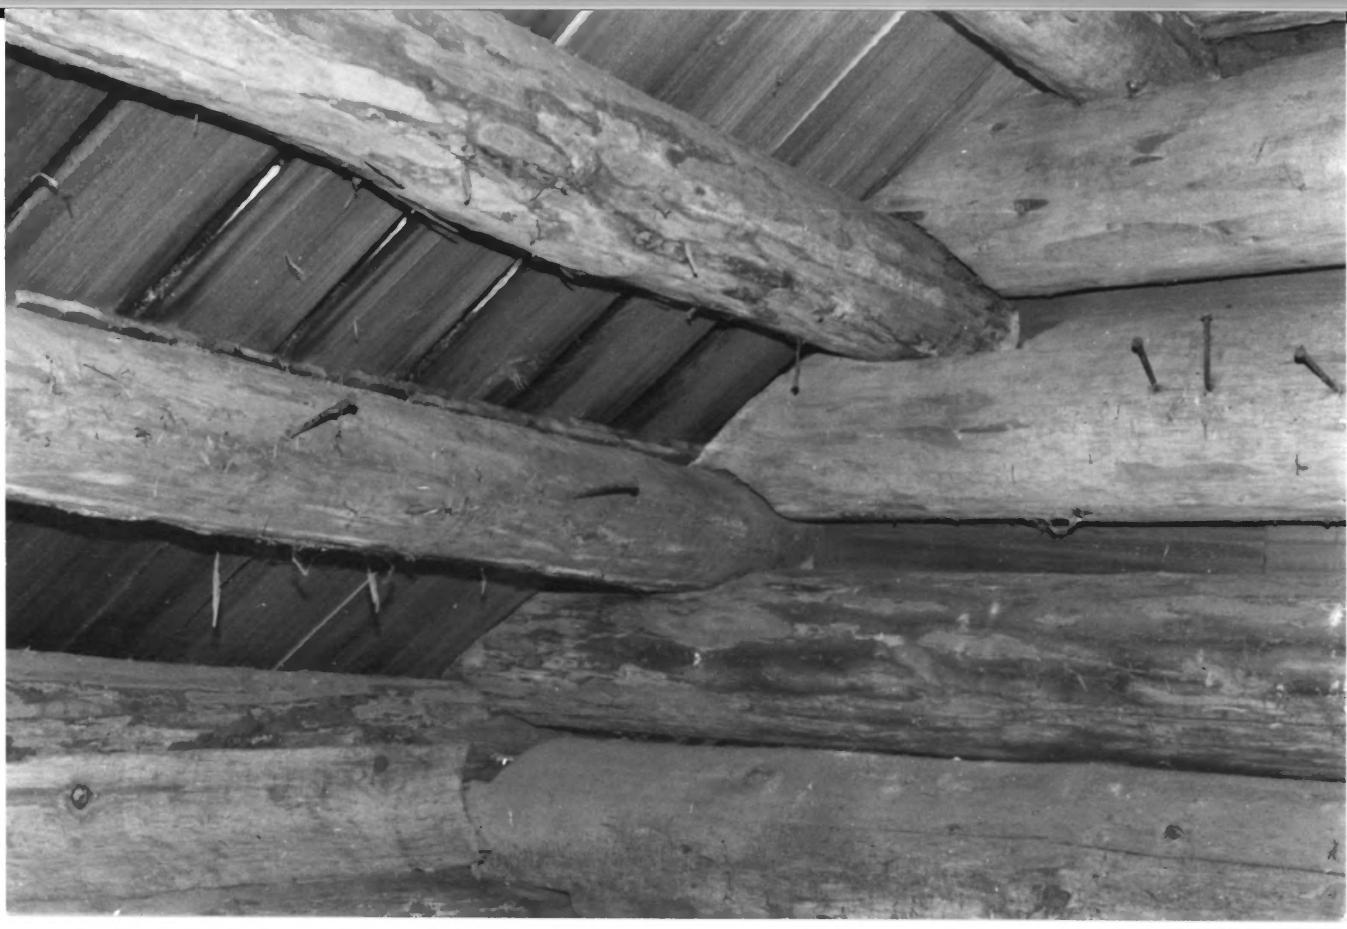
1. Independence Prairie Ranger Station, North Building.
2. Vicinity-Marion Forks, Oregon.
3. Photographer: Melissa Carlson.
4. Date: 3/2/79.
5. Negative Location: Detroit Ranger District Office, Detroit, Oregon.
6. Intersection of walls and roof interior northwest corner.
7. Photograph #6.

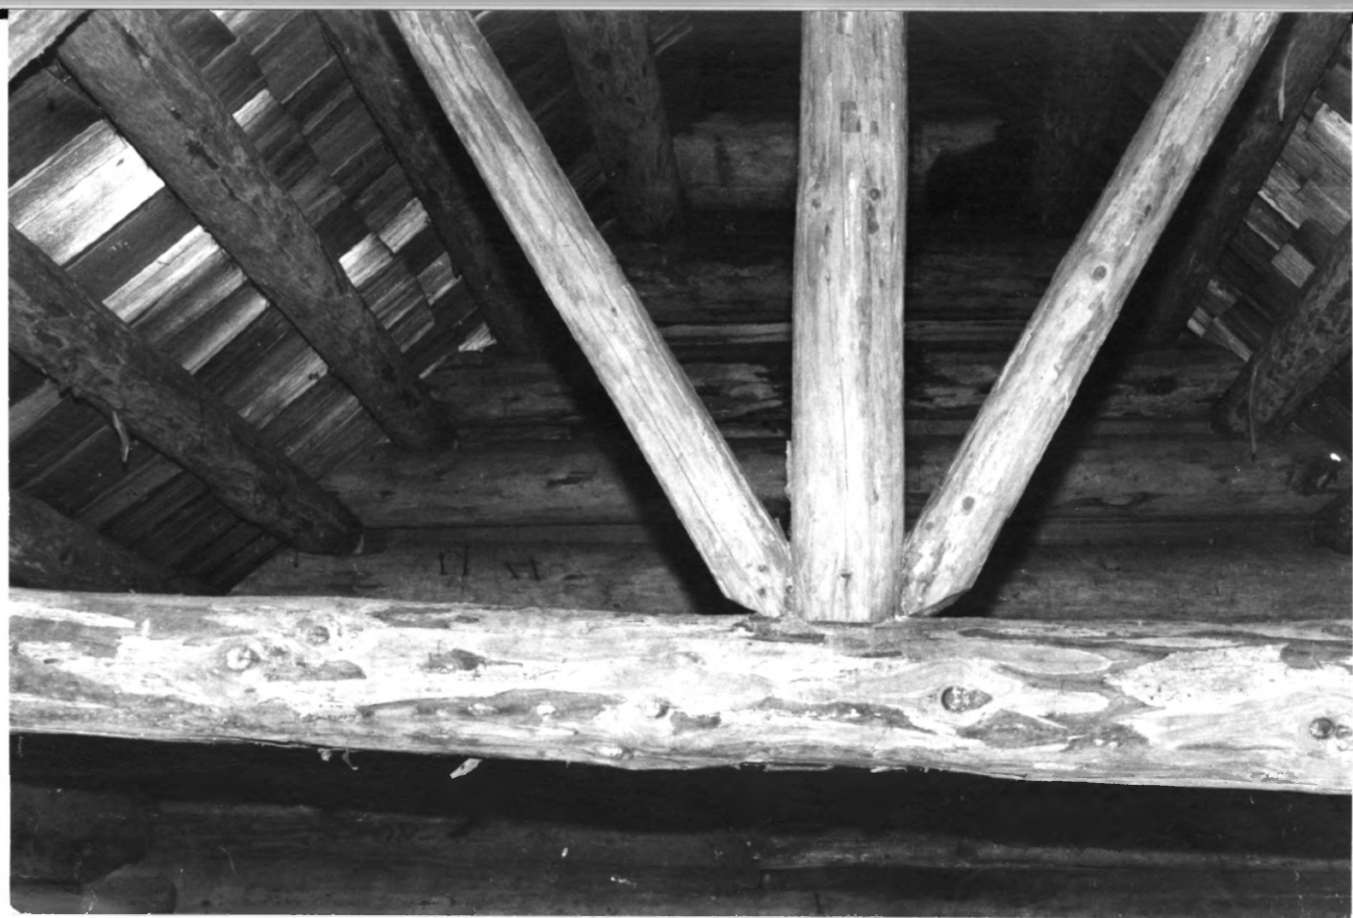
1. Independence Prairie Ranger Station, North Building.
2. Vicinity-Marion Forks, Oregon.
3. Photographer: Melissa Carlson.
4. Date: 3/2/79.
5. Negative Location: Detroit Ranger District Office, Detroit, Oregon.
6. Interior detail-crossbrace and intermediate Roof supports.
7. Photograph #7.

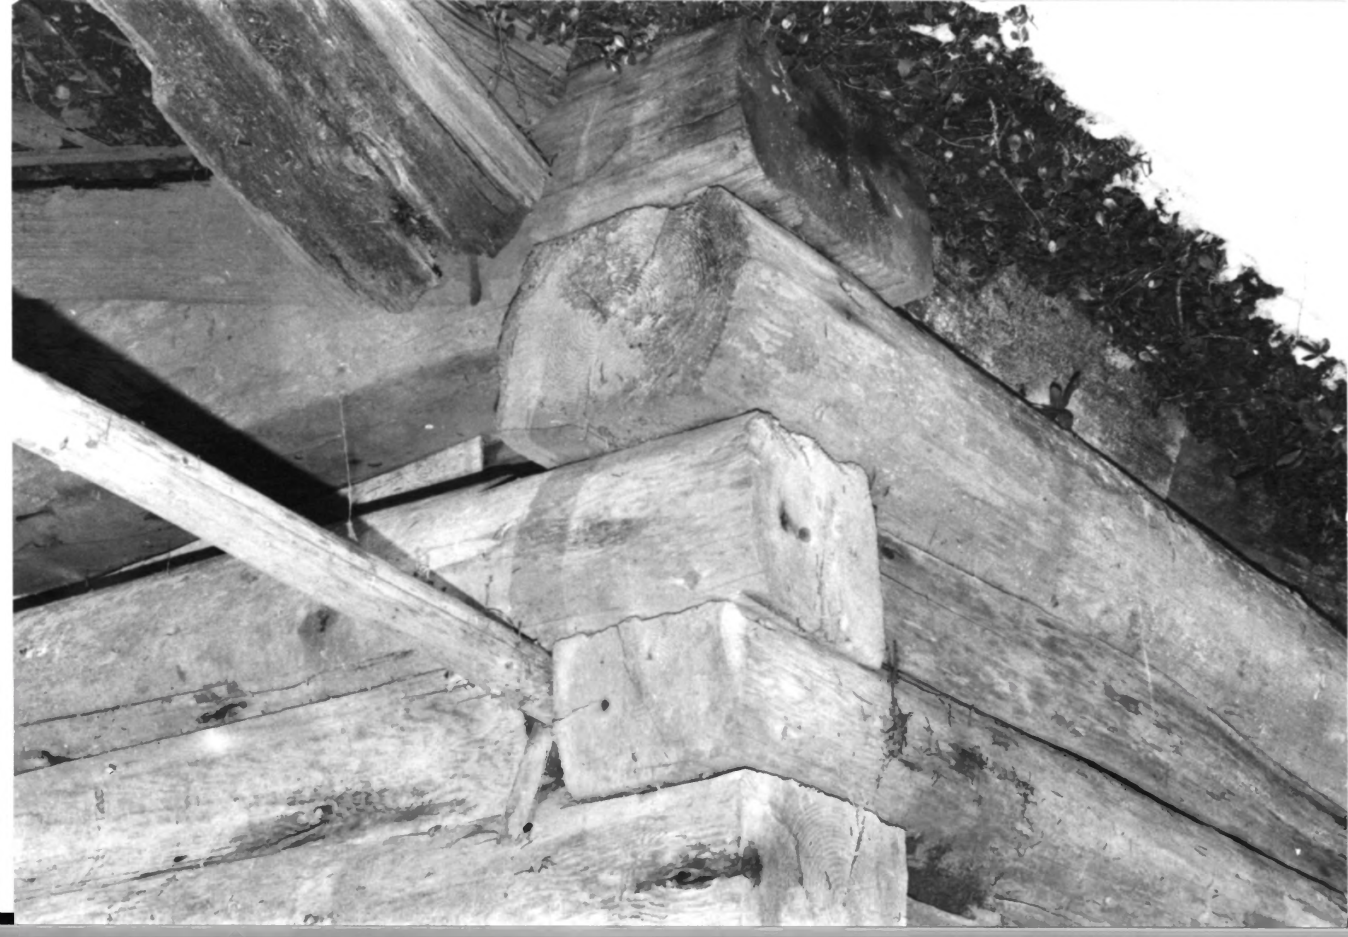
1. Independence Prairie Ranger Station, North Building.
2. Vicinity-Marion Forks, Oregon.
3. Photographer: Melissa Carlson.
4. Date: 3/2/79.
5. Negative Location: Detroit Ranger District Office, Detroit, Oregon.
6. Detail of jointure, southwest corner; horizontal pole to right is hand rail under open porch; walls rest directly on ground.
7. Photograph #8.

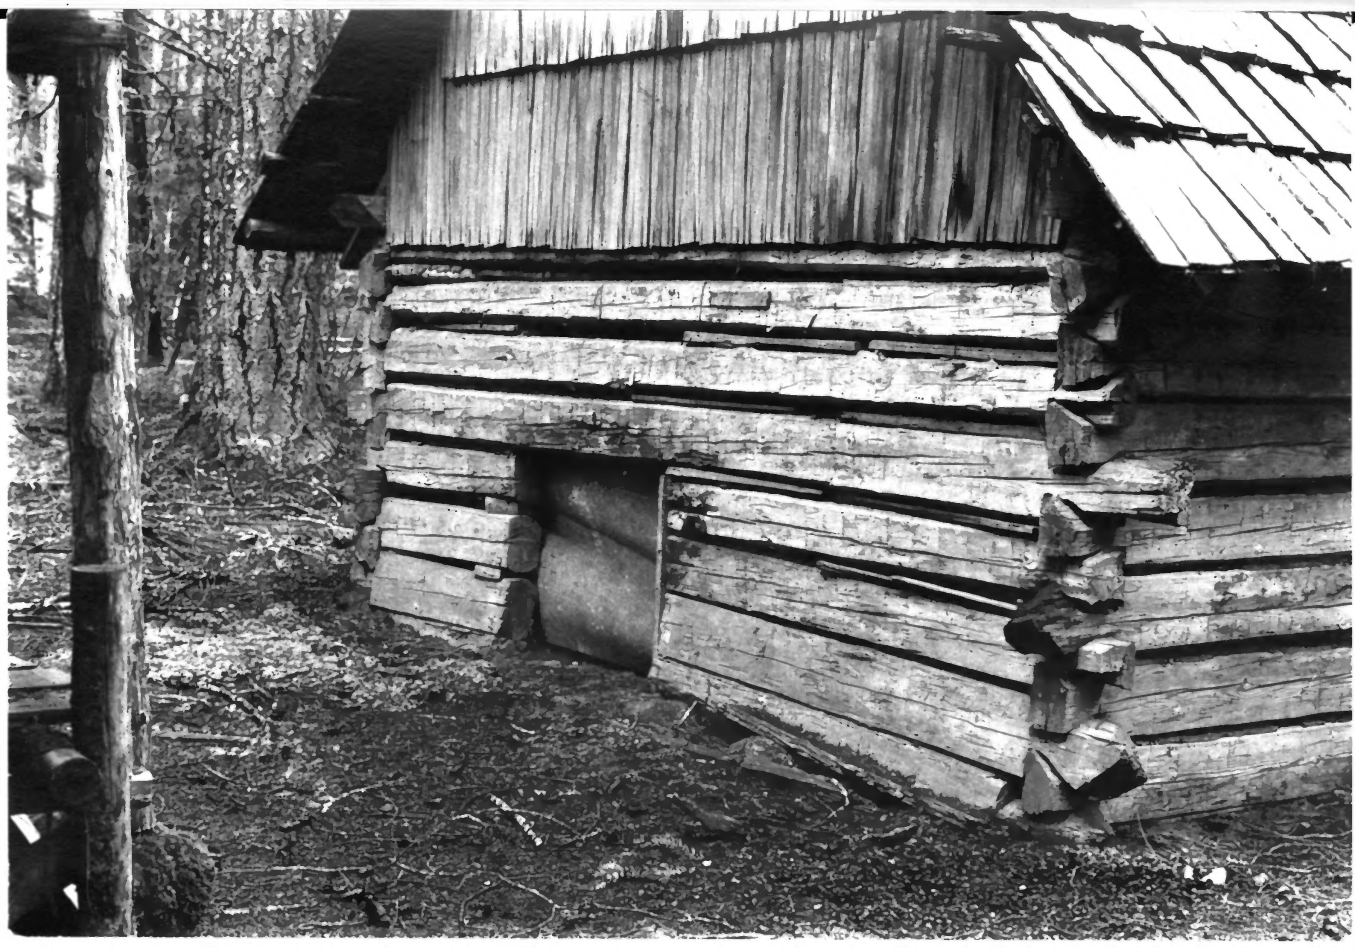
1. Independence Prairie Ranger Station, South Building.
2. Vicinity-Marion Forks, Oregon.
3. Photographer: Melissa Carlson.
4. Date: 4/3/79.
5. Negative Location: Detroit Ranger District Office, Detroit, Oregon.
6. View southeast of north gable end.
7. Photograph #9.

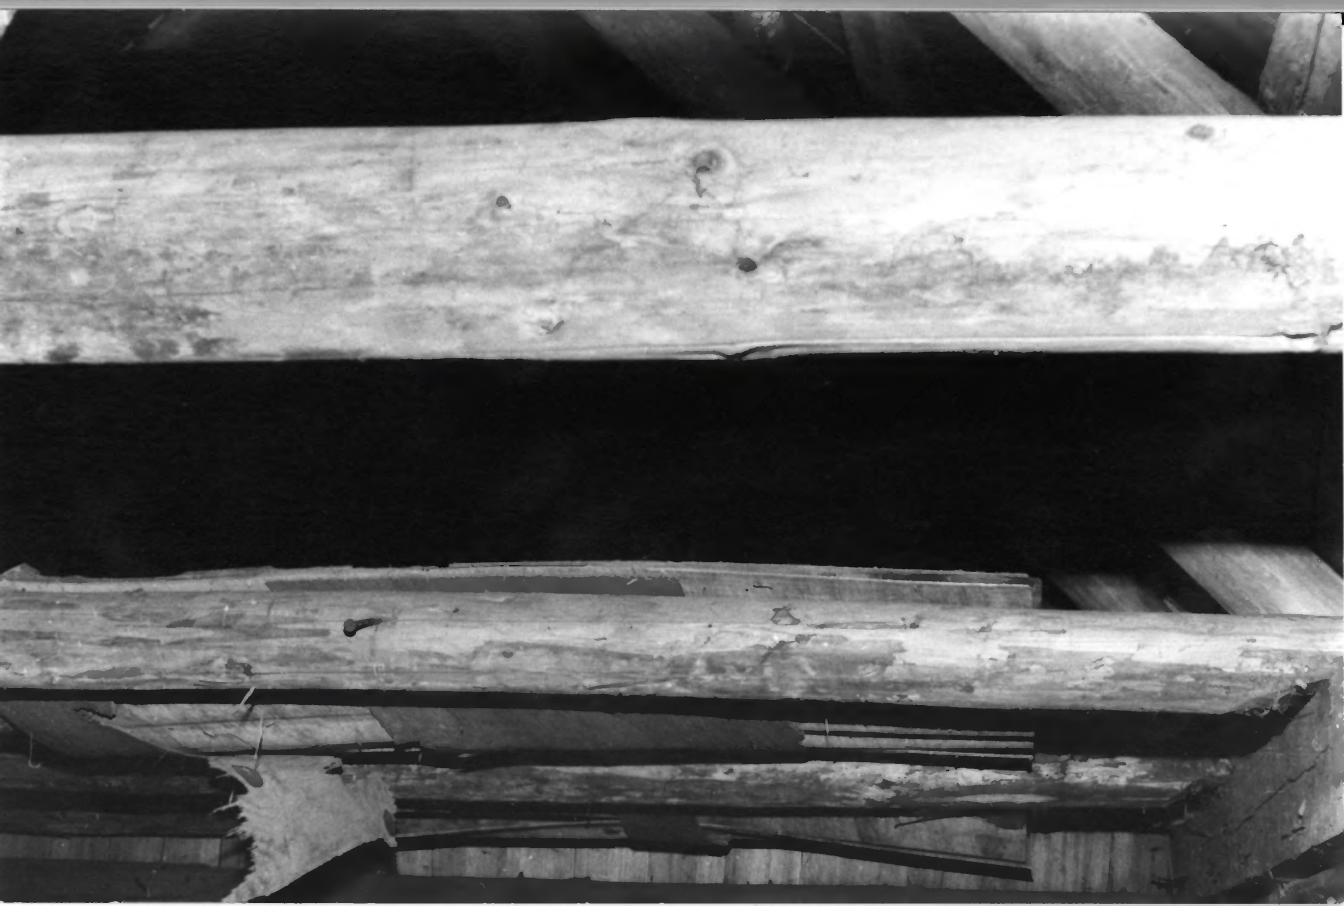
1. Independence Prairie Ranger Station, South Building.
2. Vicinity-Marion Forks, Oregon.
3. Photographer: Melissa Carlson.
4. Date: 4/3/79.
5. Negative Location: Detroit Ranger District Office, Detroit, Oregon.
6. Interior detail-cross bracing for roof structure.
7. Photograph #10.

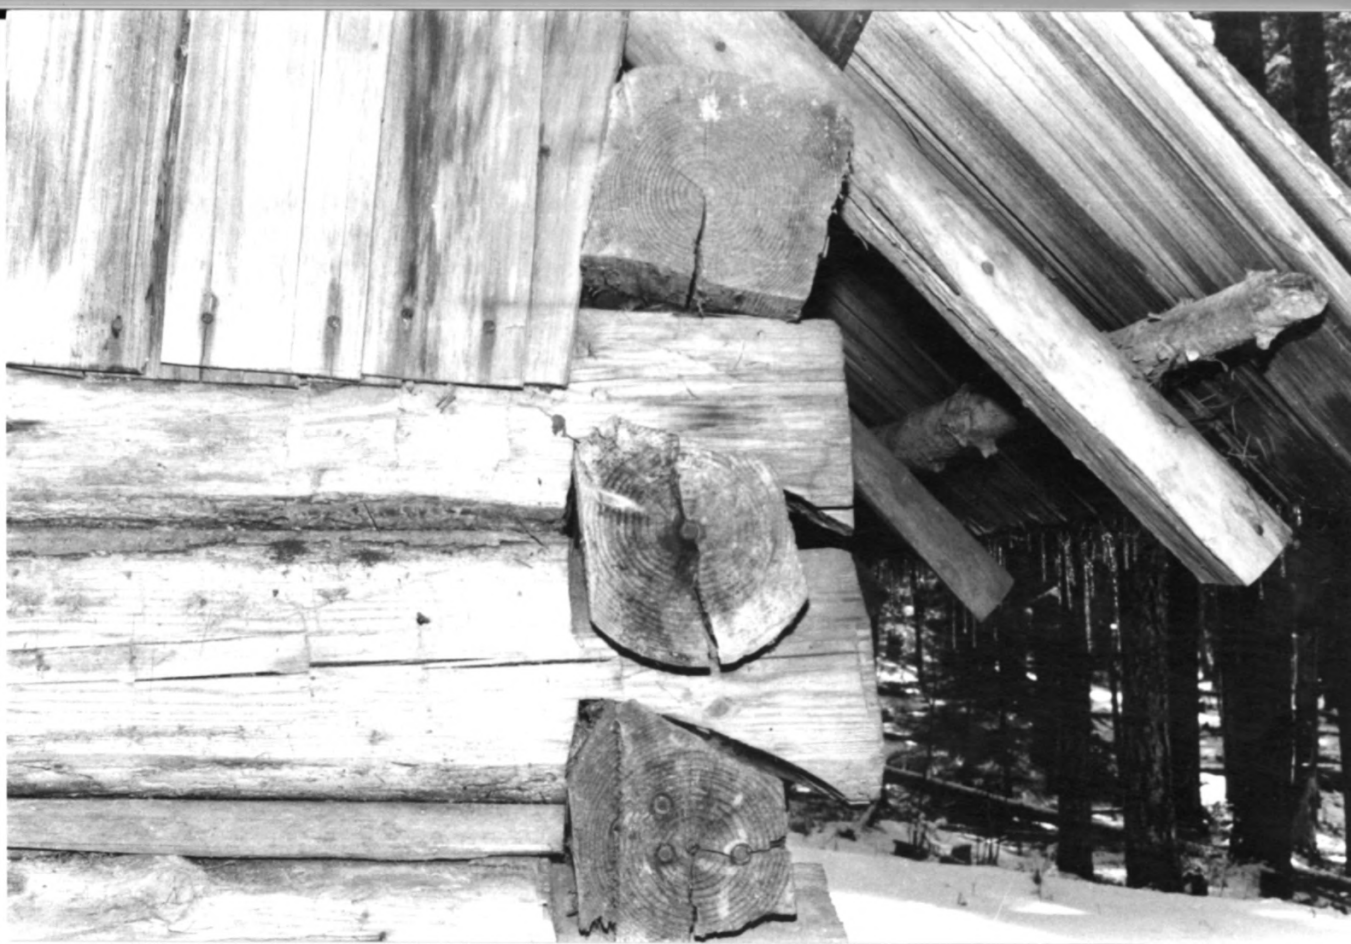
1. Independence Prairie Ranger Station, South Building.
2. Vicinity-Marion Forks, Oregon.
3. Photographer: Melissa Carlson.
4. Date: 3/2/79.
5. Negative Location: Detroit Ranger District Office, Detroit, Oregon.
6. Roof detail-northwest corner, shakes are nailed directly to roof members.
7. Photograph #12.

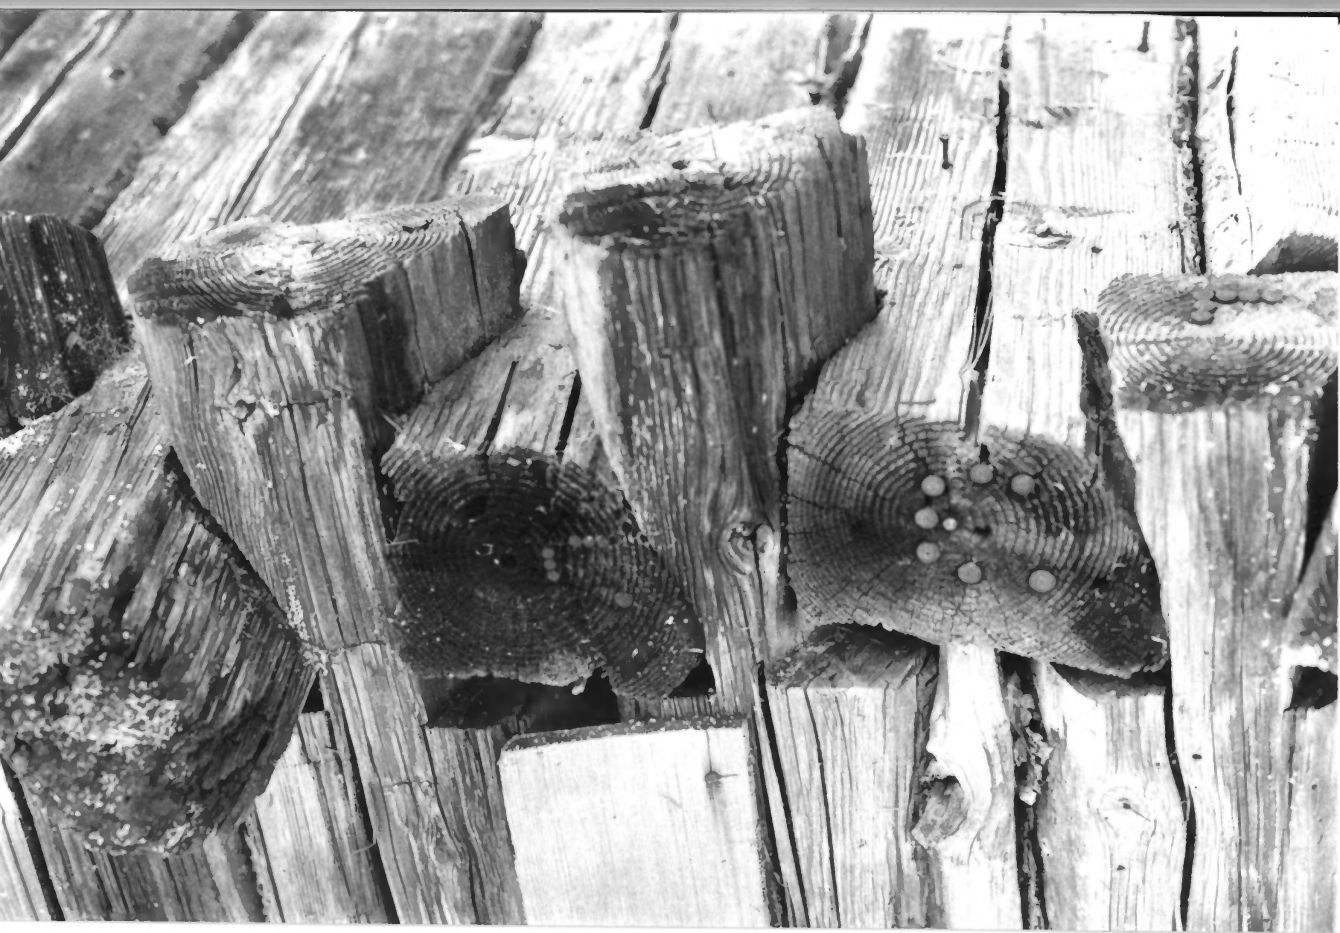
1. Independence Prairie Ranger Station, South Building.
2. Vicinity-Marion Forks, Oregon.
3. Photographer: Melissa Carlson.
4. Date: 3/2/79.
5. Negative Location: Detroit Ranger District Office, Detroit, Oregon.
6. Detail of jointure at southwest corner; rifle cartridges have been driven into the ends of some logs.
7. Photograph #13.

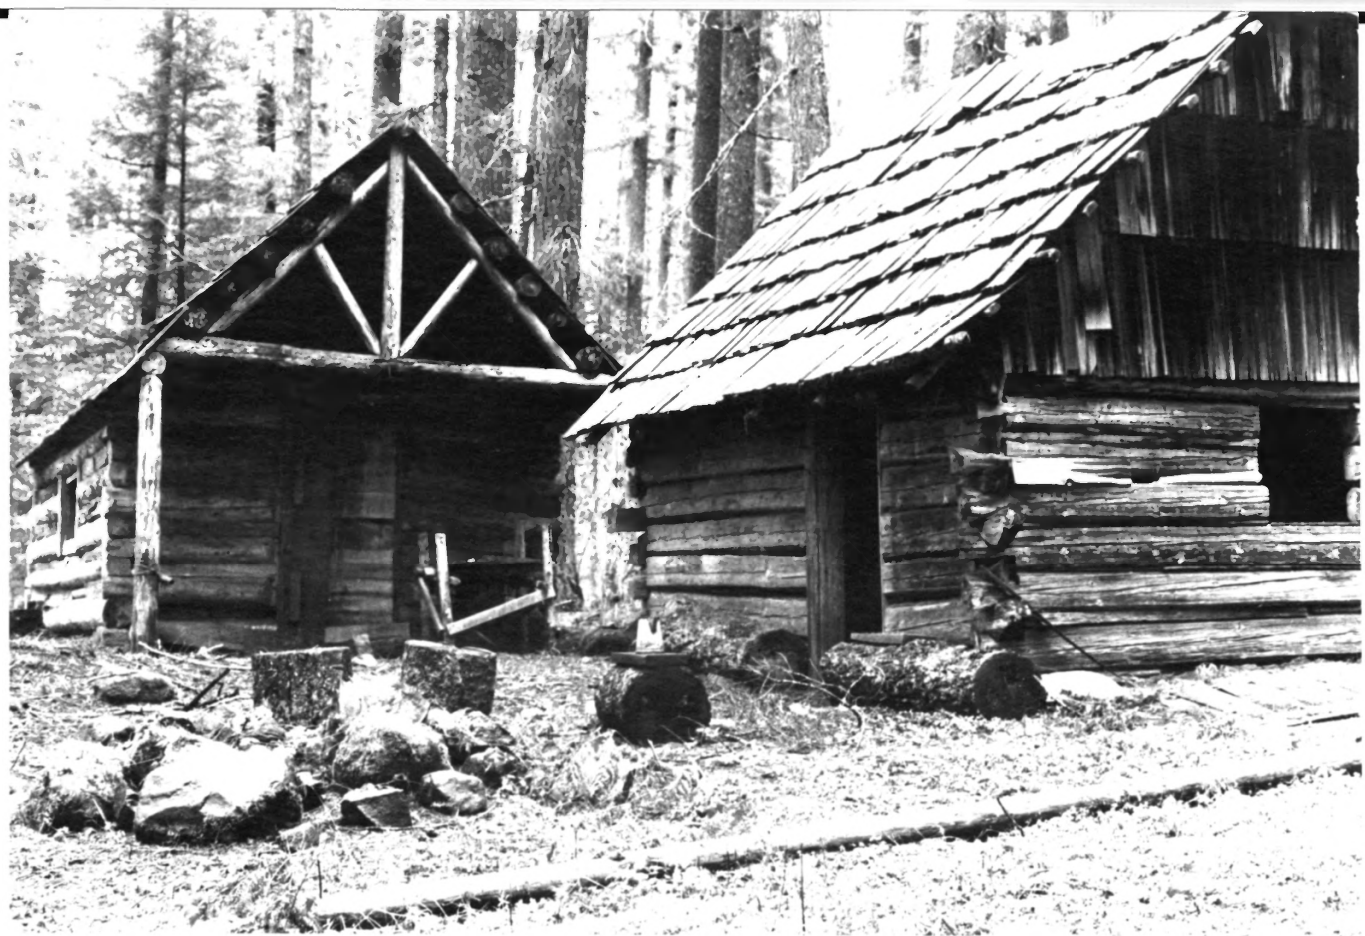
1. Independence Prairie Ranger Station.
2. Vicinity-Marion Forks, Oregon.
3. Photographer: Melissa Carlson.
4. Date: 3/2/79.
5. Negative Location: Detroit Ranger District Office,
Detroit, Oregon.
6. View northeast showing south building to right,
north building to left.
7. Photograph #14.

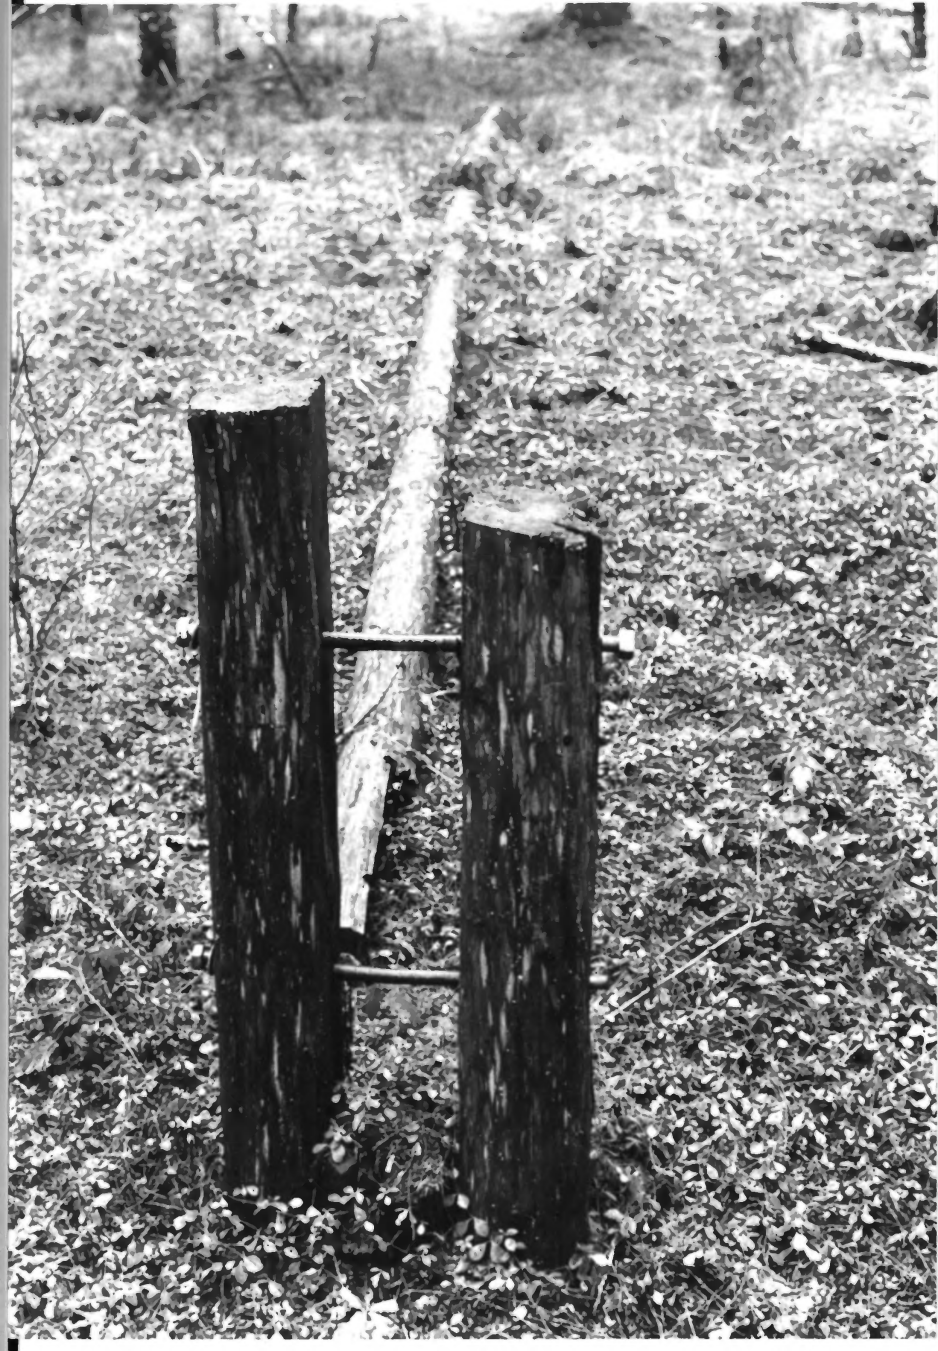
1. Independence Prairie Ranger Station.
2. Vicinity-Marion Forks, Oregon.
3. Photographer: Melissa Carlson.
4. Date: 4/3/79.
5. Negative Location: Detroit Ranger District Office, Detroit, Oregon.
6. View west, flagpole and base.
7. Photograph #15.
