National Register of Historic Places
Registration Form

historic name Rockland
other names/site number Verdier Plantation; Schley Farm; Knode House

street & number State Route 480 (Kearneysville Rd.) not for publication
city, town Shepherdstown vicinity
state West Virginia code WV county Jefferson code 017 zip code 25443

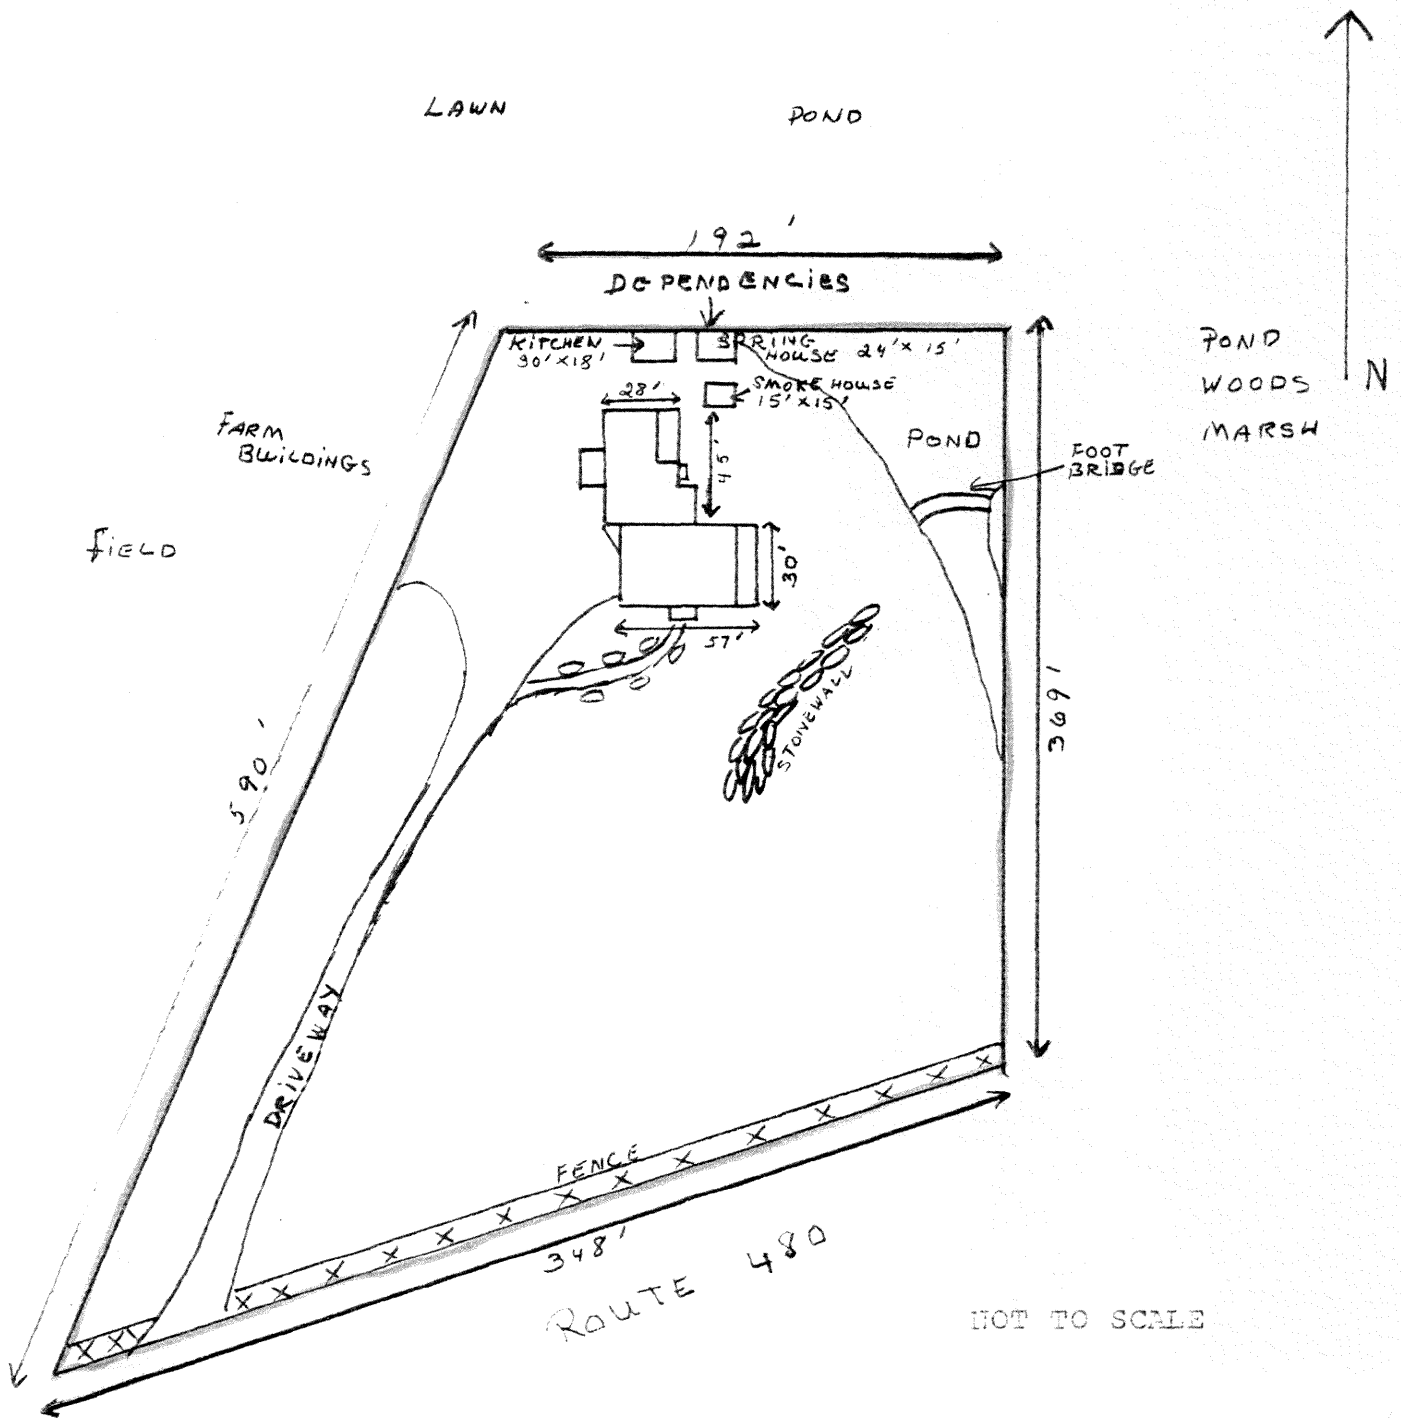
SKETCH (b)

The boundary includes a rolling green knoll leading up to the main house, the 3 dependencies and part of the pond which is fed by the spring under the spring house. A stone wall is included within the boundary; a possible site where the limestone for the house was quarried. See Sketch (b)

The nominated property boundary begins along the road running 348' across the front of the property, 590' in a straight line toward the north, 192' in a straight line toward the east, then 369' south to the beginning (see red line on sketch map).

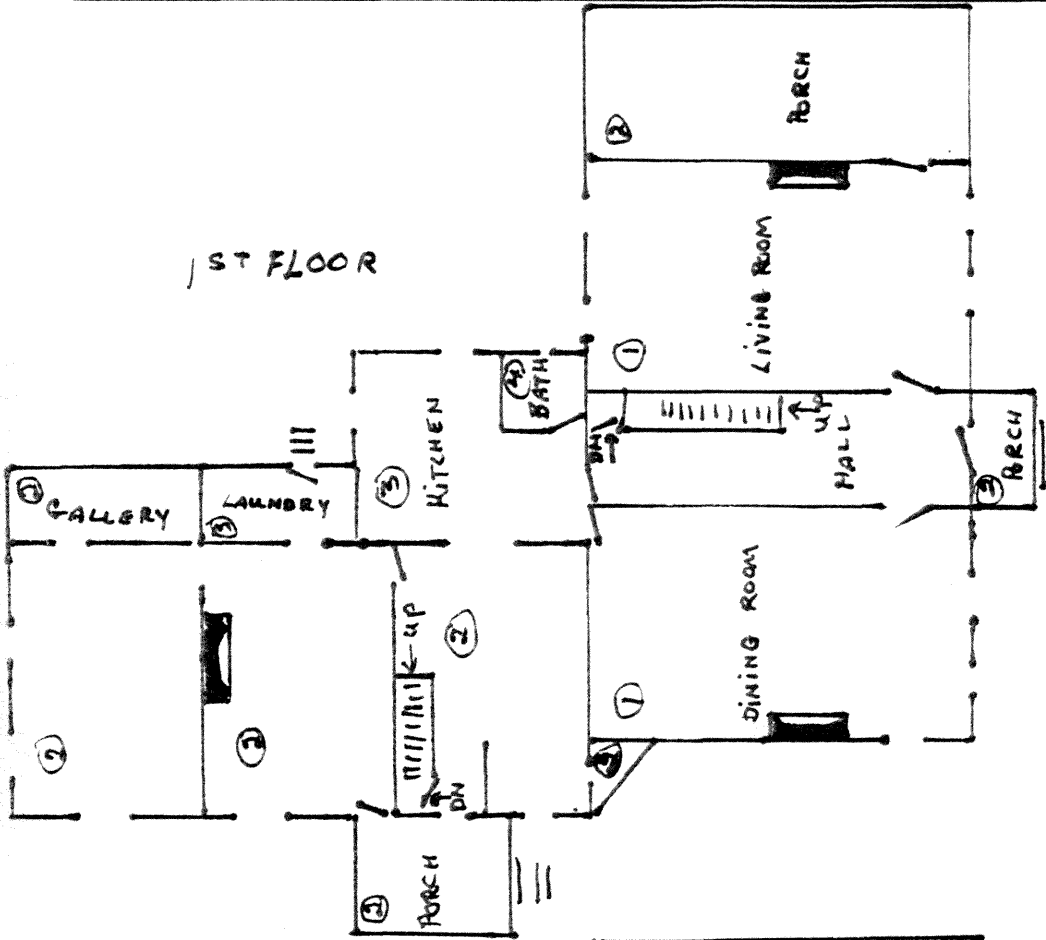
1ST FLOOR

See sketch (a) for work in progress in the Victorian ell. It has its original typical Victorian-style staircase with square walnut newel posts and balusters and pine handrails.

Each floor of the stone section has the original 2 rooms on each side of the center staircase, also original. The staircase has a walnut handrail and simple square balusters. A newel post is at the first floor and each flight ends in a goose-neck. It has decorative brackets at the outside end of the risers. A circular plaster medallion is on the ceiling of the entrance hall.

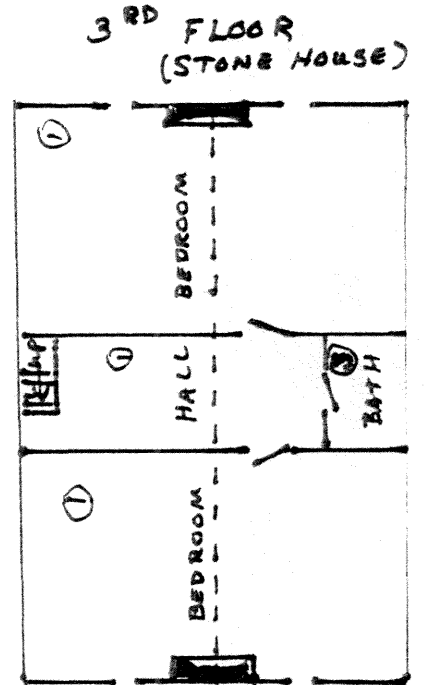
3RD FLOOR
(STONE HOUSE)

The most original of the rooms in the stone house are in the 2 attic rooms. They have their original random-width pine floors, window trim and some doors. The windows throughout the house have their original panelled window returns, some with raised panels, some not. The doors and mouldings are of mixed styles and periods. The second floor mouldings are probably original to the old part of the house. The splayed returns are similar to what was original. The floors have been replaced on the first and second floors with long-needle yellow pine. Most of the "up-dating" of mouldings, floors and doors probably took place during the building of the addition.
