KENTUCKY HISTORIC RESOURCES INVENTORY

Site No. Bh 427

1. Historic Name(s) <u>McLeod Spring house</u> Original Owner <u>?</u>		22. ADD/County <u>Bluegrass / Bourbon</u>	
2. Present Name <u>(Green Acres) McLeod place</u>		23. U.S.G.S. Quadrant (15'/75') <u>Paris West</u>

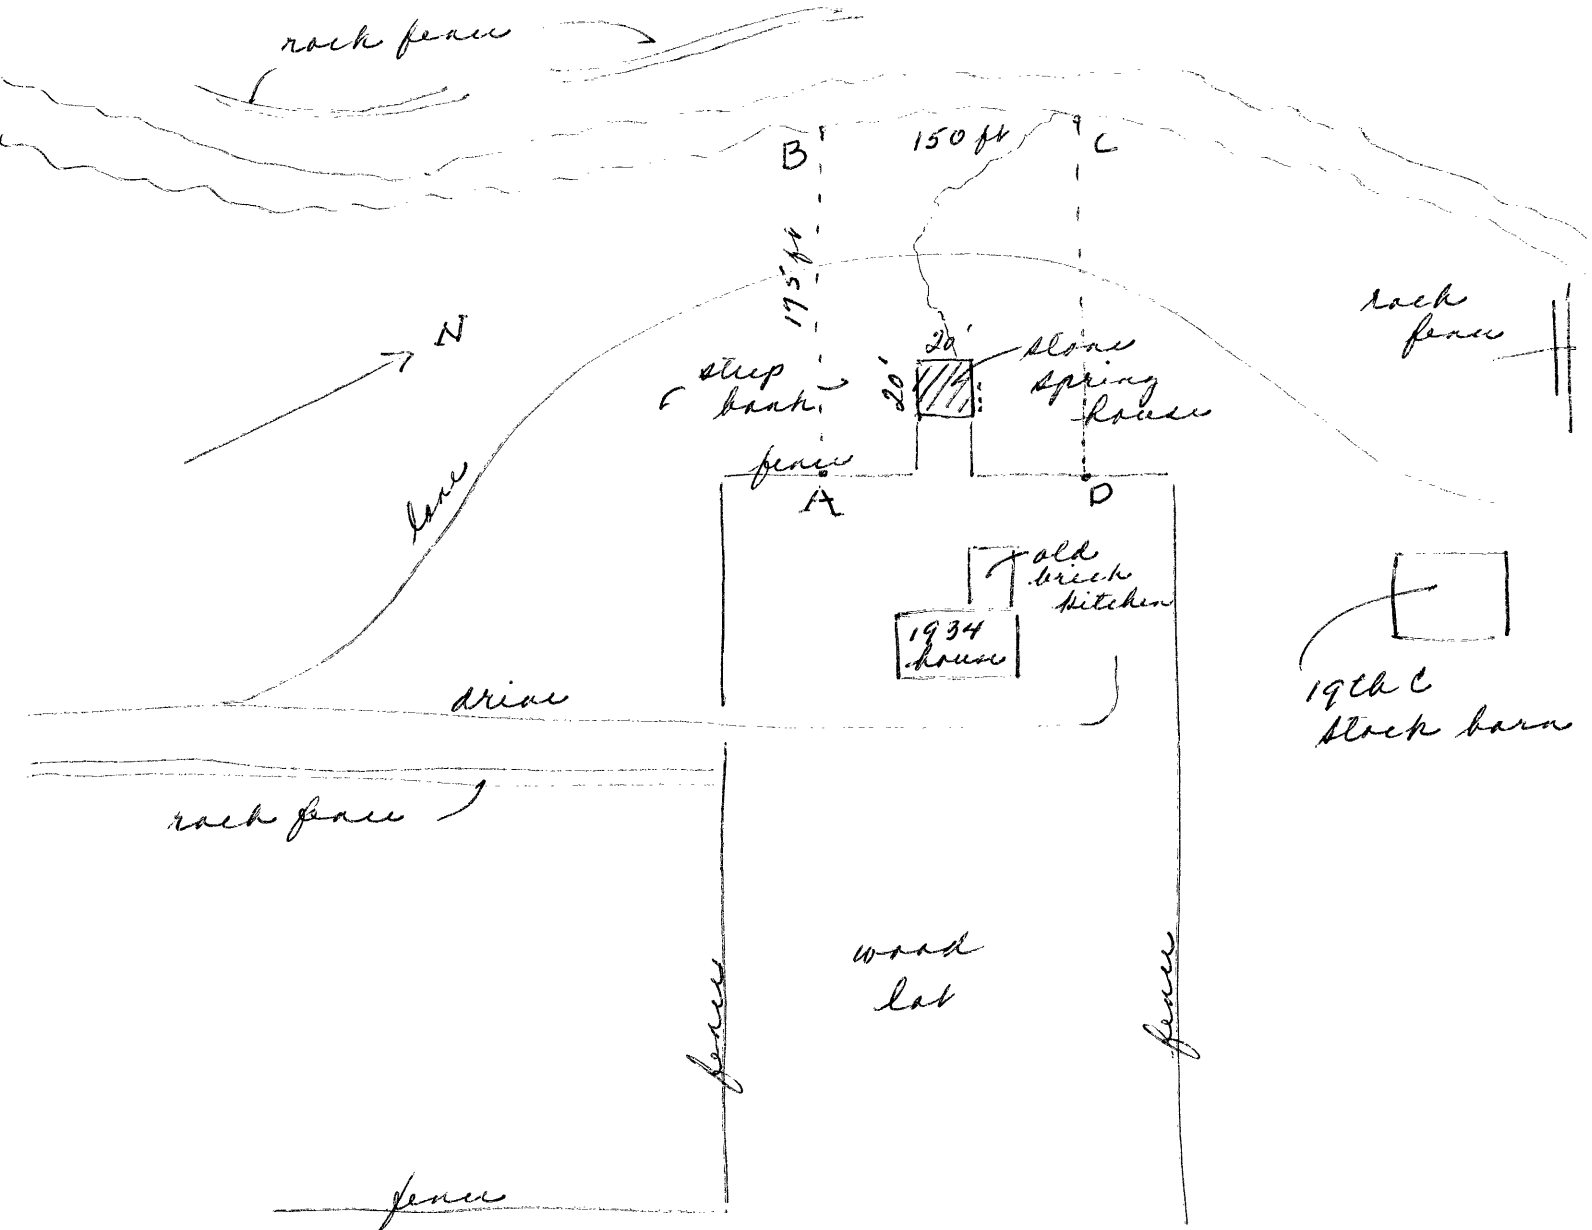
SKETCH MAP OF SITE SHOWING BOUNDARIES AND KEY BUILDINGS AND FEATURES WITH NORTH ARROW.

Beginning at A, 75 ft NE of the W corner of the yard, thence NW perpendicular to fence 175 ft to B at creek bank, thence with creek NE 150 ft to C, thence SE parallel to A-B 175 to the fence at D, thence with fence and across door yard to of Stone house SW 150 ft to the beginning - about 2/3 acre.

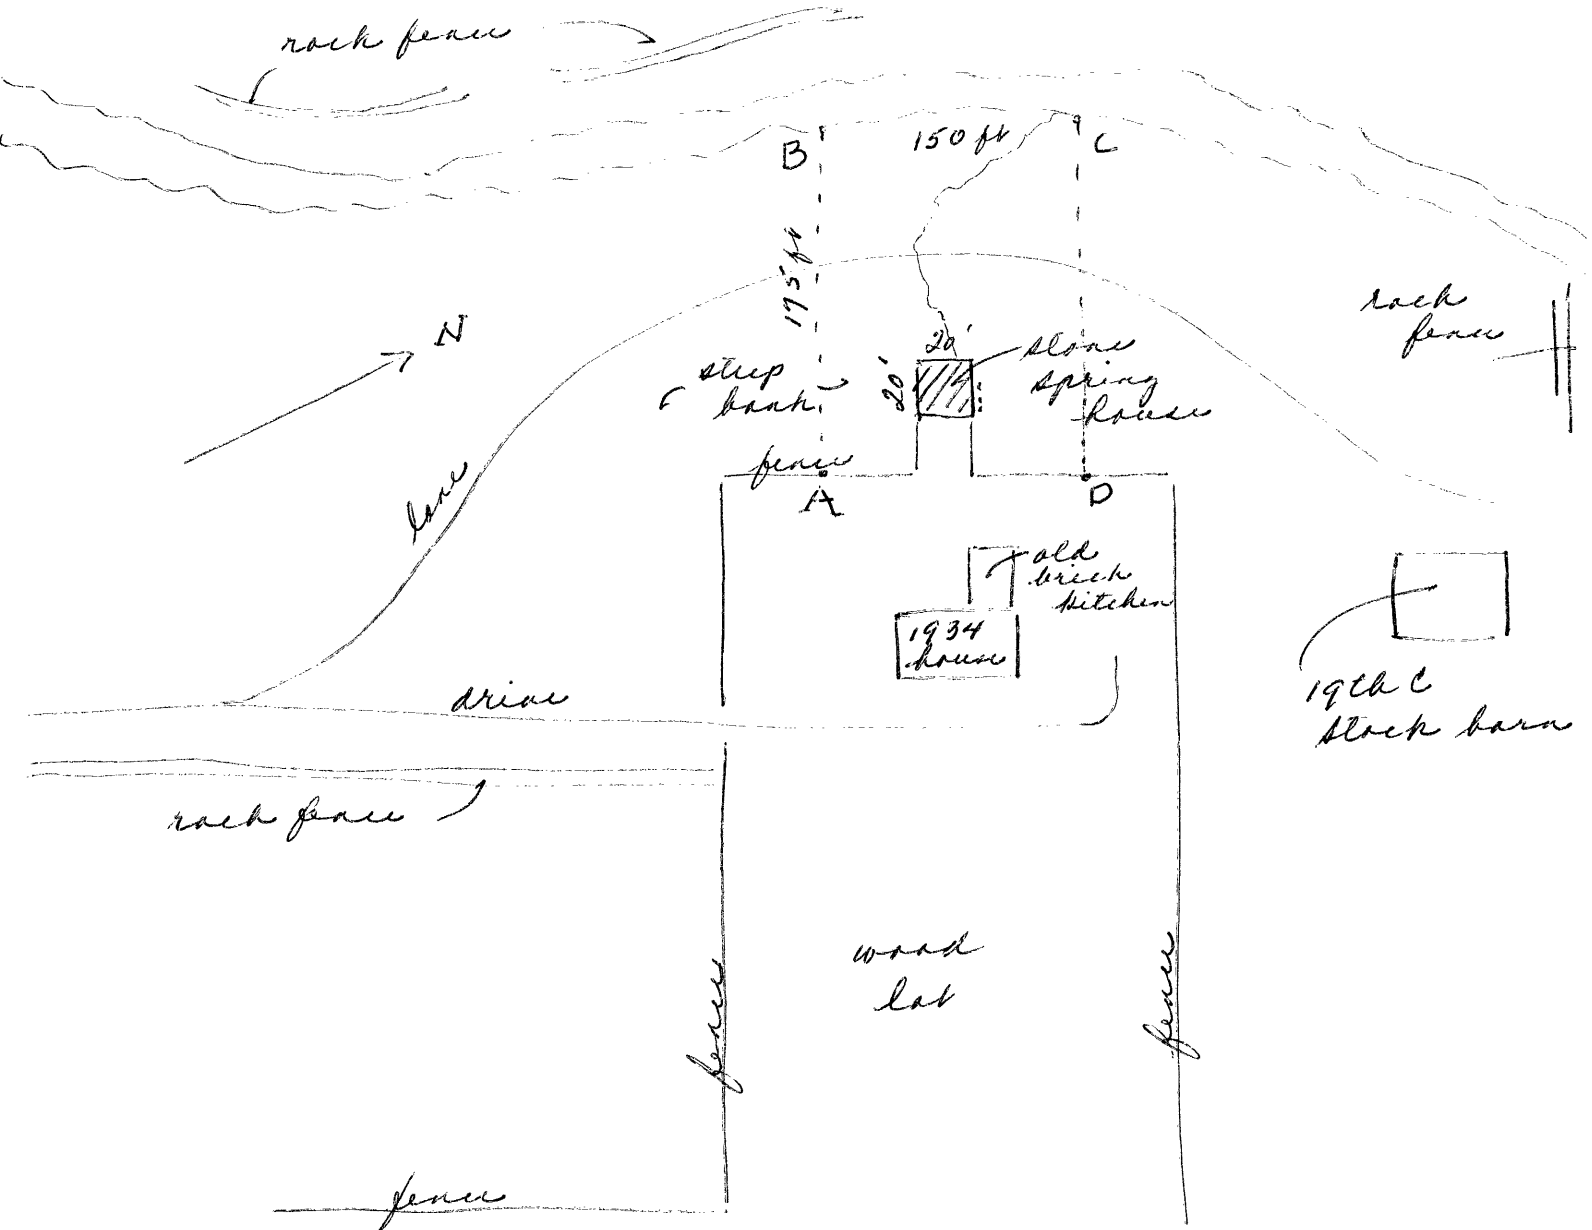
SKETCH MAP OF SITE SHOWING BOUNDARIES AND KEY BUILDINGS AND FEATURES WITH NORTH ARROW.

Beginning at A, 75 ft NE of the W corner of the yard, thence NW perpendicular to fence 175 ft to B at creek bank, thence with creek NE 150 ft to C, thence SE parallel to A-B 175 to the fence at D, thence with fence and across door yard to of Stone house SW 150 ft to the beginning - about 2/3 acre.
