National Register of Historic Places  
Inventory—Nomination Form

historic David Burnham House (preferred)  
and/or common Lakeside Farm or Burnham House

David Burnham House, Essex, MA

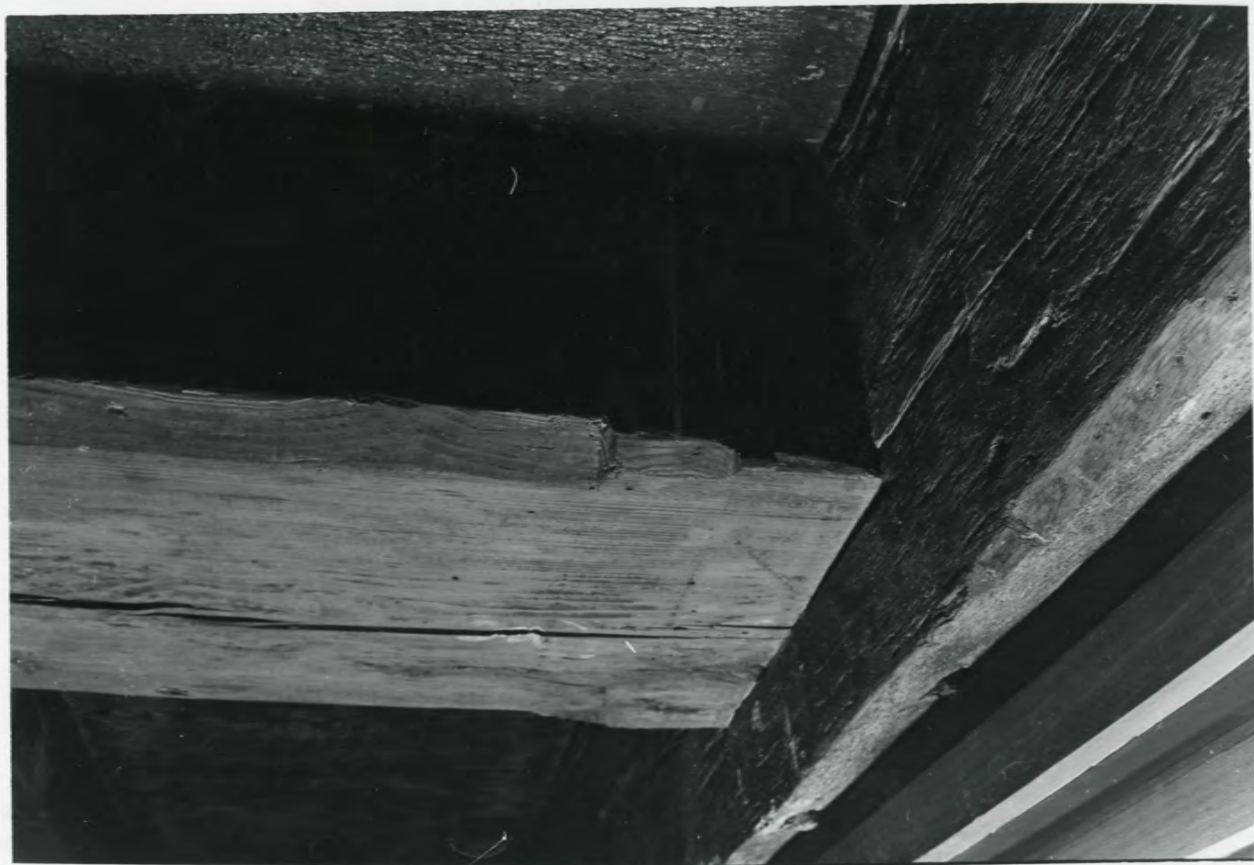
Photo #2 of 7

Lamb's Tongue Champfer

are not shouldered. The lamb's tongue stops, mentioned above, in the chamfers, are original. An extremely large fireplace (very much like the one in the 1671 Swet-Ilsley House in Newbury, Massachusetts), of which there is a well documented account of its restoration in 1924, is located on the west side of the room, near the rear (north) wall. The huge lintel above the fireplace shows in an opening almost nine feet across in front and 12-14" deep in section. The lintel has been cut at a diagonal, and slants back into the masonry opening, which was covered by plaster pargeing. There is a curious square pocket in the masonry just above one of the pieces of wood worked into the brick - there is no corresponding pocket on the other side of the fireplace. The wall on the south side is laid up straight, but the wall on north side where the lean-to is, is laid-up corbeled outward, and a beehive oven is located on the right side, near the corbeled bricks. There are inconsistencies in the brick that reveal modifications made during the 18th and 19th century. The bricks on the hearth are small, and are the type called "pea bricks," usually associated with Salem, Massachusetts. The post to the north of the fireplace carries two beams. The timber used for this post is of large dimensions, about 14" square.

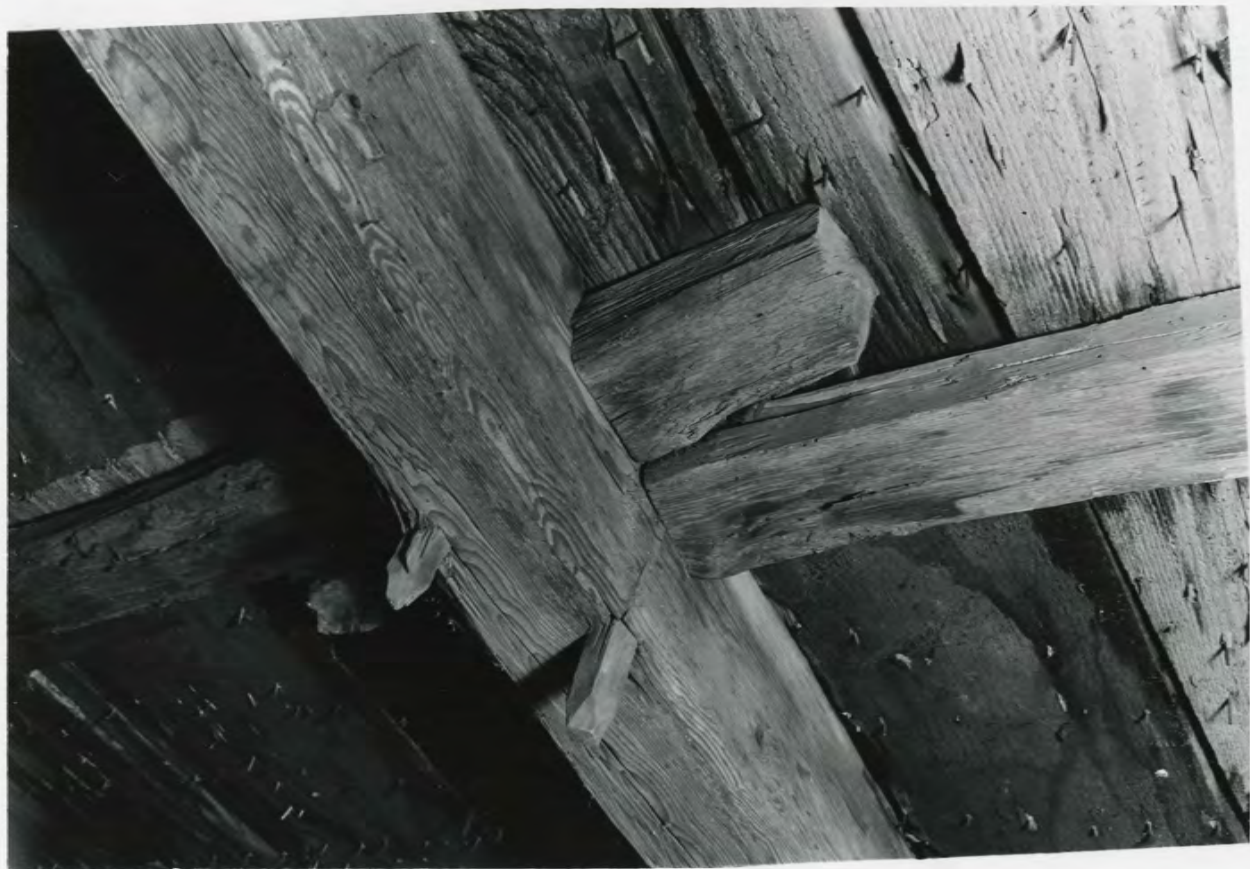
Photo #3 of 7

Purlins Joining Rafter in Attic

The roof framing represents a very early type with the rafters joined together and pegged at the ridge with a ridgepole. There are six principle rafters, two at each end of the attic, with four running across the middle. There are three purlins on these rafters, the middle set of which overlaps and is pegged in to the rafters. Beneath the middle set of purlins on each rafter is a very stout wood-pegged knee brace, apparently original to the roof structure system. A number of roof sheathing or decking boards are greater than 12'', and some are up to 18'' wide. All of the roof framing appears to be oak. Carpenters' scribe marks can be seen on the west sides of the second and third center rafters. The studs in the end walls are toenailed with wrought nails.

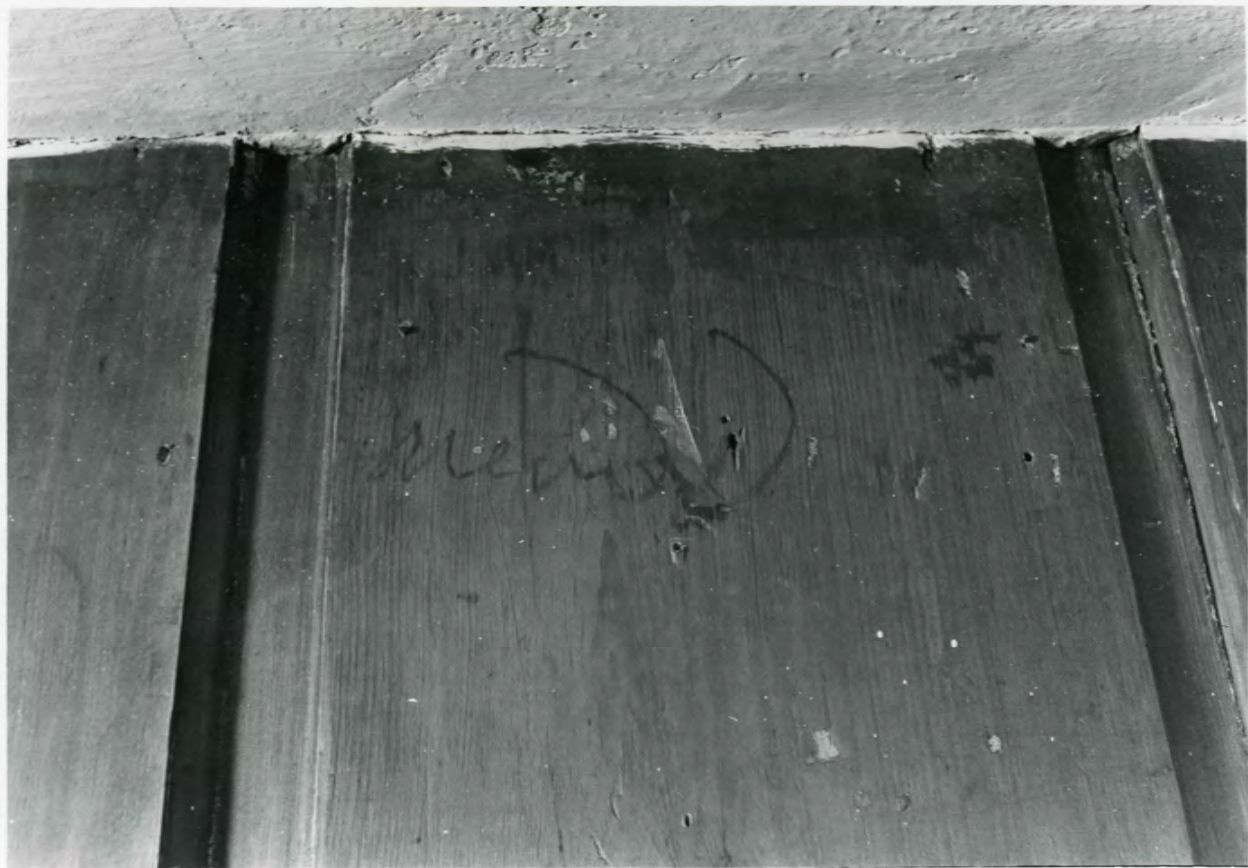
Photo 1/4 of 7

Paneling - East Chamber

The 16' wide east chamber has a smaller fireplace, measuring 16" deep. There is new wall surface treatment in this chamber, so it is difficult to tell what may have been there originally. The flooring, however, seems original, of a character typical of the late 17th century. It has the same type of nails that can be seen in the 1636 Fairbanks House in Dedham, Massachusetts, which are rather rare. The summer beams in both the east and west chambers are chamfered and show crudely hacked attempts at lamb's tongue stops. (The summer beams in the two downstairs rooms show more carefully carved lamb's tongue stops to the chamfers.) On the back of the north side of this room (now a passageway above the lean-to) wrought nail holes are visible in the sheathing. These indicate that on top of this sheathing there was rather thick and broad clapboarding, four and one-half" or more in width, given the spacing of the nail holes.

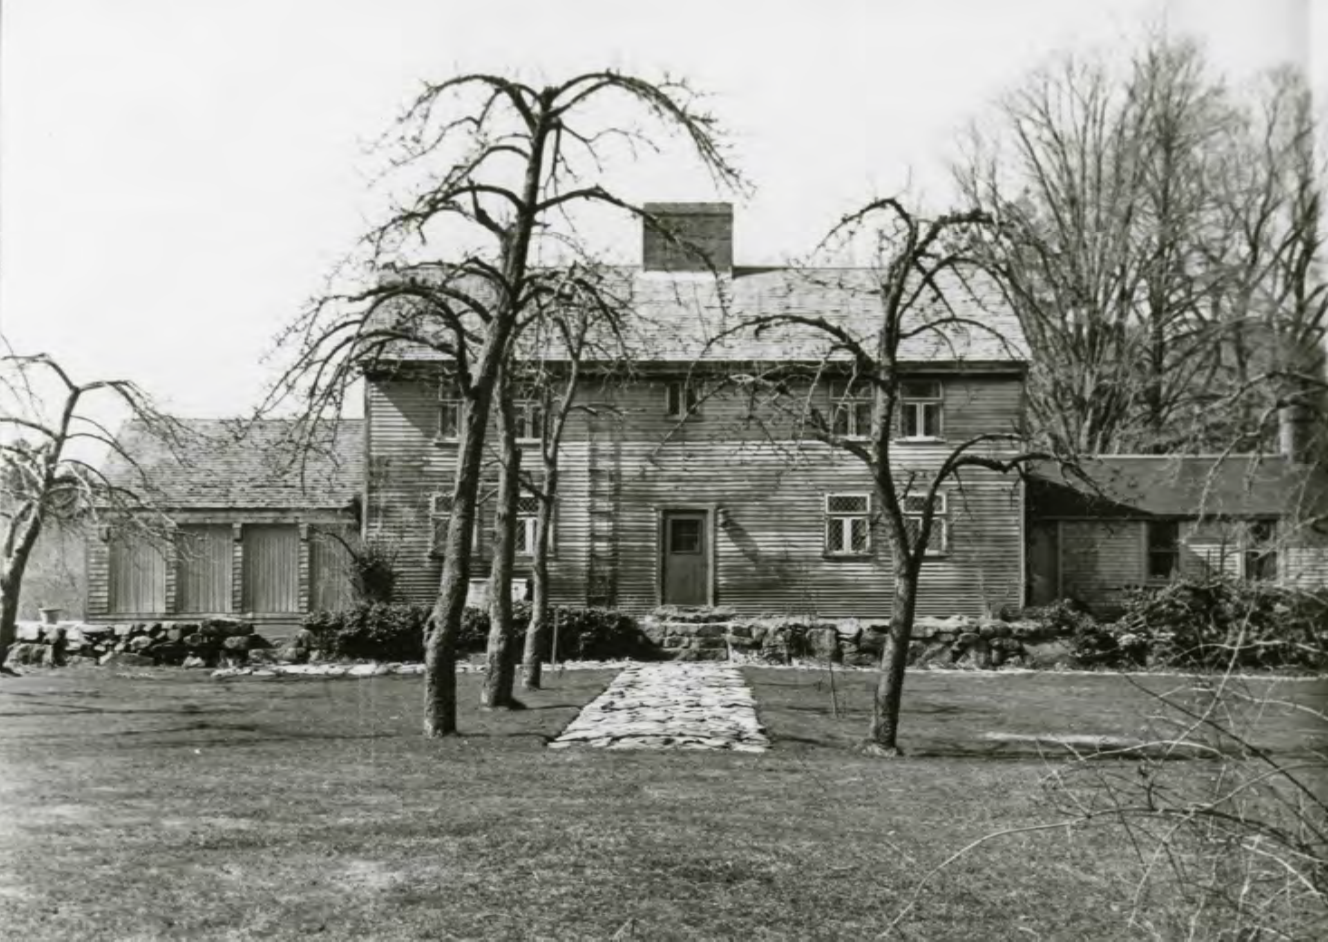
Photo # 5 of 7

South elevation. Left to right:  
solarium, main house, library.

3. The solarium is a small (21' x 21') square 1-story structure containing four bays of plate glass on each exposed elevation (south and west). Erected or moved here in 1926, it was recently modified(1981).

4. The library is a small 1-story rectangular connector with 6/6 doublehung sash and entry. A shed of unknown construction date, it was attached to the main house in 1927 and modified in 1977.

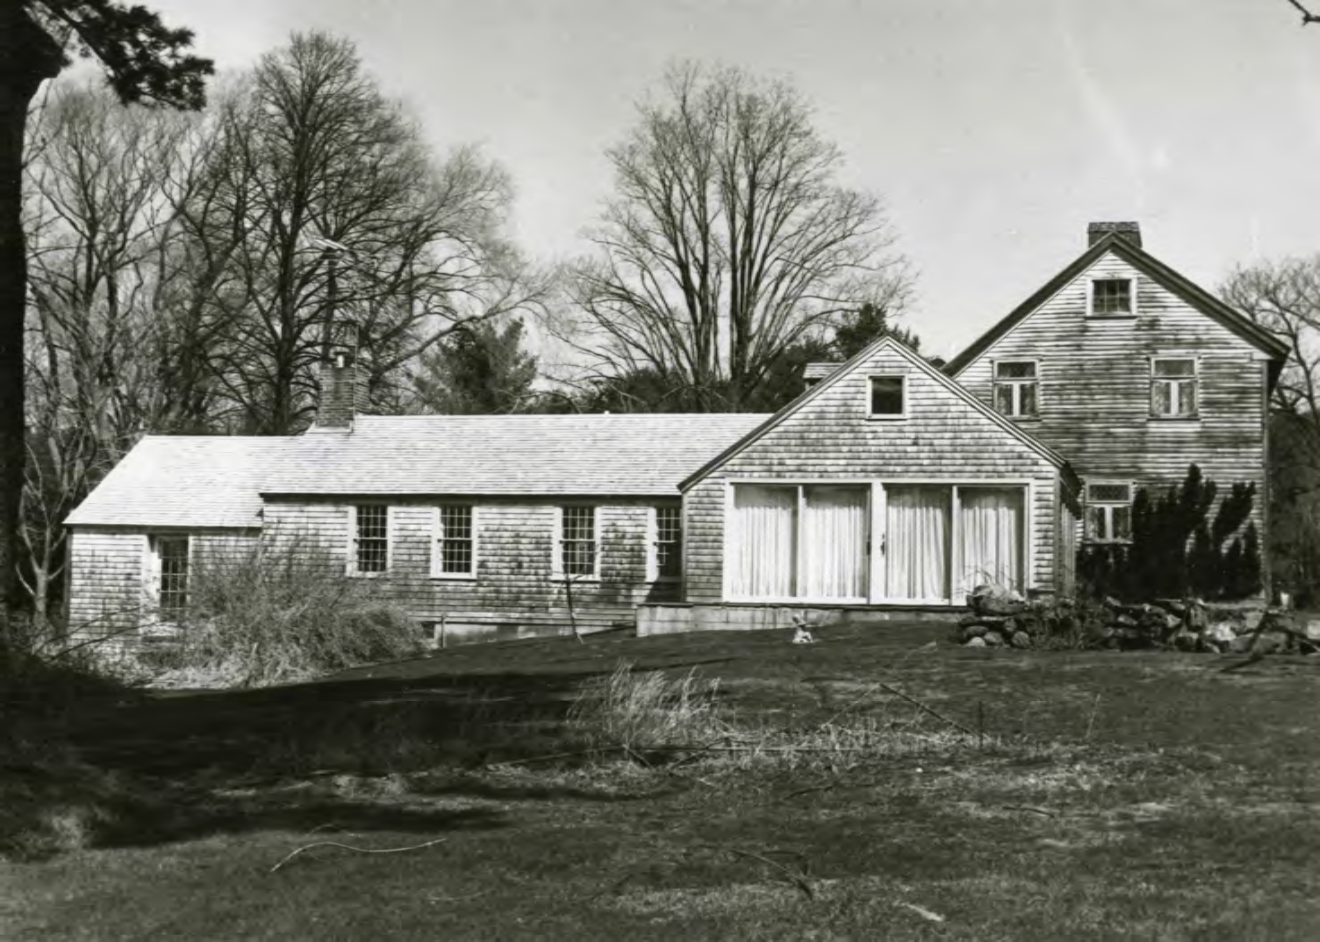
Photo 6 of 7

West elevation. Left to right: bedroom  
wing, solarium, main house.

1. David Burnham House c.1684. Described above.
2. The bedroom ell (1929) is an L-plan 1-story structure constructed on two levels to conform to the site's sloping topography. Windows are 12/12 doublehung sash.

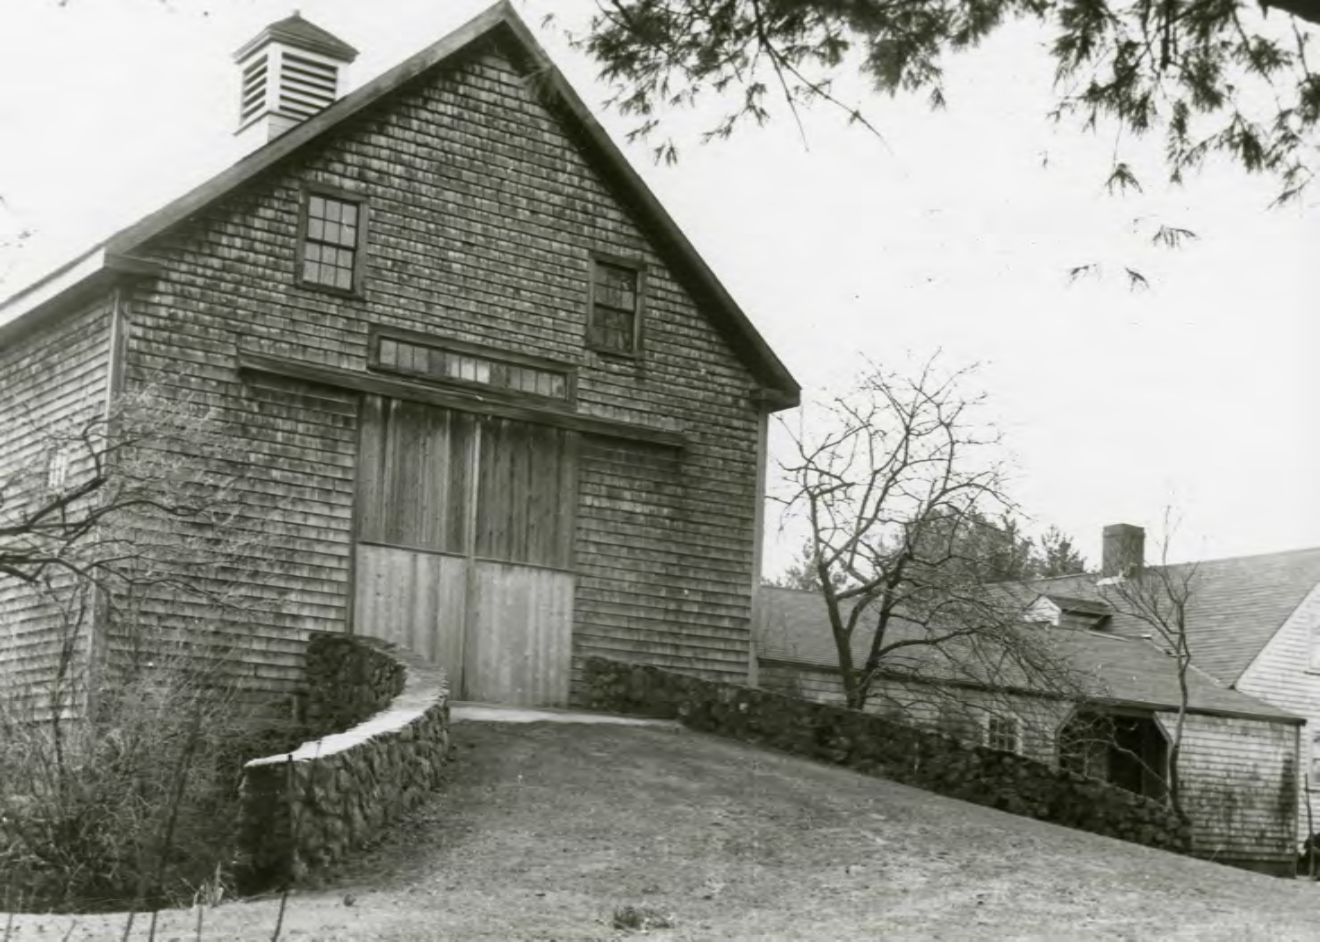
Photo 7 of 7

North elevation. Left to right: barn,  
garages, guest-servant quarters.

5. The servants-guests wing(1930) displays its gable end on the south elevation with three symmetrically placed 6/6 doublehung sash windows.
6. Connecting the guest wing and barn, the garage (1930) contains four arched opening bays.

7. The barn (1926) displays nearly identical gable ends with overlited doorways and 6/6 double hung sash windows.
