National Register of Historic Places Registration Form

Historic name: Mill & Dunn Historic District

Street & number: 100-139 Williams Street; 119 Lock Street; 200-328 Dunn Street; 100-200 Mill Street, and 209-327 Wyoming Avenue

City or town: Cincinnati State: Ohio County: Hamilton

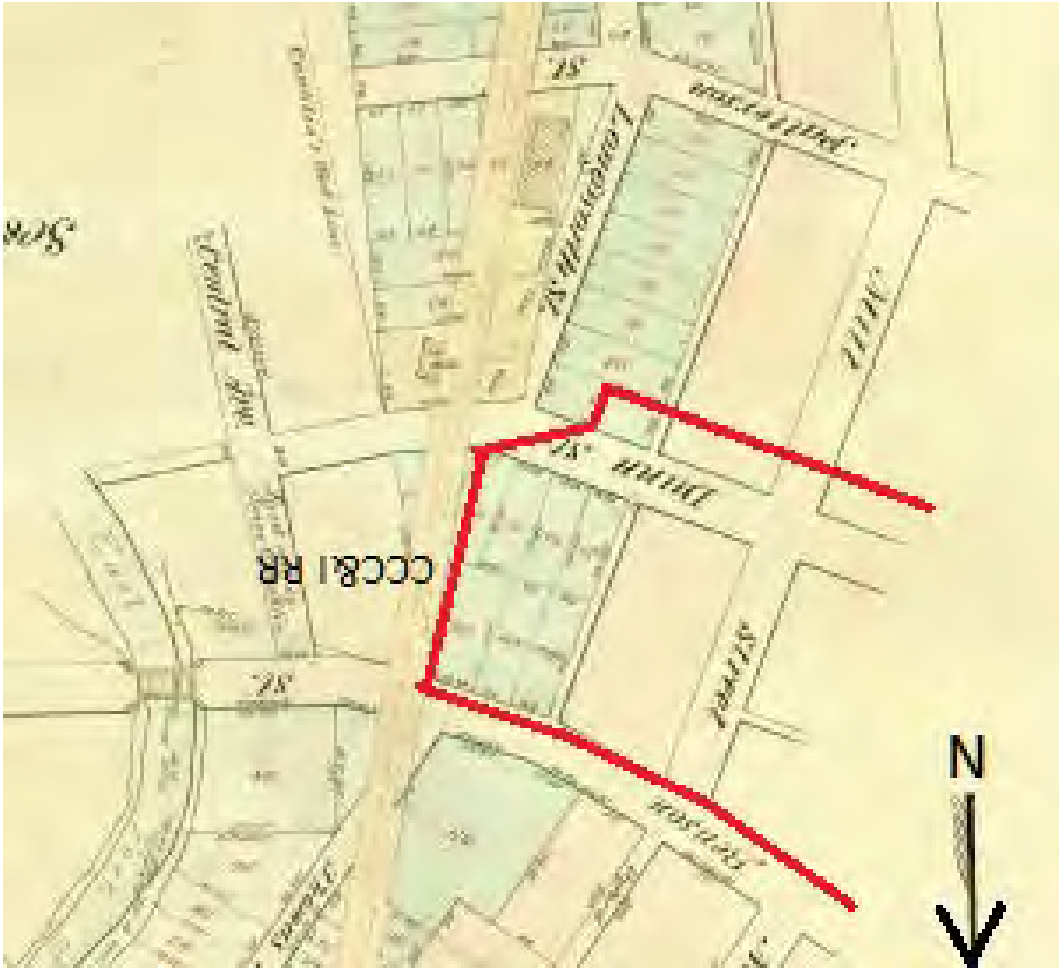
Figure 3. Detail from Longworth's Second Subdivision recorded March 4, 1873, with approximate boundary of Mill & Dunn Historic District (Hamilton County Auditor, PB4, P59)

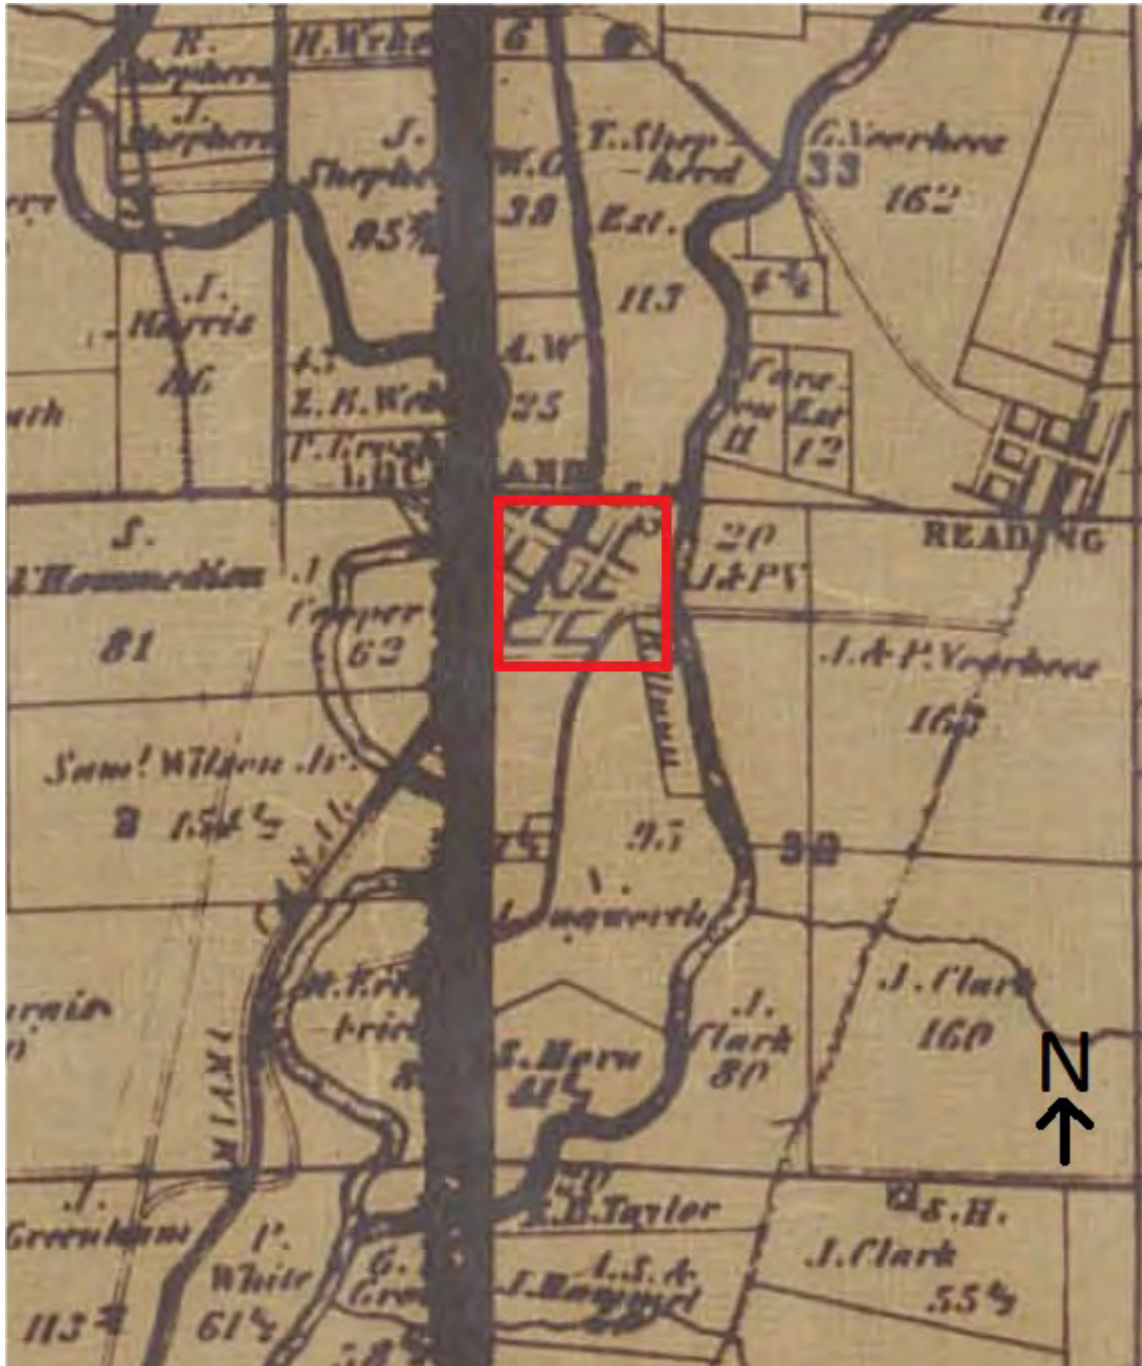
Figure 4. Detail from 1847 *Map of Hamilton County*, showing central Lockland, bisected by the Miami & Erie Canal and flanked by the West and East Forks of the Mill Creek.

The village of Lockland grew steadily and incorporated in 1849. An 1847 map shows its grid of streets, including the Mill & Dunn Historic District, clustered around the canal (Figures 4, 5). The only other towns north of Cincinnati represented by street grids on the 1847 map are

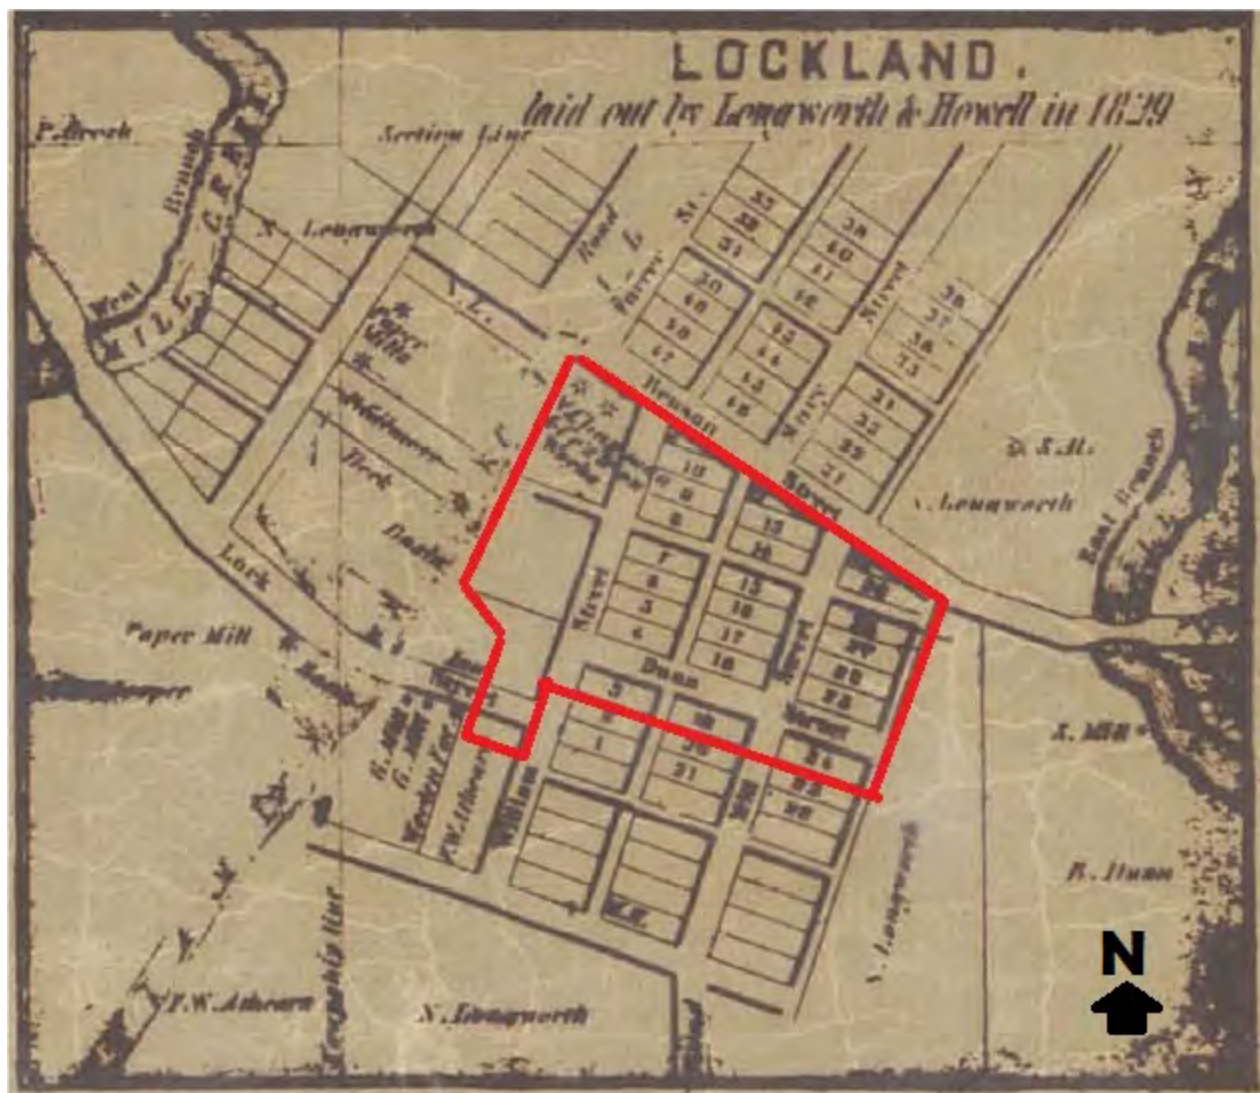
Figure 5. Detail from 1847 *Map of Hamilton County*, showing general outline of Mill & Dunn Historic District on east side of the Miami & Erie Canal.

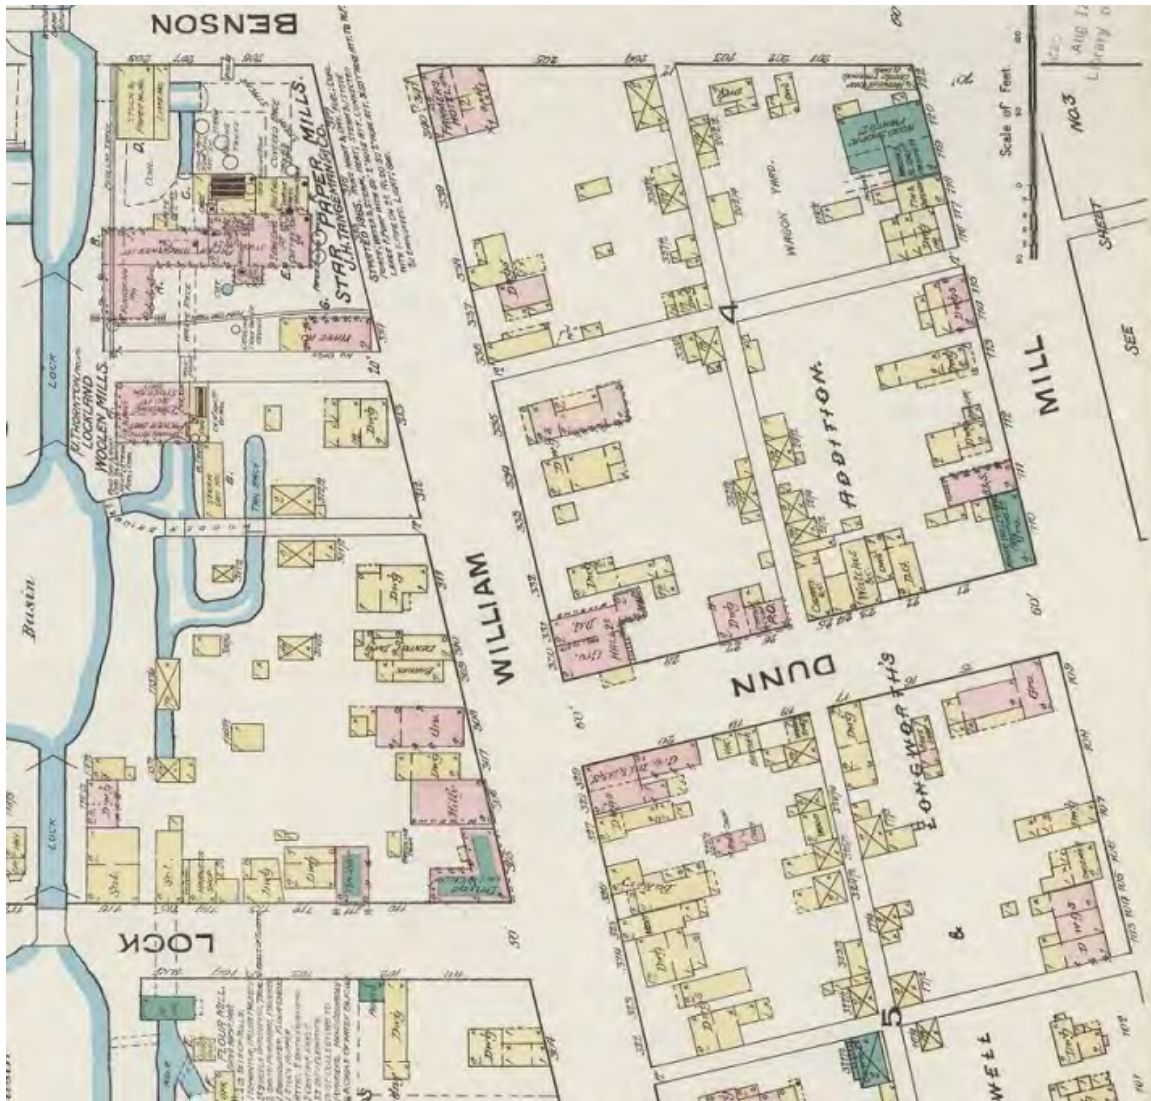
Figure 7. Detail from 1886 Sanborn Map, plate 2. (Library of Congress)
(Blue indicates hazardous materials.)

The majority of the buildings were wood-frame; masonry buildings were typically factories or corner commercial blocks. Three buildings were marked as containing hazardous materials—a brick drug store at the northwest corner of Williams and Lock (Resource 37) and two buildings on Dunn Street—the Miami Valley News print shop at the northwest corner of Dunn and Mill streets (Resource 5), and the Wagon and Wood Painting shop at 103 Mill Street. Also notable are mid-block alleys lined with carriage houses.

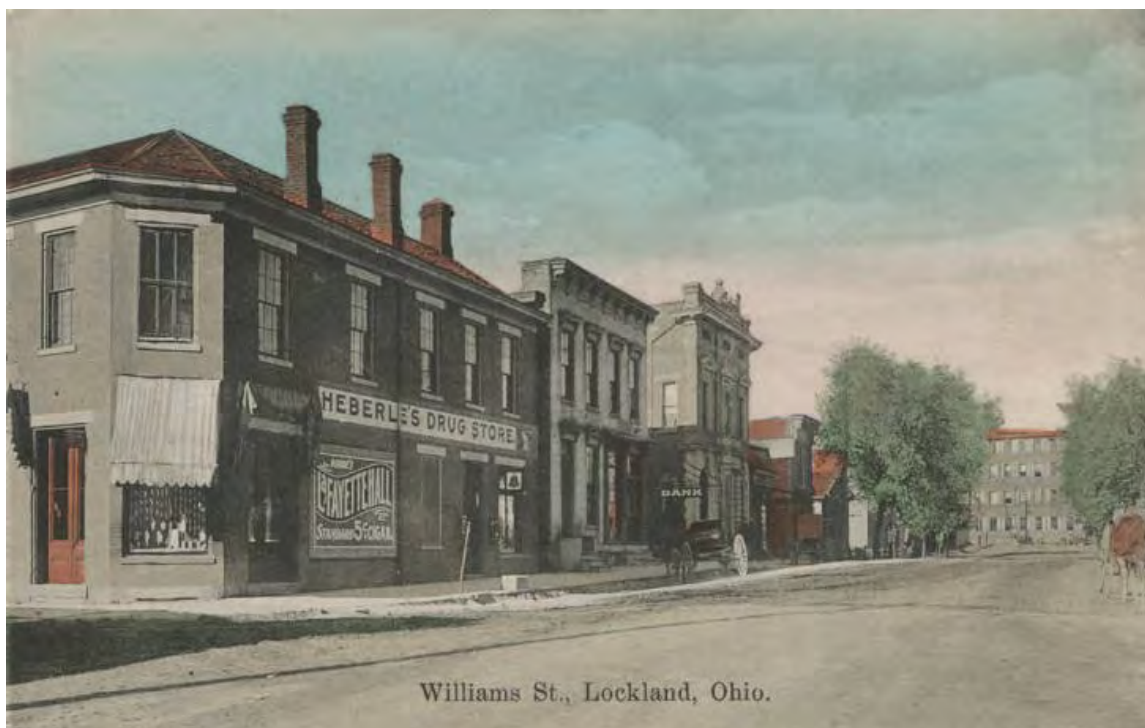
Figure 13. Williams Street, looking NW, Stearns & Foster factory at rear. (Greater Cincinnati Memory Project)

36. 135 Williams Street (Noncontributing) (Photo 30, 32): This two-story brick row building is four-bays wide. Based on a historic photo (Figure 13), it is a mid-19th-century building, formerly in the Italianate style, which has been stripped of all historic features and refaced with brick; its four second story windows have been reduced in size, and door replaced. Formerly mixed-use, the building's storefront was removed. It is currently operated as a women's residence by Christian Inn Ministries. Due to loss of historic integrity, the building is noncontributing.

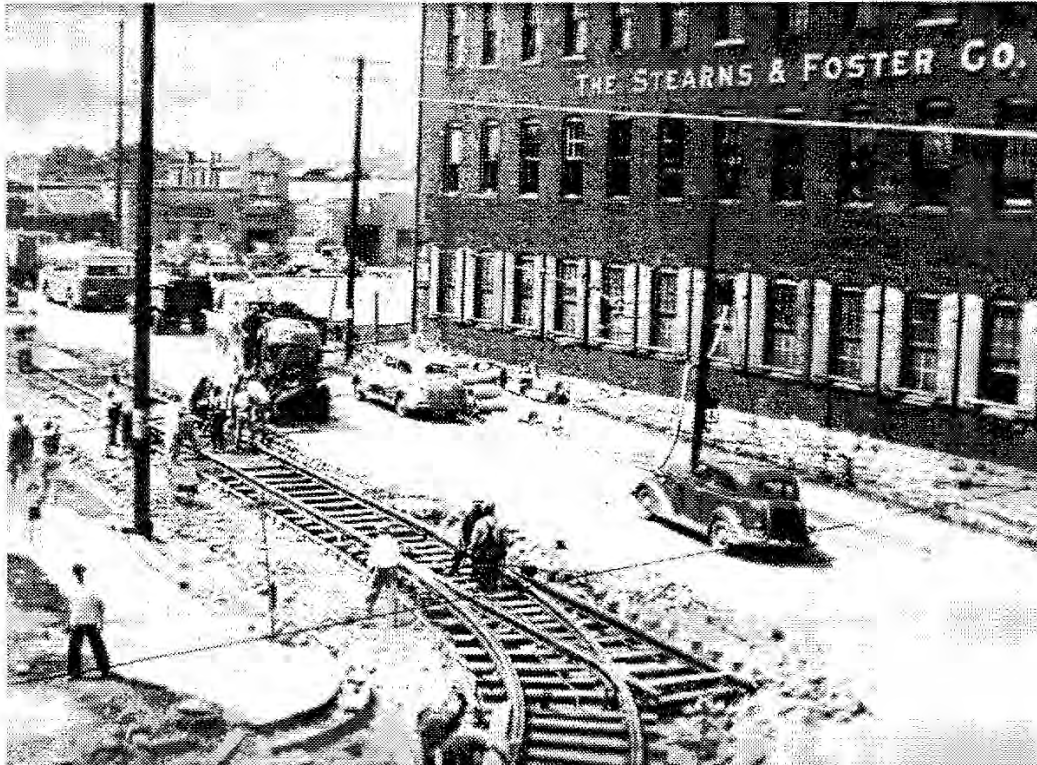
Figure 22. C.-1943 photo of streetcar tracks being relaid on East Wyoming Avenue at Williams Street, taken from Stearns & Foster Office Building (*Lockland, Ohio: A Thousand Memories in a Mile*, 364)

The streetcar lasted in Lockland until the late 1940s. A photo taken in 1943 (Figure 22) shows tracks being relaid on Wyoming Avenue after a new overpass bridge was built over the trench built for the Curtiss-Wright-Lockland Highway, which later became I-75 south. After World War II, however, there was a political shift away from electric streetcars, led by promoters of General Motors and other automobile/bus companies. Abandonments of streetcar routes started in earnest

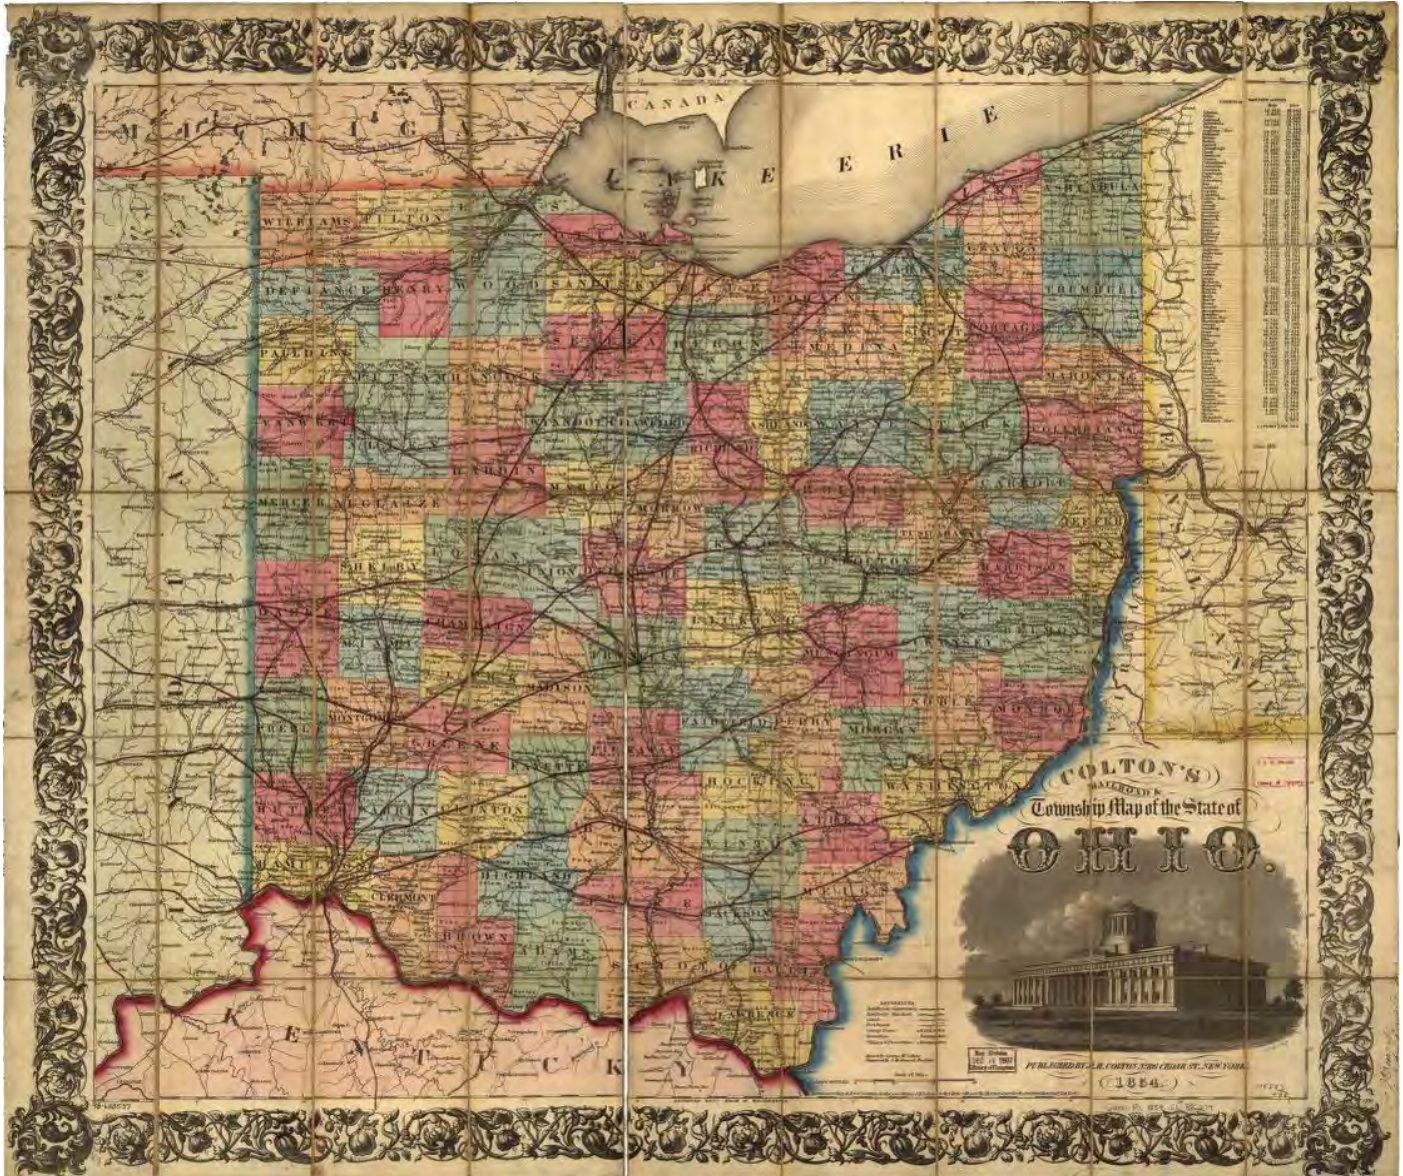
Figure 25. Railroad and township map of Ohio in 1854 showing the extensive railroad system. Library of Congress. <https://www.loc.gov/item/98688537/>.
