The Carr House <sup>DOE</sup>  
Benicia, Ca. SEP 13 1979 JUL 30 1979 # 1 of 12

*Solano County, California*

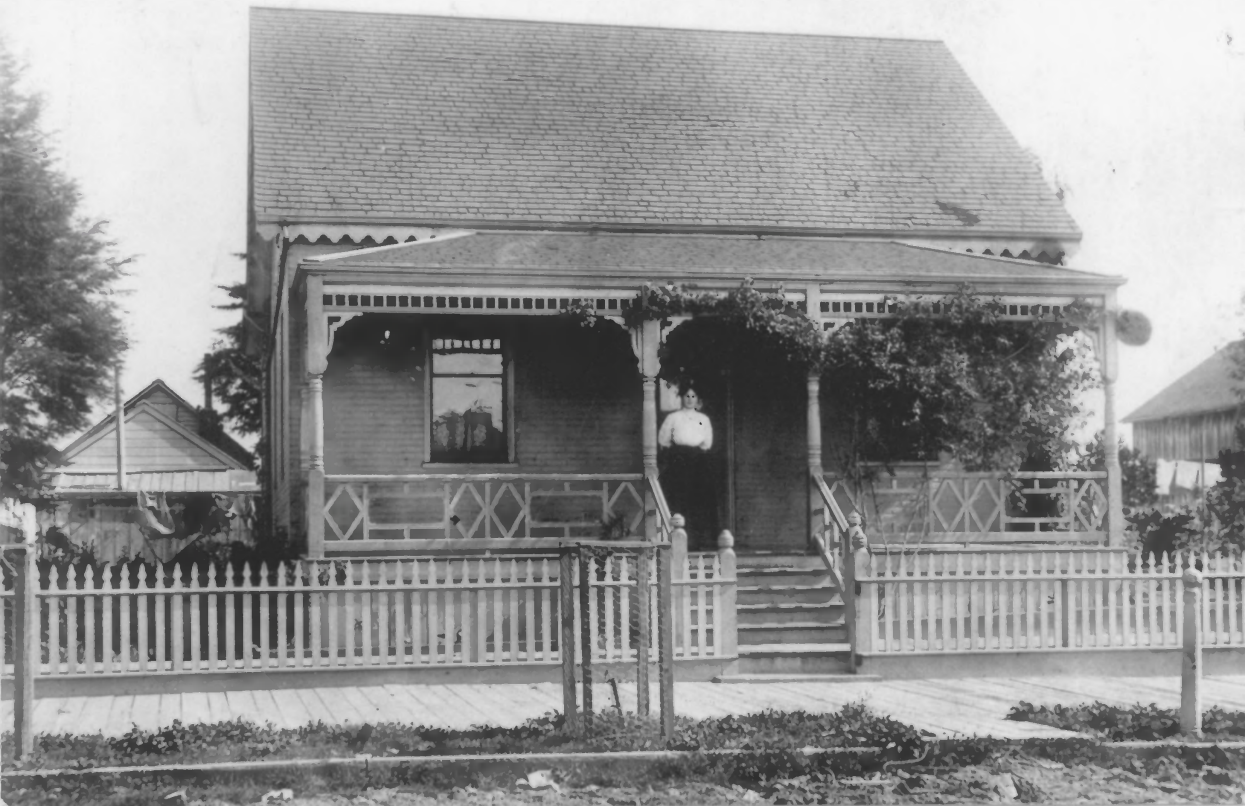
Photographer unknown; after 1900 probably  
Hill's collection, Benicia  
Front view of Carr House facing north. This  
old photo clearly shows fine details of porch  
and fence. Barn and shack are long gone.  
Photo signed, "Tillie at home."

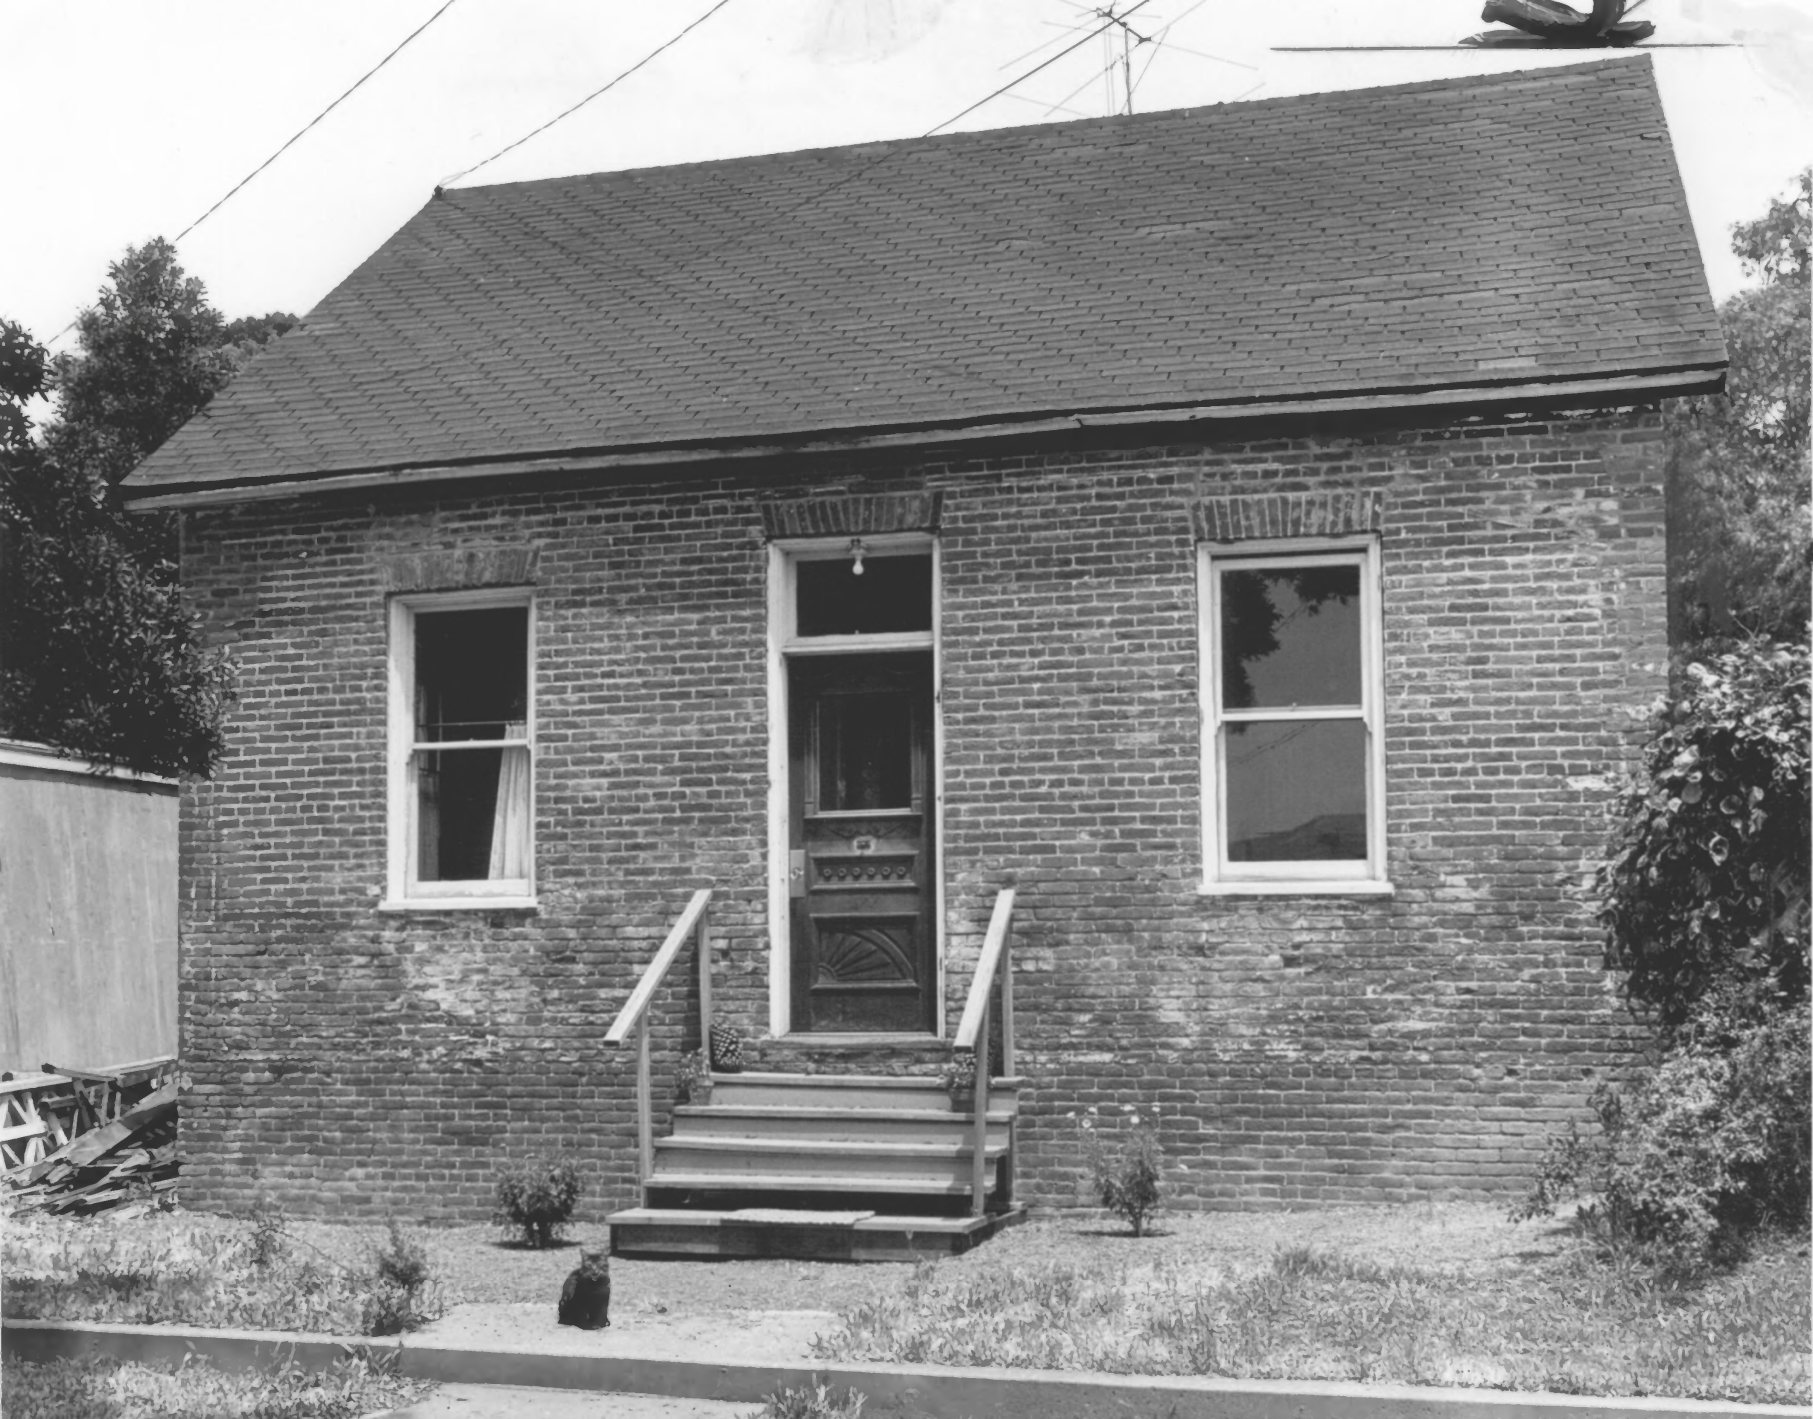
# 2 of 12

Front view of Carr House facing north. Front porch removed by present owner and stored in garage to left. Note some decorative pieces on ground. Porch had mostly collapsed.

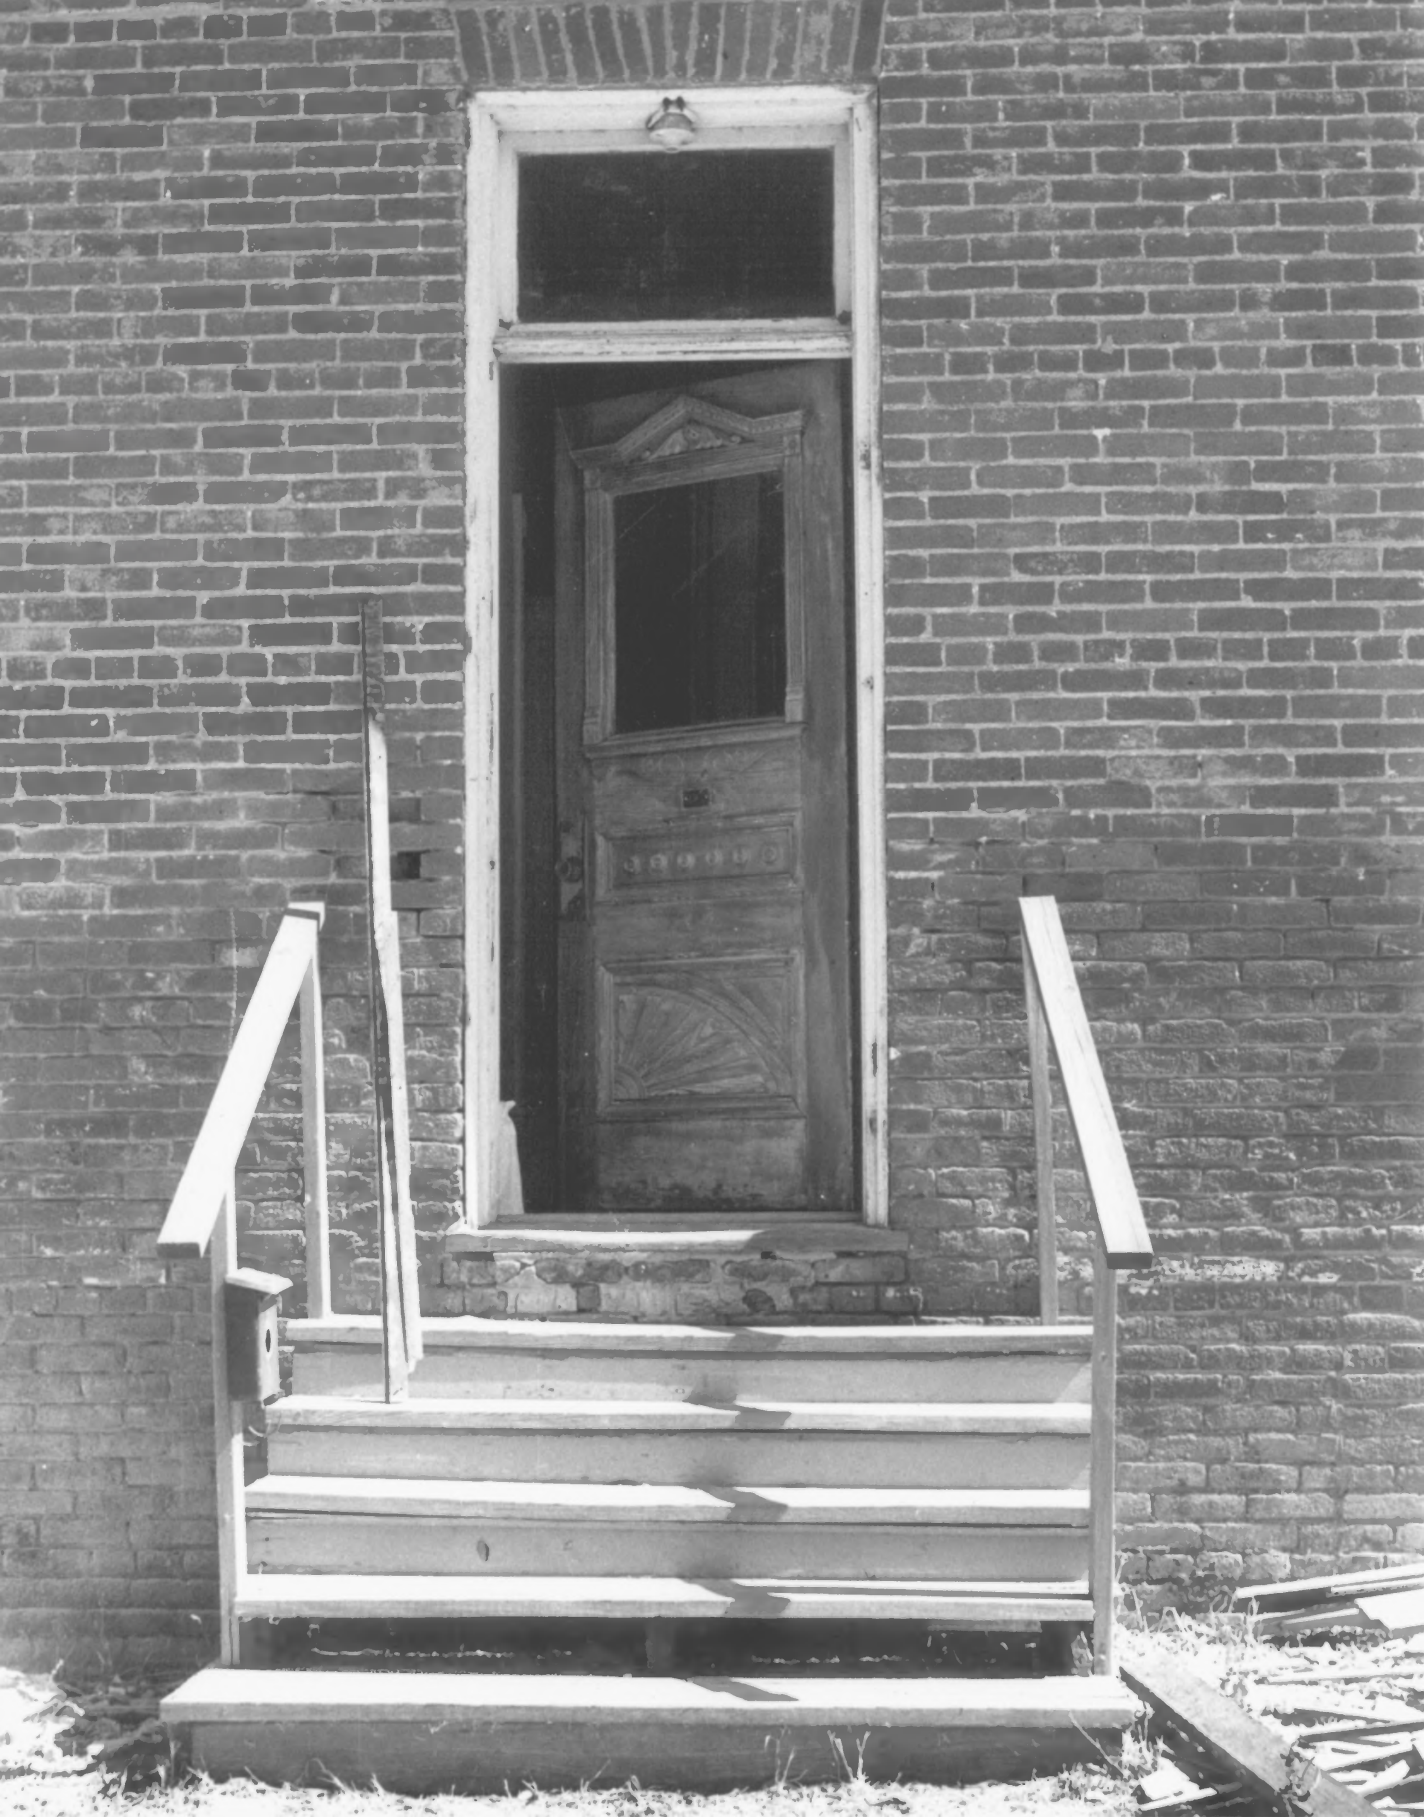
Forlorn view of the front door and stoop facing north. The electric wire to outside light probably holds door and door-frame in place. Bricks by rail have no mortar.

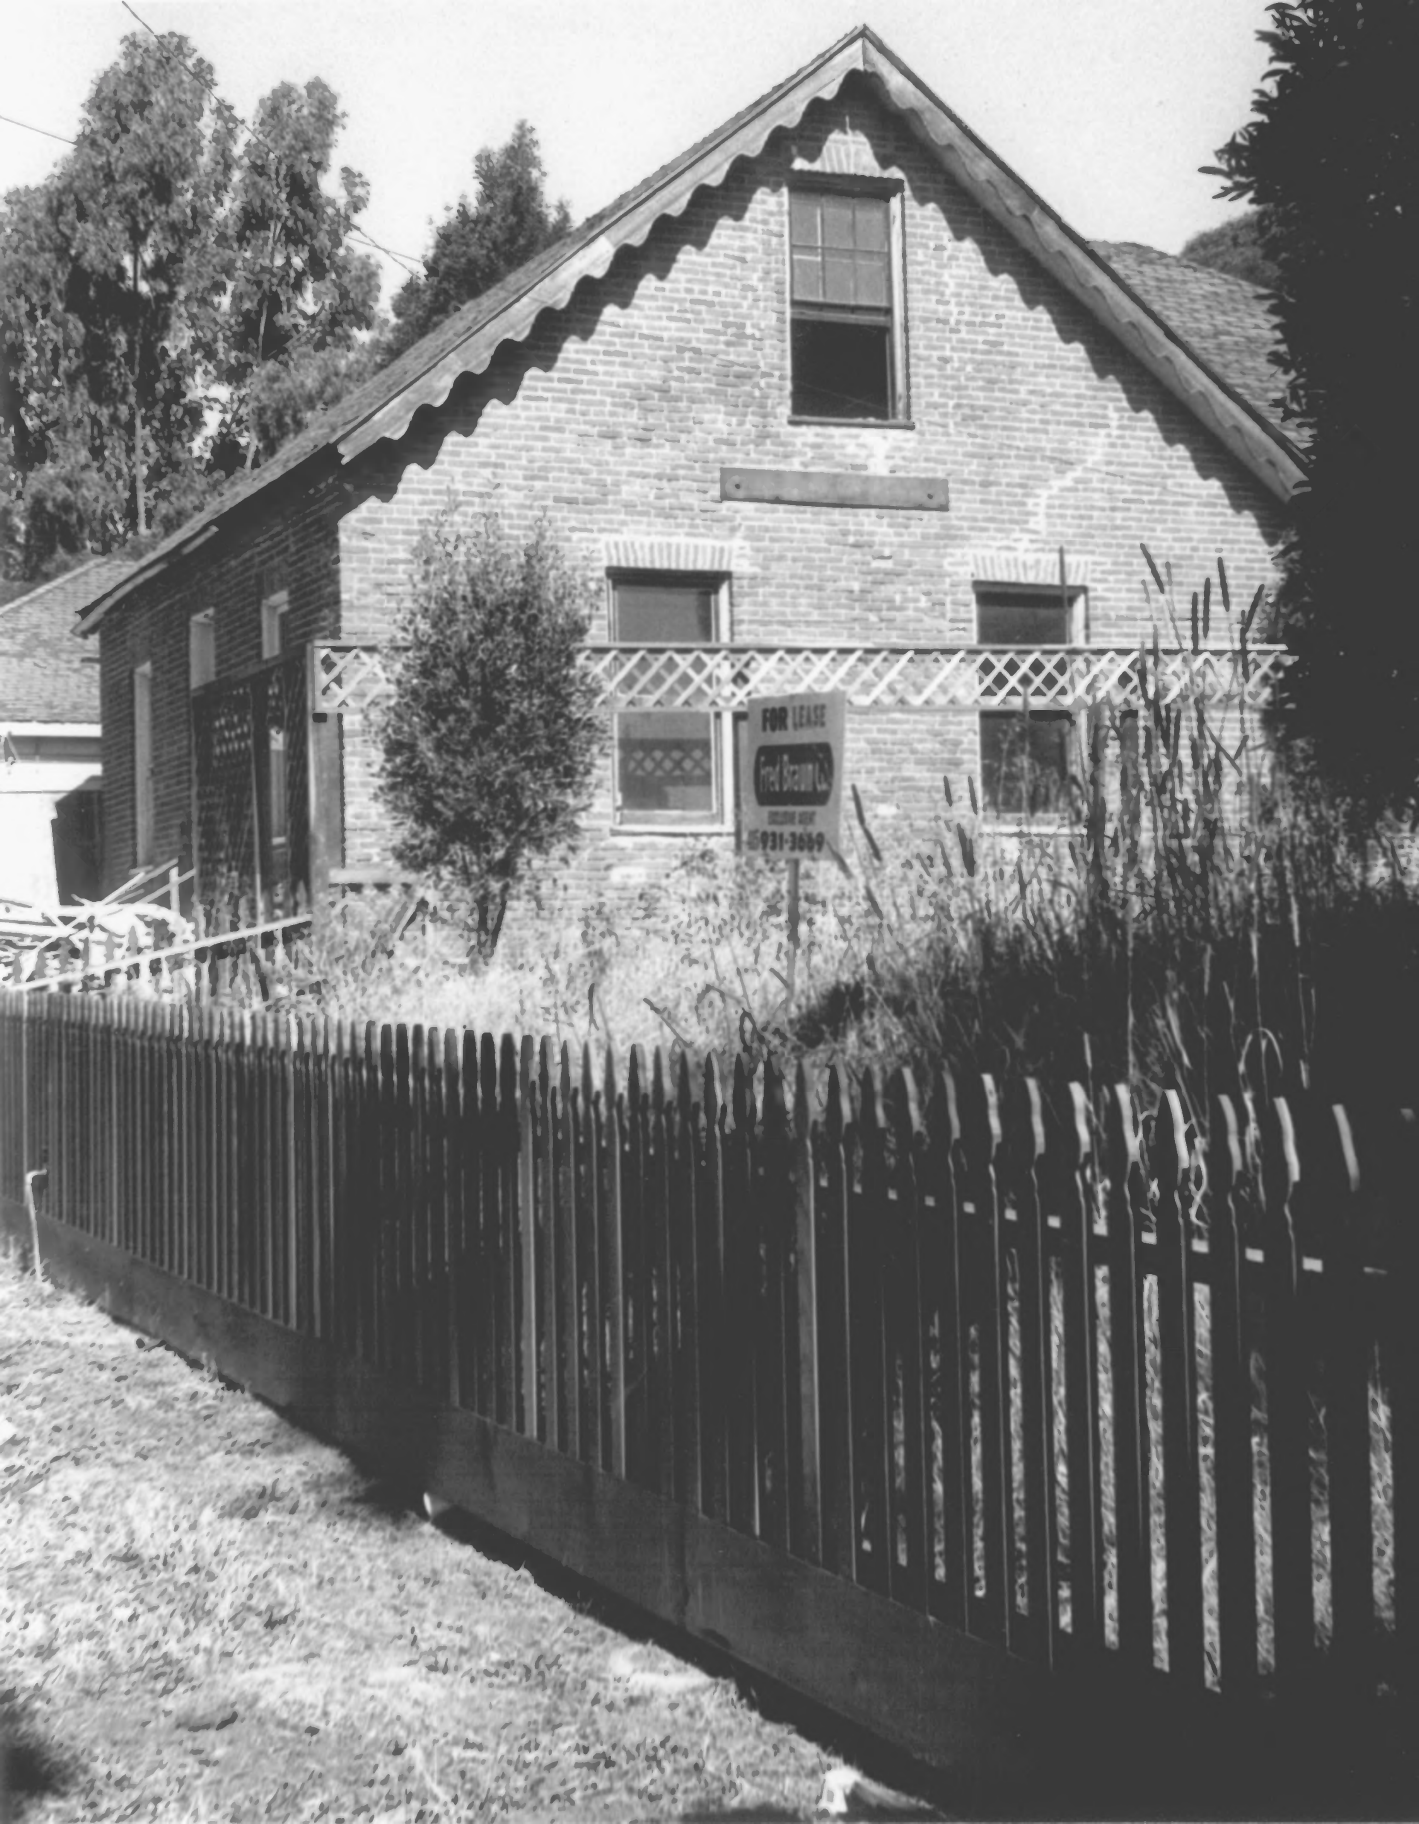
#4012

View taken from sidewalk facing north. Trellis  
and picket fence and lath recently restored.  
Last winter during a gale a tree had been  
hurled against this side causing the damage.

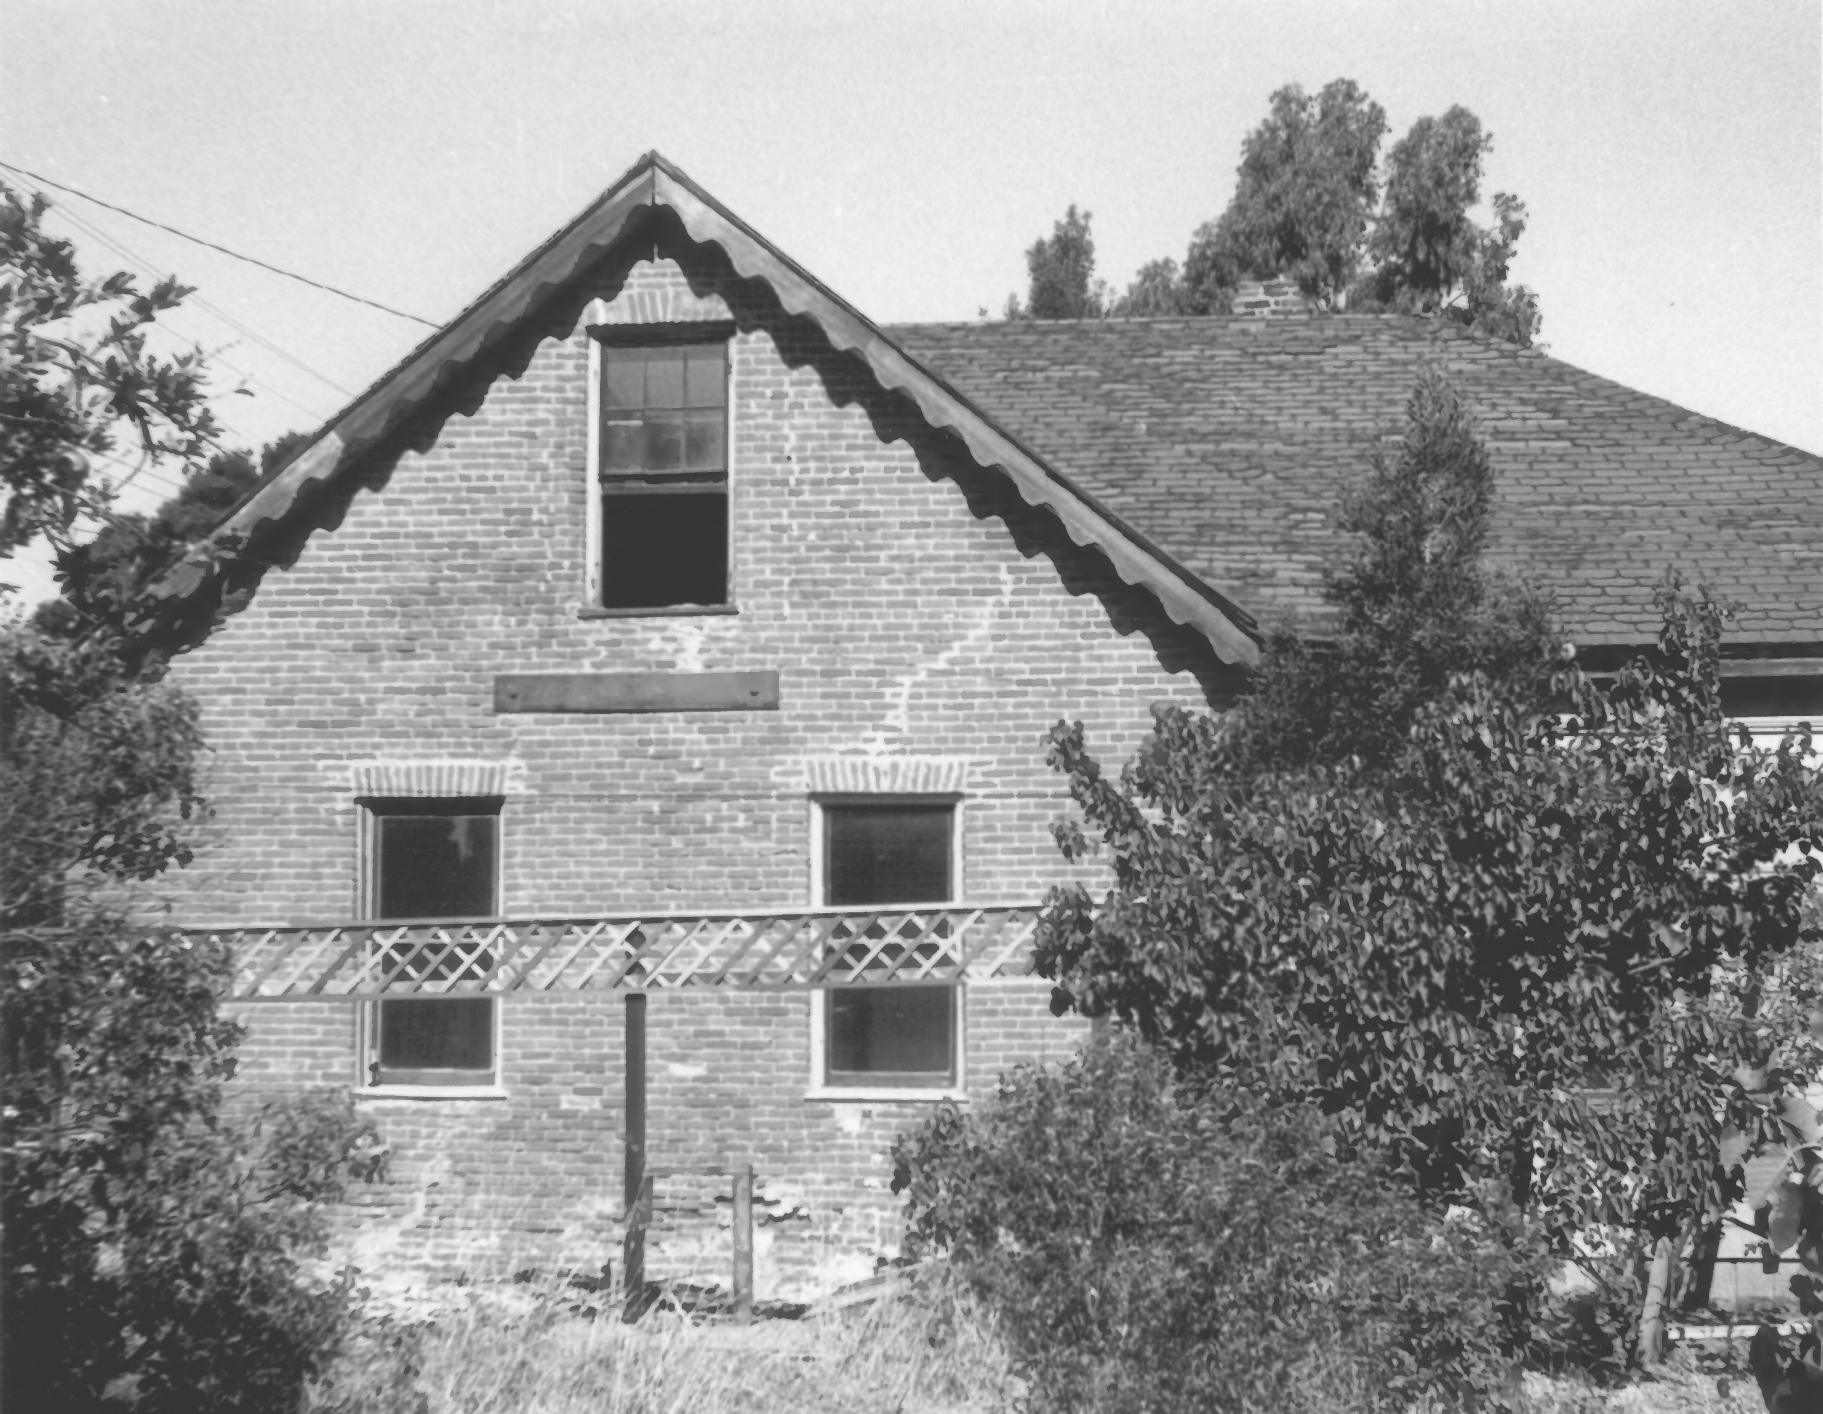
# 5 of 12

Side of house from garden facing west. Lump  
by trellis post below right window is storm  
door down to cellar. Note roof addition of  
frame building with hipped gable.

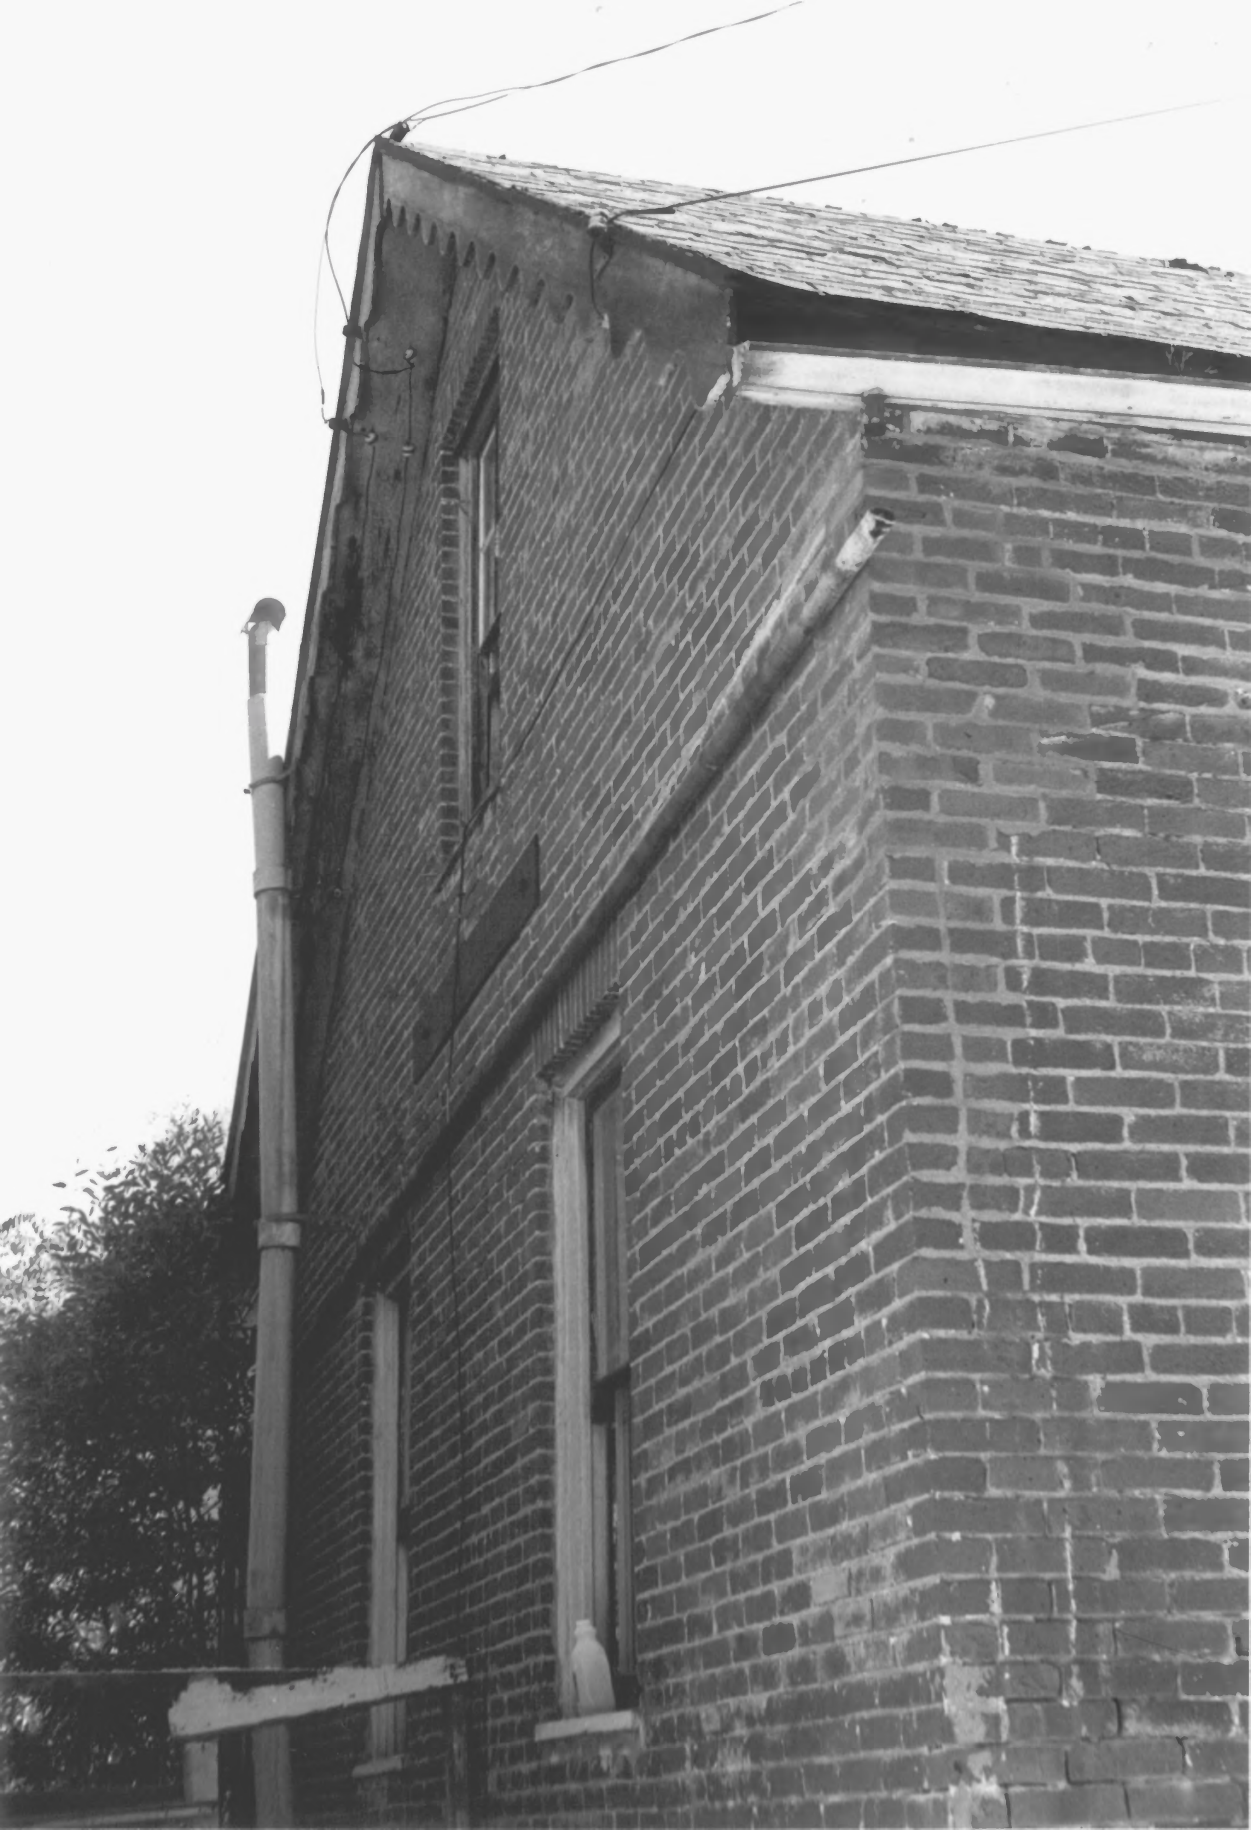
#6 of 12

Side of house facing north. Deteriorated brick  
will be replaced with bricks fired in 1872  
from wreckage of Solano Hotel. Weinmann, a former  
owner of the Carr House also owned the  
Solano Hotel.

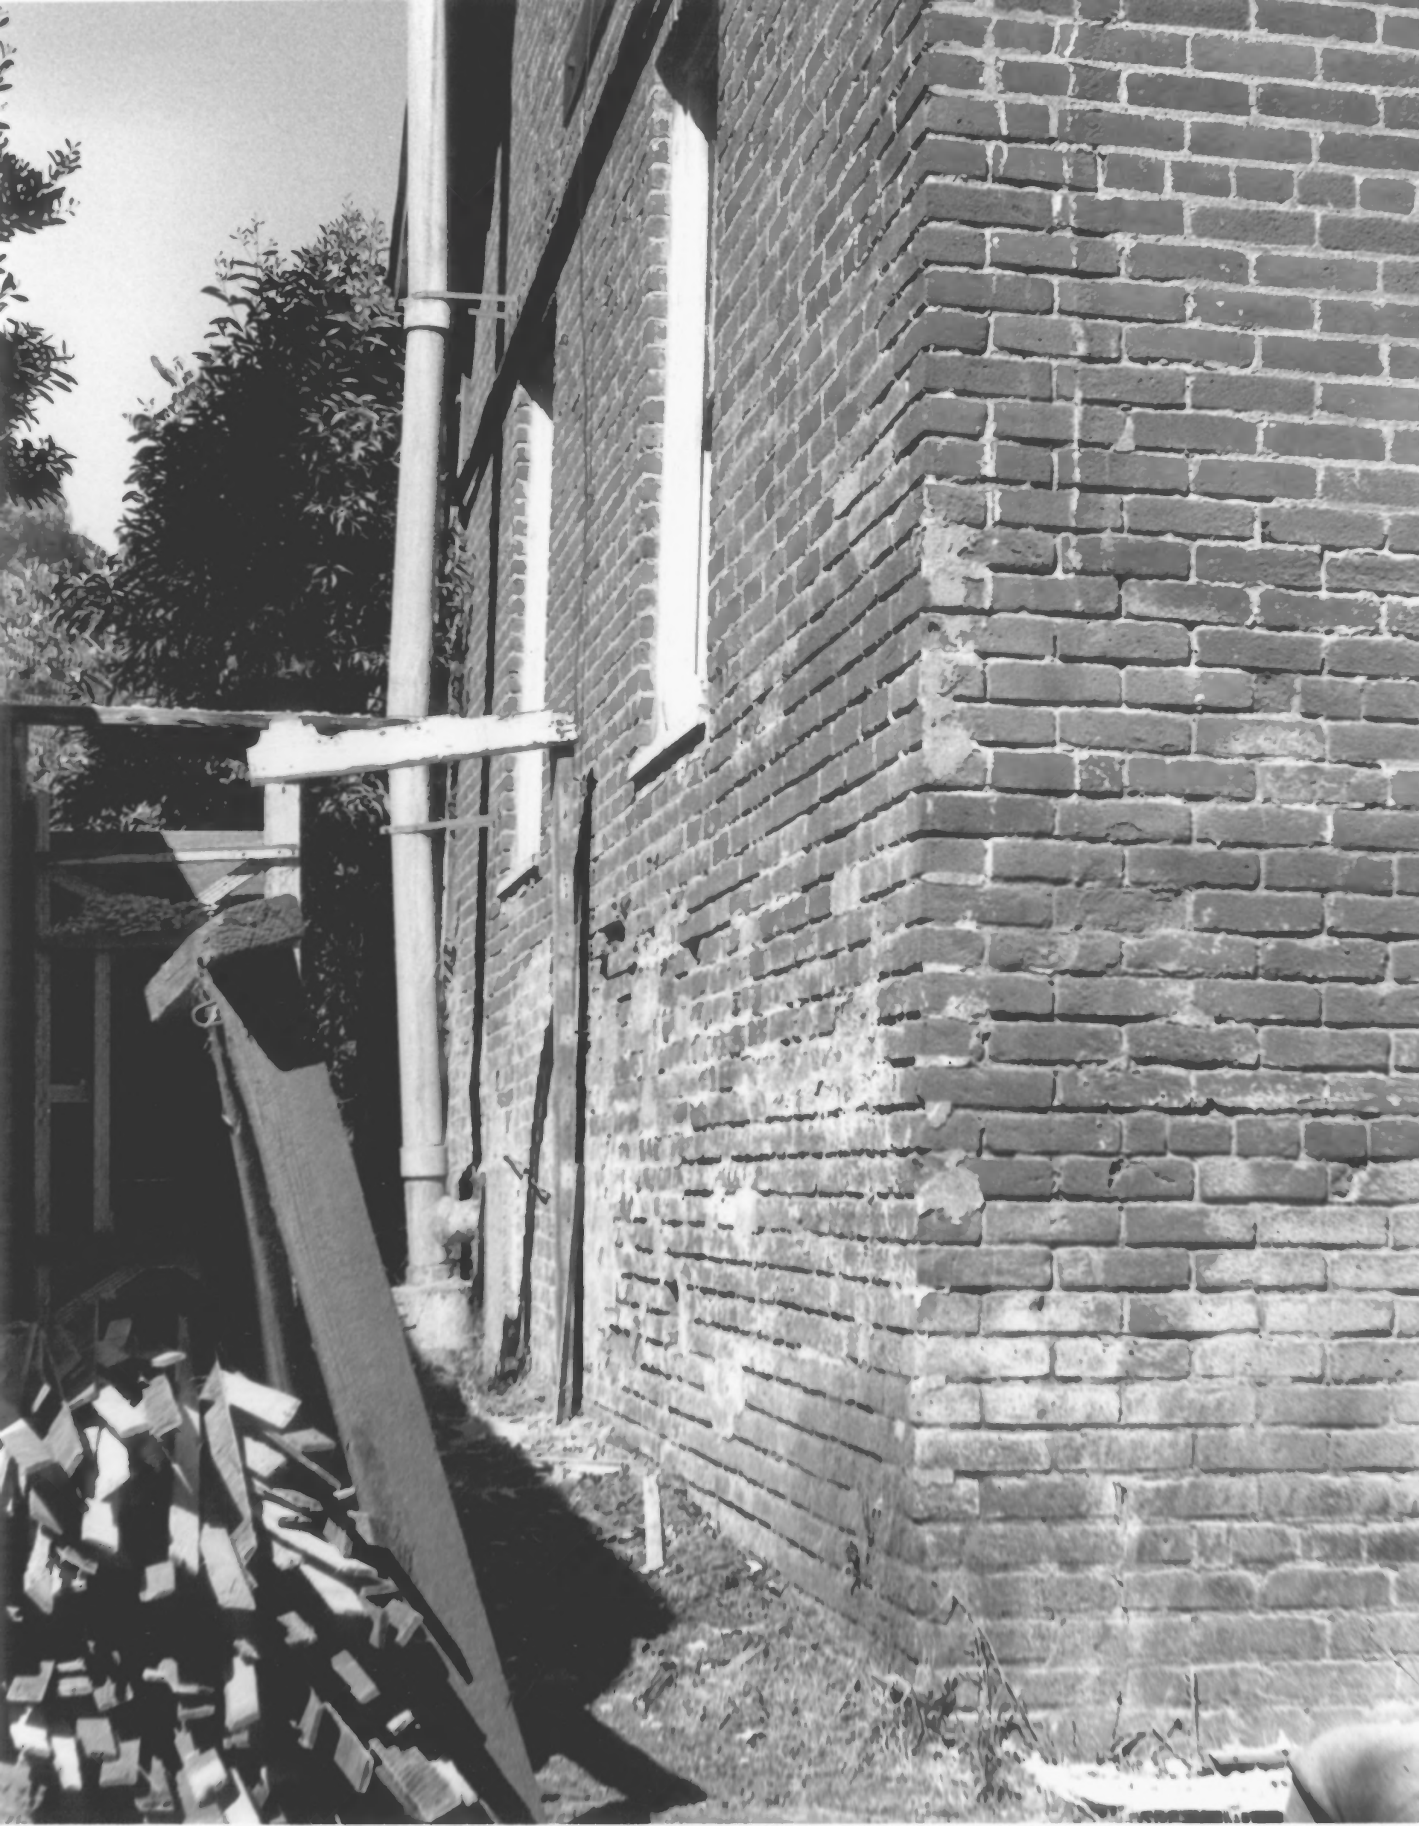
#7312

From sidewalk facing north. Notice arbor  
which was made clumsily from front porch  
fragments.

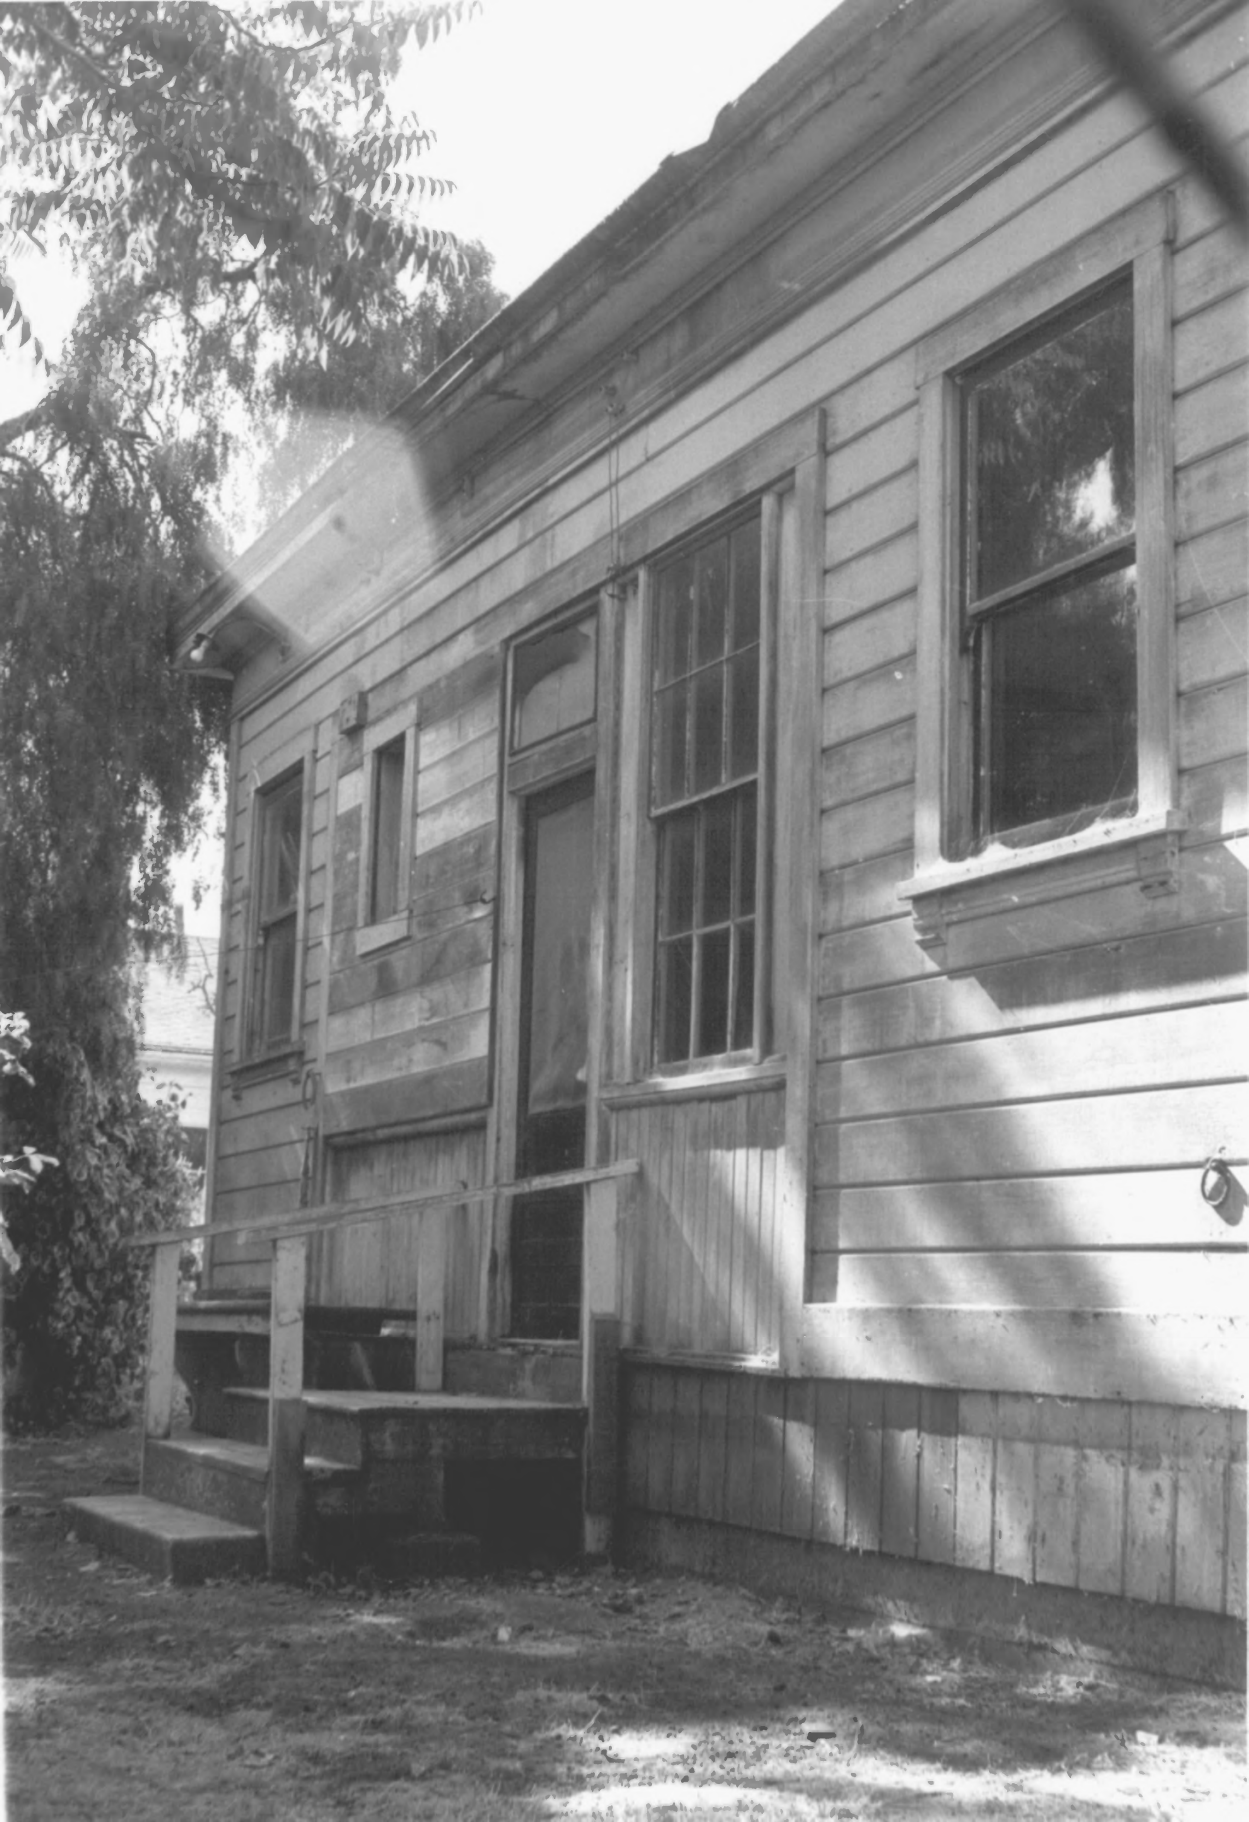
# 8 of 12

Back door facing south. Note how rear center section has been filled in and enclosed using the older window which probably came from the original back wall. Window brackets are in keeping with 1900 frame addition.

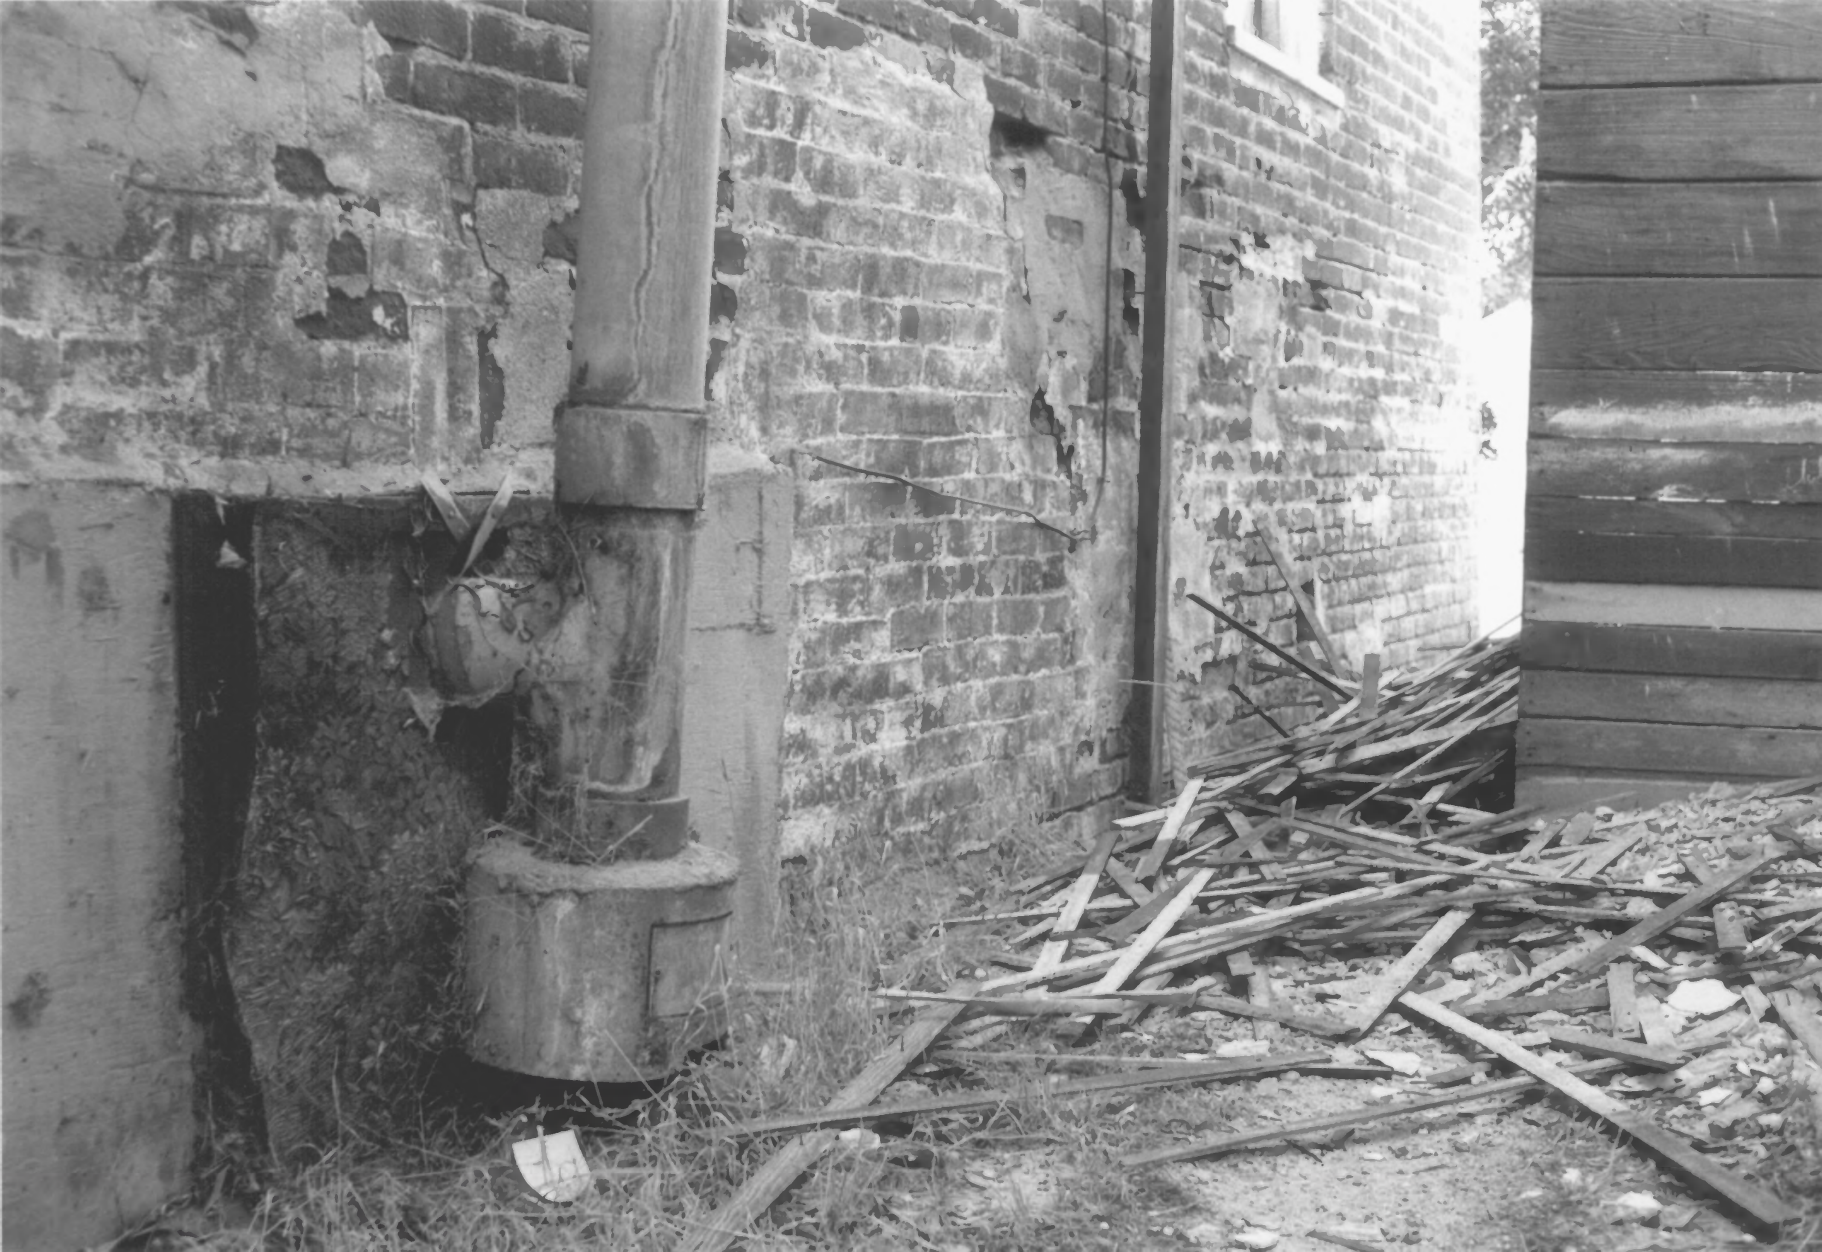
#9912

Facing east and showing old concrete botch of a patch and sad condition of brick. Cistern is by left corner and believed to be egg-shaped. When frame addition is jacked, cellar will be dug to expose the cister.
