The Carr House <sup>DOE</sup>  
Benicia, Ca. SEP 13 1979 JUL 30 1979 # 1 of 12

*Solano County, California*

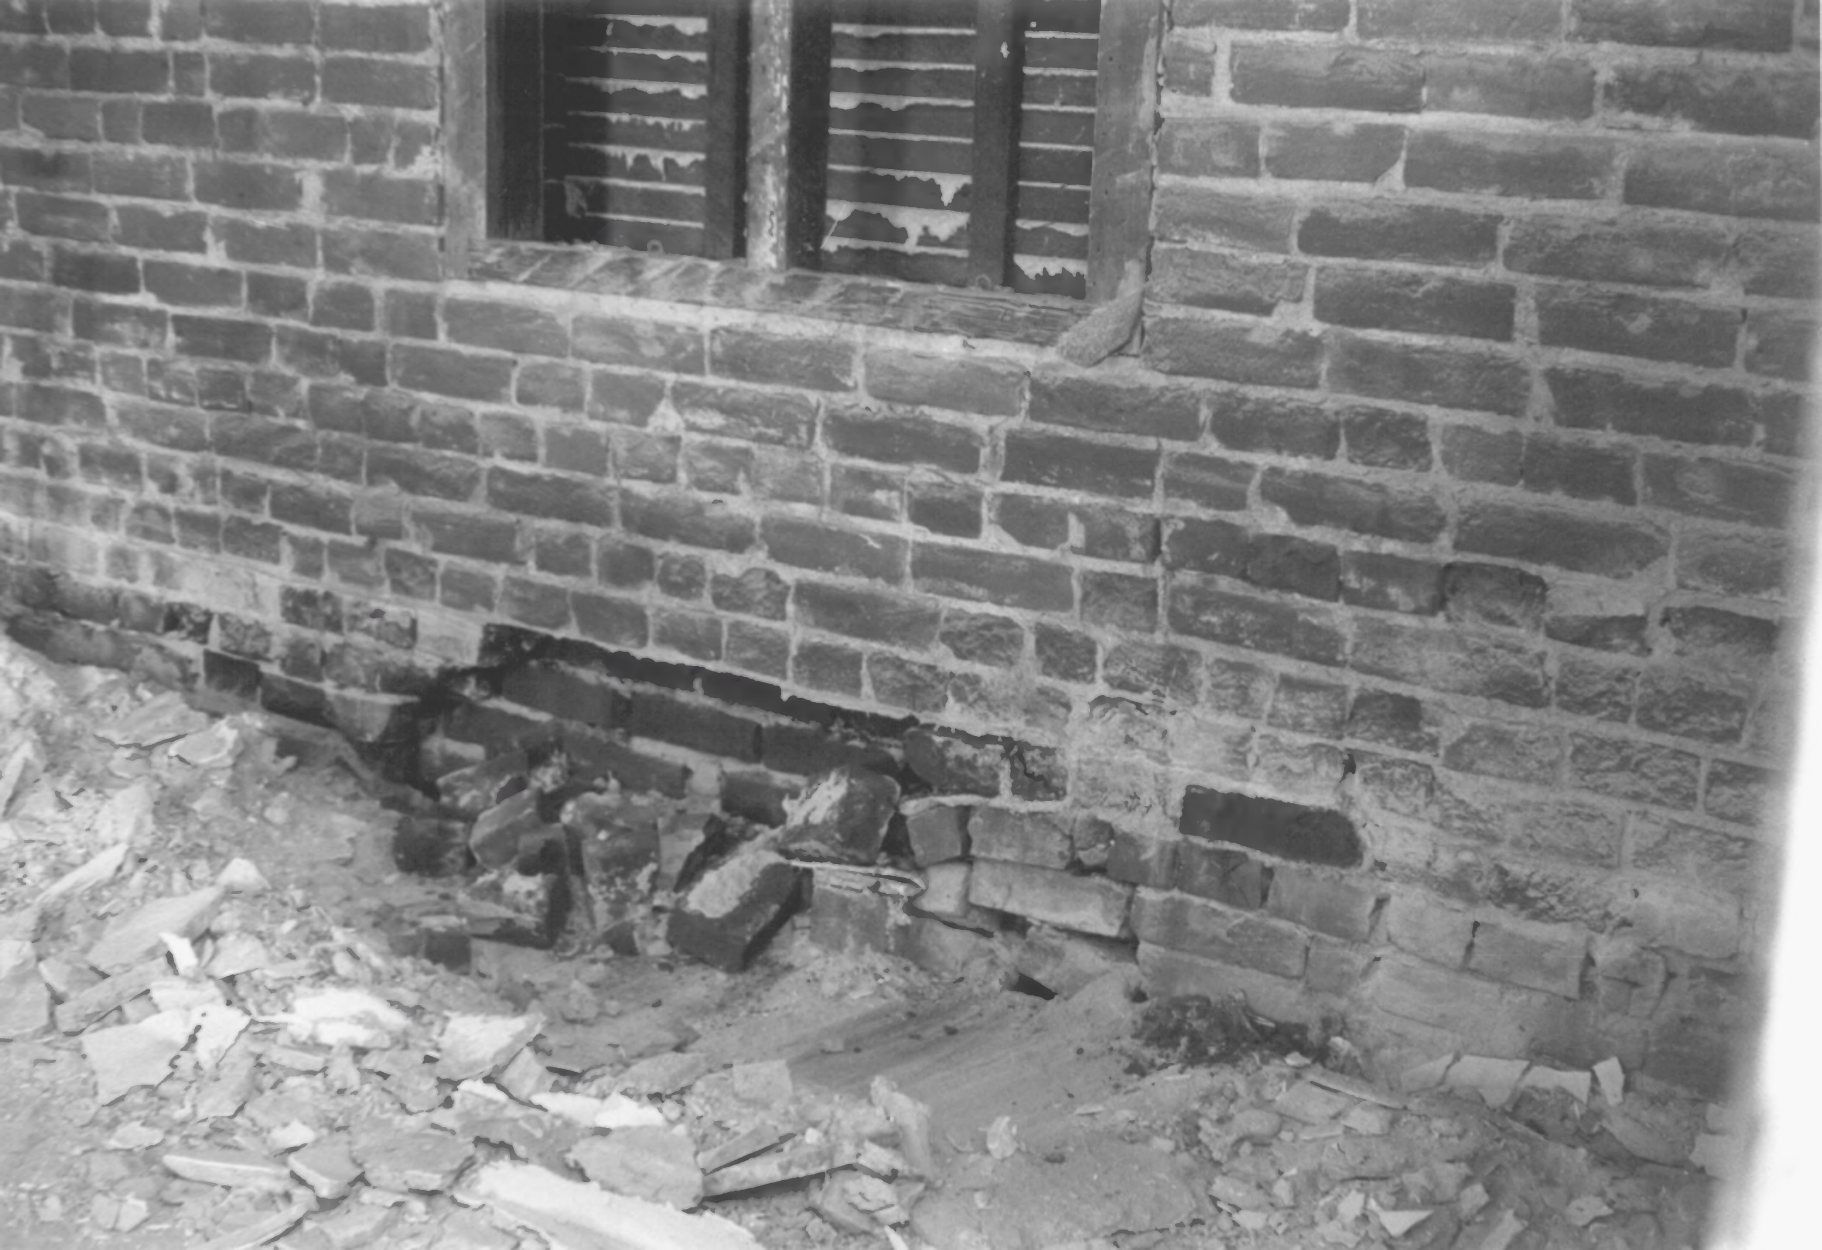
Back interior wall facing north, exposing a hidden window walled up for later frame addition. Note typical lath and plaster treatment. Plaster contained quantities of horse hair.

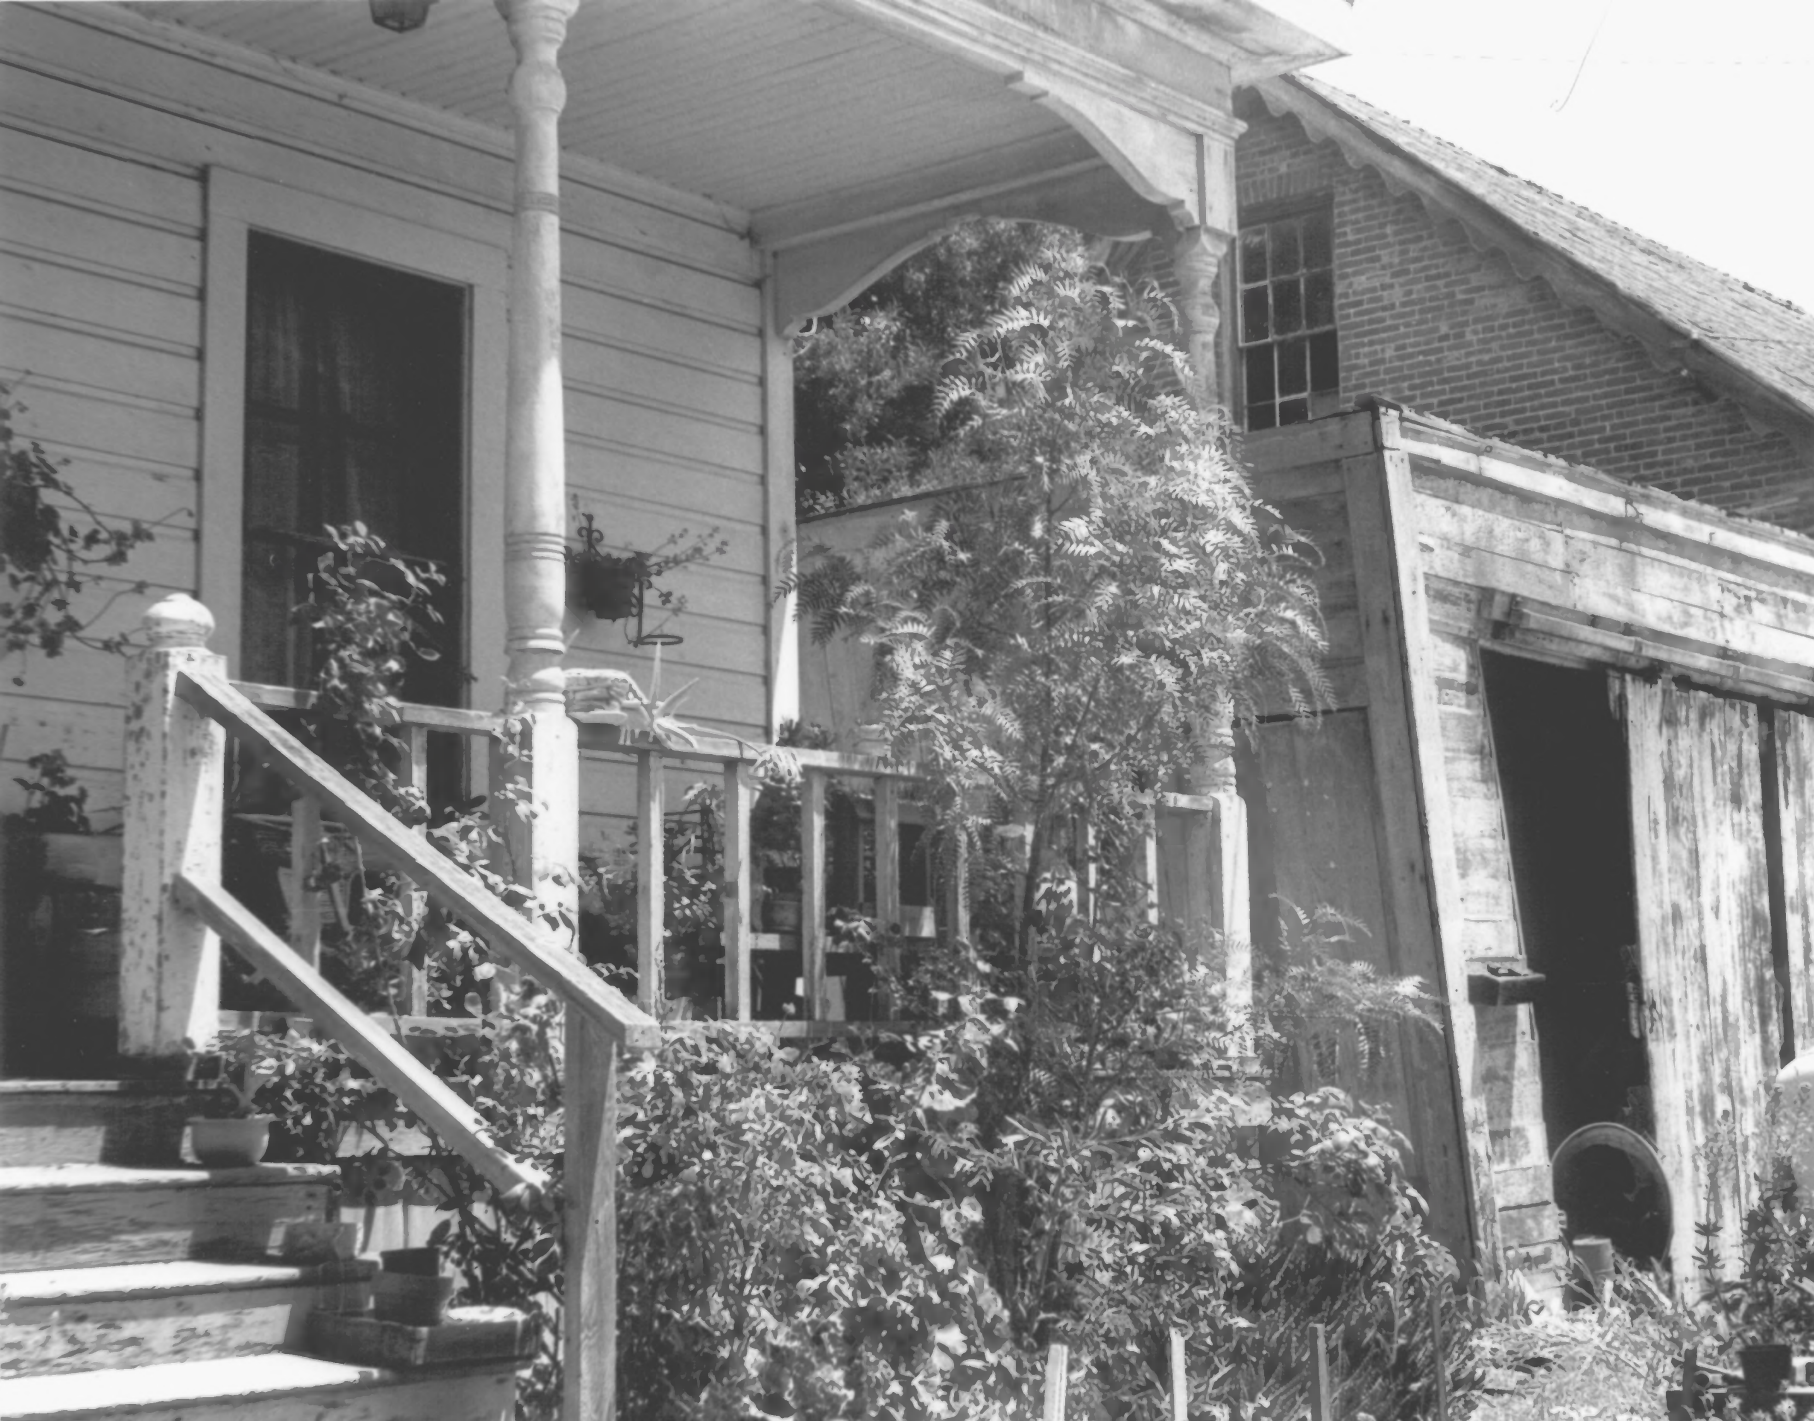
SEP 13 1979  
1000

The Carr House Garage (Middle structure)  
Benicia, California Solano County, *California*  
Photo by Nancy Olson  
neg. loc. Hill's Library, Benicia  
date of photo 1979  
view looking northeast

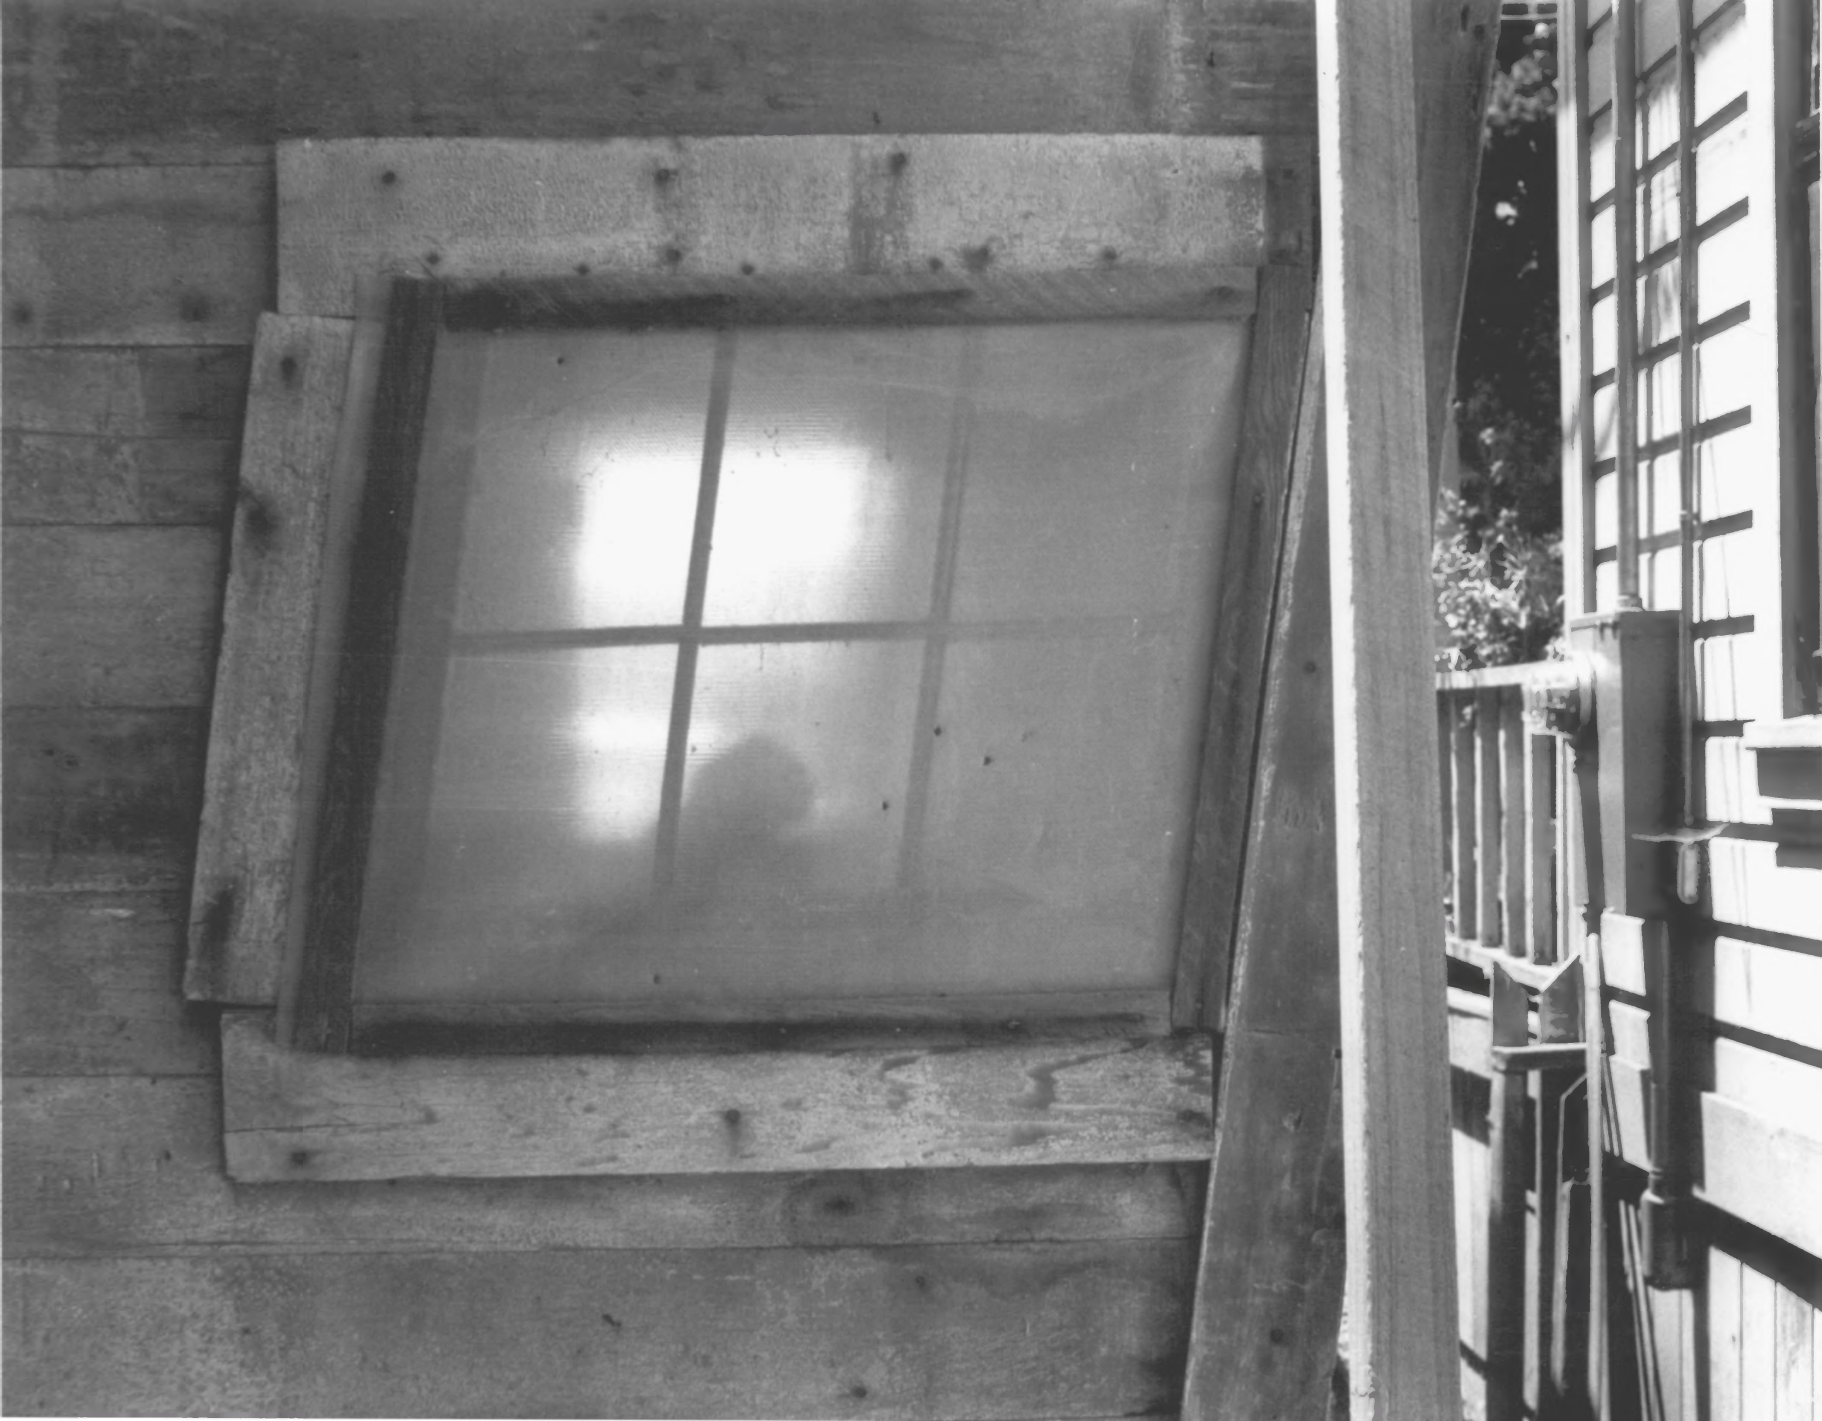
This peculiar shot of the backside of the garage facing east shows a window once owned by the Carr house tacked on here to make-do.
