National Register of Historic Places Registration Form

historic name Millage Farm Rural Historic Landscape District
other names/site number 5PL.110

Millage Farmstead
 Name of Property

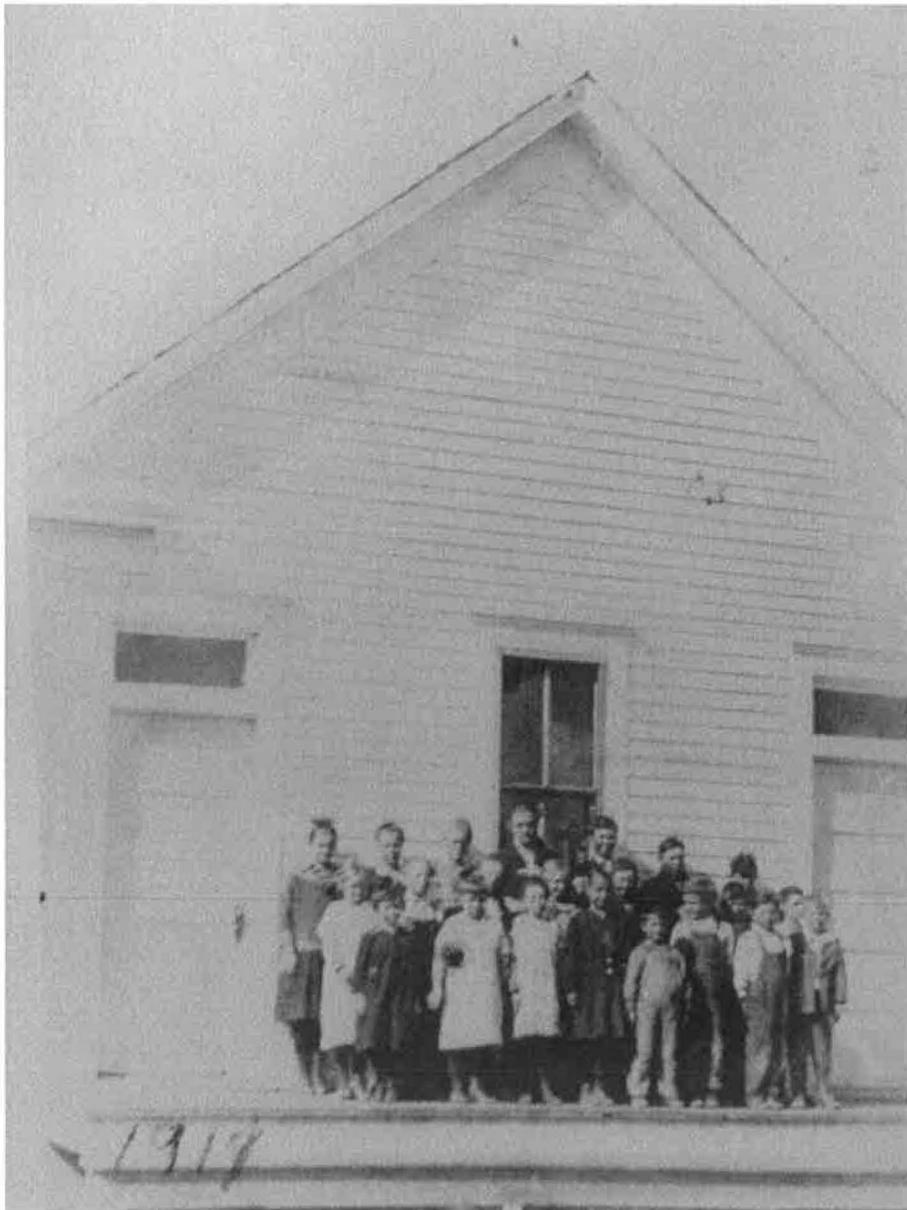
H1: Lakeside School, 1919.

of the district. The historic photograph shows the front of the school with its original configuration of a center window flanked by two doors with transoms.

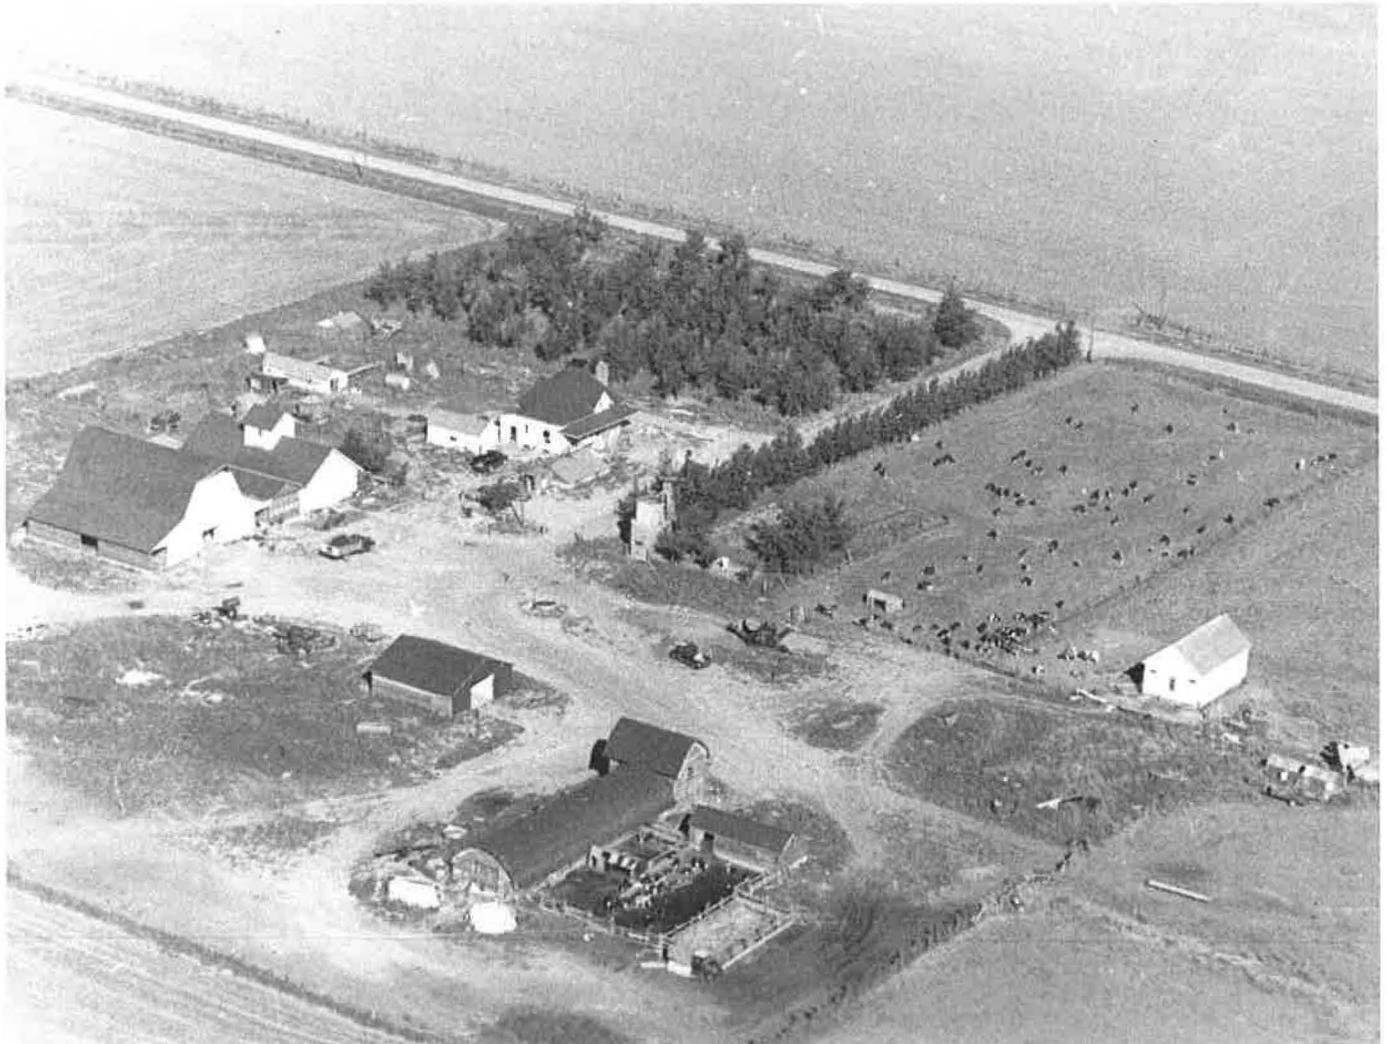
Photograph H2: Millage Farm in 1949. Shows house, garage, and school recently moved onto property.

Garage (c. 1949, Photo 14): The construction date of the farm is unknown, but it was likely moved to the farm around the same time as the house. A 1949 photograph of the farm shows the garage southwest of house, but oriented east-west rather than its current north-south orientation. Like the house, it had likely just been moved onto the farm and not yet placed in its final position. The two-bay garage (20'x 23') is rectangular in plan with a gable-front roof and exposed rafter tails. It is located south of the house. A door on the south side of the house and a concrete sidewalk provide easy access from the house to the garage. The frame garage rests on a concrete foundation and is sheathed in horizontal wood siding painted white. Two wooden overhead garage doors are located on the south side. A pedestrian entrance is located at the north end of the east side. The garage has two windows, one on the west side, and one on the east side. The windows are four-light, fixed, wood-frame windows.

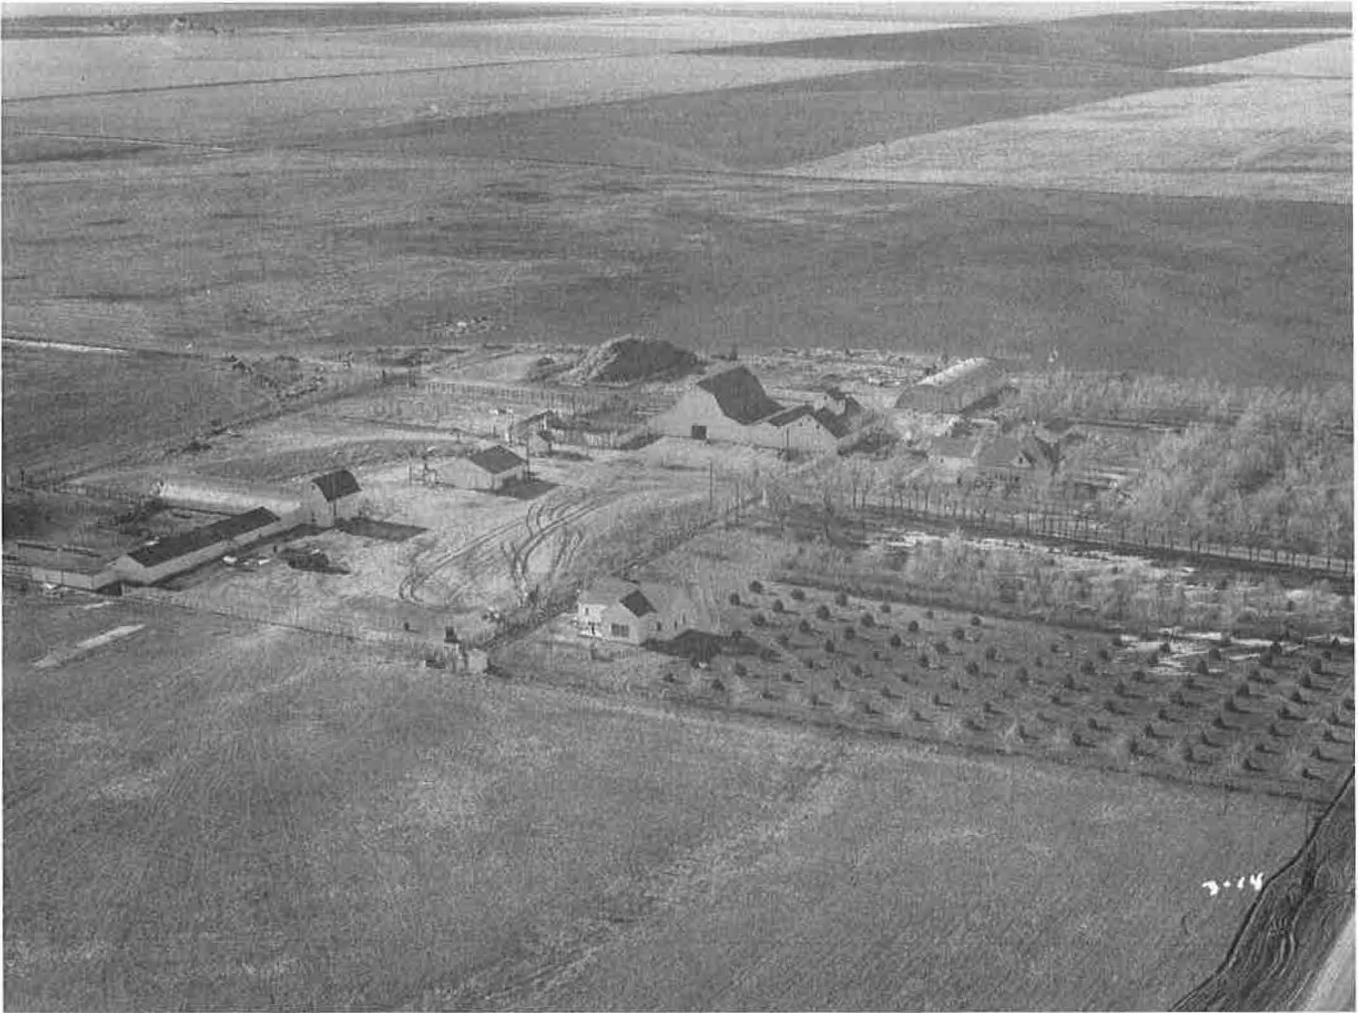
Photograph H3: Millage Farm in 1960. Shows newly planted windbreak.
