National Register of Historic Places Registration Form

Historic name: Webb, John and Maria, House
Other names/site number: _____
Name of related multiple property listing: N/A
(Enter "N/A" if property is not part of a multiple property listing)

Street & number: 121 Main Street
City or town: Bridgton State: Maine County: Cumberland
Not For Publication: n/a Vicinity: n/a

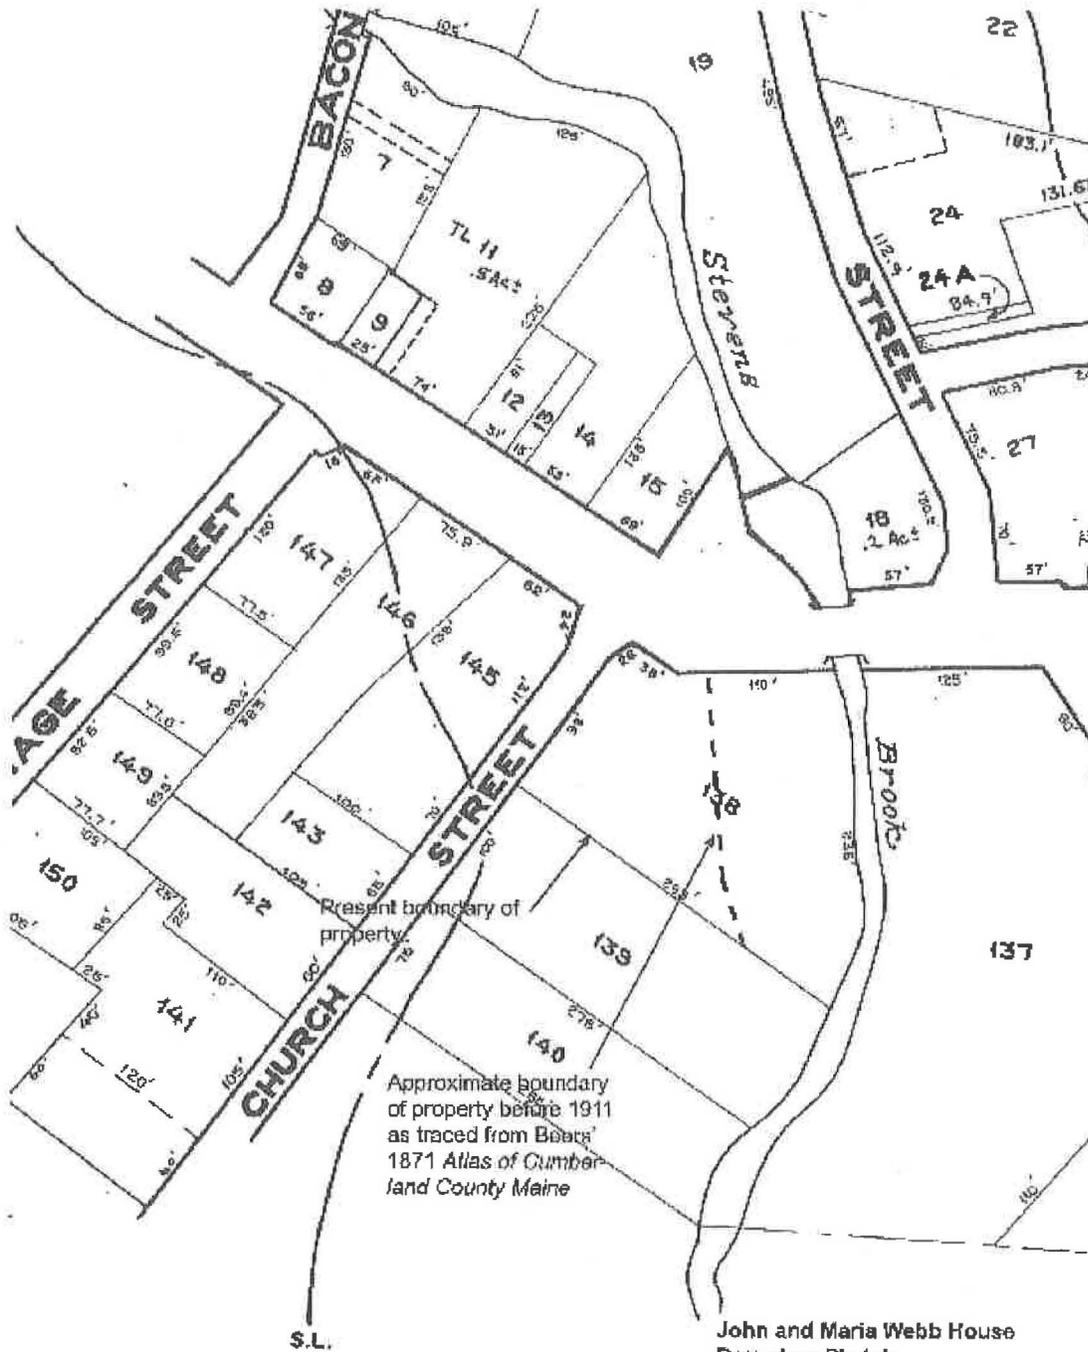
**John and Maria Webb House
Boundary Sketch**
Source: Bridgton 2012 Tax Map 023
Town of Bridgton, Maine
