National Register of Historic Places Registration Form

historic name	Ford M	lotor Cor	npany Se	rvice Bui	ldina							
other name/site						CO Buildin	ng					
2. Location	- Partusai											
street & town	280 S	outh 400	West	arki aka mas	an a spirit Marina	eville aggreen, en eg r	ngilwanga sa antaragigi	e i e si si si singulari di	Table and report and an included		not for pu	blication
city or town	Salt Lak	e Citv									vicinity	
state Utah		code	UT		county Sa	alt I ake	code 0	35	zip code	□ 84101

Ford Motor Co. Service Building, Salt Lake City, Salt Lake County, UT

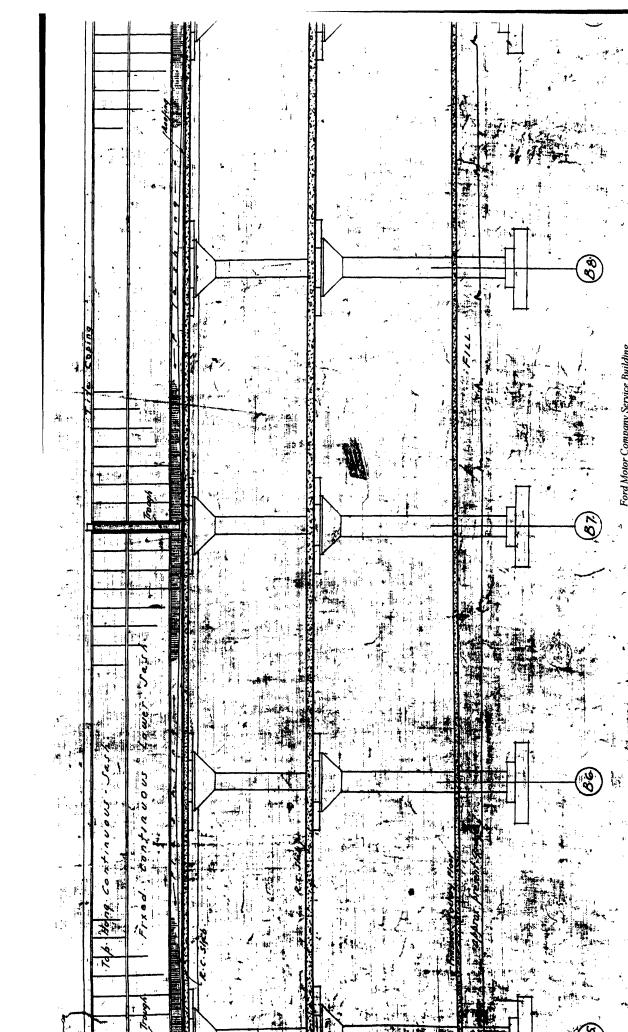
Ford Motor Company Service Building Structural section, copy of original drawing by Albert Kahn

The Ford Motor Company Building measures 164 feet by 246 feet and sits on a stone and concrete foundation. It is supported in the interior by reinforced concrete columns on both the main and second floors. The columns are mostly cylindrical with splayed tops and octagonal flanged shear caps. Exceptions include the non-splayed columns near the interior dock, hexagonal columns in the main floor showroom, and a few square columns near mechanical areas. The building has several rooflines supported by various sets of steel trusses with roof monitors. The south, east and west exterior elevations are brick and glass curtain walls supported by concrete piers faced with red brick.

Both floors are well lit and ventilated by the large daylight-factory windows and two roof monitors set in steel trusses. The western monitor lights the two-story-high shipping dock and the east monitor provides light to the second-floor factory area. The roof is built-up asphalt except the monitors, which are covered with metal above the sloped skylights. The penthouse above the freight elevator is faced with brick on all four sides. A concrete coping and aluminum caps are found on the south and east parapet walls. The 60,000-gallon water tank mounted on the roof has been painted. Two original flagpoles are mounted on the roof directly above the entrance on the south elevation. The basement is only partially excavated at the north end to provide a boiler room. The building has been given a new HVAC system.
