National Register of Historic Places Registration Form

Historic name Deerfield State Bank
Other names/site number Deerfield United States Post Office; Bacon Drug Store KHRI #093-17
Name of related Multiple Property Listing N/A

Street & number 602 Main Street not for publication
City or town Deerfield vicinity
State Kansas Code KS County Kearny Code 093 Zip code 67838

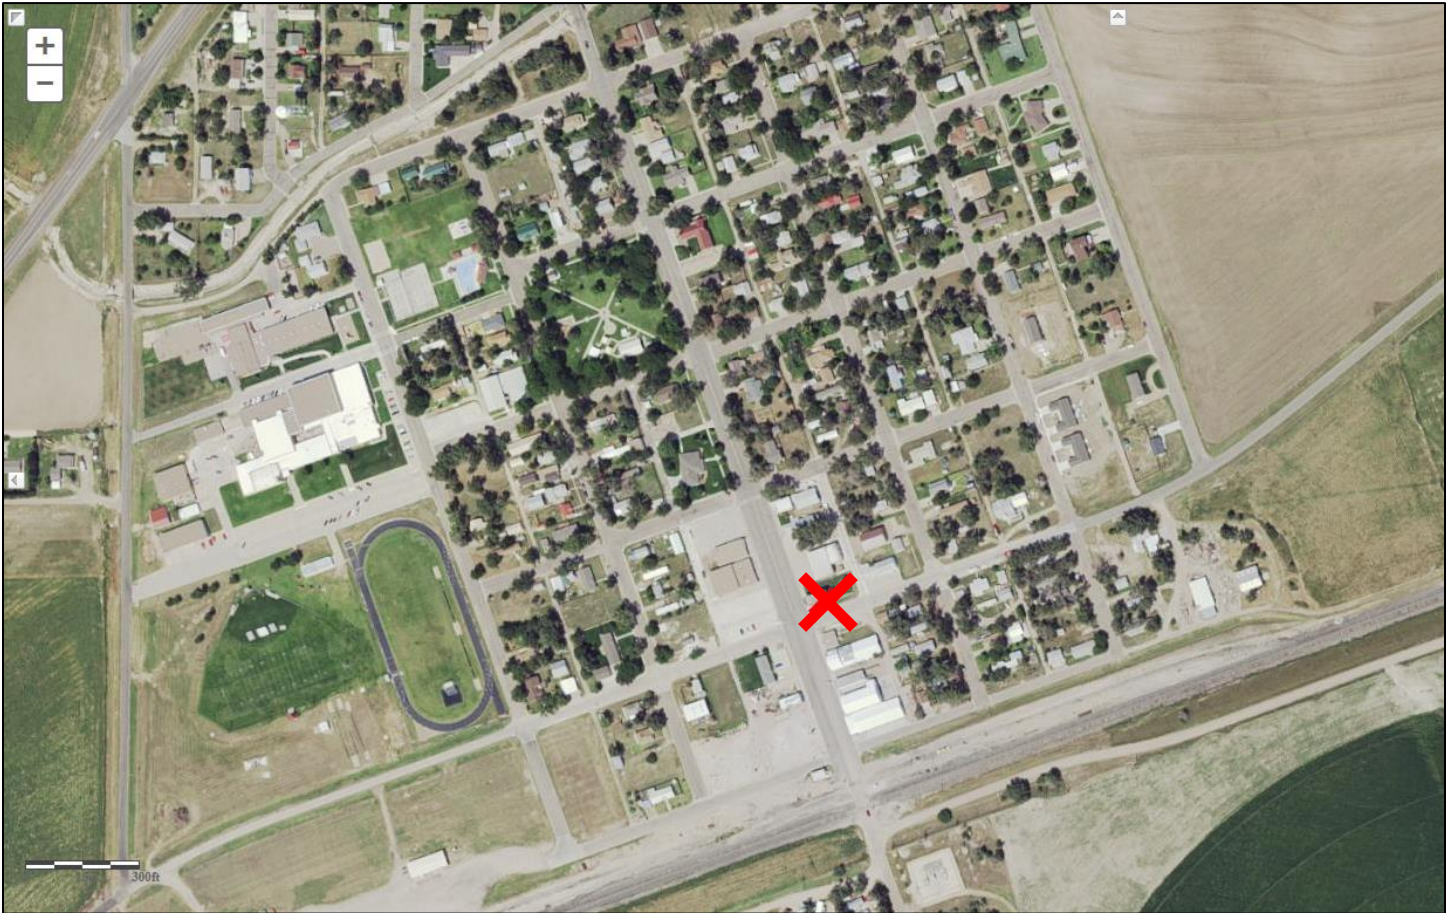
Figure 1: Contextual image, showing location of bank within the city of Deerfield with an X (KHRI). North is up.

The 1907 Deerfield State Bank is located at 602 Main Street in Deerfield (2010 pop: 700), Kearny County, Kansas just two blocks north of the Santa Fe Railroad tracks. The two-story brick building occupies a corner lot at the northeast corner of Main and East 6th streets (*Figures 1 & 3*). Distinguishing features of the building include the patterned brick parapet, canted bank entrance, and large arch-top display windows. To the east of the brick building is a one-story wood-frame structure with pressed metal siding and a simple metal parapet on the south façade. Both buildings are considered contributing resources.

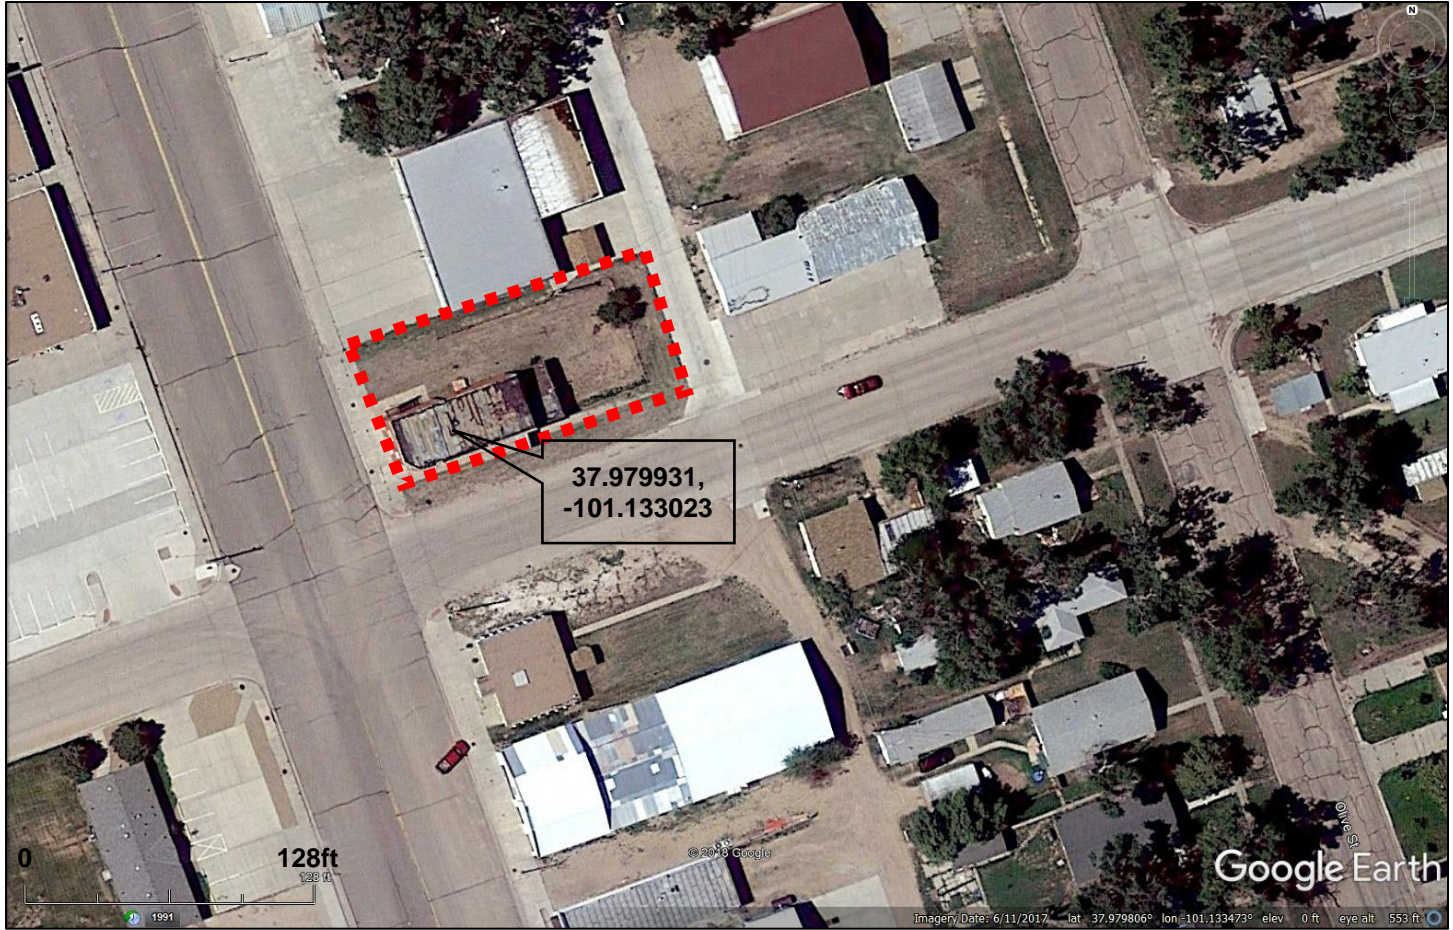
Figure 3: Boundary Map (Google Earth).

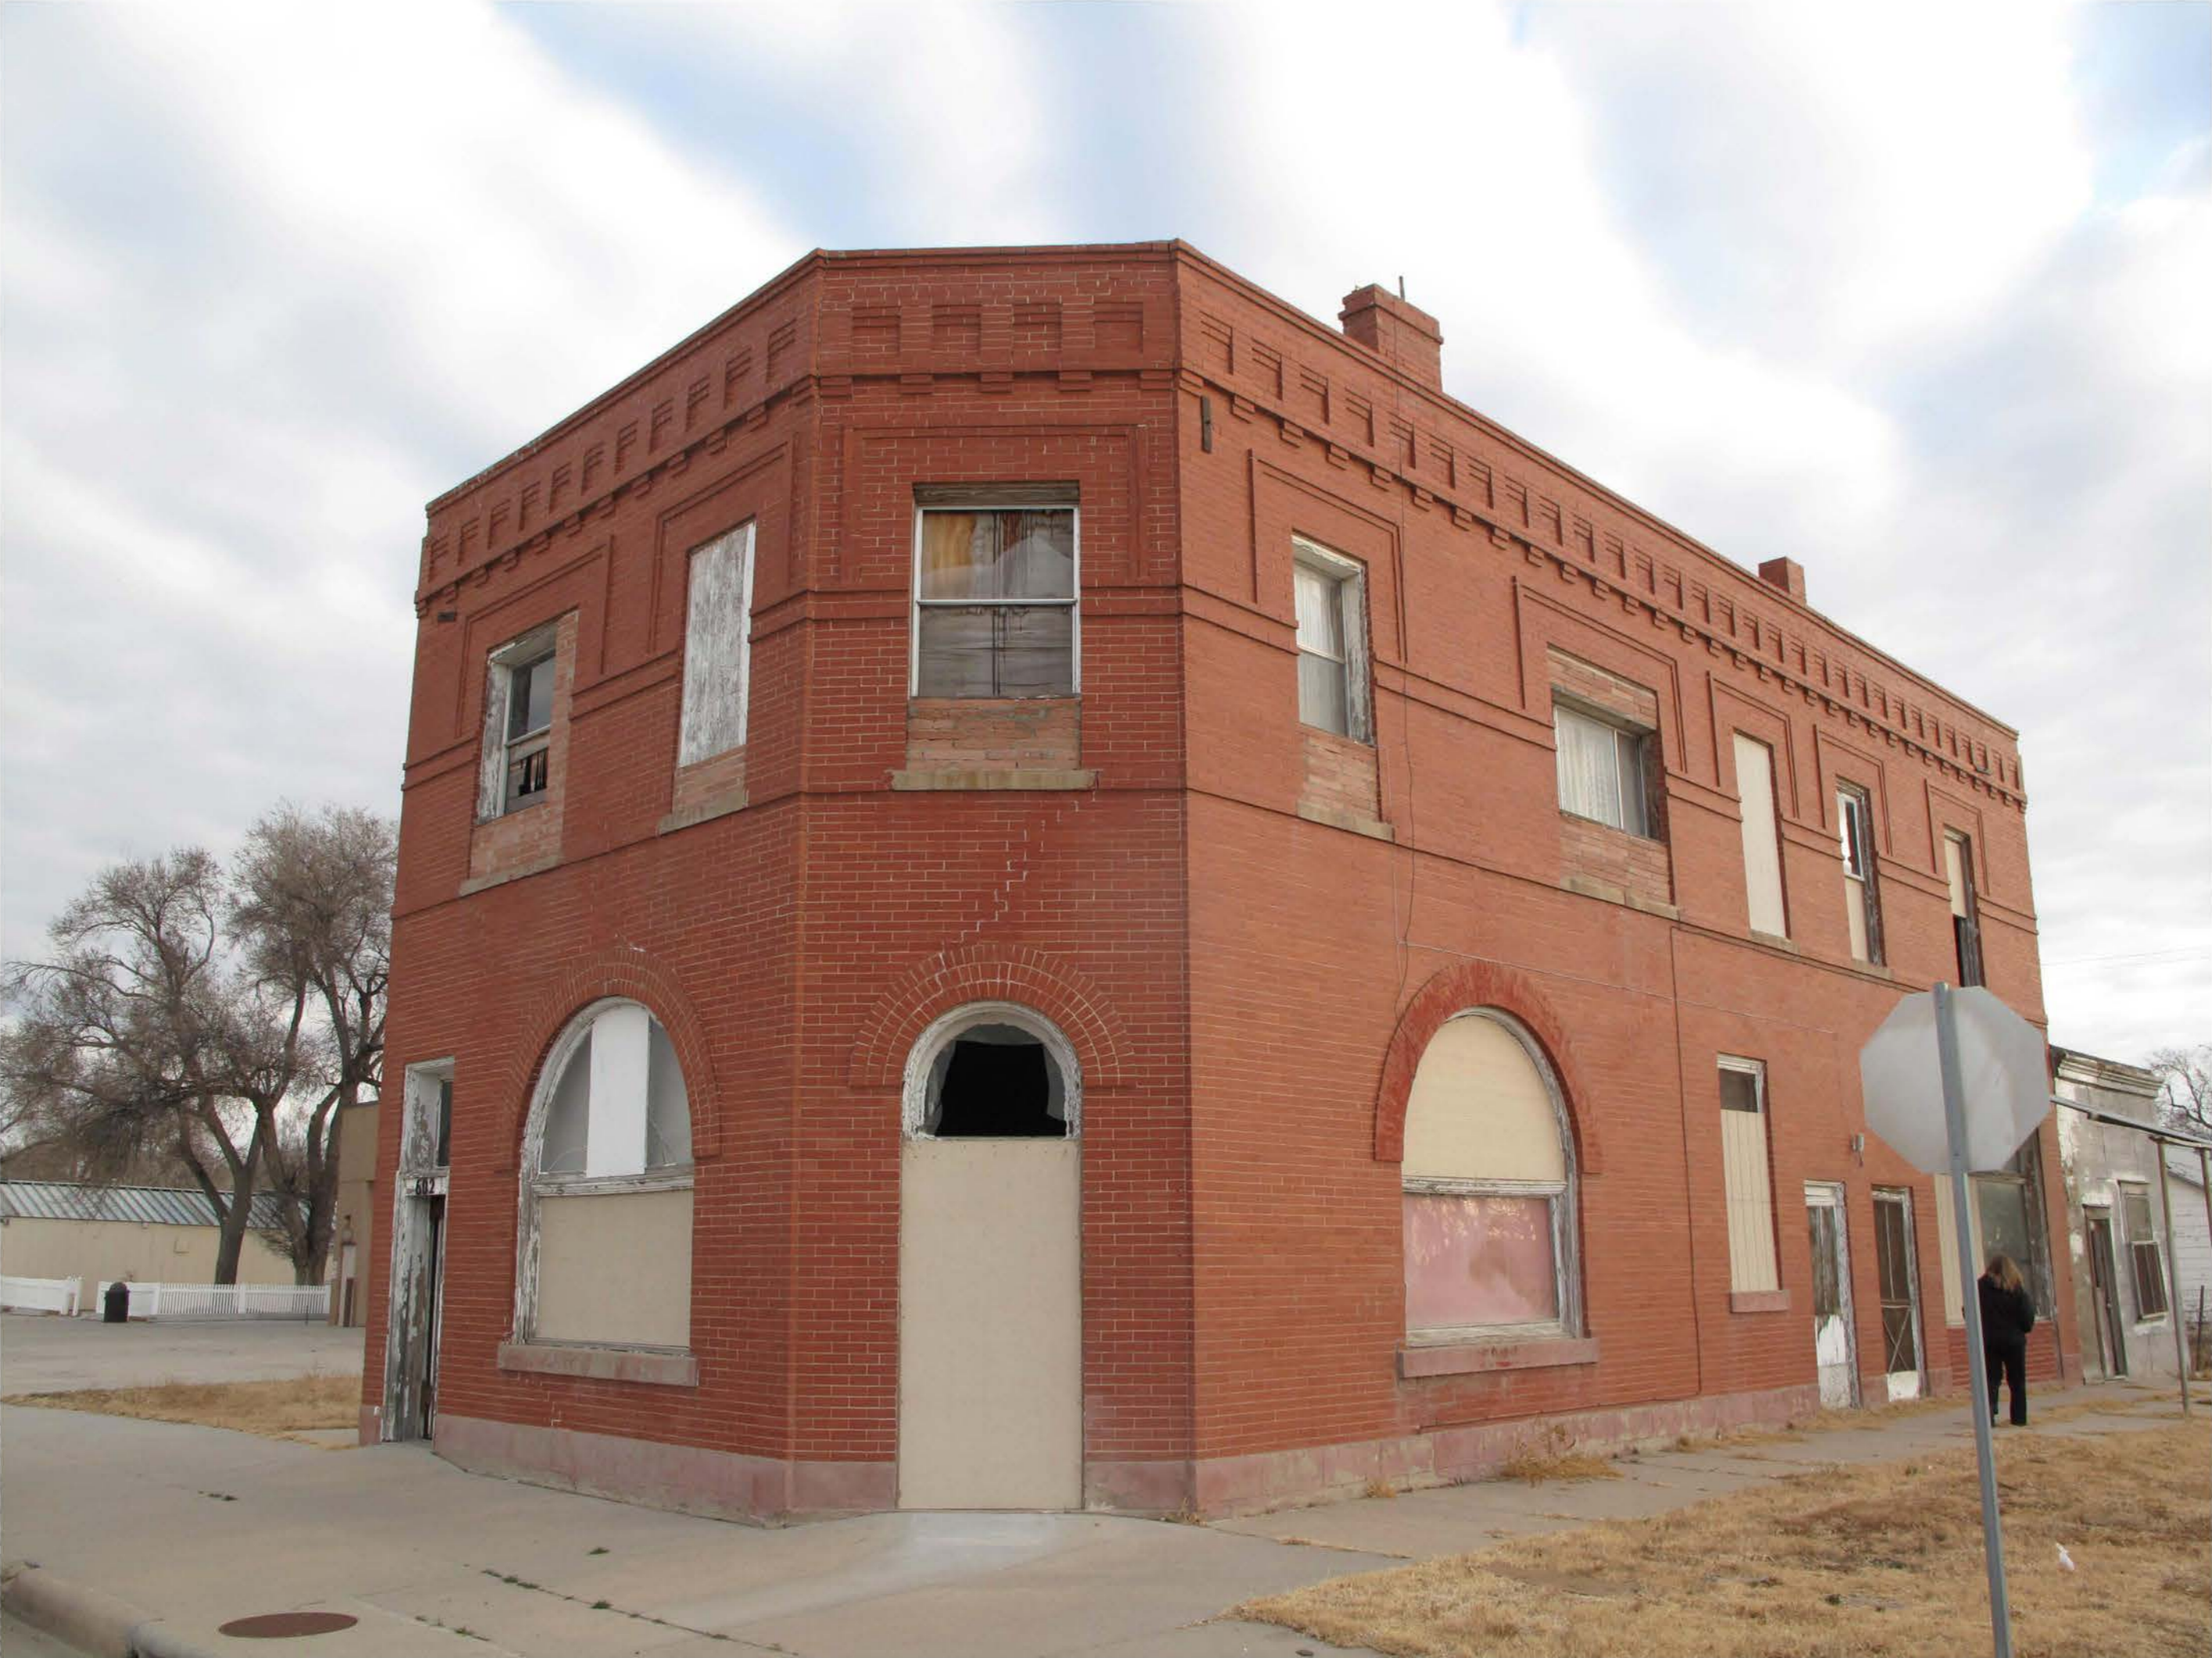
The west façade faces Main Street (*Photo 1*). The street level contains a historic wooden door with rectangular transom at the north end of the wall and a large arch-top display window to the south of the door. The arch is made of three brick courses. The window itself is historic with a single pane of glass in the bottom half and a rounded upper window divided into three vertical lights; the window works on a pulley system. The upper level contains two rectangular masonry openings. The original window units have been replaced at an unknown date with smaller wooden units and brick infill, but the original masonry openings are discernible. This is a typical treatment on the building unless noted otherwise. The upper portions of the masonry openings are surrounded by rectangular brick surrounds (typical of all upper windows). All windows on the building have simple stone sills that are in line with a brick datum that runs the length of the public facades.

The building's main entrance is located in the canted southwest corner of the building (*Photo 1*). The entrance is through a single, historic wooden door. This door has a lunette transom window above it that is made mainly out of glass. The original door consists mainly of glass but is also bordered by wood. A single window is located above the door.

The south façade faces 6th Street (*Photos 1 & 2*). The ground level has five historic masonry openings. The westernmost opening is a round-arch display window like that on the west façade. To the east of this window is a historic double-hung window. To the east of this window is a historic Craftsman style door (three lights in upper third with two vertical panels below). Another door is located to the east of this door. The easternmost masonry opening contains a large rectangular display window with steel lintel. The window has four vertical lights in the top third and two vertical lights in the bottom part of the window. The bulkhead is brick of a different type than the remaining wall, indicating this window, although historic, was potentially installed after the building's construction. A corrugated metal awning covers this window and sidewalk and is supported by three metal poles. Five masonry openings are located in the upper façade. The opening second from the west is wider than the others; the windows located in the center and east bays appear to be historic one-over-ones (there is not brick infill in these openings).

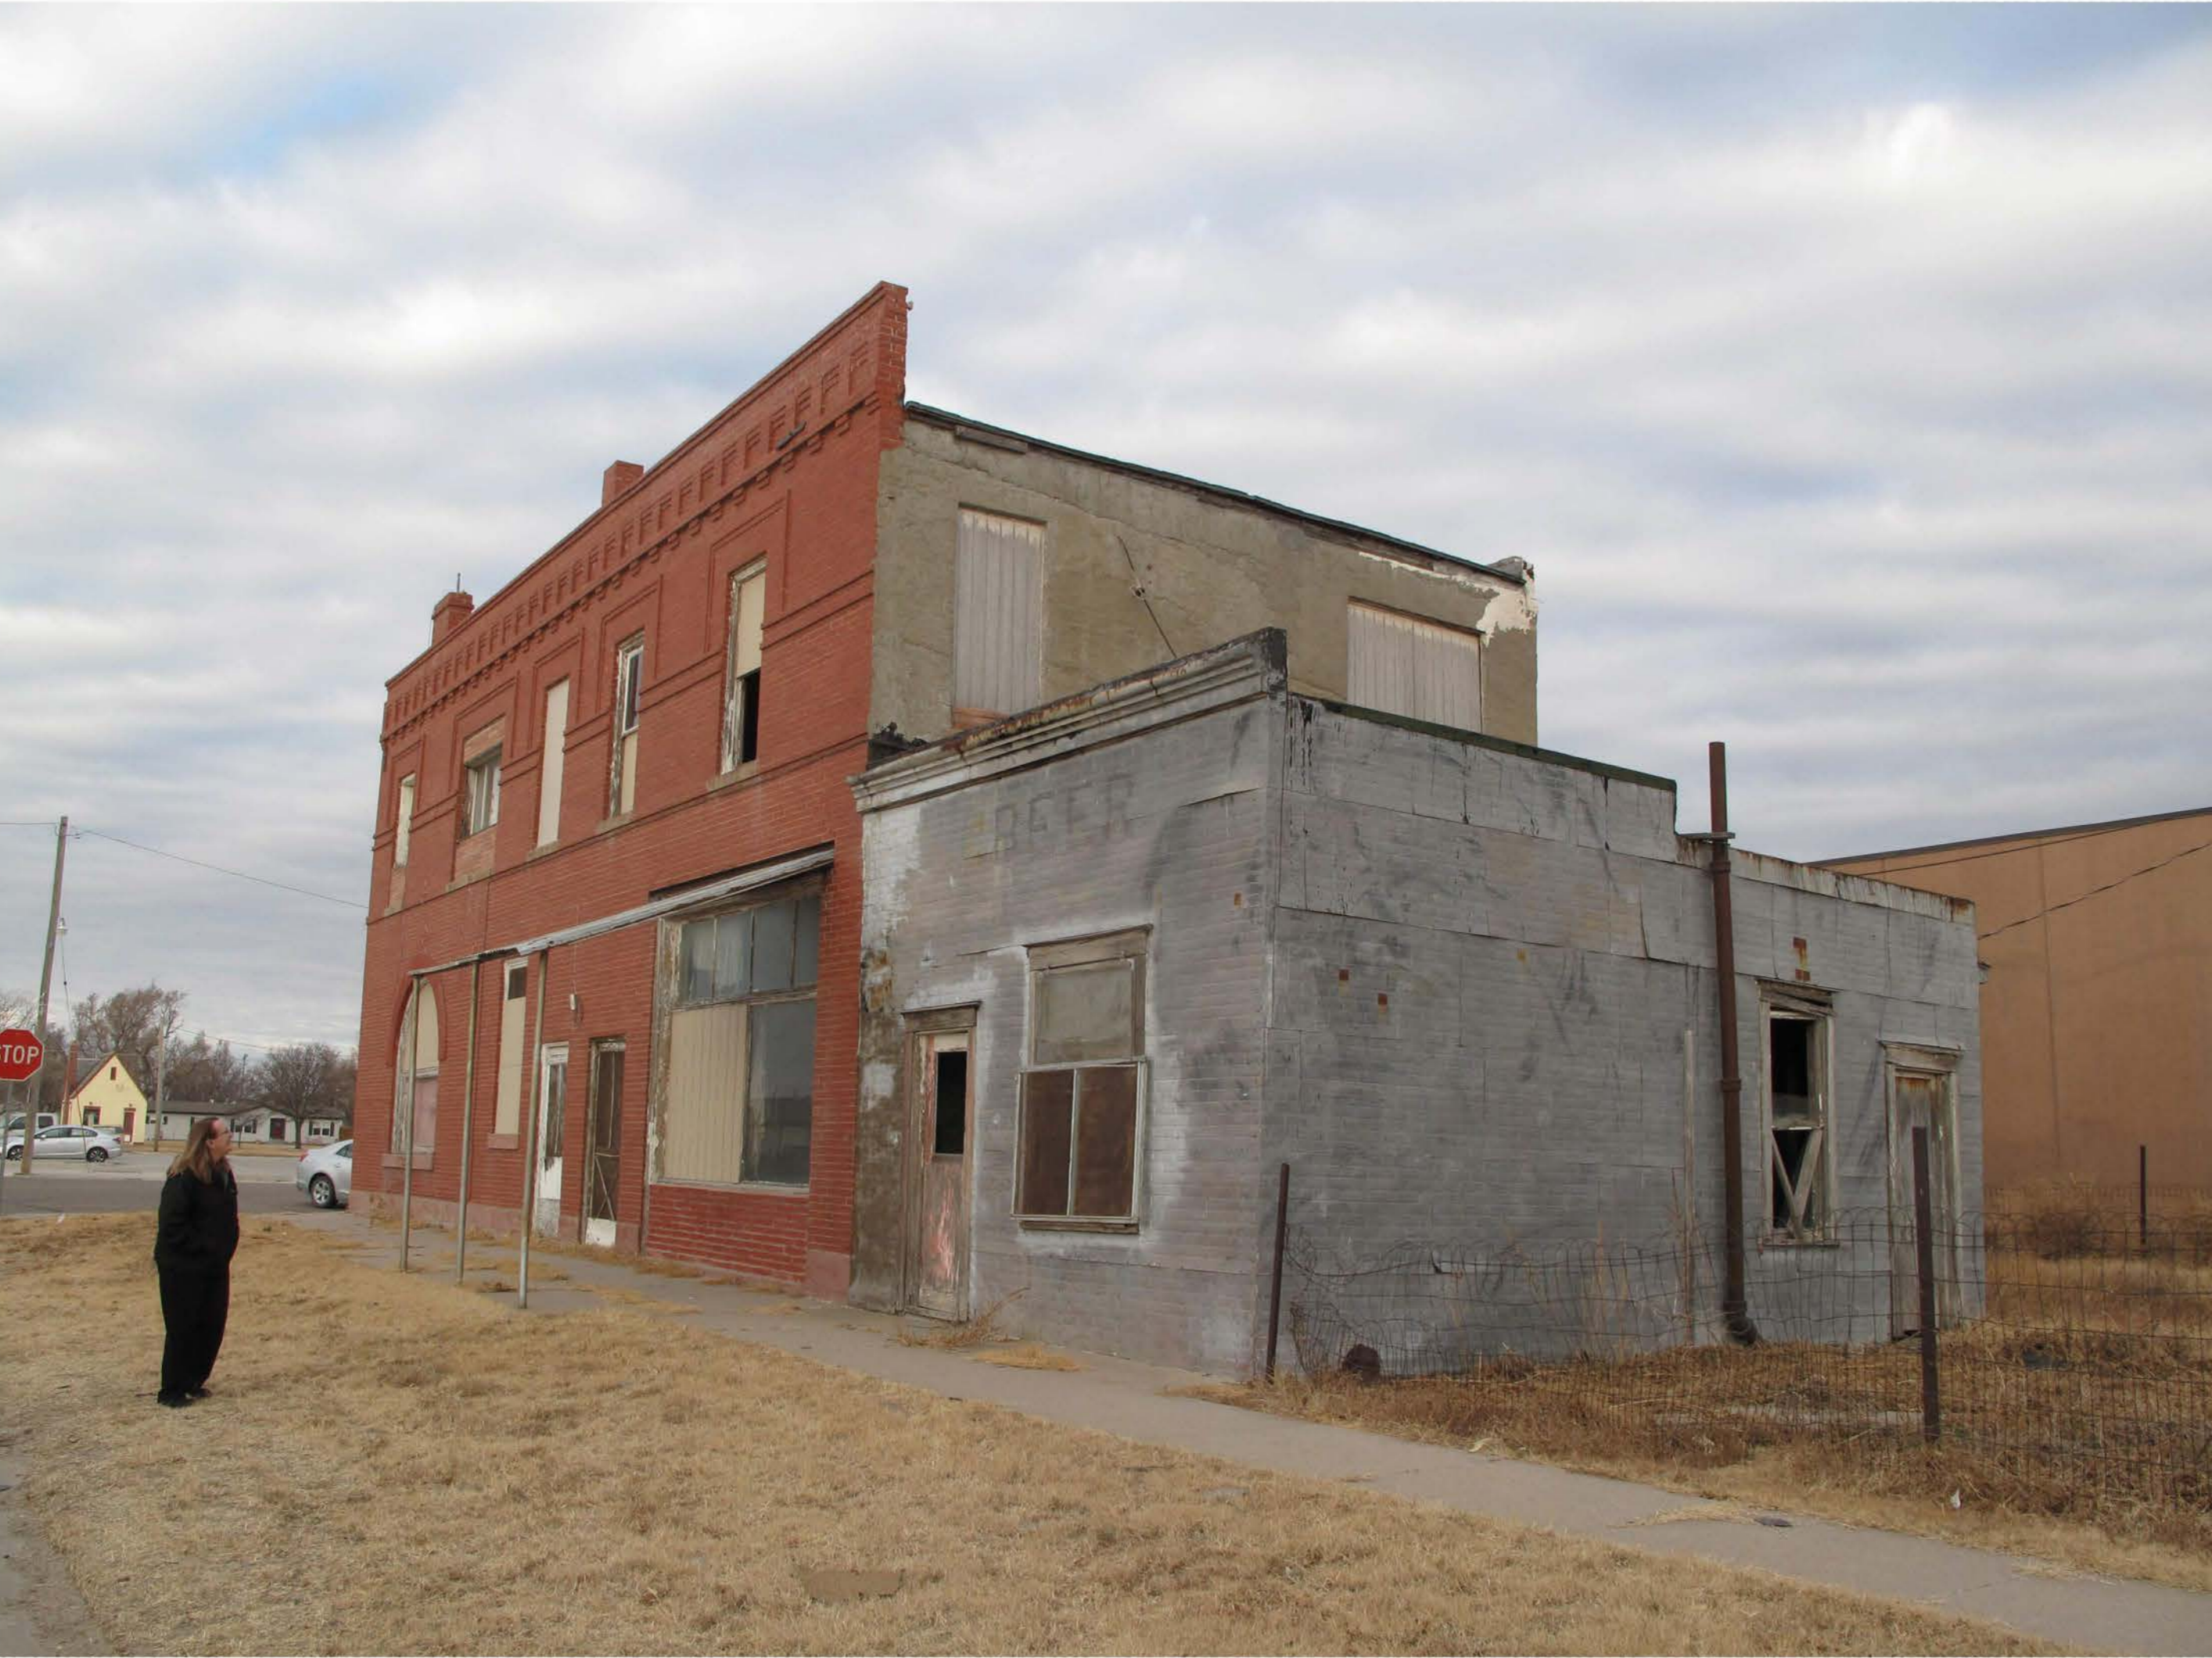
The east façade is partially obscured by the one-story building attached to the east of the brick building (*Photos 2 & 3*). Two historic openings are visible in the upper portion of the façade. The south window is a historic one-over-one window. The north window is covered on the interior and exterior, so its condition/integrity is currently unknown.

The east façade has a stepped parapet and two openings located at the north end of the wall (*Photos 2 & 3*). The south opening is a window that is in poor condition. A wooden door is located to the north of this window. A single window (covered) is located in the center of the north façade (*Photo 3*).

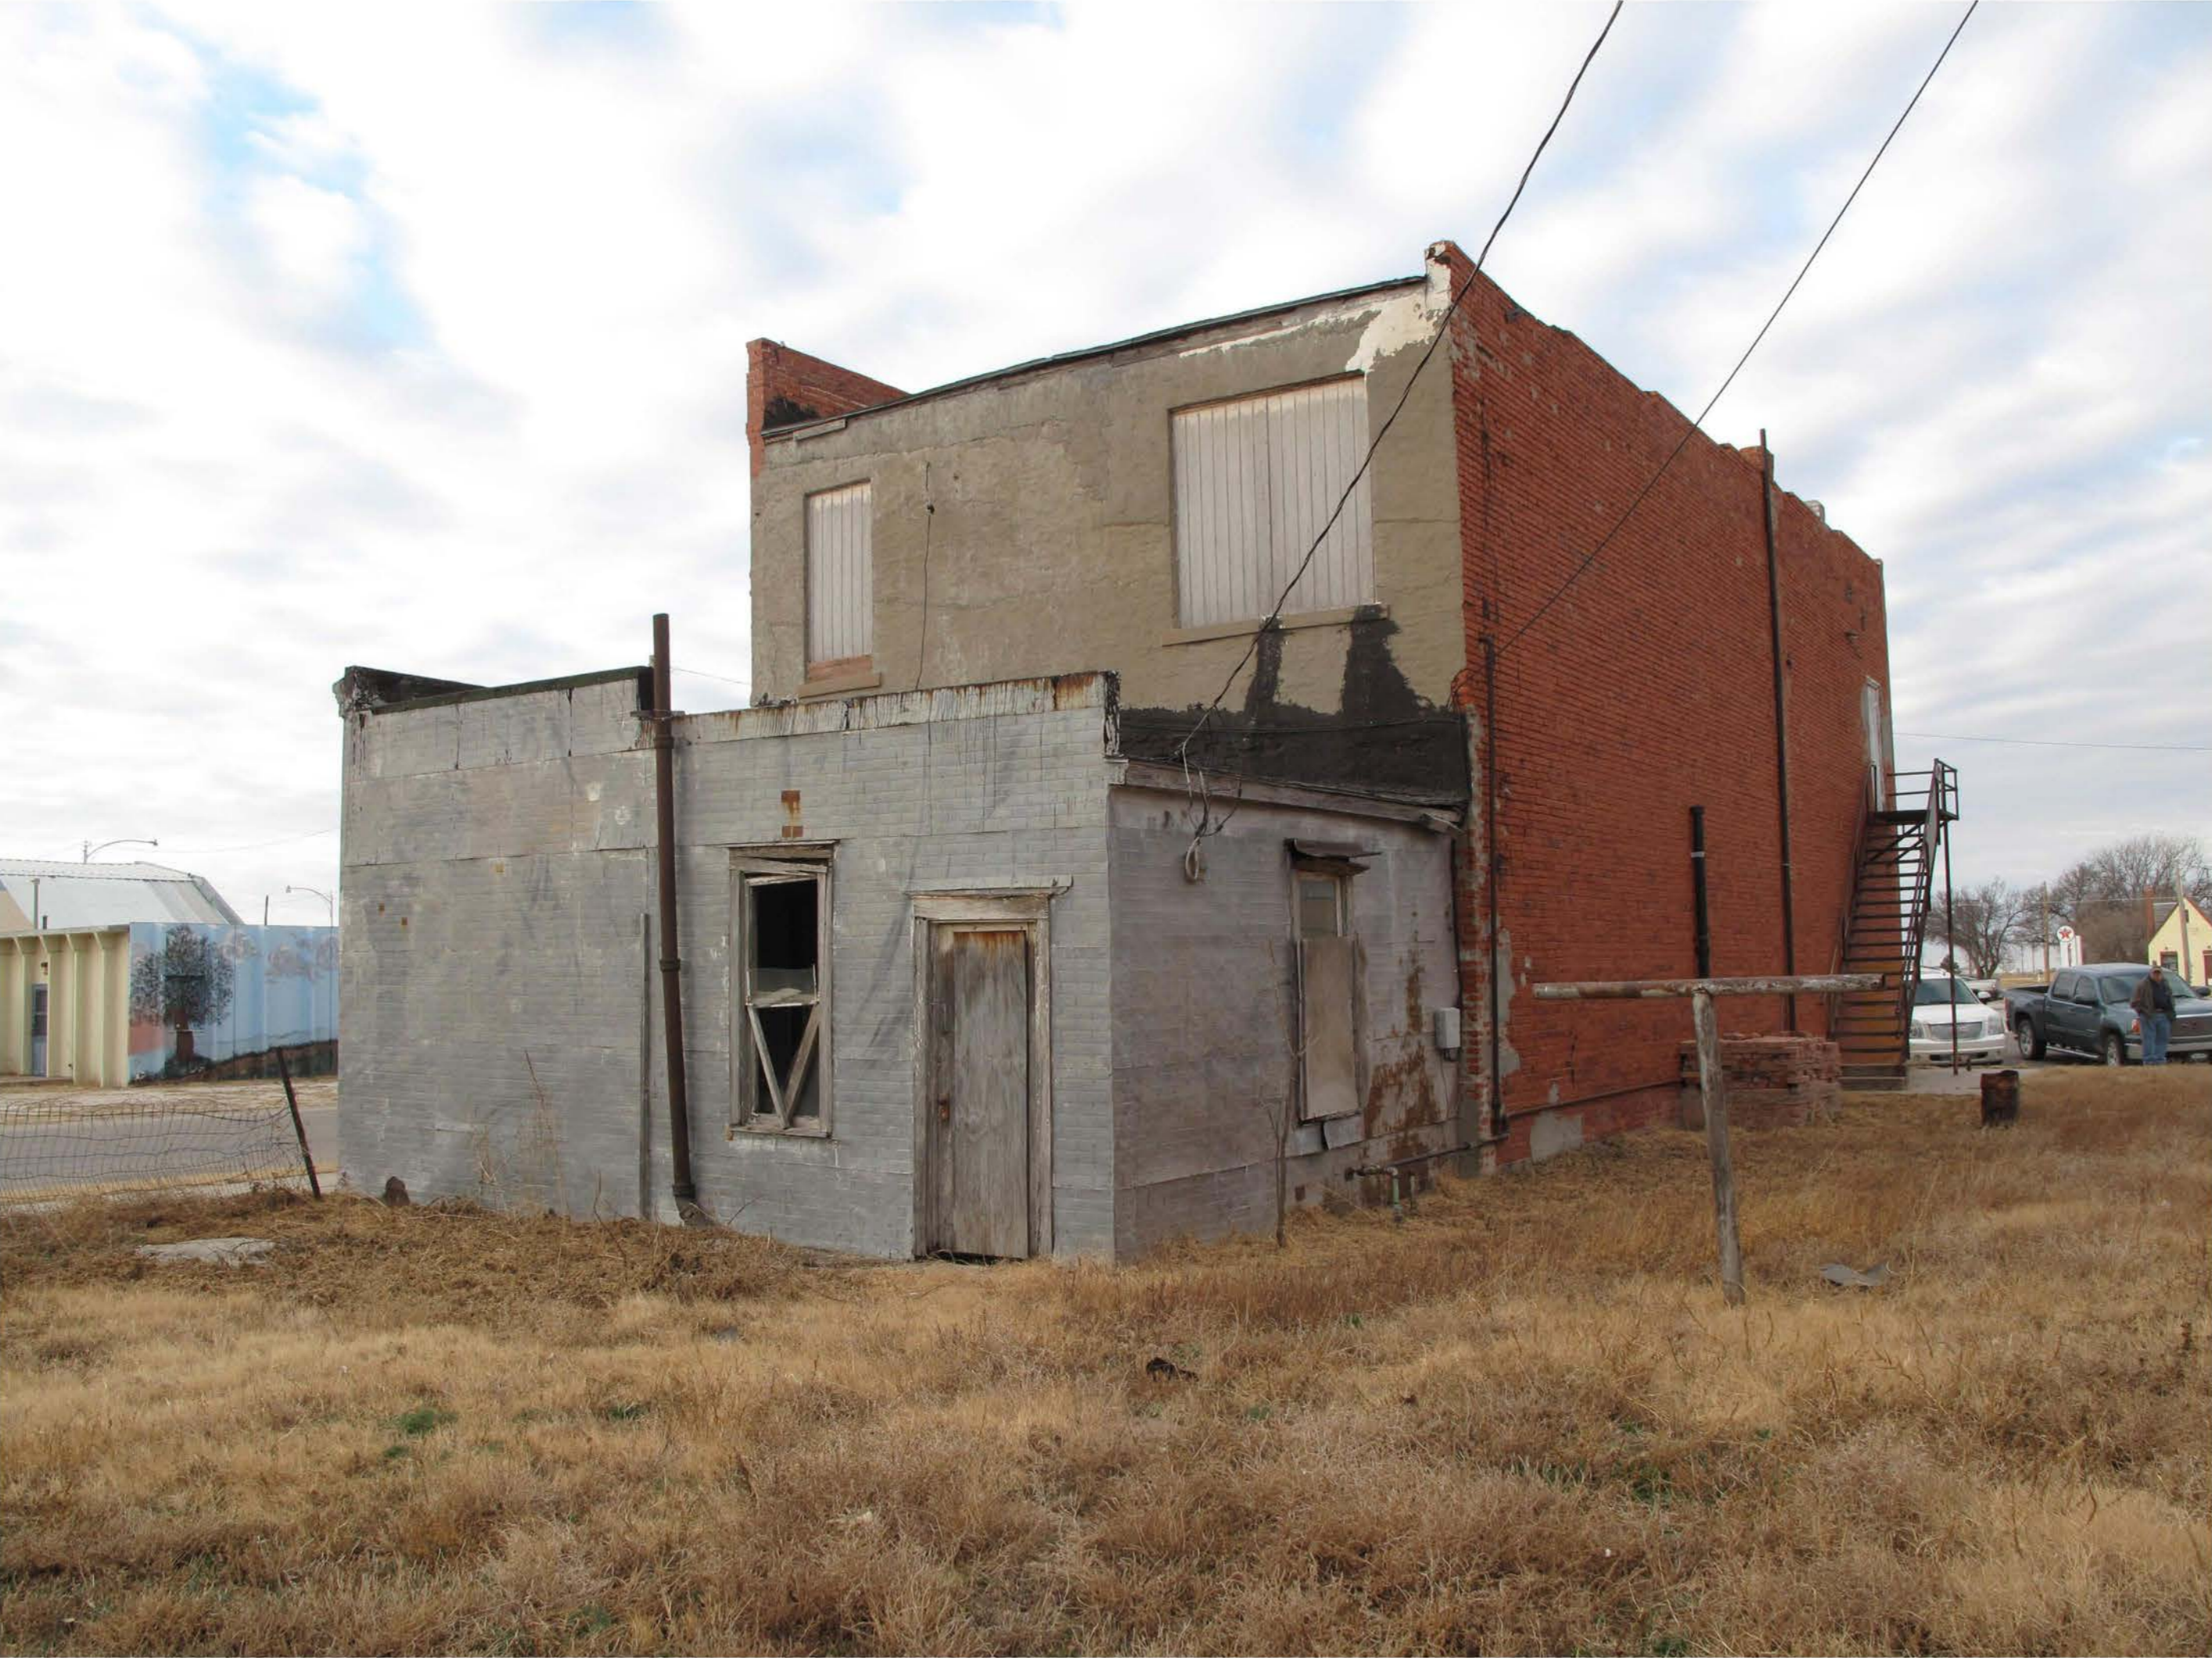
The north façade is unadorned and has a stepped parapet (*Photo 3*). One masonry opening is located at the upper level at the west end. This historic exterior door exits onto a metal staircase that leads down to the east along the wall, leading to a concrete pad. Underneath the fire escape is a yellow sign, advertising a circus that had come to Deerfield.

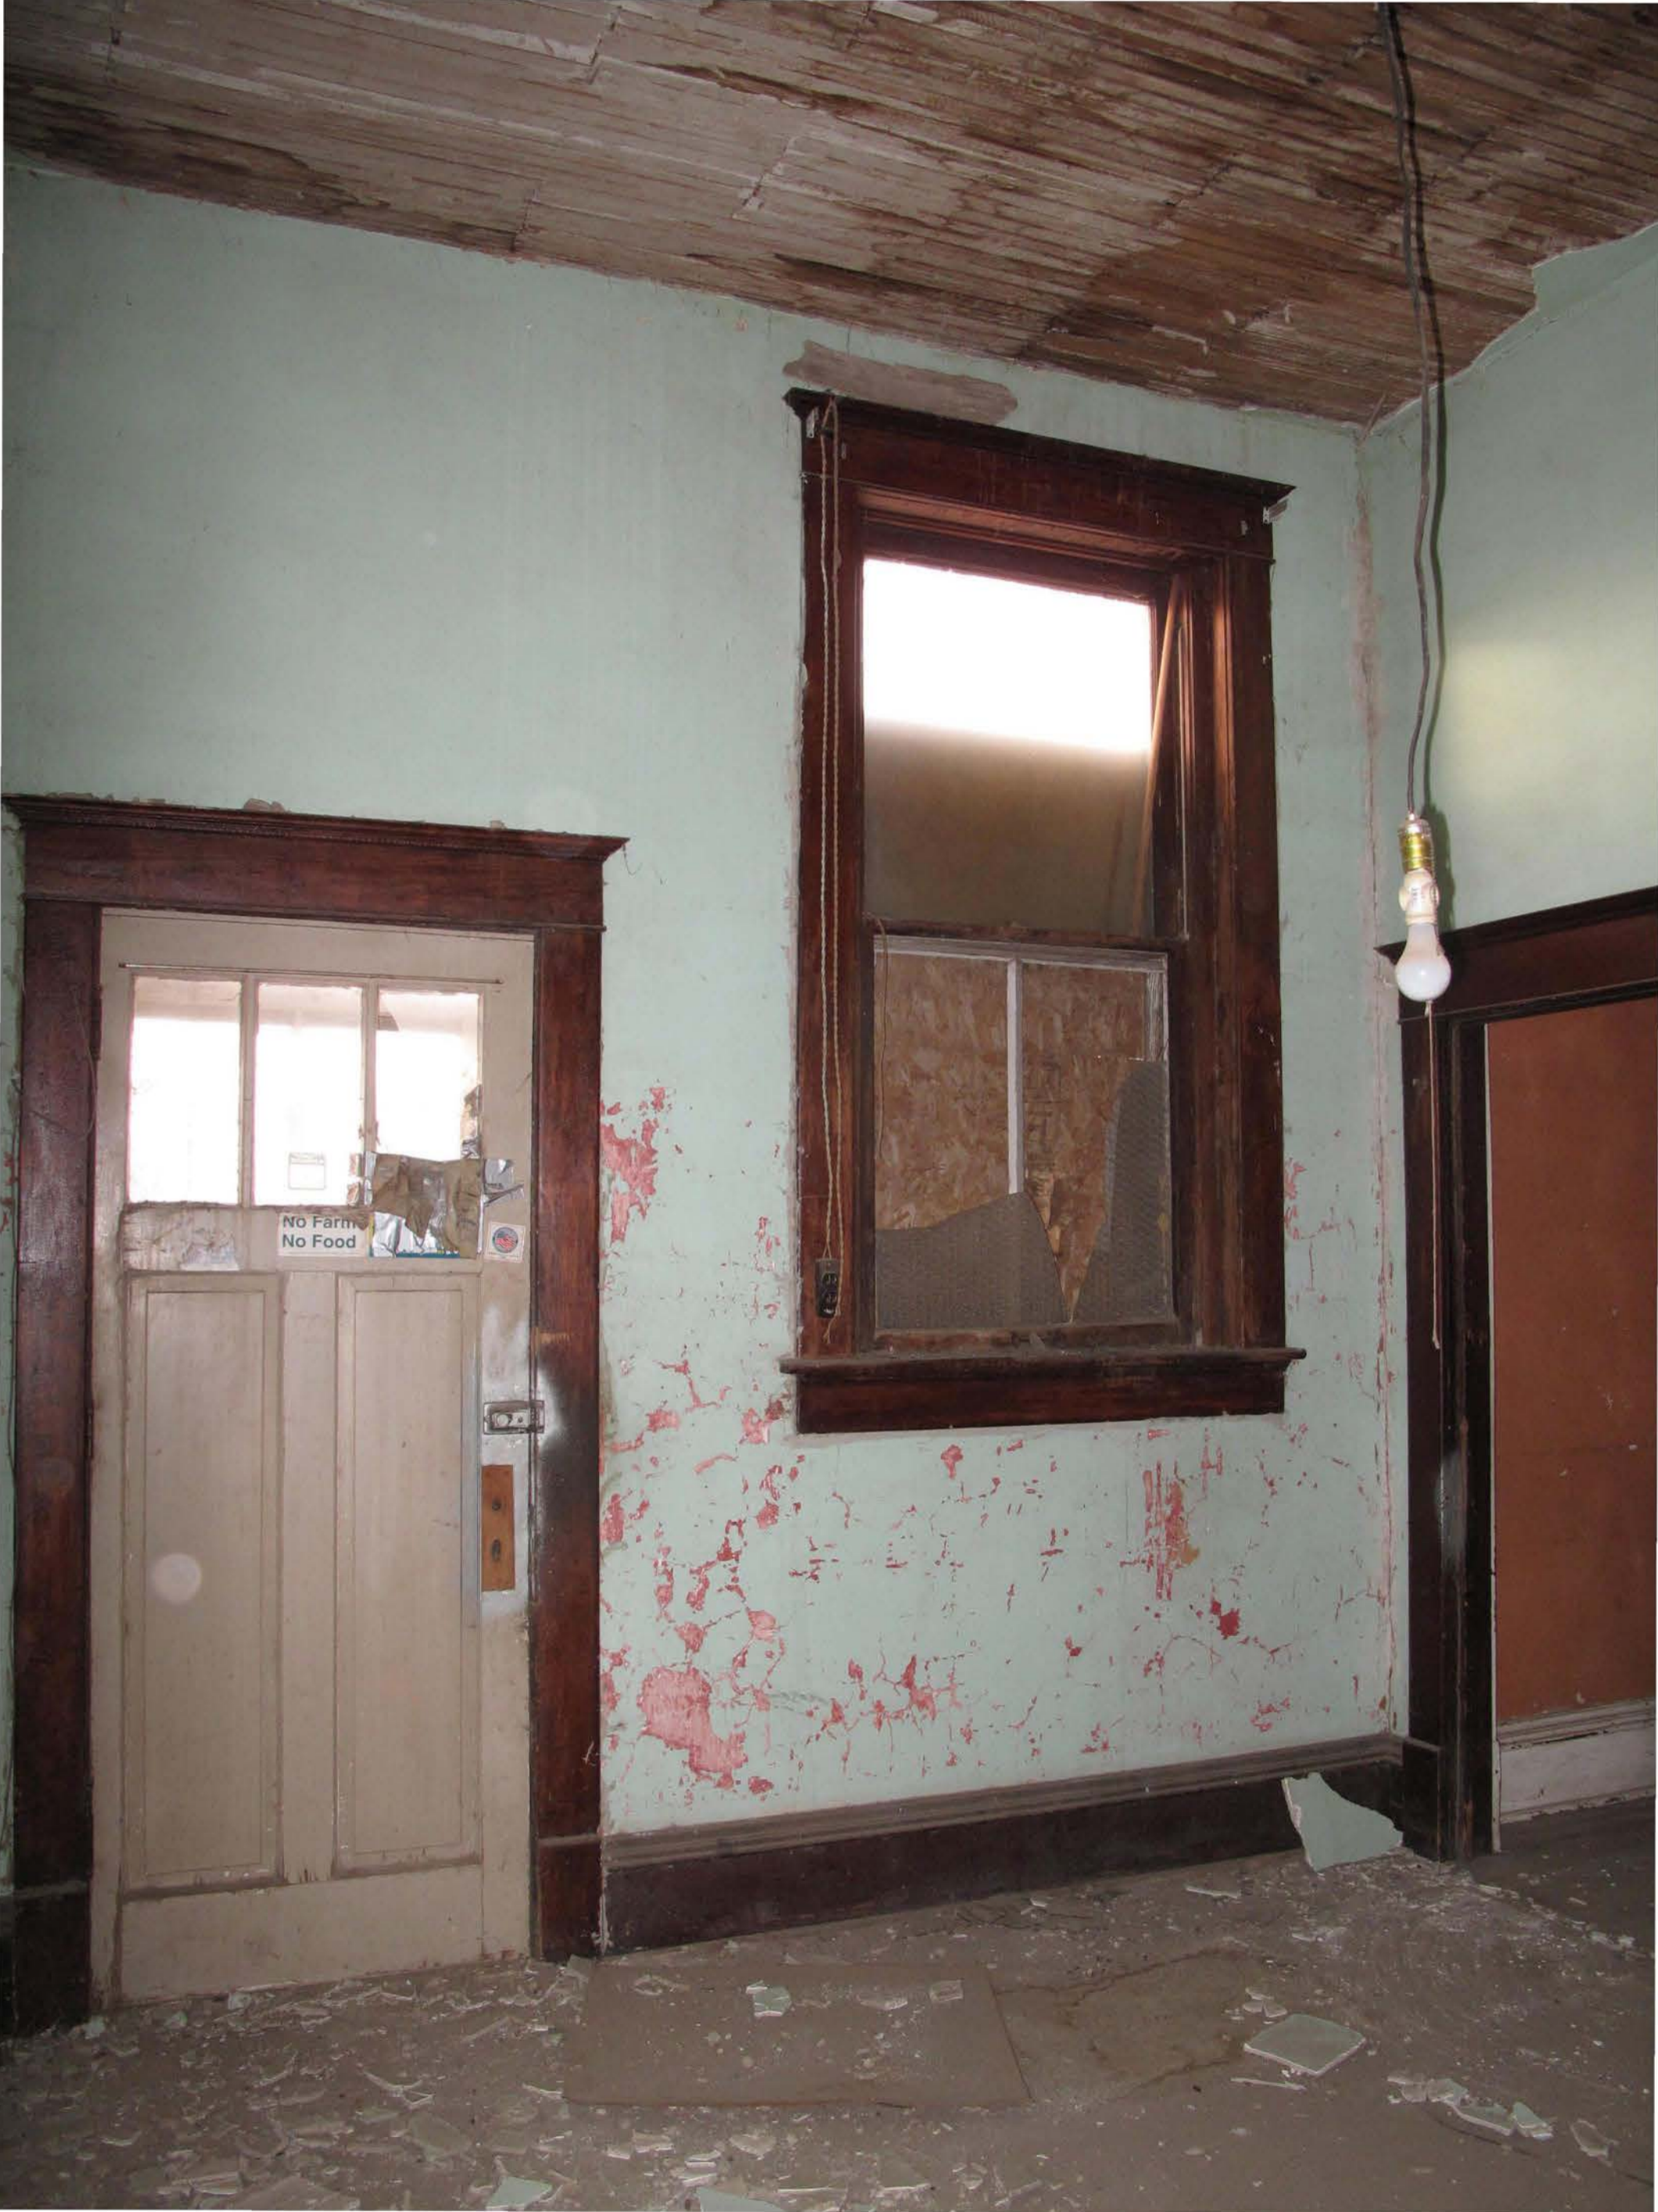
At the south end of the main room's east wall is a door into the former *bank president's office* (*Photos 4 & 7*). This room has an exterior door and window in the south wall but is otherwise bare. The ceiling plaster has almost completely failed, but the floor and wood trim are extant. There is a room to the east of the office that is accessed through a door in the south façade; this room was not accessed during a recent site visit.
