INTRODUCTION AND CONTENTS

This Field Guide offers step-by-step instructions about how to observe, take field measurements, and create field notes and a short-form report about a historic site or structure to HABS standards. These guidelines are intended for use by those without professional experience and/or training in the production of drawings and the undertaking of field work. They address floor plans, elevations, and details to help develop basic note taking and delineation skills. Once these skills are mastered, recorders can refer to the HABS Guidelines for Measured Drawings to learn about site plans, sections, axonometric, and other more complex types of drawings. The Secondary House at Best Farm was selected as the case study because its relative simplicity encourages the development of basic skills and the establishment of realistic goals, while still offering thought-provoking interpretation. This guide is supplemented with a “Field Observations” and “Short-format Report” sections, as applied to the Secondary House, to assist the recorder with learning to “read” a building and to report on their findings. The Field Observations are applicable to both the preparation of

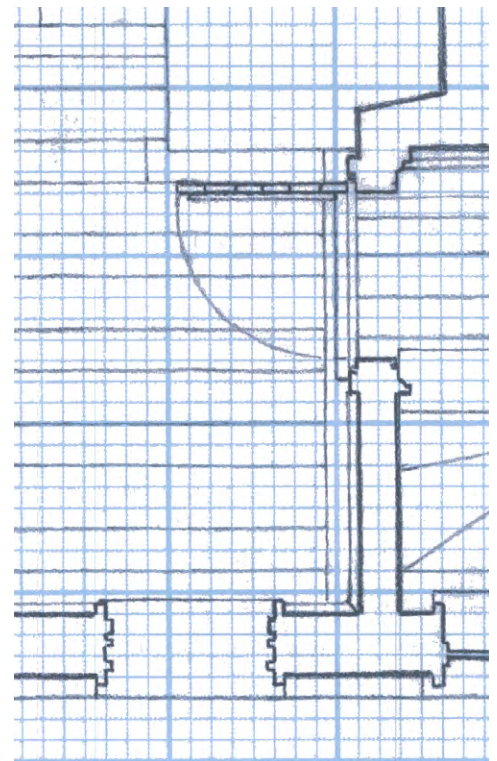
Level of detail typically required for a floor plan field note.

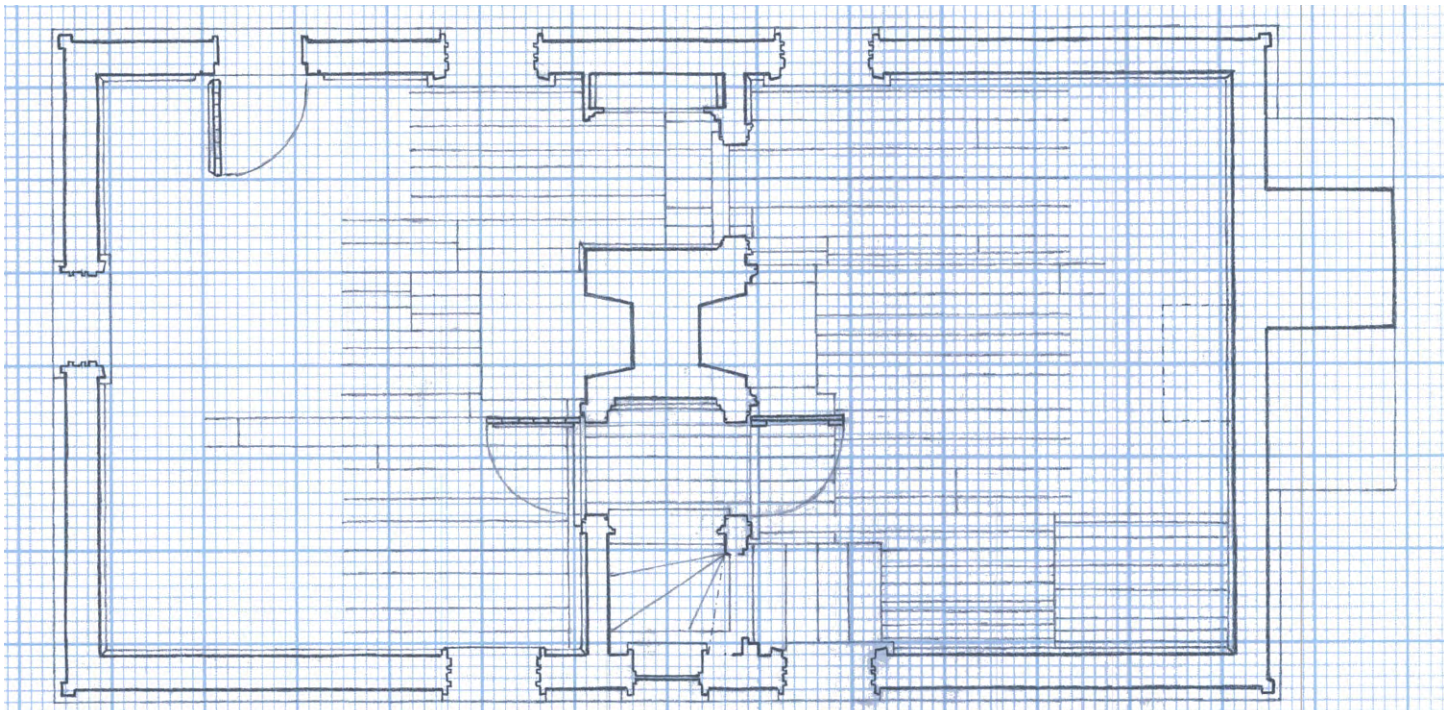
Completed sketch of the first floor plan, Secondary House

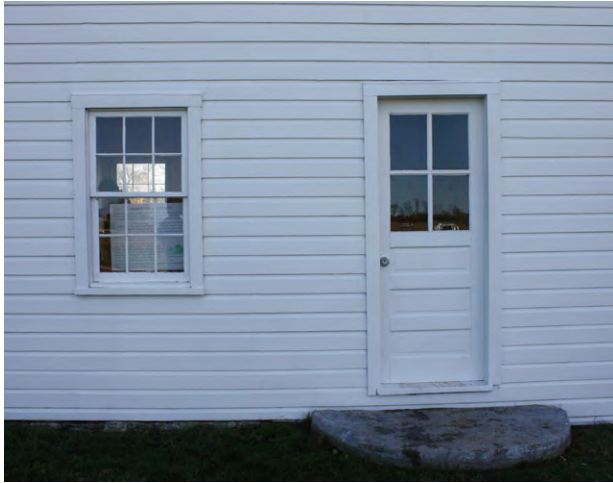
North Entry, Farm House

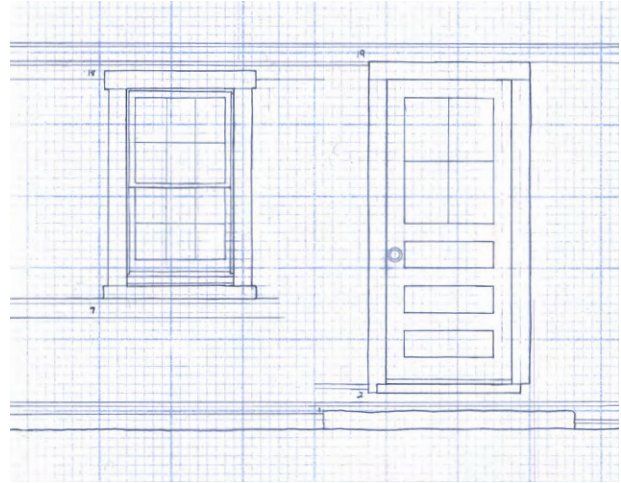
Field Sketch

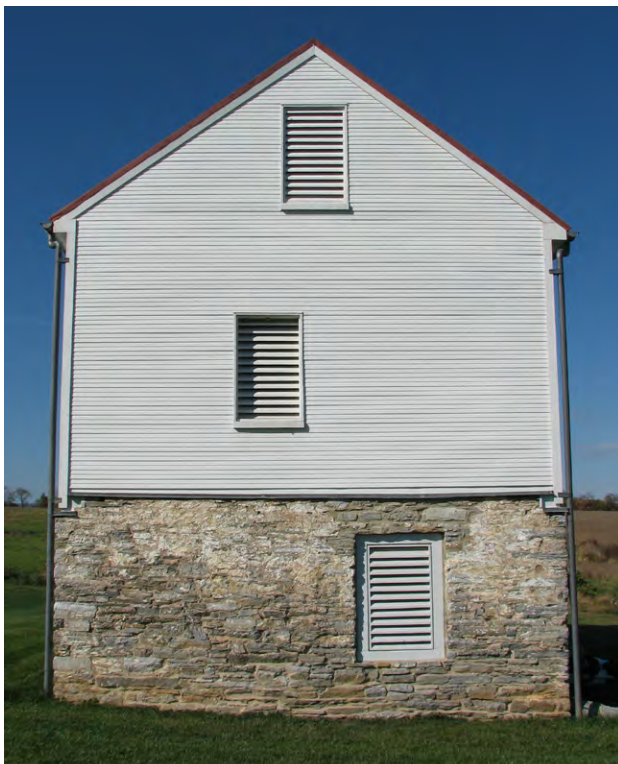
South Elevation, Secondary House

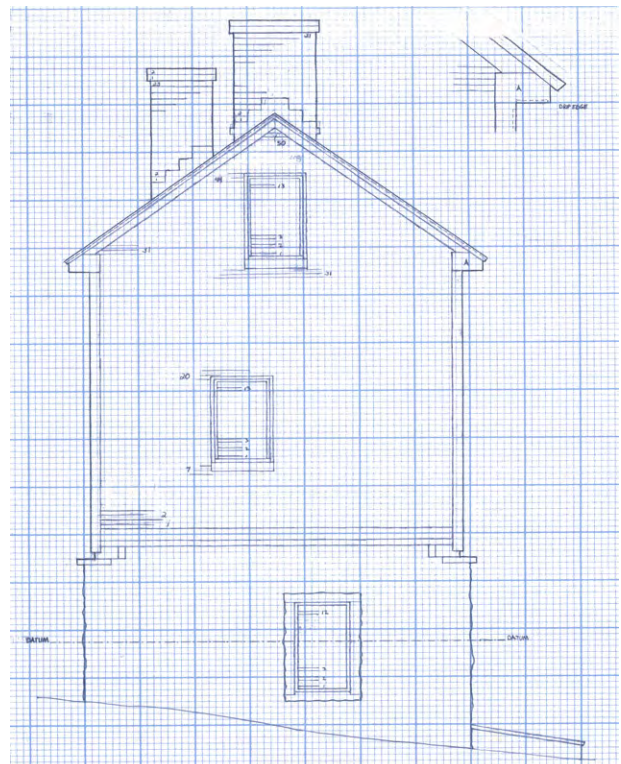
Field Sketch

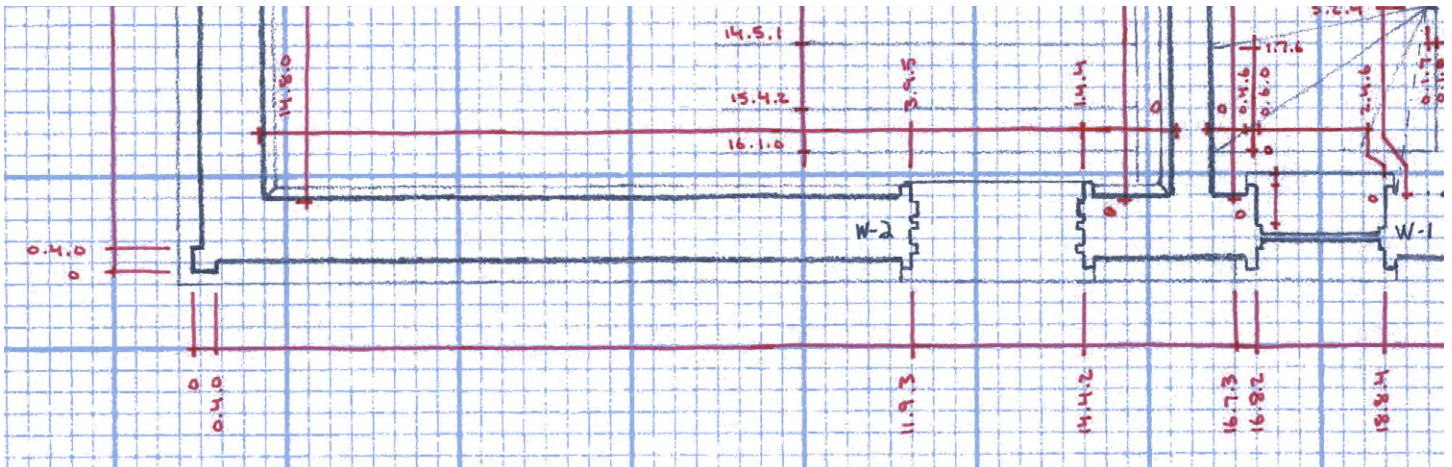
First floor plan, Secondary House

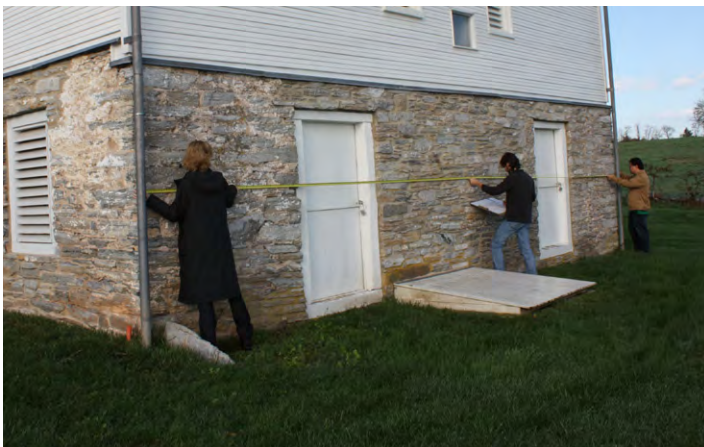
Measuring the first floor plan, Secondary House

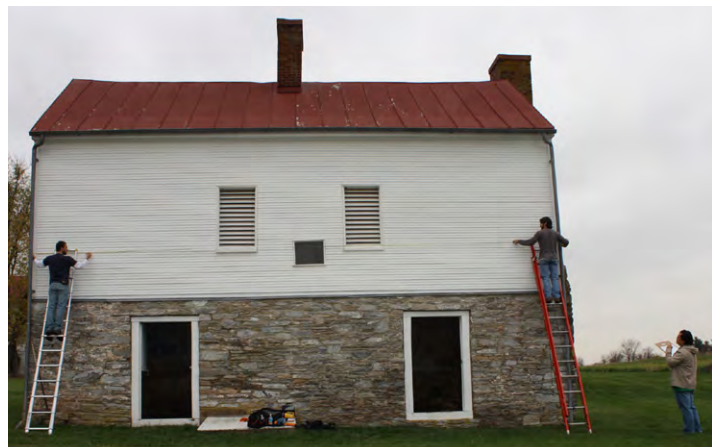
Measuring the second floor plan, Secondary House.

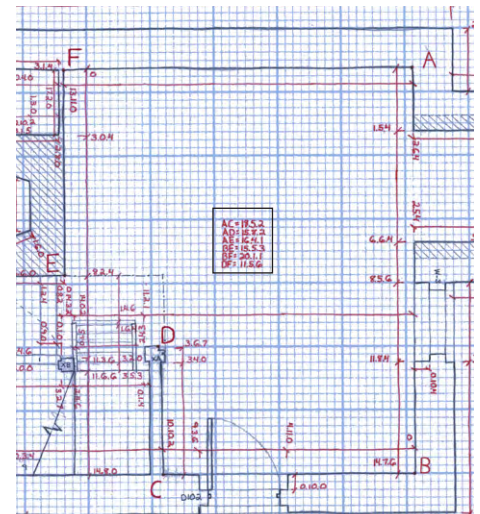
Ground floor plan with diagonals, Secondary House

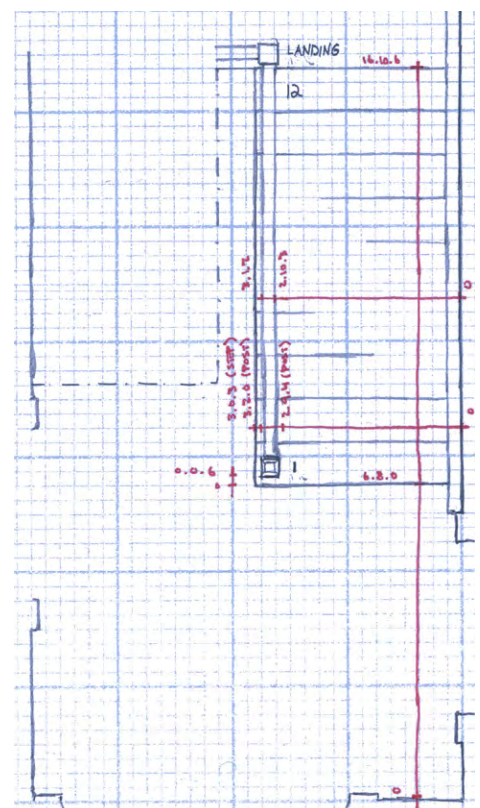
Typical first floor stair dimensions, Farm House

When measuring stairs, measure both the first step and the highest step possible from the same zero. Then divide evenly by the number of treads. It is not necessary to measure individual steps unless they are obviously irregular. Always measure to the nosing and not to the riser underneath. Be sure to locate any newel posts and hand rails.

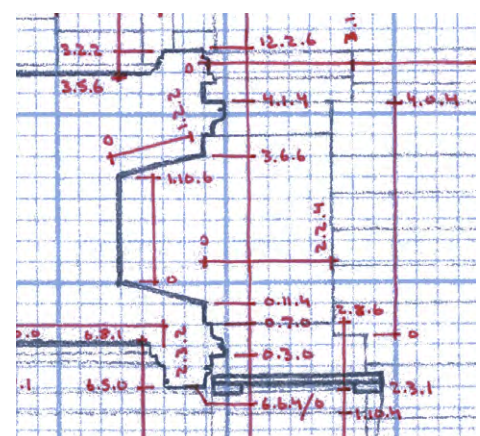
Fireplace dimensions, Secondary House

When measuring fireplaces, be sure to first locate the opening of the fireplace in a general string of dimensions. Then measure the perimeter of the firebox at its deepest point. Locate and measure the hearth in relation to the firebox opening. Remember to measure the mantel.

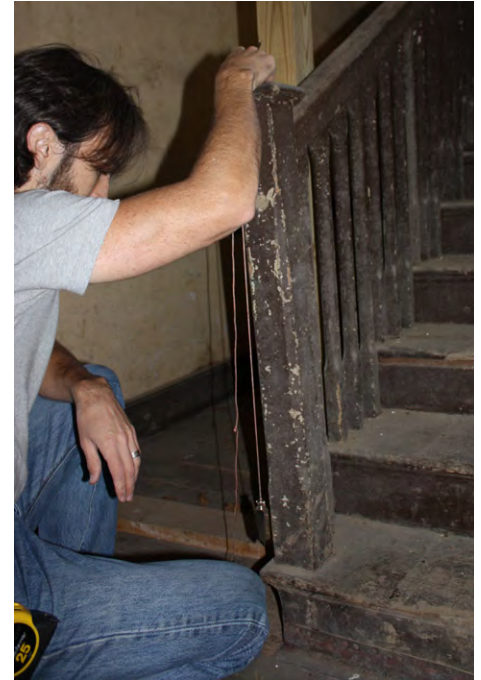
Using a plumb bob: A plumb bob can be used to tie ceiling or floor features into a string of dimensions taken at chest height, such as the edge of a stair tread or a ceiling hatch. After unstringing the plumb bob, allow it to come to a complete rest. If you are measuring up from the floor (figure 1), make sure the point is aligned with the feature you are measuring. If you are measuring down from the ceiling (figure 2), hold the string of the plumb bob on the edge to be measured.

Using a plumb bob to locate the first floor newel post, Farm House

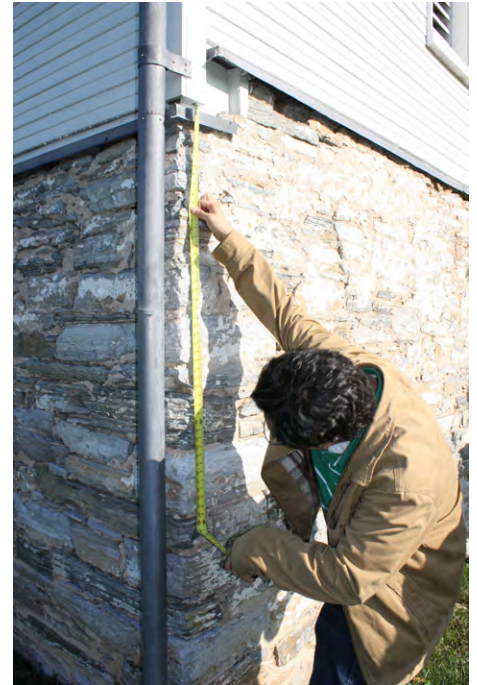
Measuring to the datum, Secondary House

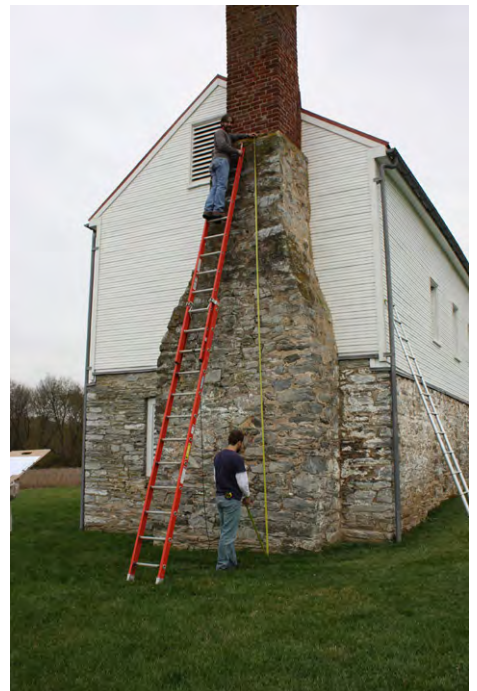
Chimney dimensions, Secondary House

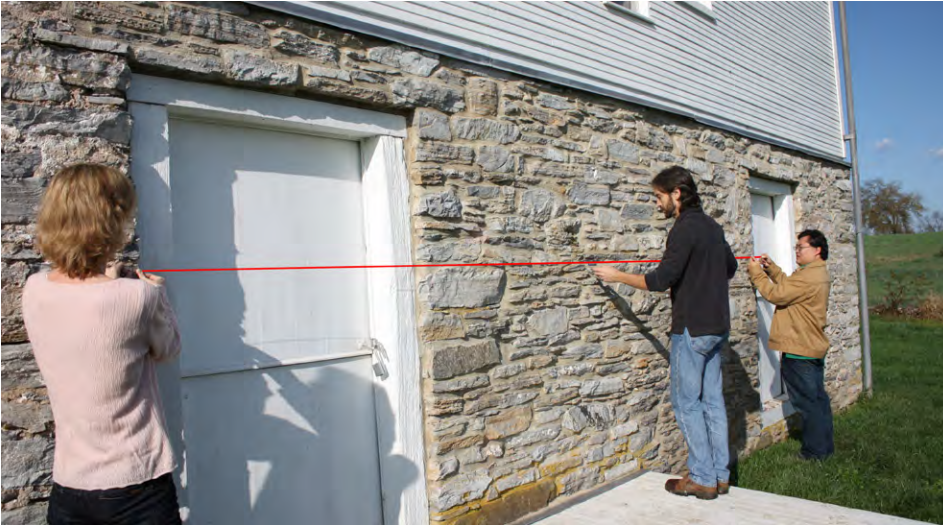
Using a line level: Decide where you would like to cast the datum; often this is done along a sill, though in the absence of any convenient features it may be arbitrary. The point can be marked with a pencil or tape according to building material. On your sketch, draw in the datum with a dash-dot line.

It takes three people to use a line level. The first person holds one end of the string at the mark, while the second person runs the string to the first door or window, pulling it taut. The third person centers the line level between the two ends and determines if any vertical adjustments are needed by the second person. Once the string is level, draw a second mark at the door or window frame and take any vertical dimensions to it.

Creating a datum using a line level, Secondary House

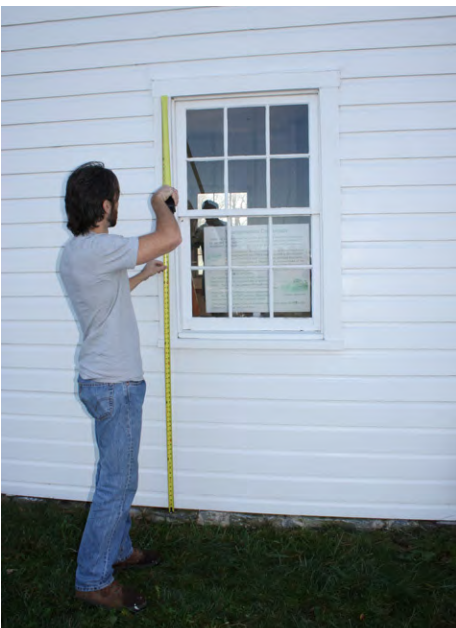
Photo 1, Farm House

Windows must be measured with the sashes completely closed so the meeting rails are in line with each other. There are generally three sets of dimensions that are required to measure a window for an exterior elevation. The first set of dimensions places the window opening in relation to the datum (Photo 1), the second set locates the upper sash (Photo 2) and finally the lower sash is measured (Photo 3).

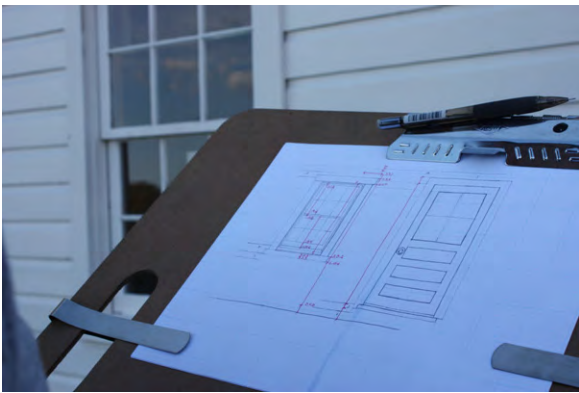
When measuring doors, do not measure them independently of the frame. Always place zero either at the top of the frame or at the threshold. It usually takes two sets of dimensions to measure a door. The first set locates the door opening in relation to the datum and the second set picks up door panels and hardware. Remember to take the panel profile of the door if it was not taken for plan details (see Measuring Details).

Dimensioned door and window field note, Farm House

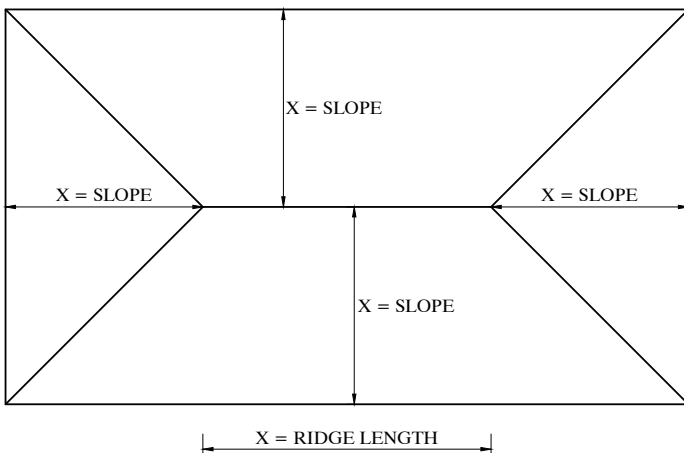
If the roof is hipped, the roof slope and height will be more difficult to obtain. A measurement along the slope of the roof from shingle edge to the ridge as well as a horizontal length of the ridge can provide some accuracy (Figure 1). If the roof rafters are exposed in an attic space, measuring them in section may enhance the accuracy of the exterior roof dimensions as it will be possible to obtain the rise and run of the roof over a greater distance (Figure 2). Dormers, chimney and other relevant roof information should be measured horizontally from the roof edge as well as vertically.

Figure 1, Roof plan

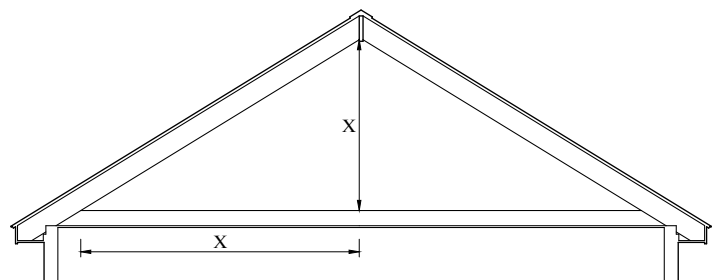
Figure 2, Roof section

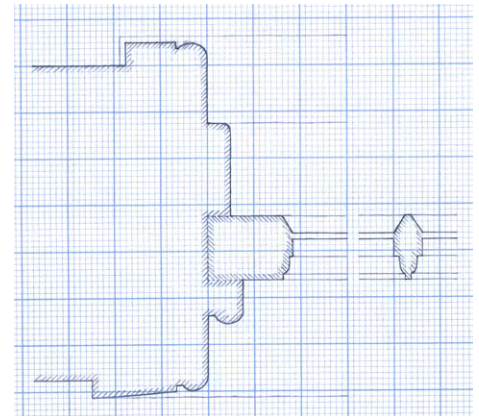
Window profile, Farm House

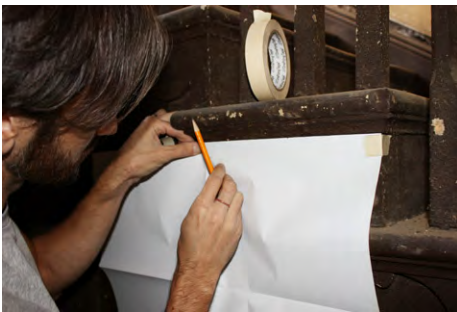
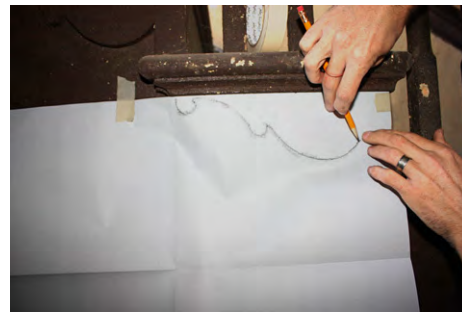
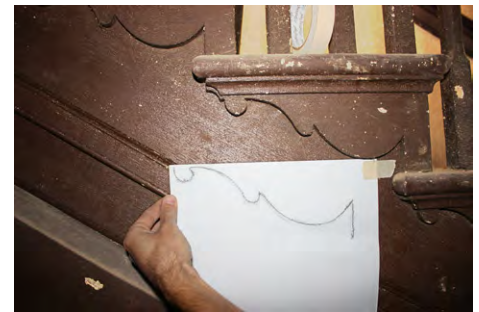
For some flat details, such as “gingerbread” decoration, it may be easier to create a rubbing by laying a piece of paper on it and sketching over any defined edges with the side of a pencil.

Stair bracket rubbing, Farm House

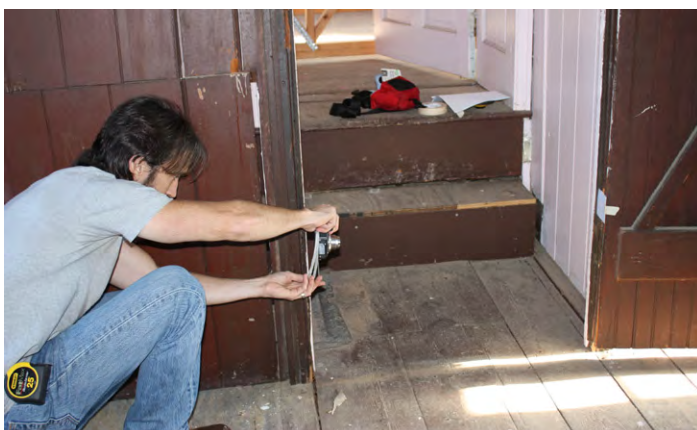
Digital photography can also be useful in capturing details that a profile comb can not. Be sure to take overall dimensions of the detail you are photographing so that the image can be scaled correctly later. Alternately, you can use a reference scale (as pictured below right).

Detail photography using a scale square, Farm House

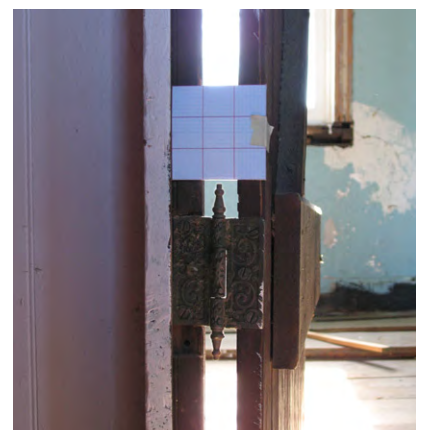
Detail photograph, Farm House

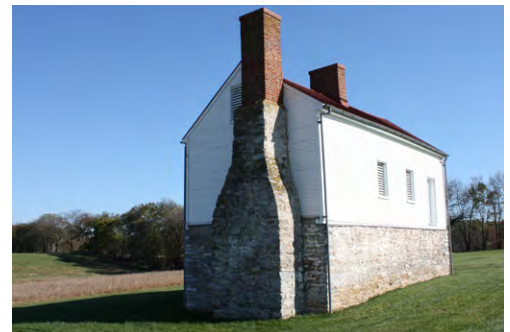
Figure 4

Notice the high, raised basement which is unusual for this rural, more northern setting. Coupled with the large stone end chimney it is possible that this was used as a domestic service space. Note the traces of whitewash on the (randomly laid) stone (Fig. 4).

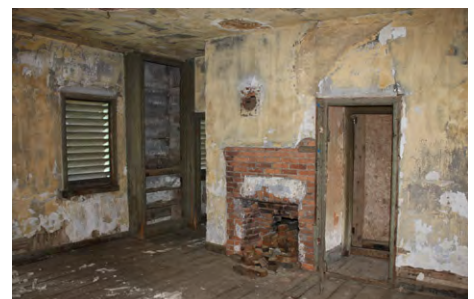
Figure 35

There is a fireplace that corresponds to that in the north room, but it is missing its mantel (Fig. 35).

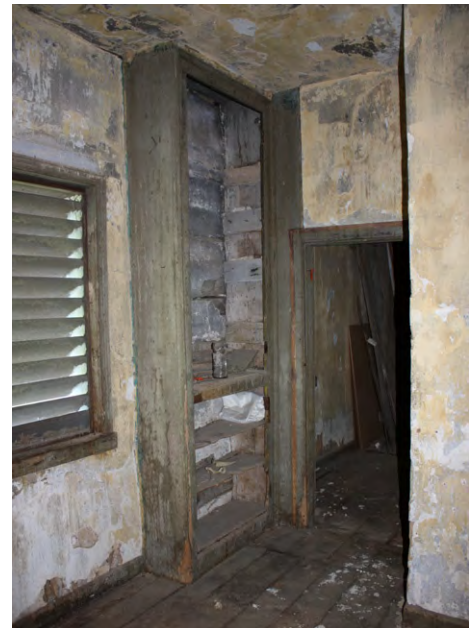
Figure 36

There is a built-in floor-to-ceiling cabinet in the south room against the front wall where it joins with the interior wall near the doorway between the two rooms (Fig. 36). The cabinet doors are missing but notches for hinges indicate that the cabinet was divided into upper and a smaller lower space. The molding profiles matches that of the interior doorways suggesting that it may be an original feature.
