PROPERTY State Bank of Antler
NAME:

Name of Property: State Bank of Antler, 32BU4

historic name State Bank of Antler
other names/site number Antler Square Building

The State Bank of Antler is a two-story, wood frame, Neo-Classical Revival building clad in pressed metal siding to simulate cut stone. It is located on its original site in the central square in the town of Antler and, aside from the addition of a two-car garage on its east side, has sustained only minor alterations to its exterior. Because the plat of Antler has not changed since its founding and because the bank building has such good integrity, the State Bank of Antler retains its historic prominence as the formal visual focal point of the town of Antler.

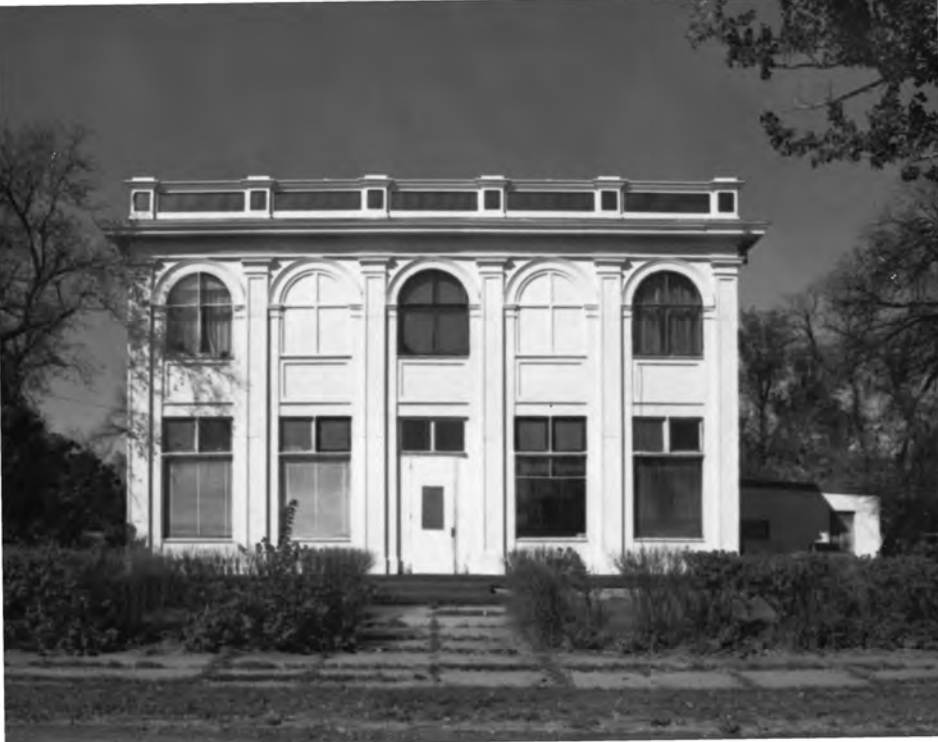
State Bank of Antler
Antler, North Dakota
Photographer: Fredric L. Quivik
Date: September 28, 1987
Negative at RTI, Box 4113, Butte, MT
View of south elevation, camera to north

Each elevation has a similar configuration: the foundation is topped by a water table; paneled pilasters sit on a simple base and have Doric capitals; each arch has architrave haunches and architrave moulding; a full entablature, with egg and dart moulding at the top of the frieze, rests above the pilasters and arches; the parapet with paneled pedestals surmounts the entire composition. The main entry to the building is in the central bay of the south elevation and has a simple door which is not original. The other bays on the south elevation have large fixed sash on the first floor and all five first floor bays have two-light transoms. The second floor of the south elevation has two-over-two double hung wood sash in the first, third, and fifth bays (the upper sash are round-headed and set into the arches) and pressed metal panels, with the simulated tooled or chiseled finish, in the second and fourth bays.

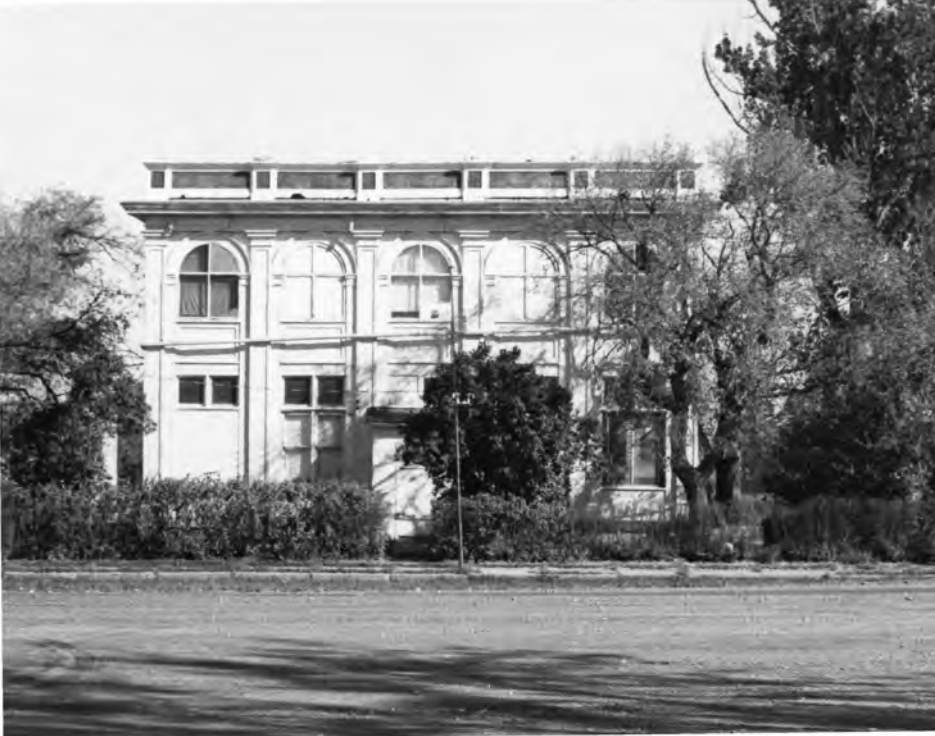
View of the west elevation,
camera to the east

bay, a door cut through a similar pressed metal panel. The door opens onto a wood frame fire escape supported on the roof of the garage addition. The first floor of the west elevation has double transoms in all five bays with a fixed light in the southern-most bay; a pair of one-over-one double-hung sash in the second bay; a small wood frame and plywood vestibule enclosing an original entry in the third bay; and pressed metal panels simulating cut stone in the fourth and fifth bays. The first floor of the north elevation has the tooled finish pressed metal panels in the eastern-most bay and the second bay from the west; a door with single transom and a small concrete stoop in the western-most bay and the second bay from the east; and a one-over-one double hung wood sash with single transom in the middle bay. Centrally-located on the north elevation is a small wood-frame and beaded-ceiling-board vestibule leading to the basement. The second floor configurations on the west and north elevations are like the east (without the door cut through one the metal panels).

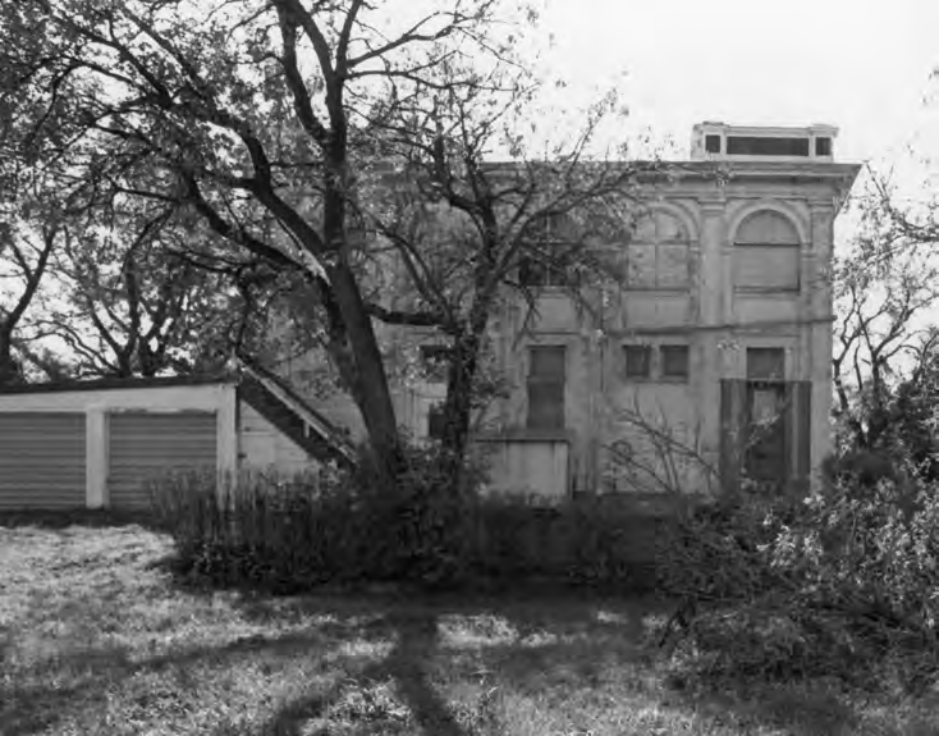
View of the north elevation,
Camera to the south

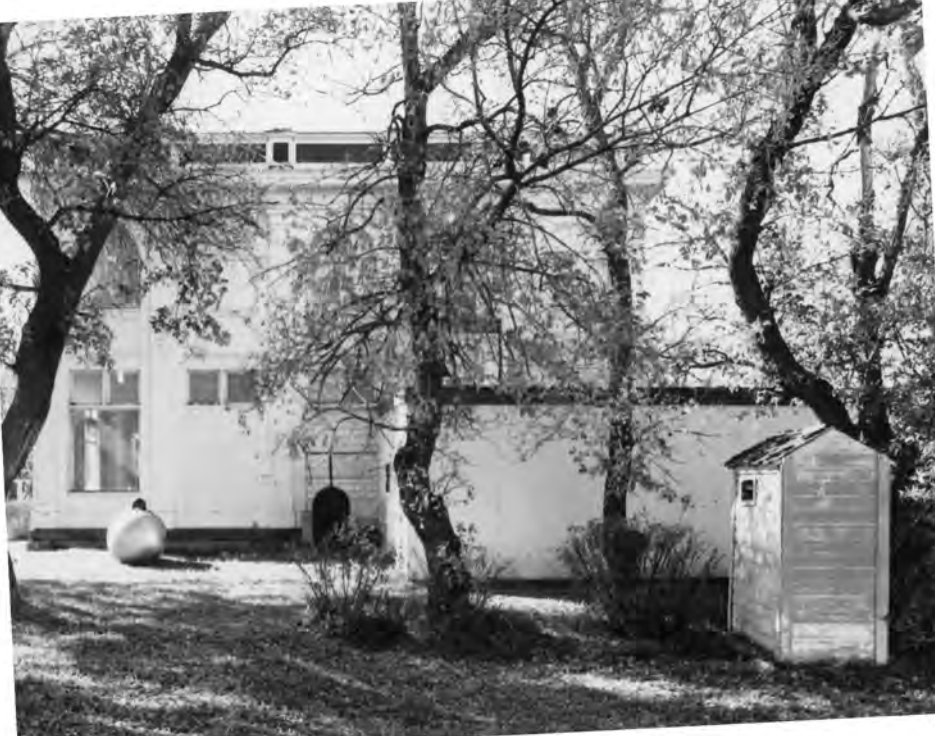
View of east elvation, camera to west

The other elevations are similarly arranged. The first floor of the east elevation has a fixed light with double transoms in the southern-most bay; pressed metal simulating cut stone in the second and third bays, again with double transoms; and the fourth and fifth bays are covered by the garage addition. The second floor has two-over-two double-hung wood sash in the first, third, and fifth, bays; a pressed metal panel simulating machine-tooled stone in the second bay; and, in the fourth

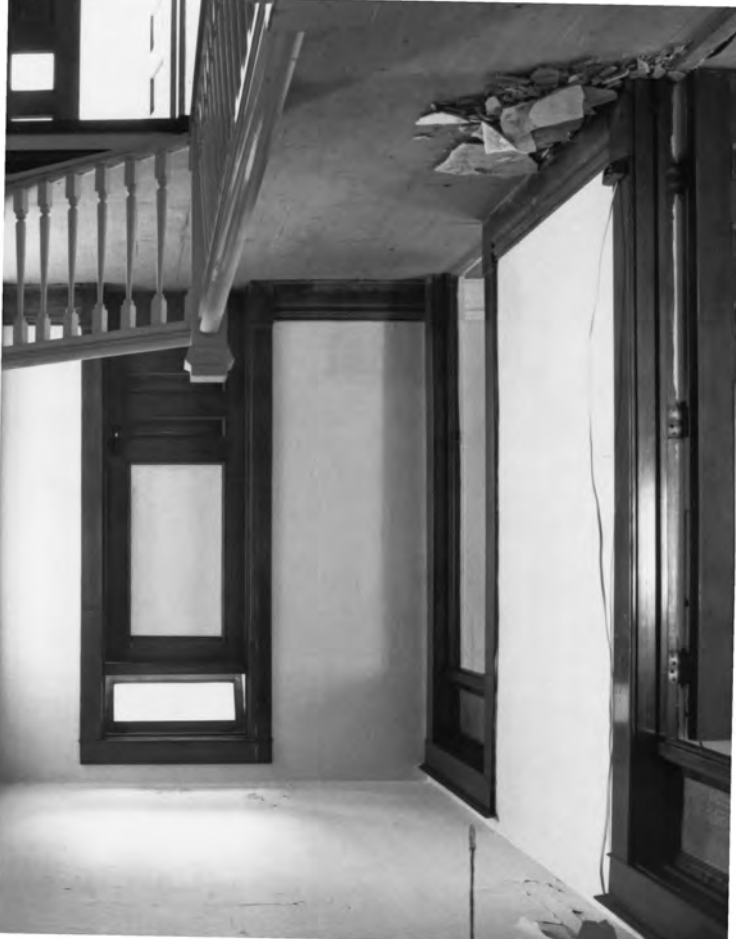
View of the second floor hallway
at the top of the stairs,
camera to the south

There is a small landing with a set of double doors about one third of the way up to the second floor. The stairs, with a railing of turned balusters, lead to a central second floor hall around which are situated eight rooms. All rooms except the central west room, which is blocked by the stairs, are entered from the hall through paneled doors with transoms. To convert the second floor to an apartment, the room at the northeast corner was remodeled into a kitchen, a large opening was cut in the wall between the central east and the southeast rooms, and the central north room was divided into a bathroom and a pantry. The walls and ceiling are lathe and plaster and the floors, most of which are now covered with linoleum, are fir.
