National Register of Historic Places Registration Form

Historic name Lipp Barn
Other name/site number 195-153

Street & number 17054 130th Avenue not for publication
City or town Collyer vicinity
State Kansas Code KS County Trego Code 195 Zip code 67631

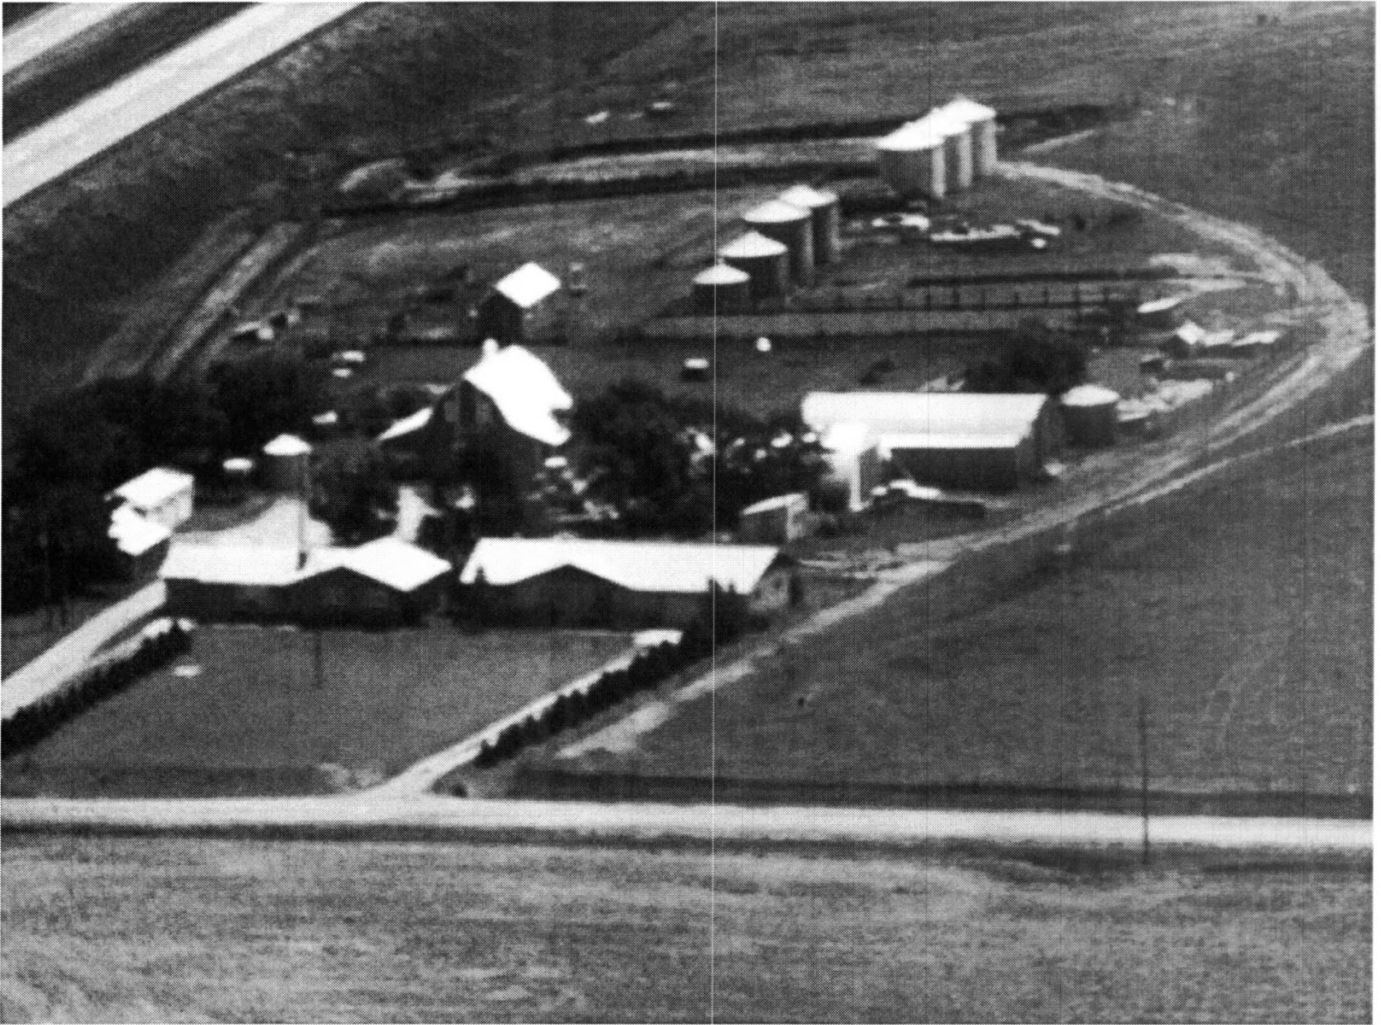
Lipp Homestead. Historic Photo, early 1970s (Ranch house at left of image removed 1990s). *Provided by Reginald and Betty Lipp, copied by author 26 December, 2008.*

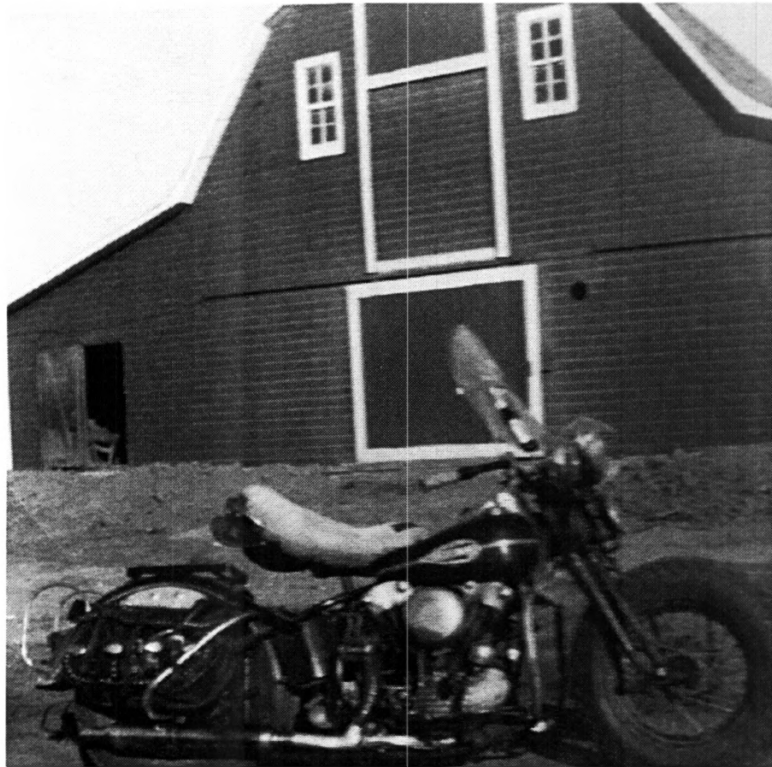
Lipp Barn (West elevation). Historic Photo, early 1950s.
Provided by Reginald and Betty Lipp, copied by author 26 December, 2008.

The west elevation features three doors at the main level. A single, hinged pedestrian door on the north side of the west facade accesses the milking parlor in the north shed bay. Large sliding doors provide entrance to the center bay and south shed bay. Almost hidden on this main level is a small opening between the two sliding doors. This door was added when a hammer mill was acquired for grinding grain in the 1940s. A two-foot square concrete slab just south of the center door marks the location where the hammer mill sat. Ground grain was augered from the hammer mill, through the opening, and directly into the grain storage room.

The upper level of the west façade is highlighted by a large sliding hay door with one evenly spaced double hung, four-over-four window on either side. These windows are currently in deteriorated condition with the north window missing the top sash muntins and glass. The sliding door was preferred over swinging doors due to high winds common in the region. The door was raised and lowered using a hand-cranked winch with a cable and pulley mechanism. The hay track extends out of the loft from under the peak of the gambrel roof, supported by a 6x6" beam. The large hay door and hay track, along with the existing four-tine grapple hay hook, originally allowed for large amounts of loose hay to be
