National Register of Historic Places
Continuation Sheet

Charter Oak Mine and Mill
Property Name

NATIONAL REGISTER OF HISTORIC PLACES REGISTRATION FORM

historic name: Charter Oak Mine and Mill

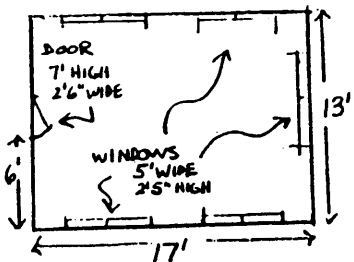
PLAN

REAGENT SHED
CHARTER OAK MINE
RECORDED AND DRAWN BY L. FOSTER - JULY 1995

CHEMICALS
(EX: CYANIDE CANISTER)
INSIDE

REAGENT SHED (CA. 1936-1945)
FROM BONNER OPERATION
OF HOPKINS' CHARTER OAK
MINE - BALLOON FRAME, ROUGH-SAWN
HORIZONTAL PLANKS, ASPHALT ROLLED ROOFING

The reagent shed is located just to the northwest of the flotation mill. It is a single-story building that measures 17' x 13' in plan. It sits directly on pad of crushed waste rock and has no foundation. The floor is dirt. It is built of dimensional lumber framing and rough sawn, horizontal siding (balloon frame construction). The building has a gabled roof covered with asphalt rolled roofing. Fixed, horizontal 6/6 pane windows are located on three elevations. A rectangular door on the south elevation provides ready access to the mill.

The building dates to J. Bonner's renewed operation of the Charter Oak Mine in 1936-1939. The reagent shed stored chemicals used in the flotation cells and milling process. It was also a workshop. A 50-gallon barrel drum fireplace is located in one corner; two workbenches, old drill bits, and various tools are still found inside. The building was apparently used for storage during the waning years of the mine's operation as the building was filled with post-1960's tools, machinery parts and domestic furniture prior to abandoned mine reclamation. This building is in good structural condition, and is a contributing resource within the Charter Oak Mine and Mill site.

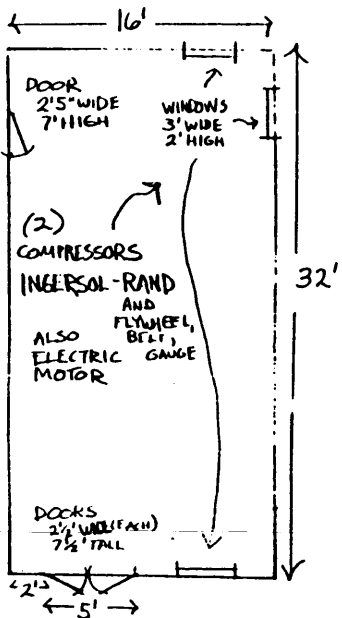
PLAN

COMPRESSOR HOUSE (SHED) CHARTER OAK MINE RECORDED AND DRAWN BY L. FOETER - JULY 1995

The compressor house lies on a bench directly above the flotation mill. This single-story building measures 16' x 32' in plan. It rests on a pad of crushed rock and has a dirt floor, and features dimensional lumber framing and rough sawn, horizontal siding (balloon frame construction). Plank Sheathing and rolled asphalt cover the gabled roof. Compared to the other buildings at Charter Oak, the compressor building has few windows. Two fixed, six pane windows are located on the north and south elevations. The east elevation has a rectangular door made of dimensional lumber planks. The north elevation has a large, rectangular, double door that provided easy access to the compressor and electrical equipment. Ventilation and outlet pipes from the compressor extend through the south wall but are now disconnected from the pipe systems outside the building.

The compressor building was also constructed sometime between 1936-or 1939 and supported Bonner's eventual World War II operation of the mine. It is almost completely intact with the Ingersoll-Rand compressor, flywheel, belt, gauge, and electric motor still inside. Drill bits, machinery parts and other mining refuse are located inside the building. Little cleaning occurred here during the mine reclamation, although scattered equipment located directly outside the building was either removed (if it was clearly post-1960 in age) or re-arranged around the building exterior. The compressor building is a contributing resource within the Charter Oak Mine and Mill property.

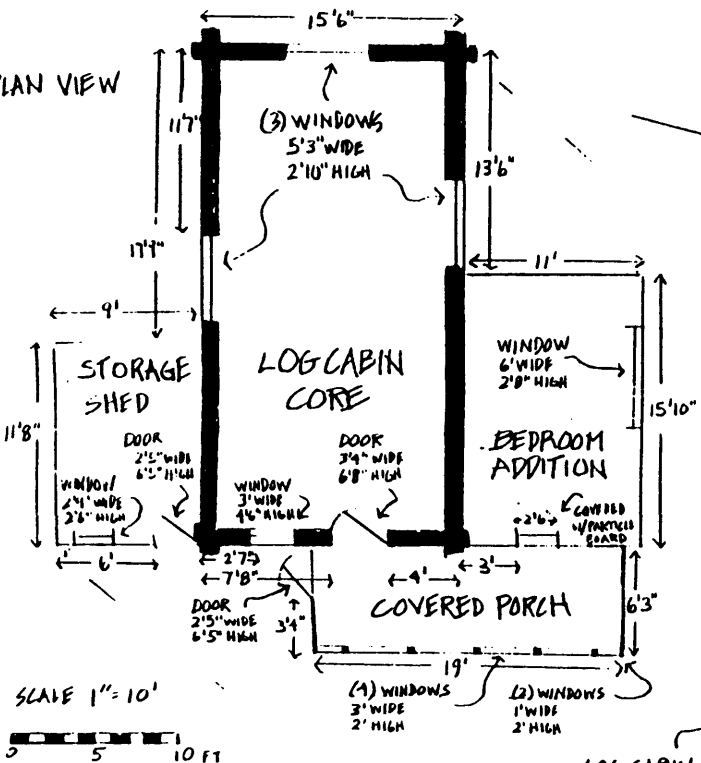
MAIN RESIDENCE CABIN CHARTER OAK MINE

LOG CORE CABIN PROBABLY DATES FROM ORIGINAL HOPKINS MILL OPERATION (c. 1916-1936), WHILE BALLOON FRAME ADDITIONS (STORAGE SHED, BEDROOM ADDITION, + COVERED PORCH) ARE FROM BONNER'S 1936-1941 REBUILDING OF THE CHARTER OAK SITE.

The main residence cabin is the oldest building on the site. It is the original homestead built by the Hopkins family in the early 1910s. This single-story log cabin originally measured 29'5" x 15'6". However, a bedroom (11' x 15') was added to the north elevation, a storage shed (9' x 11'8") was added to the south elevation, and a covered porch (19' x 6'3") was added to the east elevation in later years, giving the cabin a "hodge-podge" appearance. The entire building sits directly on an earth and crushed rock pad. Walls are made of 8 to 10 logs that were probably cut on-site. The corners of the original log cabin are trimmed, sawn and saddle-notched. The original mud and mortar daubing has been repaired with a commercial mortar mix. Wood shakes are present on the gable ends. The roofed is composed of plank sheathing and rolled asphalt roofing. It has been patched numerous times. A metal chimney pipe extends through the roof. Fixed four and six pane windows are found on all elevations. The interior of the cabin is accessed through a rectangular door and covered porch on the cabin's east elevation. The later additions were constructed with dimensional lumber, probably as part of the late 1930s renovation of the mine complex. The roof over the bedroom addition is gabled, while the storage shed and porch roofs are flat. The roofs over all three additions are covered with rolled asphalt roofing. The rough appearance of the cabin exterior is testament to its age, and the effects of weathering, rodents, and hard human use. Sill logs are badly deteriorated, daubing is cracked or missing, siding is in disrepair, and the roof leaks.

The cabin interior has been modernized over the years with carpet, linoleum flooring, and low ceilings. Due to the threat of Hantavirus contamination, furniture, appliances and domestic refuse were removed from the cabin during the 1998 reclamation project. The cabin interior requires repair and cleaning before it can be opened for public visitation. The cabin exterior retains better integrity, and plans are to use the glass-enclosed entrance porch to house interpretive signs and information. However, substantial repairs (i.e., foundation and sill log replacement) are needed to prevent this building from further deterioration. This building is a contributing resource within the Charter Oak Mine and Mill property.
