**NATIONAL REGISTER OF HISTORIC PLACES
INVENTORY -- NOMINATION FORM**

HISTORIC **Scully Ranch**

AND/OR COMMON
Scully Ranch

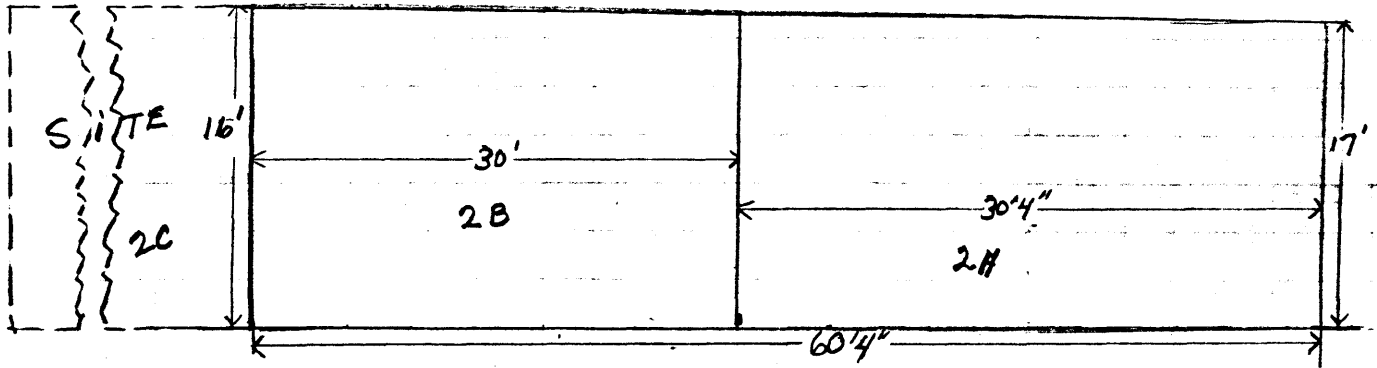
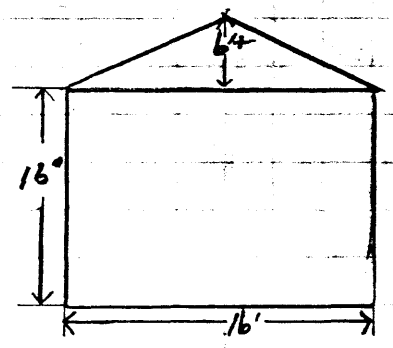
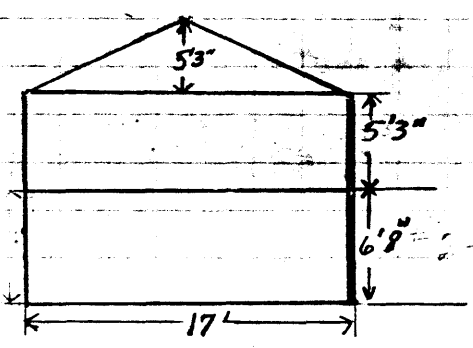
ROBERT H. SCULLY RANCH, IONE, CALIFORNIA
SHED & STONE HOUSE (BUILDINGS 2A & 2B)

SITE 2C WAS LOCATION OF A BUNK HOUSE. DIMENSIONS:
PROBABLY ABOUT THE SAME AS 2B. BUILT ABOUT 1882;
DEMOLISHED ABOUT 1963.

PLACEMENT: BUILDINGS 2A & 2B -- West end of A
joins east end of B.

2 A	2 B
PLAN :	RECTANGULAR (17' X 30')	RECTANGULAR (16' X 30')
STORIES :	ONE	ONE
BASEMENT :	NONE	NONE
FOUNDATION :	NONE	NONE
EXT. WALLS :	WOOD, SEE DIAGRAM.	STONE & MORTAR ^{18" ± THICK}
ROOF SHAPE :	LOW GABLE, shiplap - east end	LOW GABLE, ^{WEST END, (COBBLES)} FIELD STONE _{IN}
ROOF MATERIAL :	TAR PAPER (asphalt)	CORRUGATED METAL SHEETING Extends over ext. wall.
EAVES :	EXTEND 4', EXPOSED Rafters	Unexposed rafters
CHIMNEYS :	NONE	NONE
FLOOR :	GROUND	GROUND
WINDOWS :	NONE	NONE
DOORS :	NONE (NORTH SIDE; OPEN)	1. DOOR N. SIDE (42" X 7' 6")
CONDITION :	DETERIORATED	FAIR
DATE BUILT :	UNKNOWN	UNKNOWN
BUILDER :	UNKNOWN	UNKNOWN
USE :	FARM EQUIPMENT	GRANARY
ALTERATIONS :	NONE	NONE
ON ORIGINAL SITE ?	YES	YES
SURROUNDINGS :	SCATTERED BUILDINGS - SEE SKETCH MAP	
THREATS TO BUILDINGS :	Time & WEATHER	
PHOTOGRAPH NO	B1/104/781 & B1/105-781

Stonehouse (2B) -- A structure 16 feet wide by 30 feet long (Appendix 2-2). Exterior walls: native stone & mortar. Roof: low gable, covered with corrugated galvanized metal sheeting. Condition: fair. Apparently, no alterations. Original use: granary; present use: miscellaneous storage. Date of construction: prior to 1882. Building on original site.

Stonehouse (2B) is joined on the west end by structure 2A: 17 feet wide and 30 feet long. Exterior walls: shiplap and planking (?). Roof: low gable, covered with tar paper. Present use: farm equipment storage. Condition: deteriorated. Construction date: prior to 1882 (?).

A bunk house once joined the west end of the Stonehouse (2B). Bunk house was approximately 16 feet wide and possibly 30 feet long. Built about 1882; demolished about 1963.

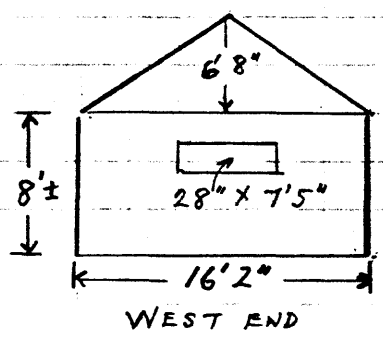
- PLACEMENT: STANDS ALONE (NO. 3 ON SKETCH MAP)
- PLAN: RECTANGULAR (16' X 28'); SINGLE STORY; NO BASEMENT; DIRT FLOOR
- WALLS: EXTERIOR: VERTICAL BOARD (1" X 7" TO 1" X 12")
- ROOF: LOW GABLE^{EAST & WEST}; CORRUGATED GALVANIZED METAL SHEETING; EAVES PLAIN; EXPOSED RAFTERS; NO CHIMNEY
- WINDOWS: WEST SIDE, 28" X 7'5"; EAST SIDE, 28" X 57"; BOTH WINDOWS: T & G COVER, STRAP HINGED AT TOP.
- DOORS: OPEN DOORS, SOUTH SIDE; WEST OPENING, 7'5" X 6'10 (WIDE) EAST OPENING, 7'5" X 7'7" (WIDE).
DOOR ON NORTH SIDE, WEST END: 2'11" X 6'7" (HIGH).
- CONDITION: DETERIORATED. THREAT: TIME & WEATHER; LARGE OAK
- ALTERATIONS: NONE. BUILDING ON ORIG. SITE? YES.
- PHOTOGRAPH NO.: B1/106-781. USE: BLACKSMITH SHED
- PROBABLE DATE OF CONSTRUCTION: PRIOR TO 1882; ON ORIG. SITE

Blacksmith Shop (3) -- A structure 16 feet by 28 feet long (Appendix 2-3). Exterior walls: vertical board. Roof: low gable covered with corrugated galvanized metal sheeting, plain eaves. Building on original site; built prior to 1882; no alterations; condition: deteriorated. Used continuously: blacksmith shop-- many of the original tools and equipment are in the building.

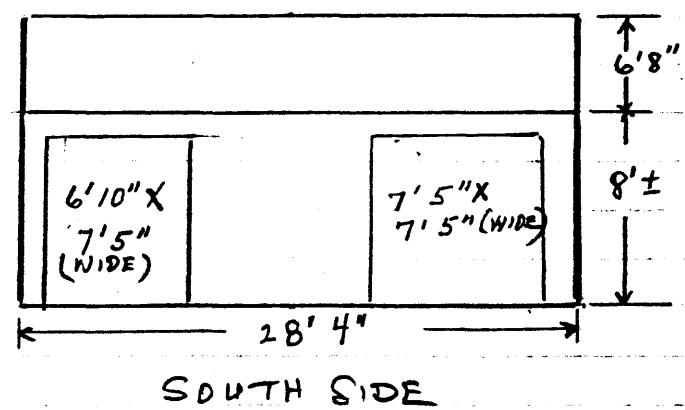
WAGON SHED

- PLACEMENT: STANDS ALONE (NO. 4 ON SKETCH MAP).
PLAN: RECTANGULAR (44'3" X 55'); SINGLE STORY;
 : NO BASEMENT; CONCRETE FOUNDATION & FLOOR
WALLS: WOOD - 1" X 12" TO 1" X 5 1/2" ROUGH.
ROOF: LOW GABLE^{EAST & WEST}; CORRUGATED GALVANIZED METAL SHEETING,
 PLAIN EAVES; EXPOSED RAFTERS
WINDOWS: NONE
DOORS: NONE. BUILDING OPEN: EAST & WEST ENDS.
CONDITION: DETERIORATED
USE: WAGON SHED. PRESENT USE:
PROBABLE DATE OF CONSTRUCTION: PRIOR TO 1882. ON ORIG. SITE.
PHOTOGRAPH NO.: B1/107-781

Wagon Shed (4) -- A structure 44 feet wide by 55 feet long. (Appendix 2-4) Exterior walls: vertical boards. Roof: low gable; covering corrugated galvanized metal sheeting. Building on original site; built prior to 1882; some alterations. Condition: damaged and deteriorated. Use: wagon shed; however building design suggests it may have been used as a barn for feeding stock. Present use: storage.

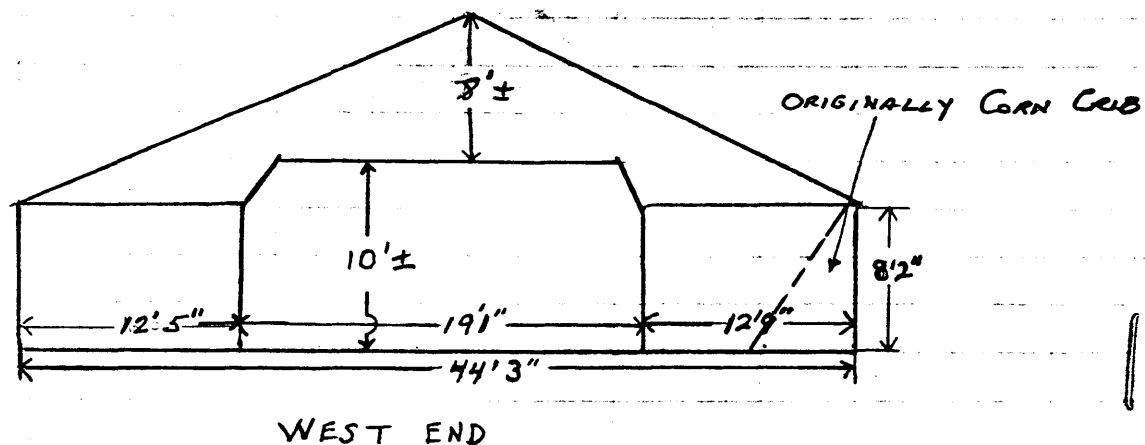
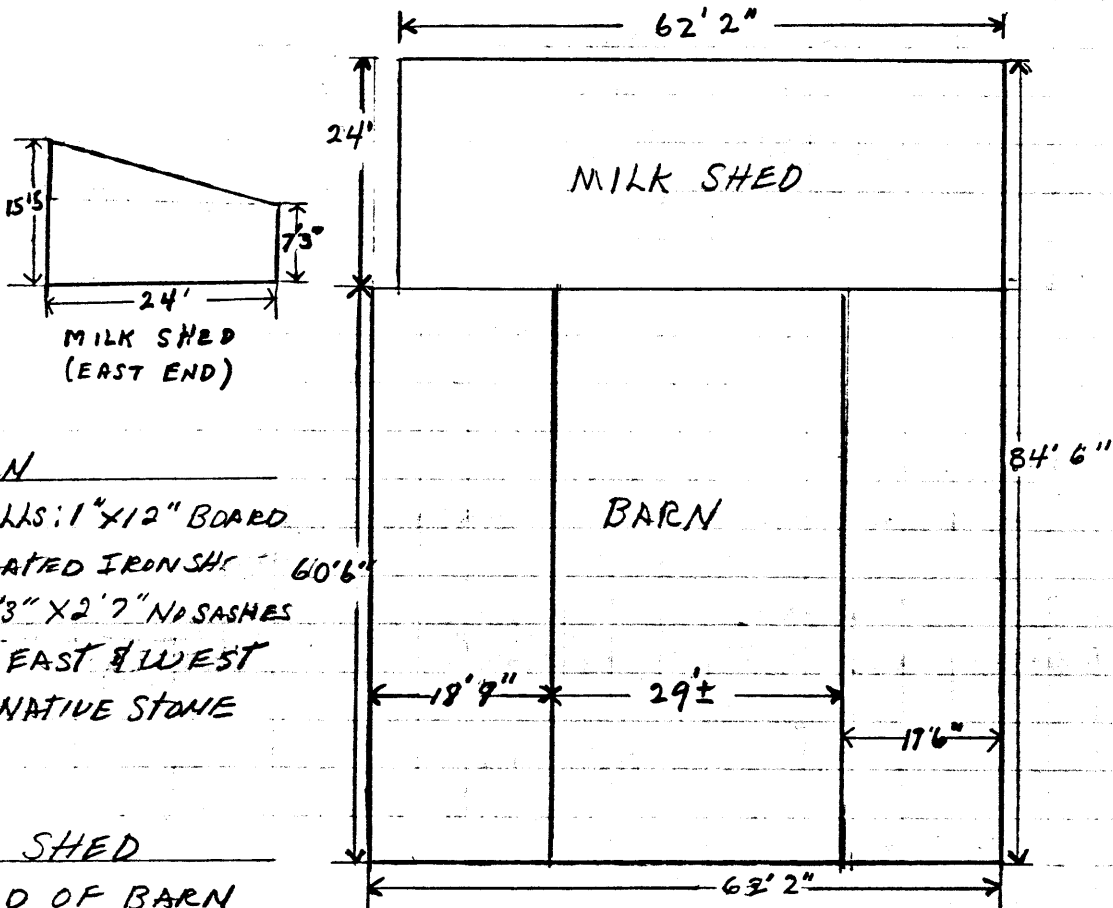
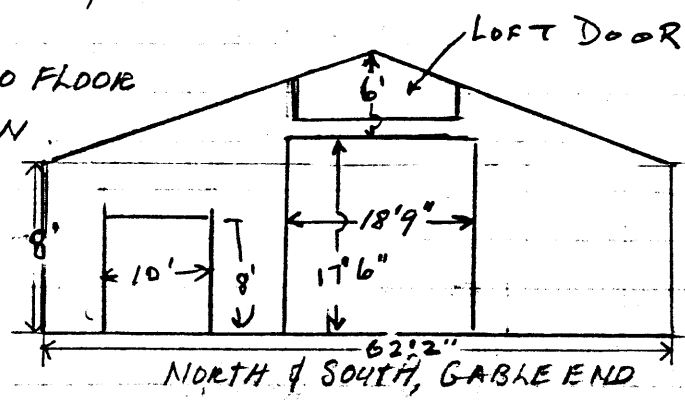
BARN AND MILK SHED

BARN
 INTERIOR WALLS: 1" X 12" BOARD
 ROOF: CORRUGATED IRON SHEETING 60' 6"
 WINDOWS: 3' 3" X 2' 7" NO SASHES
 BLE: LOW, EAST & WEST
 FOUNDATION: NATIVE STONE

MILK SHED
 NORTH END OF BARN
 INTERIOR WALLS: 1" X 10" BOARD
 ROOF: CORRUGATED IRON SHEETING,
 RAFTERS EXPOSED
 FOUNDATION: CONCRETE - ALSO FLOOR
 WINDOWS: 21" X 3' 2" OPEN

PLACEMENT : NORTH END OF BARN JOINS SOUTH SIDE OF MILK SHED.

PLAN : RECTANGULAR : (1) BARN = 60'6" X 62'2" ; (2) MILK SHED = 24' X 62'2" ; SINGLE STORY ; NO BASEMENTS ;

FOUNDATION : BARN = NATIVE STONE ; SOME CONCRETE
MILK SHED = CONCRETE

WALLS : EXTERIOR : (1) VERTICAL BOARDS 1" X 12" ; (2) VERTICAL BOARDS, 1" X 10" - 12" HORIZONTAL

ROOF : (1) = LOW GABLE (SOUTH - NORTH) ; (2) SHED.
(1) = CORRUGATED GALVANIZED SHEETING ; (2) SAME.
(1) = PLAIN EAVES, EXPOSED RAFTERS ; (2) SAME

PROBABLE DATE OF CONSTRUCTION : BARN, PROBABLY PRIOR TO 1882
RELICATED TO PRESENT SITE - SEE SKETCH MAP. 1900 ±

NOTE : (B1/109-781) -- WHAT APPEARS AS COARSE SIDING (EAST SIDE OF BARN) IS TERRA COTTA PIPE.

Barn & Milk Shed (5) -- Barn is 62 feet wide and 60 feet long; (Appendix 2-5) milk shed is 62 feet wide by 24 feet long. Exterior walls: vertical board, both buildings. Roof: Barn, low gable; milk shed, shed. Roof covering: corrugated galvanized metal sheeting for both buildings. Probable dates of construction: Barn prior to 1882; milk shed about 1910. Present condition: barn is deteriorated; milk shed is fair. Present use: none, both buildings.

The barn was originally placed about 250 feet south of its present location. Moved to present location about 1900.

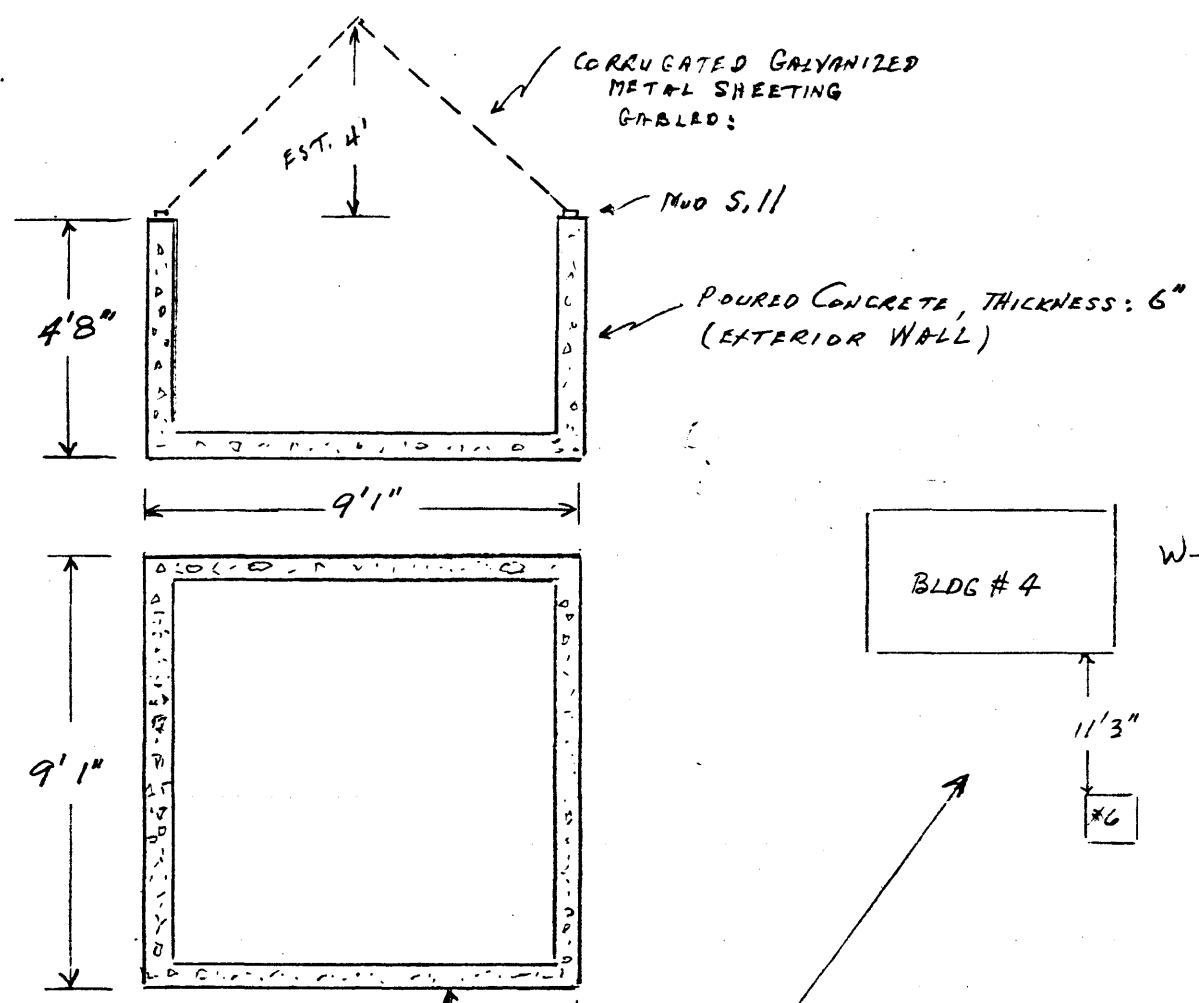
BUILDING No. 6
(MILK PROCESSING STRUCTURE)

BUILDING No. 6:

FOUNDATION: POURED CONCRETE
ROOF: ON GROUND, SOUTH OF CONCRETE STRUCTURE, DAMAGED (WIND) GALVANIZED, CORRUGATED METAL SHEETS.
 IN A HEAP, SOUTH SIDE OF STRUCTURE
YEAR CONSTRUCTED ABOUT 1945

STRUCTURE ON ORIGINAL SITE
BUILDER: UNKNOWN PHOTOGRAPH No. BI/108-781

SIGNIFICANCE: An auxiliary building in dairy operation -- SEE BLDG # 3, MILK SHED, Appendix 2-6

Milk Processing Structure (6) -- 9 feet by 9 feet -- and adjunct to a dairy operation. (Appendix 2-6) It was constructed in 1945. Exterior walls: poured concrete; low gable, covered with corrugated galvanized metal sheeting, damaged by wind. Structure on original site. Present use: none. Condition: damaged.

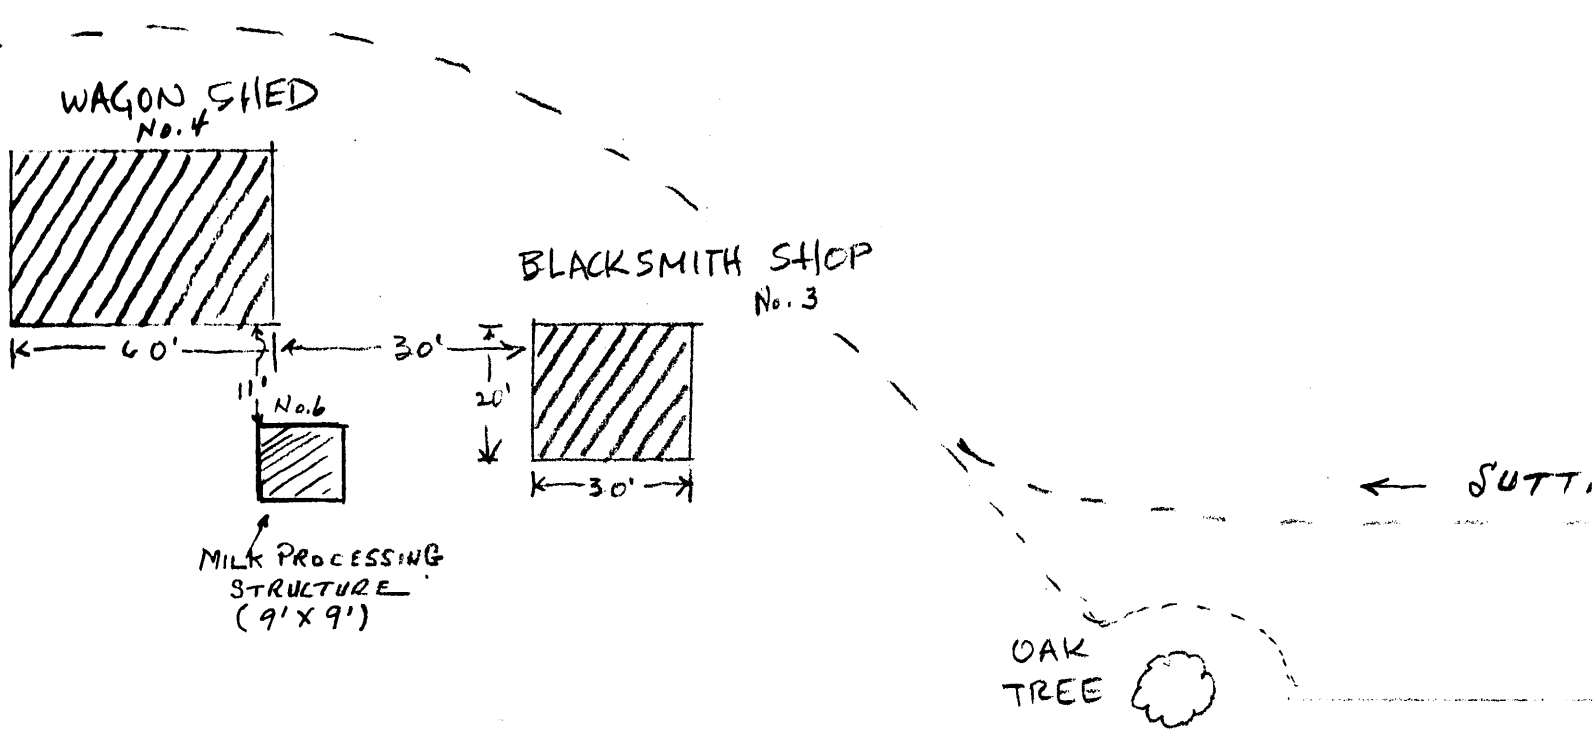
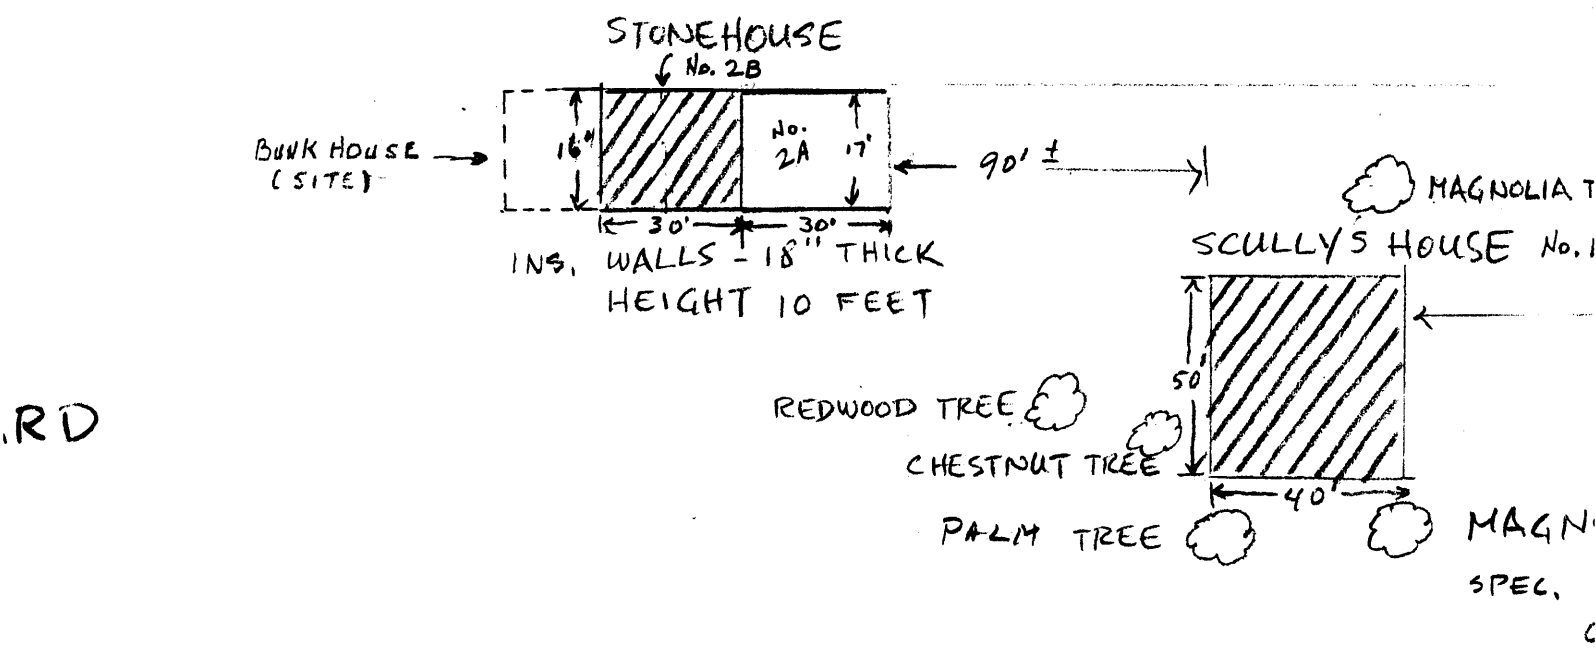
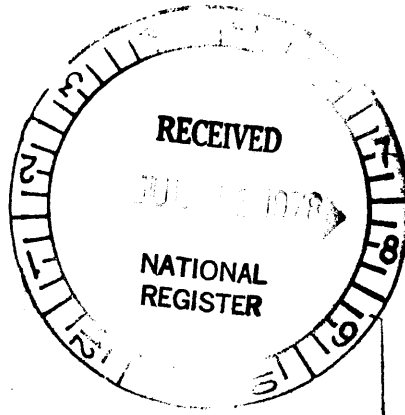
SKETCH MAP
 ROBERT H. SCULLY RANCH
 IONE, CALIFORNIA
 JAN. 1978

MAGNOLIA TREE
HOUSE No. 1

MAGNOLIA TREE
SPEC. 60' HIGH
90± YEARS OLD
