National Register of Historic Places Registration Form

Historic name: Whitney Farm
Other names/site number: Applemount
Name of related multiple property listing: N/A
(Enter "N/A" if property is not part of a multiple property listing)

Street & number: 215 Whitney Road
City or town: Appleton State: Maine County: Knox
Not For Publication: N/A Vicinity: N/A

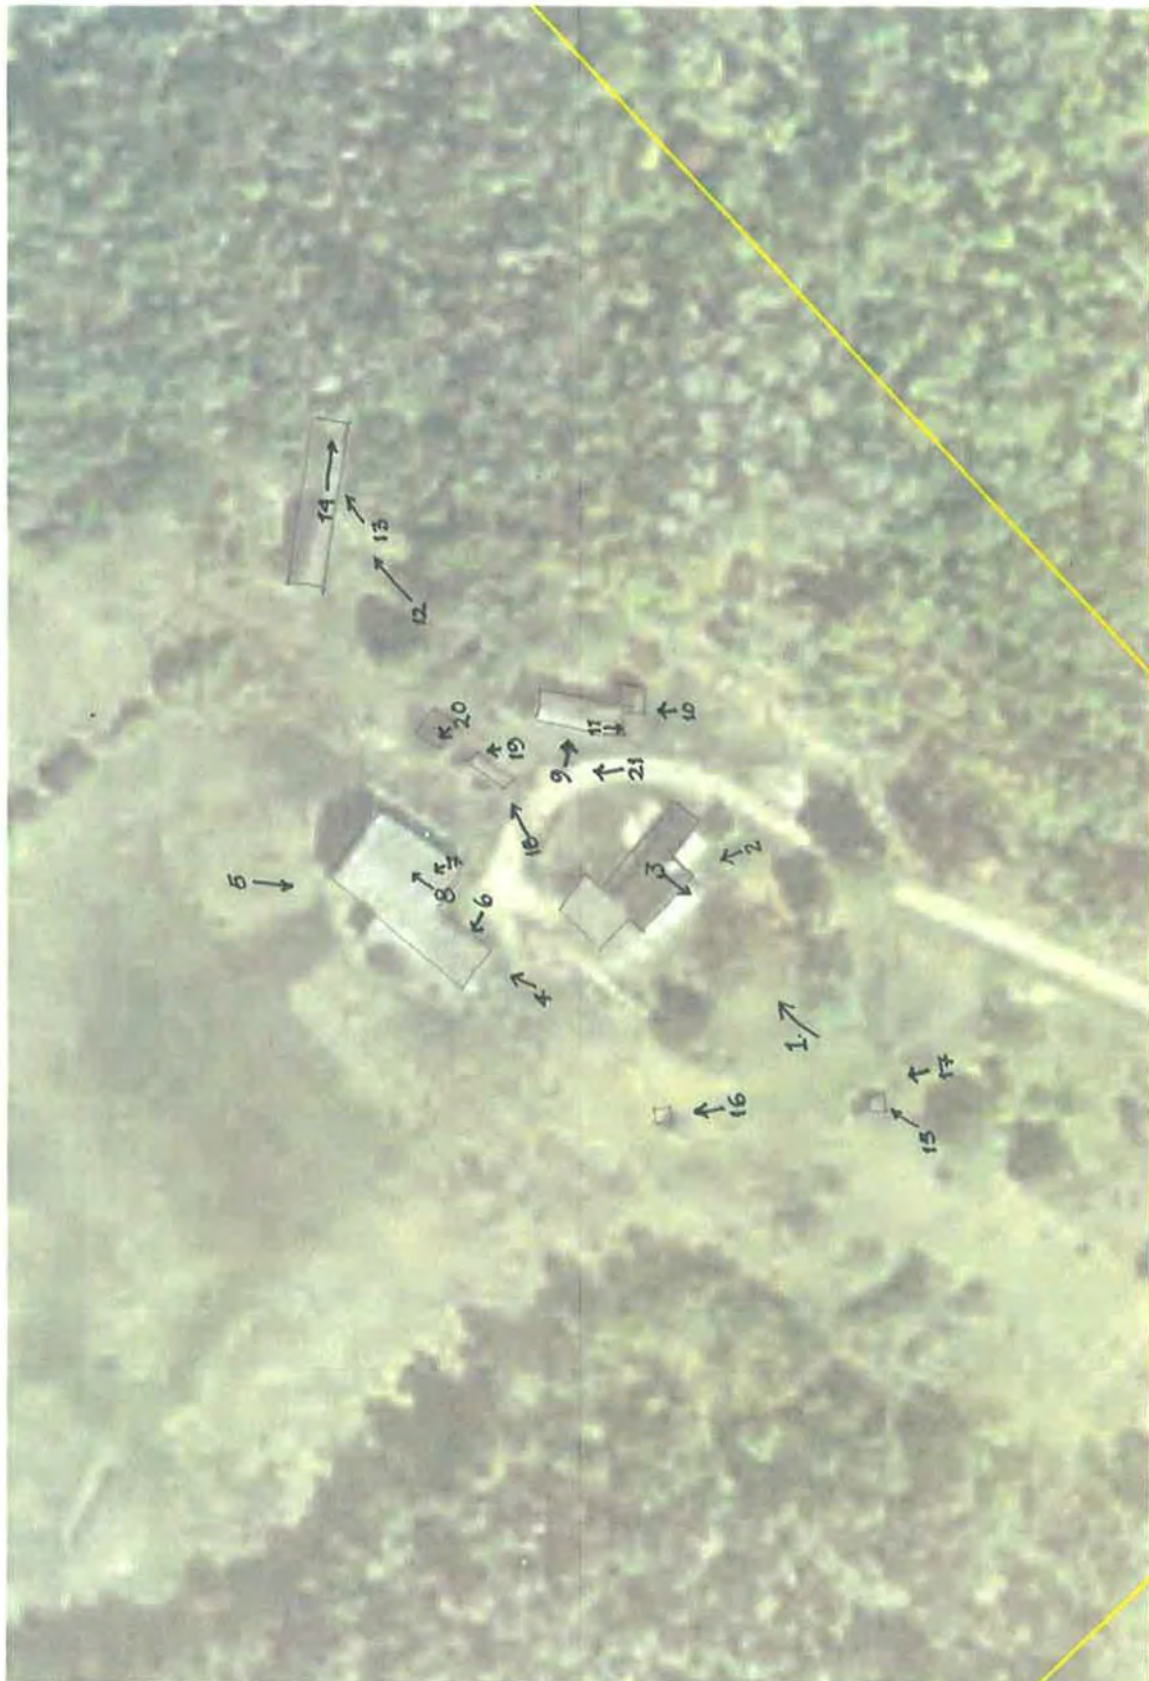
WHITNEY FARM
PHOTOGRAPHIC KEY
Knox County, Maine
16 January 2015

Historic District
Boundary in YELLOW
