# **Registration Form**

Name of Property		<b>7</b> ,		
Historic Name Pea Ridge Commercial	Historic District			
Other Names/Site Number <u>BE 3155; B</u> BE3168; BE1355; BE1356; BE3162; B

Pea	Ridge	Commercia	l Historic	District
Nam	e of Pro	pperty

Benton County, Arkansas	
County and State

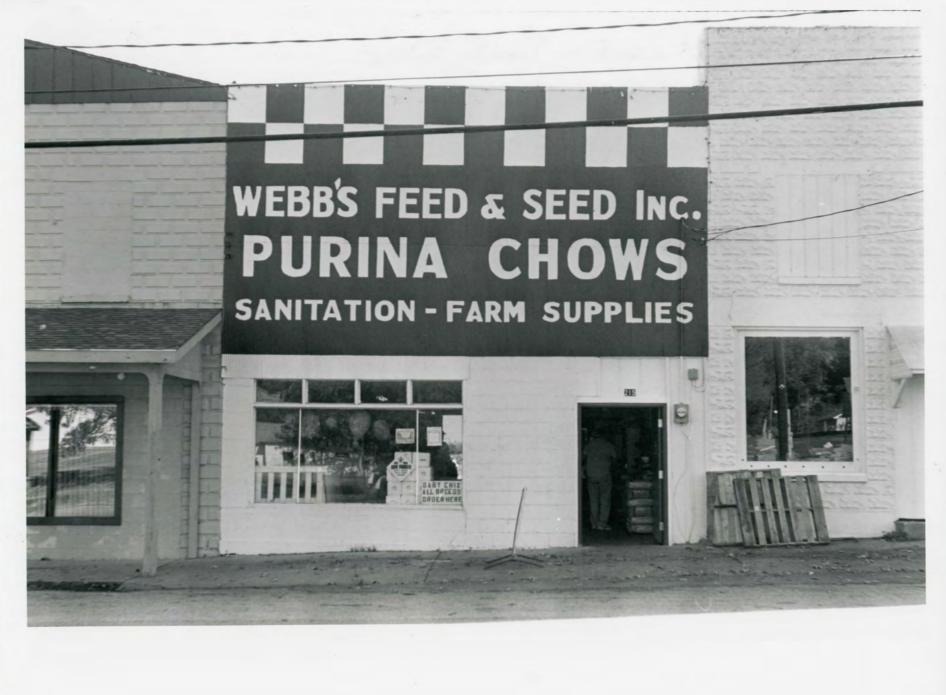
- 1. Well's Food of Sed Show
- 2. Beaton County AR
- 3. Kay Chiffin
  - 4. November 2006
- 5. andonnas Office of Historia Plesseriction Little Rose, ar
  - Le. North Front facade, Look North
  - 7. #1

The top of this façade is covered with a Purina Chows sign in red and white checkerboard and blue with white lettering. The concrete blocks are plastered and painted white. The windows on the second story are boarded and covered by the sign. The first story window is stationary. The window has four small rectangular panes in a wood frame over a large single stationary plate glass pane. The black metal door is off-center on the west side of the façade.

Webb's Feed and Seed Store is an early 20<sup>th</sup> Century Standard Commercial style building. Built in 1920, it is a rectangular, two-story, concrete-block structure. The roof is flat with a parapet and the roof material is tar built-up. The foundation is cast concrete. Fred and Mabel McKinney own this building.

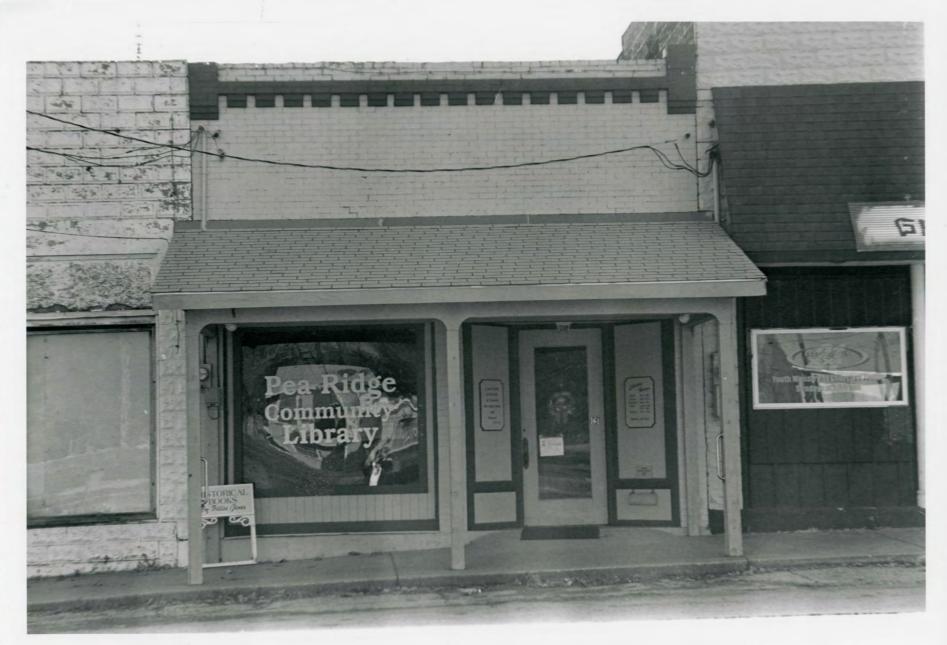
1. Ros Rules Comminder Library 2 Beston Country AR 3 Kay Driffin 4. November 2006 5 andonnes Office of Historic Preservation Little Road, AR Doch front forod story story

Near the roofline, the building has a corbelled brick cornice with dentils. This façade is painted grey with burgundy wood trim around windows and door. The single glass recessed door is off-centered on the west side and is painted gray. Wooden panels with trim boards have replaced the rectangular window panes in the windows on either side of the door. One large stationary single-pane glass window is on the east side of this façade. A full wooden porch covers the window and door. It has a shed roof with composition shingles and is supported by five wood posts. The floor of the recessed entry is covered with black tiles.

Pea Ridge Community Library was built circa 1920 in early 20<sup>th</sup> Century Standard Commercial style. The brick, rectangular-shaped, one-and-one-half story building has a

flat roof with a parapet. The foundation material is brick and the roof is tar built-up. A chimney is near the center of the east side of the roof. An addition to the library is on the rear façade. A shed roof with composition shingles covers the addition.

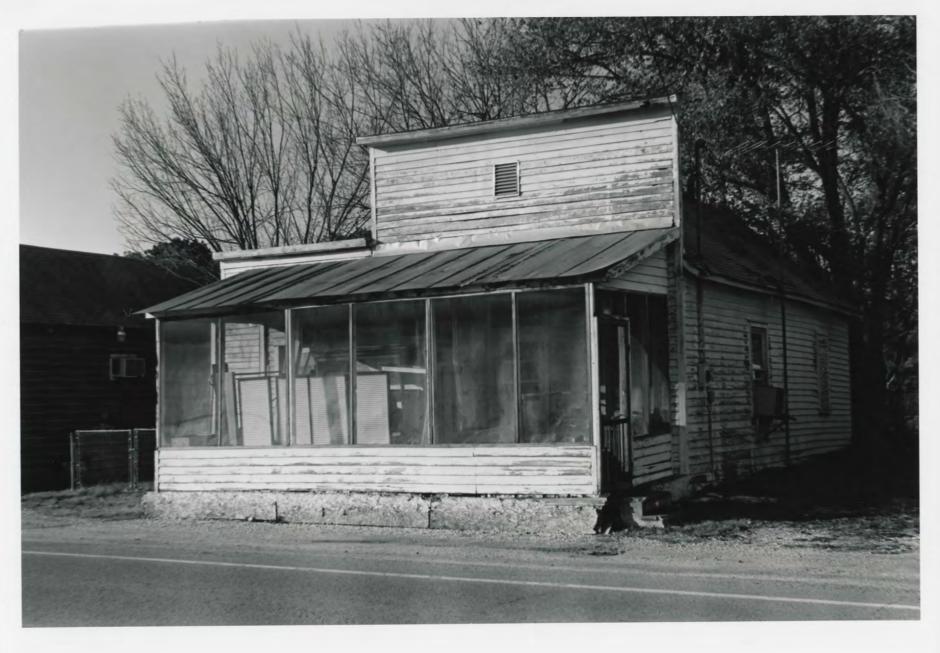
1. John D. Stasteen Trust Building 2. Bouten Country AR 3. Kay Drifter. 4. November 2006 5. alons Office of Histories Plesouslin Sittle ROD, AR le Front facable looking South w/ view of cart facarly

A screened front porch covers this façade. The porch has a corrugated metal roof which projects from the parapet. The

porch is enclosed by eight panels of metal screening separated by narrow boards attached to the frame of the porch. A screened door is on the east side of the porch.

The front of the building has a large one-over-one pane window on the east side of this facade. A wooden door with rectangular glass window is in the upper section of the door. The door is placed east of center of the façade. A window was placed near the center of the façade. It is a one-over-one pane window in a wooden frame. A wood door is on the west side of the façade. Horizontal weatherboard covers the façade, including the parapet, which has an air vent in the center of the parapet into the high-pitched gable of the roof.

The John D. Shasteen Trust Building was built in 1910 in early 20<sup>th</sup> Century American Movement Commercial style. It has a gabled roof with a shed roof over west side of structure. A tall wooden parapet covers the high gable section of the roof and a lower parapet covers the shed roof. The structure's walls are covered with weatherboard except for the west façade which is covered in vertical siding.

The east façade is covered with weatherboard and there are two windows. One is on the south end of the façade. It has a two-over-one pane arrangement. The window is in a wood frame. The other window, on the north end of the façade, is boarded. There is a clear view of the red brick chimney from this façade. The chimney is placed in the center of the gable on the roof on the north interior.
