National Register of Historic Places Registration Form

historic name Twenty-Ninth Ward LDS Meetinghouse
other names/site number _____

street & number 1102 W. 400 North not for publication
city or town Salt Lake City vicinity
state Utah code UT county Salt Lake code 035 zip code 84116

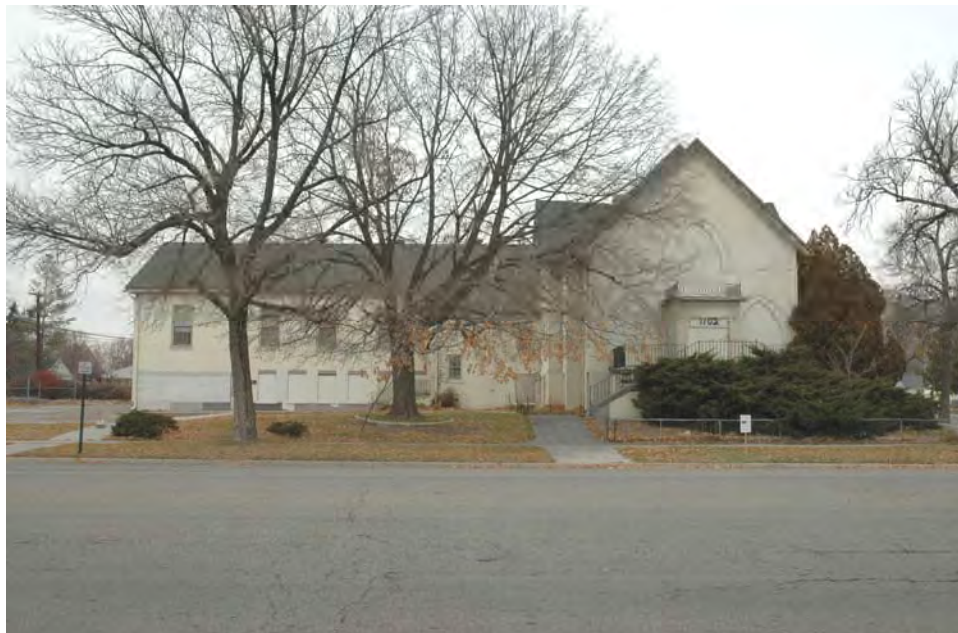
Photograph 1 of 14

South elevation of the Twenty-Ninth Ward LDS Meetinghouse. Camera facing north.

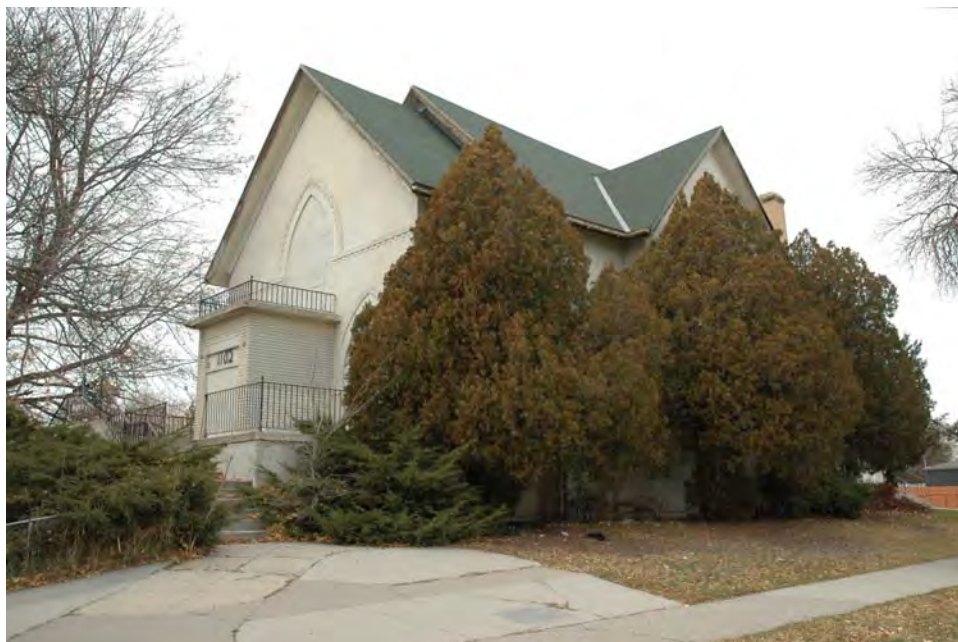
Photograph 2 of 14

South and east elevations of the Twenty-Ninth Ward LDS Meetinghouse (Assembly Hall).
Camera facing northwest.

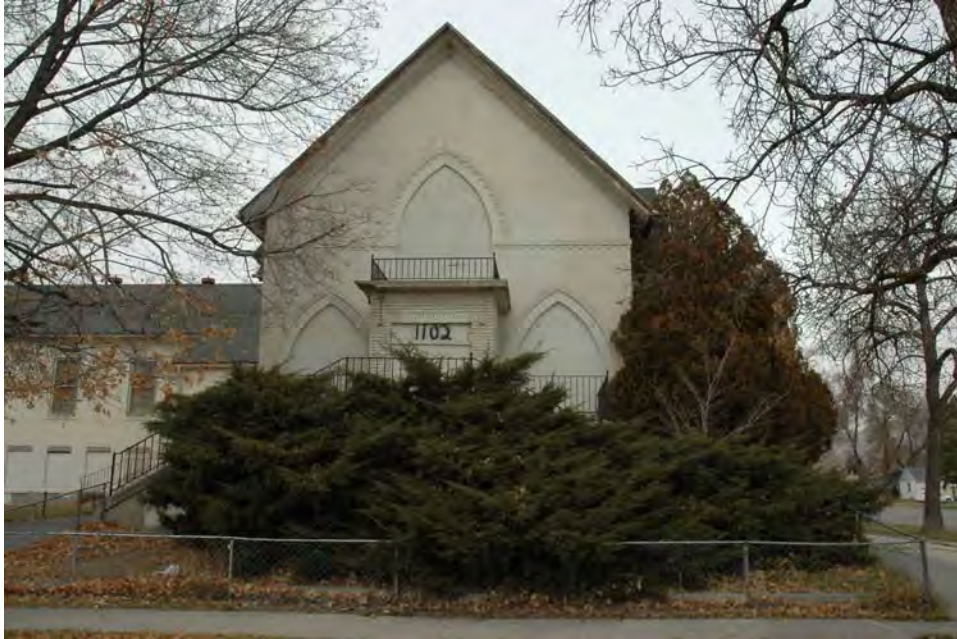
Photograph 3 of 14

South elevation of the Twenty-Ninth Ward LDS Meetinghouse, entrance detail.
Camera facing north.

At the completion of the Amusement Hall in 1926, the Assembly Hall (chapel) was renovated in 1927. The most dramatic alteration was on the façade (south elevation). The ground level entries were blocked and a new brick vestibule was built in the center of the façade. A symmetrical pair of concrete steps was built nearly up to the main level. The inscription plaque was removed and mounted on the front of the steps. Black wrought-iron rails are on the steps, around the landing and on the top of the vestibule's flat roof. The original wood doors had small lancet-shaped openings. During this alteration, only the top half of the art glass in the center lancet was retained. On the interior, the level of the main floor was extended under the balcony. A short set of steps connected the vestibule to the main floor assembly space. The balcony was tiered to provide better viewing. At the north end, the rostrum was remodeled by moving the aisle to the outside walls and building a central pulpit. An opening on the west wall was enlarged to provide double doors from the south vestibule.

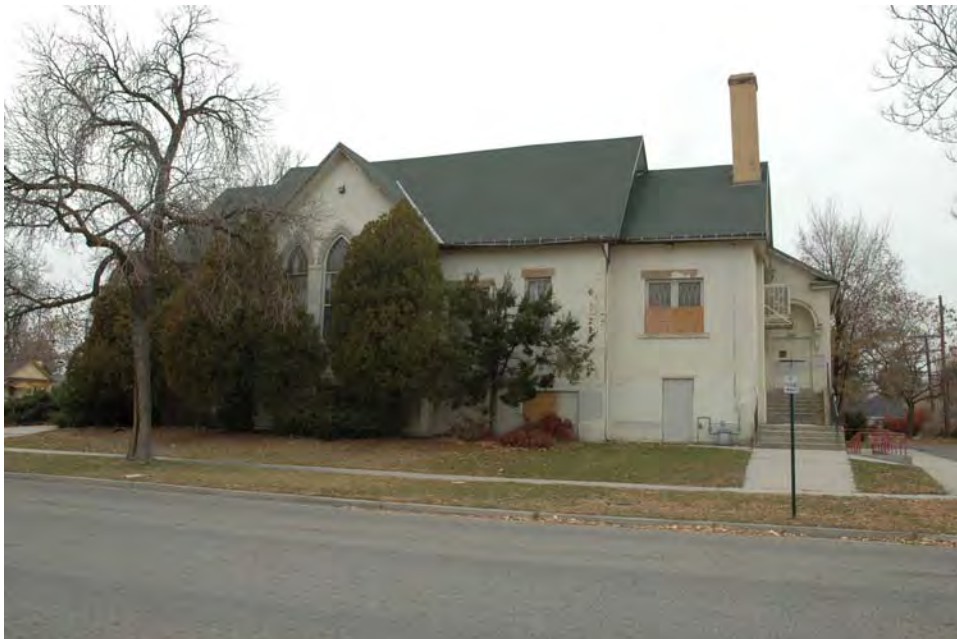
Photograph 4 of 14

East elevation of the Twenty-Ninth Ward LDS Meetinghouse (Amusement Hall). Camera facing west.

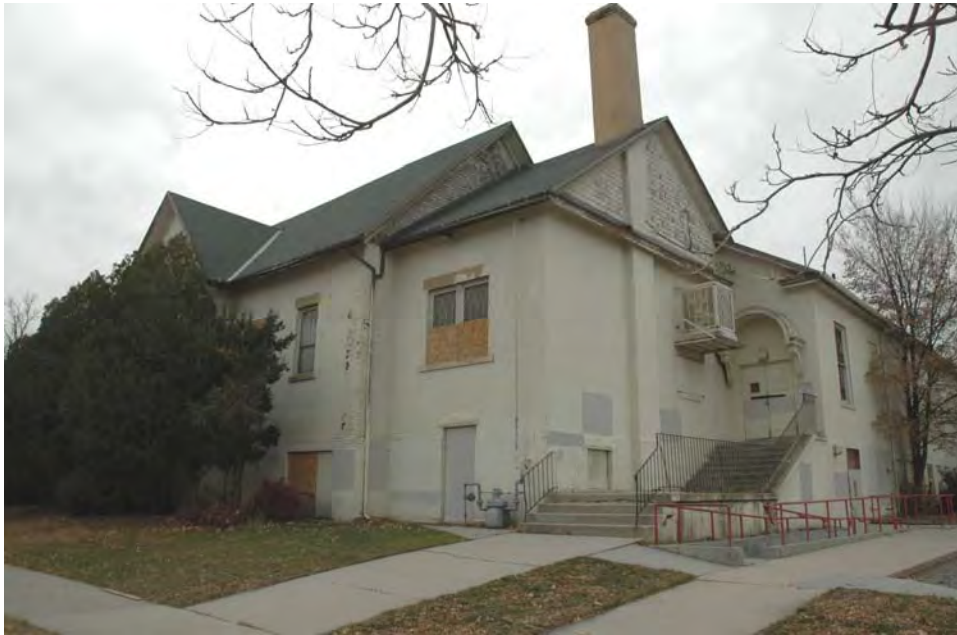
Photograph 5 of 14

East and north elevations of the Twenty-Ninth Ward LDS Meetinghouse. Camera facing southwest.

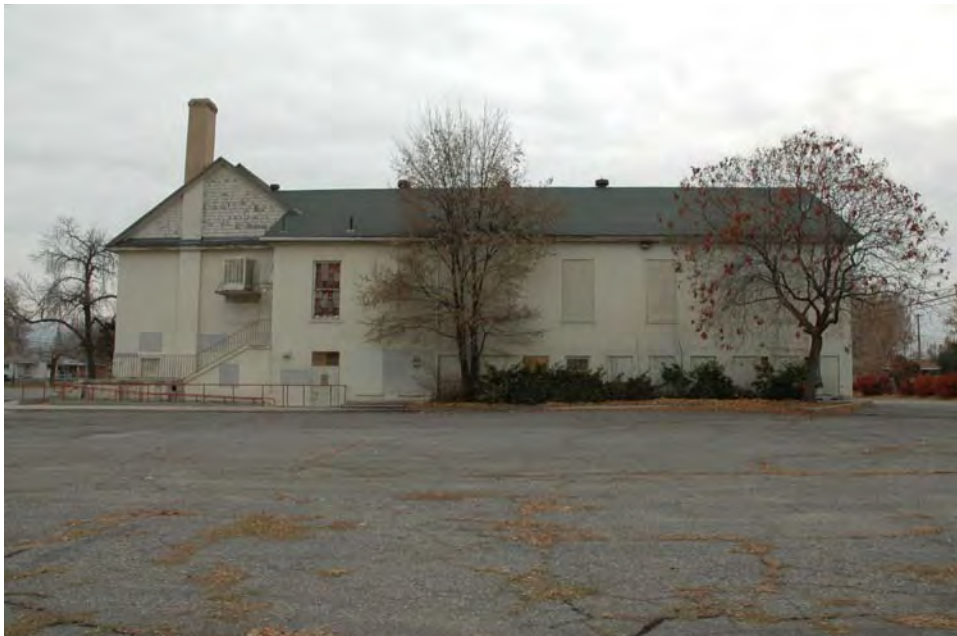
Photograph 6 of 14

North elevation of the Twenty-Ninth Ward LDS Meetinghouse. Camera facing south.

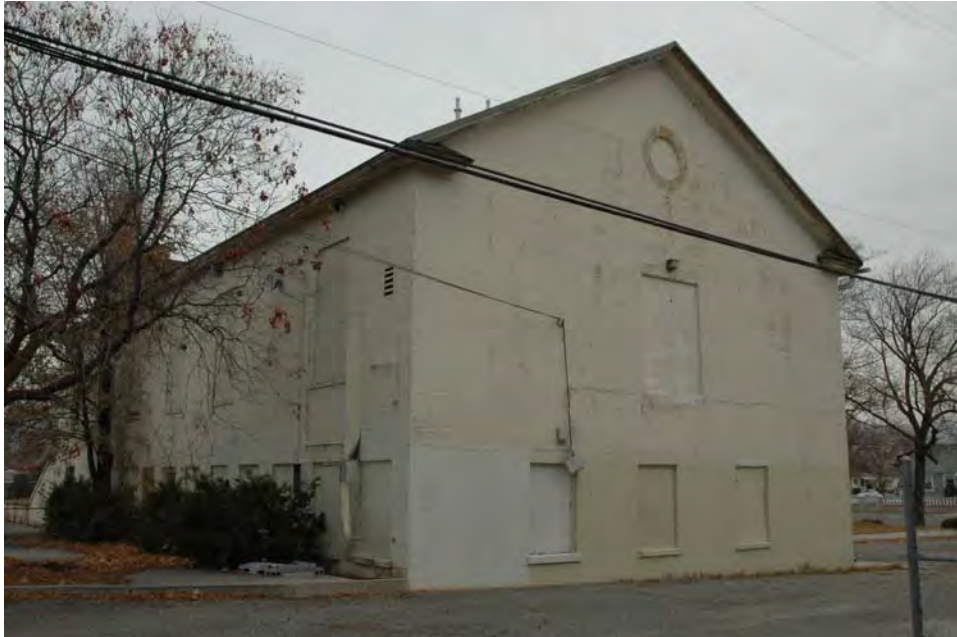
Photograph 7 of 14

West elevation of the Twenty-Ninth Ward LDS Meetinghouse (Amusement Hall).
Camera facing southeast.

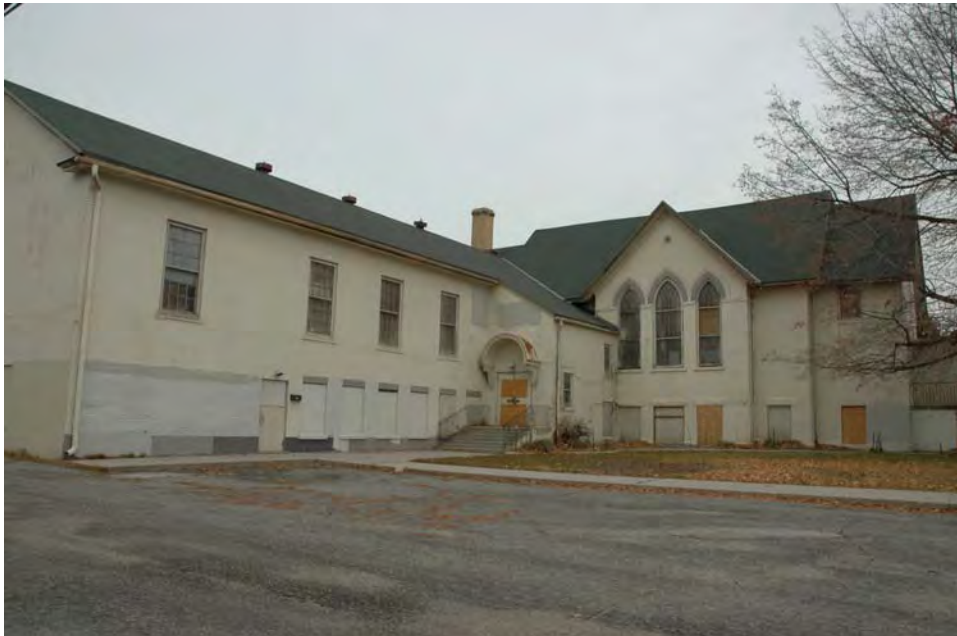
Photograph 8 of 14

South and west elevations of the Twenty-Ninth Ward LDS Meetinghouse.
Camera facing northeast.

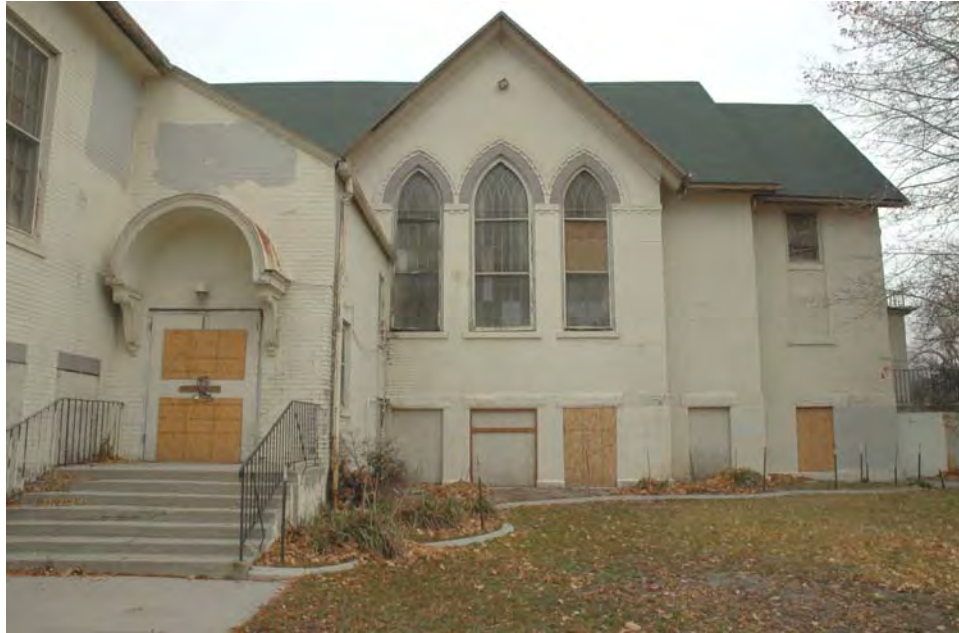
Photograph 9 of 14

West elevation of the Twenty-Ninth Ward LDS Meetinghouse (Assembly Hall).
Camera facing east.

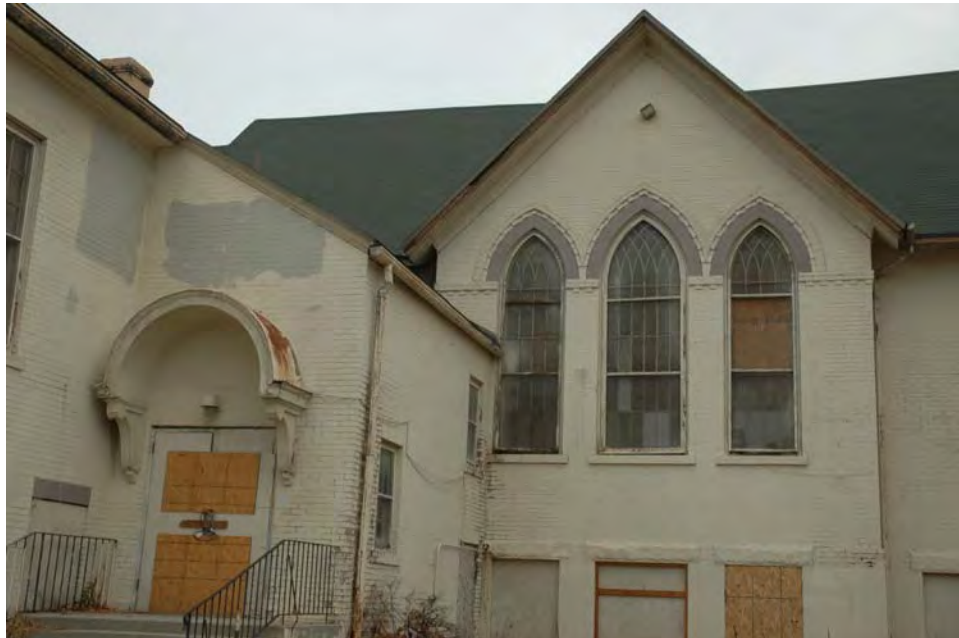
Photograph 10 of 14

West elevation of the Twenty-Ninth Ward LDS Meetinghouse, west entrance detail.
Camera facing east.

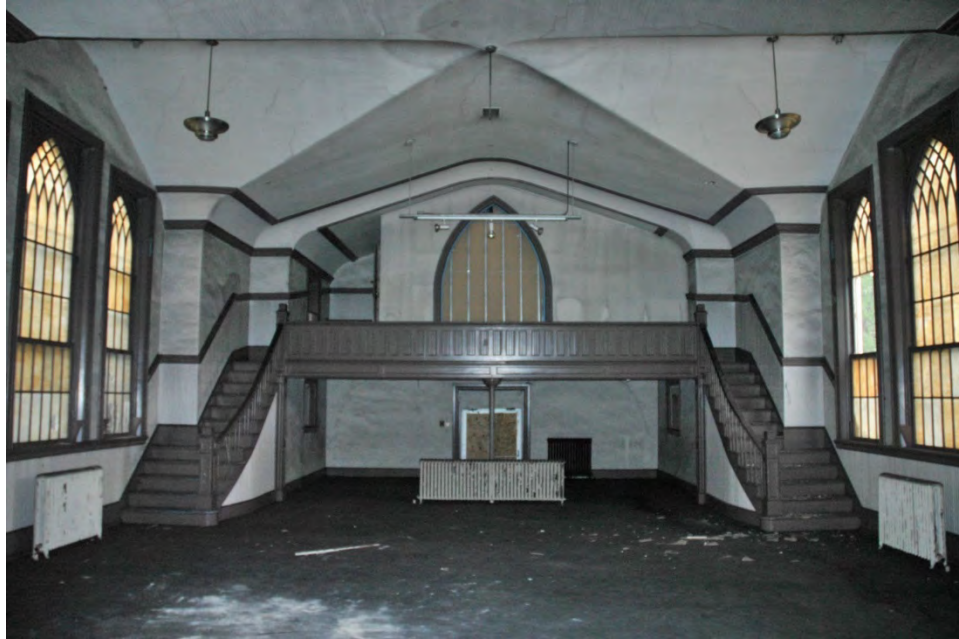
Photograph 11 of 14

Main floor, interior of the Chapel, Twenty-Ninth Ward LDS Meetinghouse.
Camera facing south.

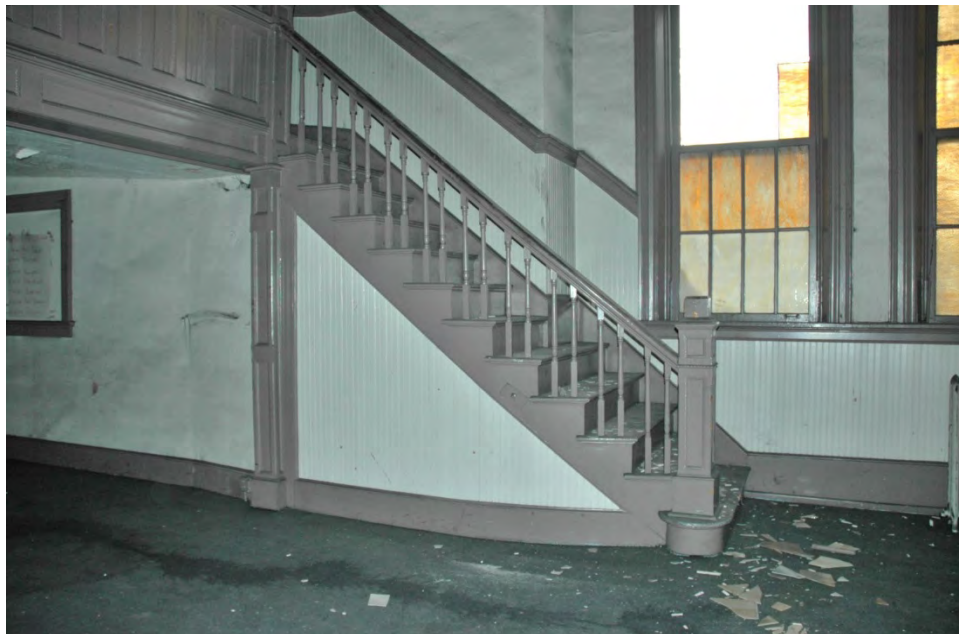
Photograph 12 of 14

Stair detail, main floor interior of the Chapel, Twenty-Ninth Ward LDS Meetinghouse.
Camera facing southwest.

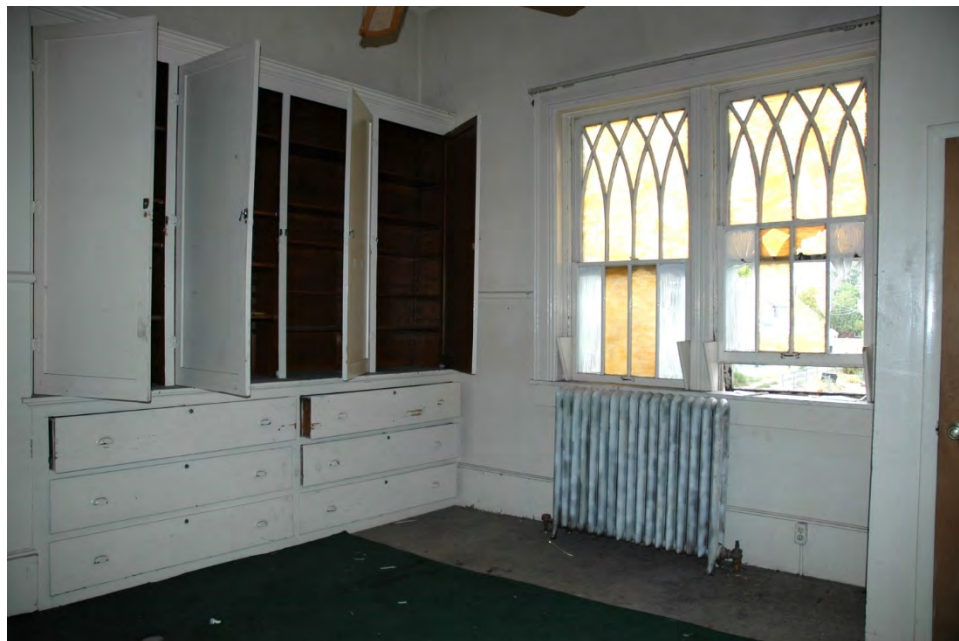
Photograph 13 of 14

Vestry detail, main floor interior of the Twenty-Ninth Ward LDS Meetinghouse.
Camera facing northeast.

The vestry was divided into two rooms: office space (east) and projection equipment room (west). A steam-heating system had been previously installed in 1925 and many of the radiators are extant.³ The two brick chimneystacks at the south corners of the Assembly Hall were likely removed after the steam-heat system was installed. Also in the mid-1920s, a frame cottage was built for the ward custodian's family just south of the addition. In 1938, the chapel space was carpeted and painted in pastel colors and gold leaf. The rostrum was remodeled a second time during which the tiers were eliminated and the pulpit shifted to the east wall. In 1940, a large opening was cut in the west wall of the Assembly Hall so that the Amusement Hall could be used for overflow seating with a somewhat obstructed view of the rostrum (blocked circa 1980).

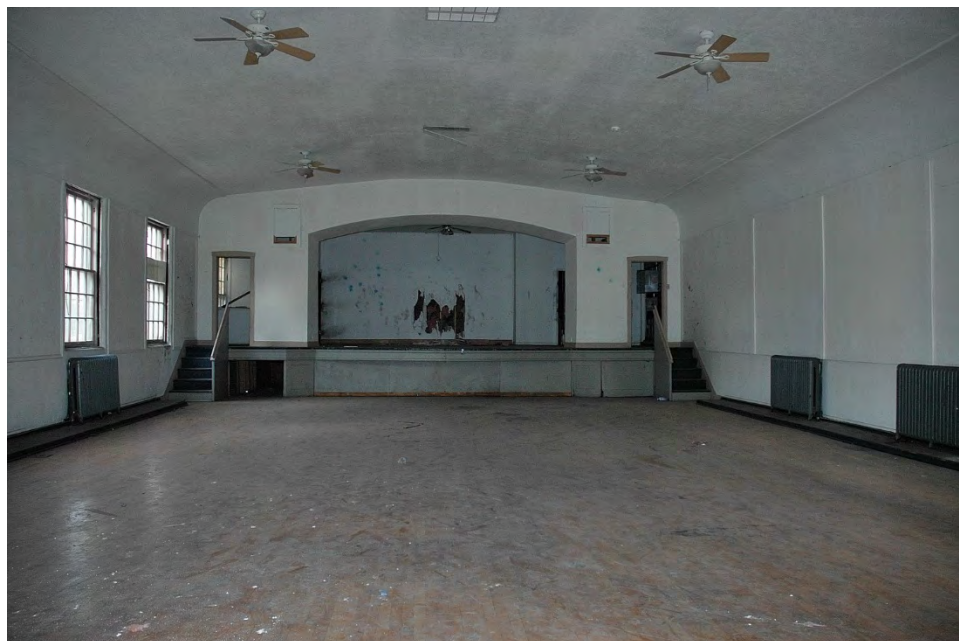
Photograph 14 of 14

Main floor interior of the Amusement Hall, Twenty-Ninth Ward LDS Meetinghouse.
Camera facing west.

The Amusement Hall is essentially a large open space. The flooring is maple. The ceiling has an elliptical shape that is coved along the north/south walls. Also at the east end, a door was cut to provide access to the original vestry. The south vestibule is a split-entry space that provided stairs to double doors cut into the west wall of the Assembly Hall and a south entry into the Amusement Hall. At the west end of the Amusement Hall was a rounded stage platform and an elliptical proscenium arch. A narrow L-shaped enclosed stair at the southwest (rear) corner of the stage provides access to the dressing rooms in the basement. Underneath the hall, the basement is divided by a central hall with nine flanking classrooms. A few of the four-panel classroom doors are intact. A kitchen and restrooms were installed at the east end of the basement space. The basement is accessed by stairs in the south vestibule and the stage area.

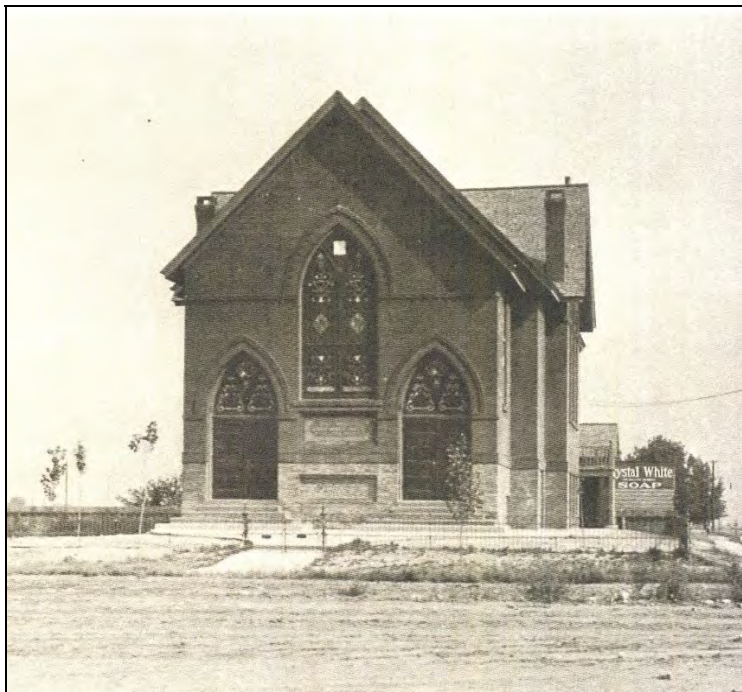
Figure 1
Twenty-Ninth Ward LDS Meetinghouse, circa 1915.
Camera facing north.

younger brother, George S. Ashton, known as Ashton Brothers Construction.¹⁵ Although Edward T. Ashton may have provided oversight and expertise, the bulk of the labor was donated by ward members. On September 7, 1902, the first meeting was held in the basement. In a request for matching funding sent to the LDS Church leadership in November 1902, Bishop McKean described the congregation as “generally poor as to means” but noted that the members had “bent [their] energies to the task of Building a place of Worship” and had donated \$2,250.00 toward the estimated \$7,000.00 needed to complete the project.¹⁶ Both worship meetings and socials were held in the basement until the 350-seat capacity worship space above was completed in the spring of 1905. Considered very modern at the time, in the winter, the chapel was heated by stoves, and in the summer the top window sashes would be lowered for ventilation. Bishop McKean, a successful sheep rancher, donated the stained-glass windows in the façade [Figures 1 & 2].

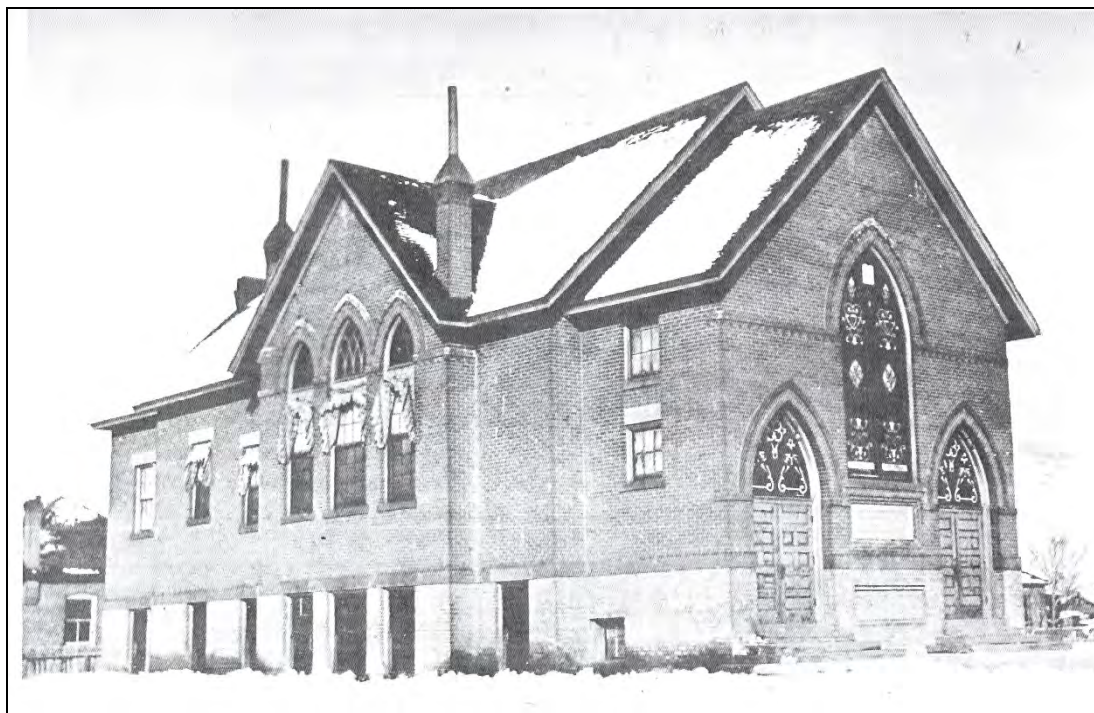
Figure 2
Twenty-Ninth Ward LDS Meetinghouse, circa 1920.
Camera facing northeast.

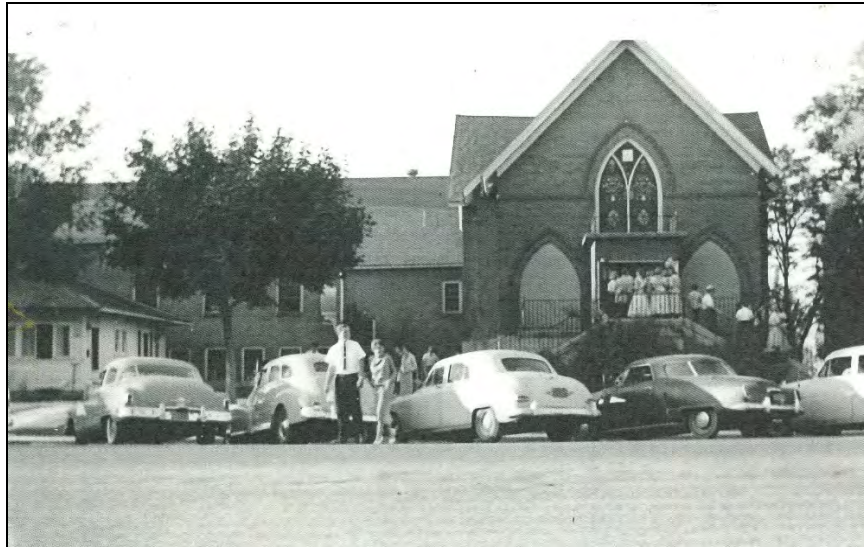
Figure 3
Twenty-Ninth Ward LDS Meetinghouse, circa 1959.
Camera facing north.

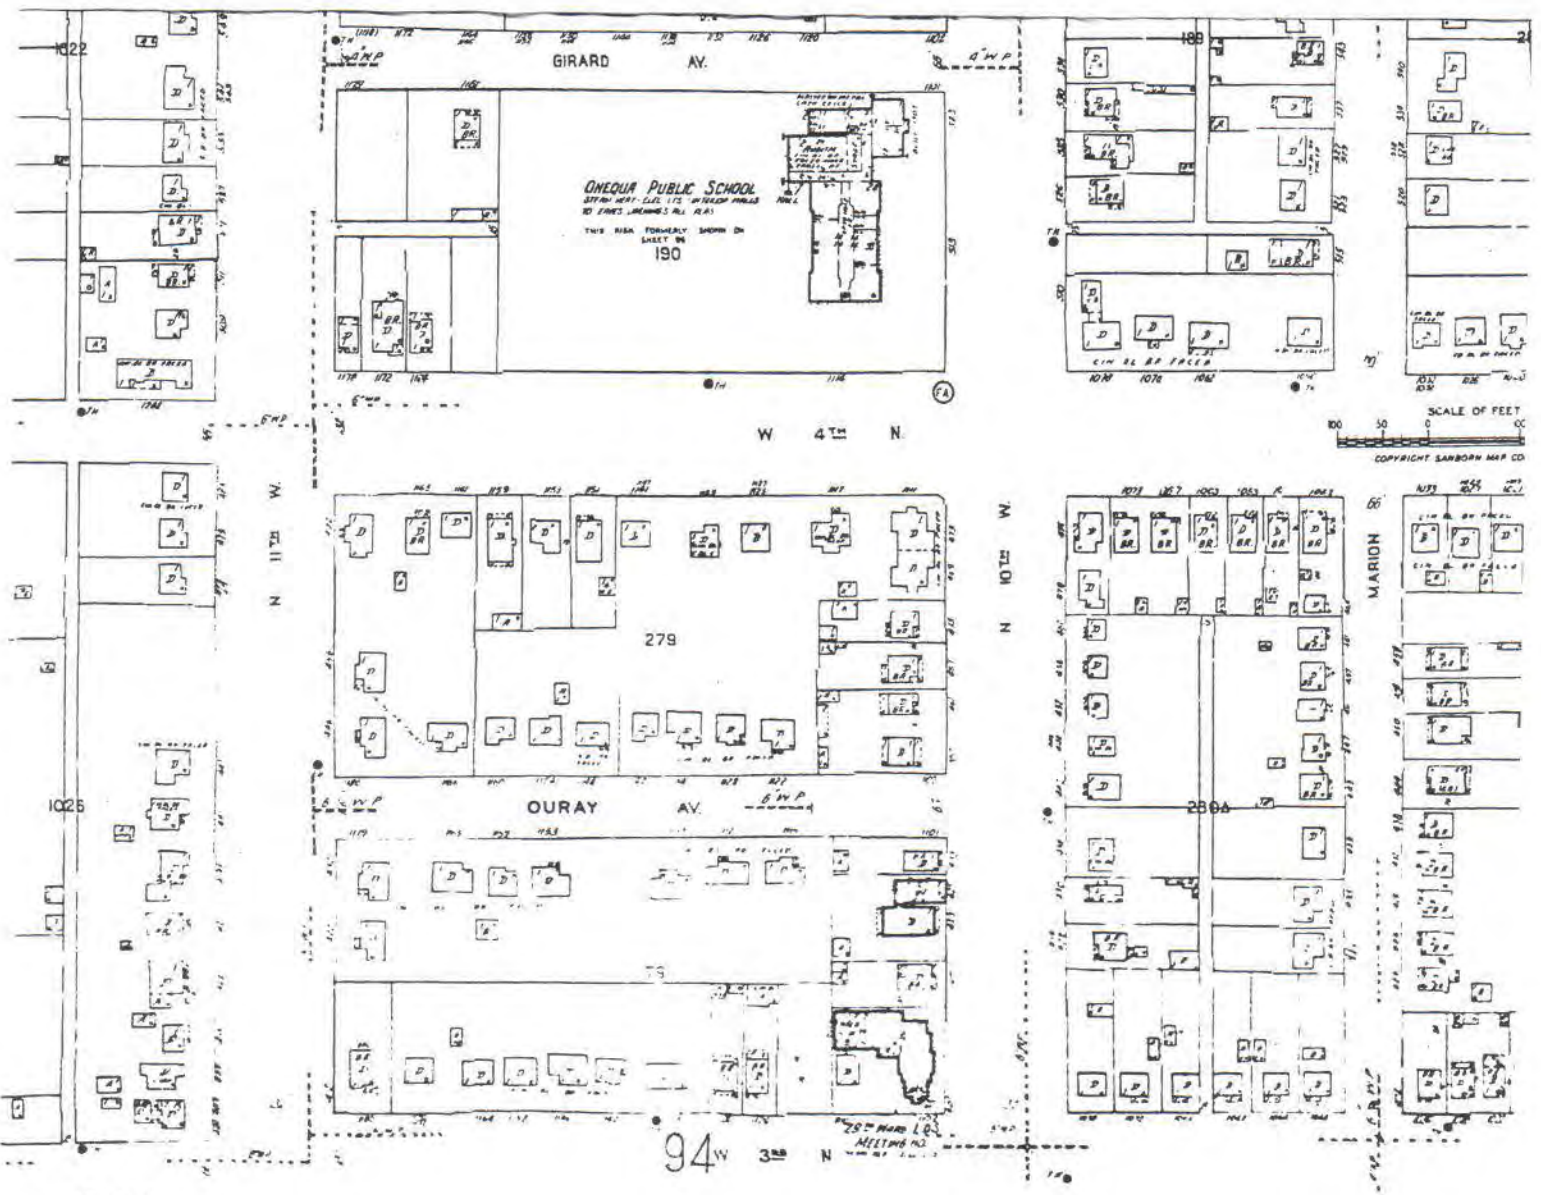
1102 W. 400 North (1106 W. 3rd North)
 Sanborn Fire Insurance Map 1969
 Salt Lake City, Utah
