BISHOP SCHOOL

Waterbury, Connecticut

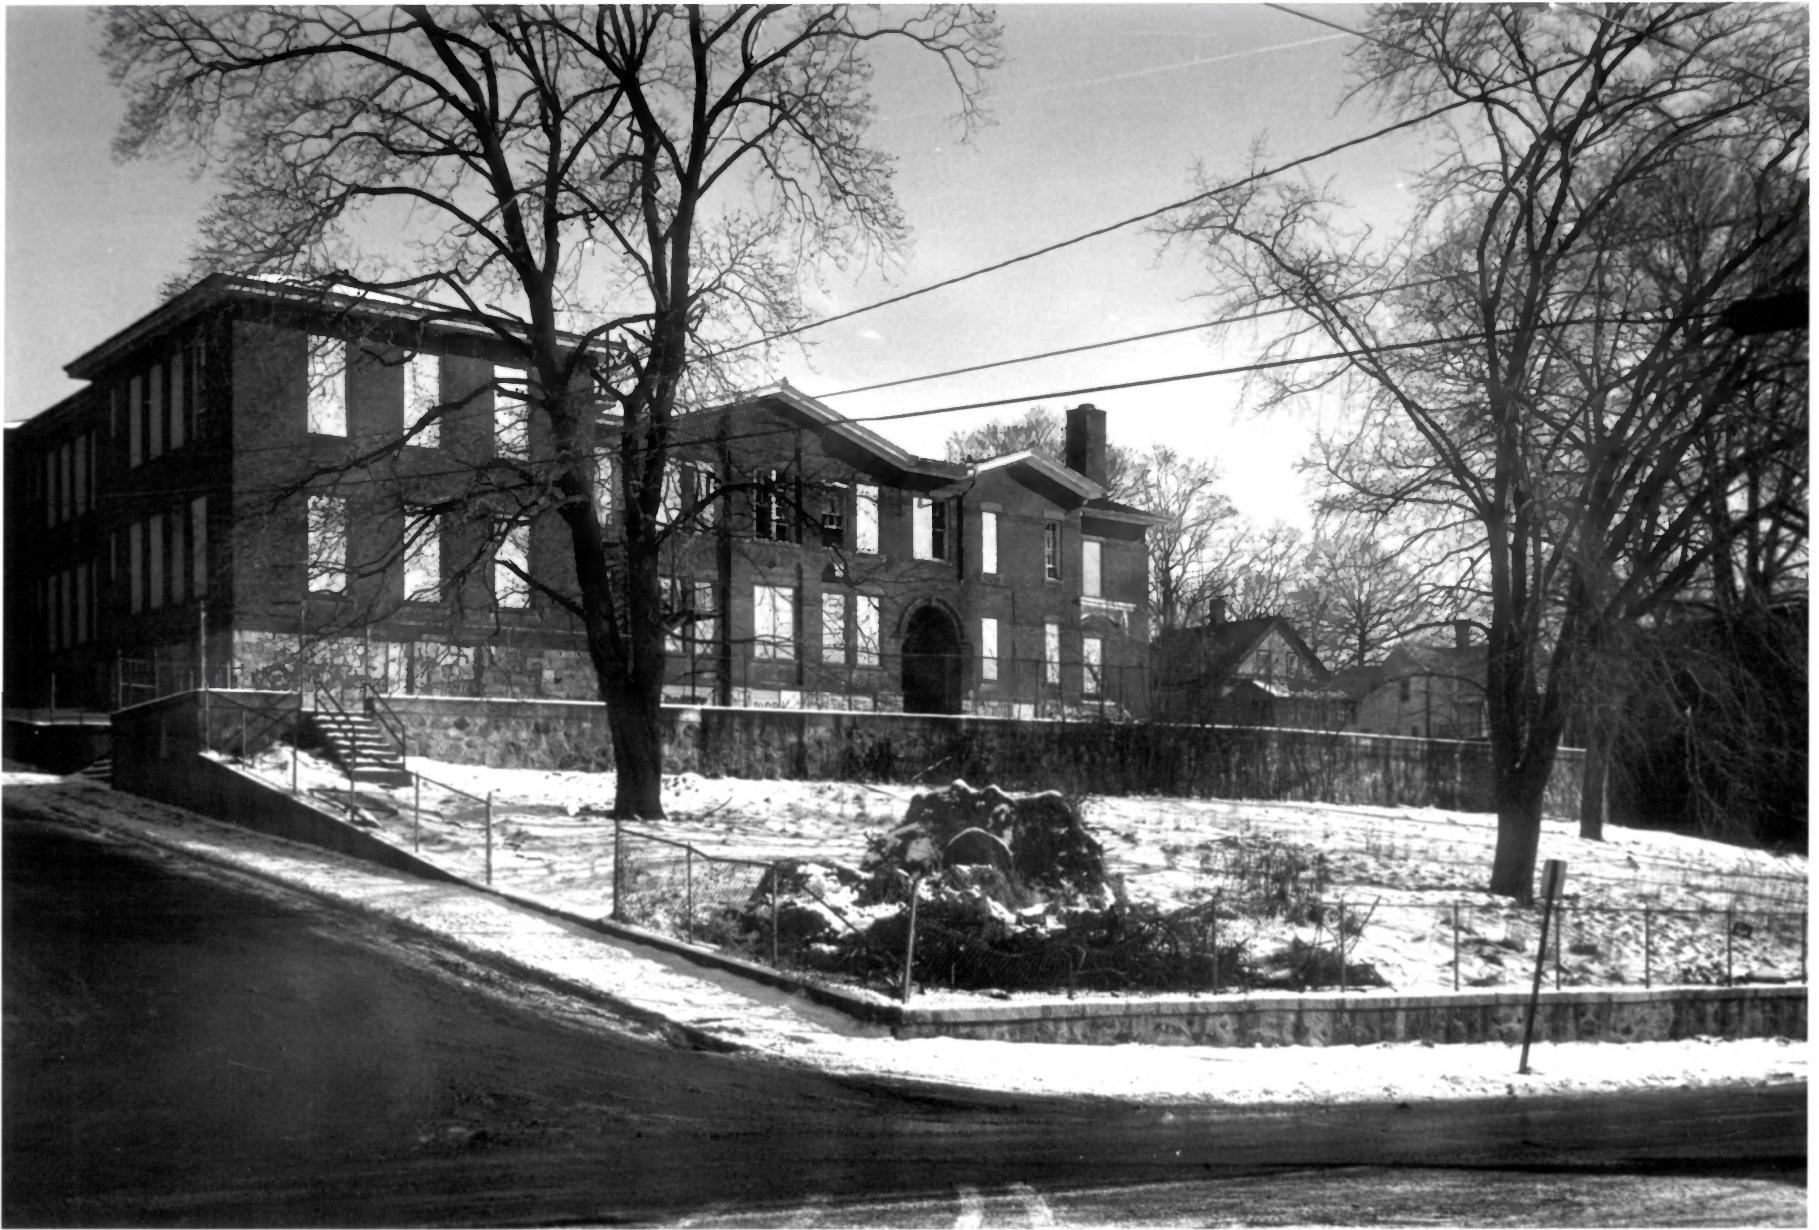
Photo # 1 Date: 12/5/80

View: West elevation - looking  
southeast. Crown St. is at  
left - Bishop St. in fore-  
ground. 1886 addition is at  
far right - 1895 addition  
at far left.

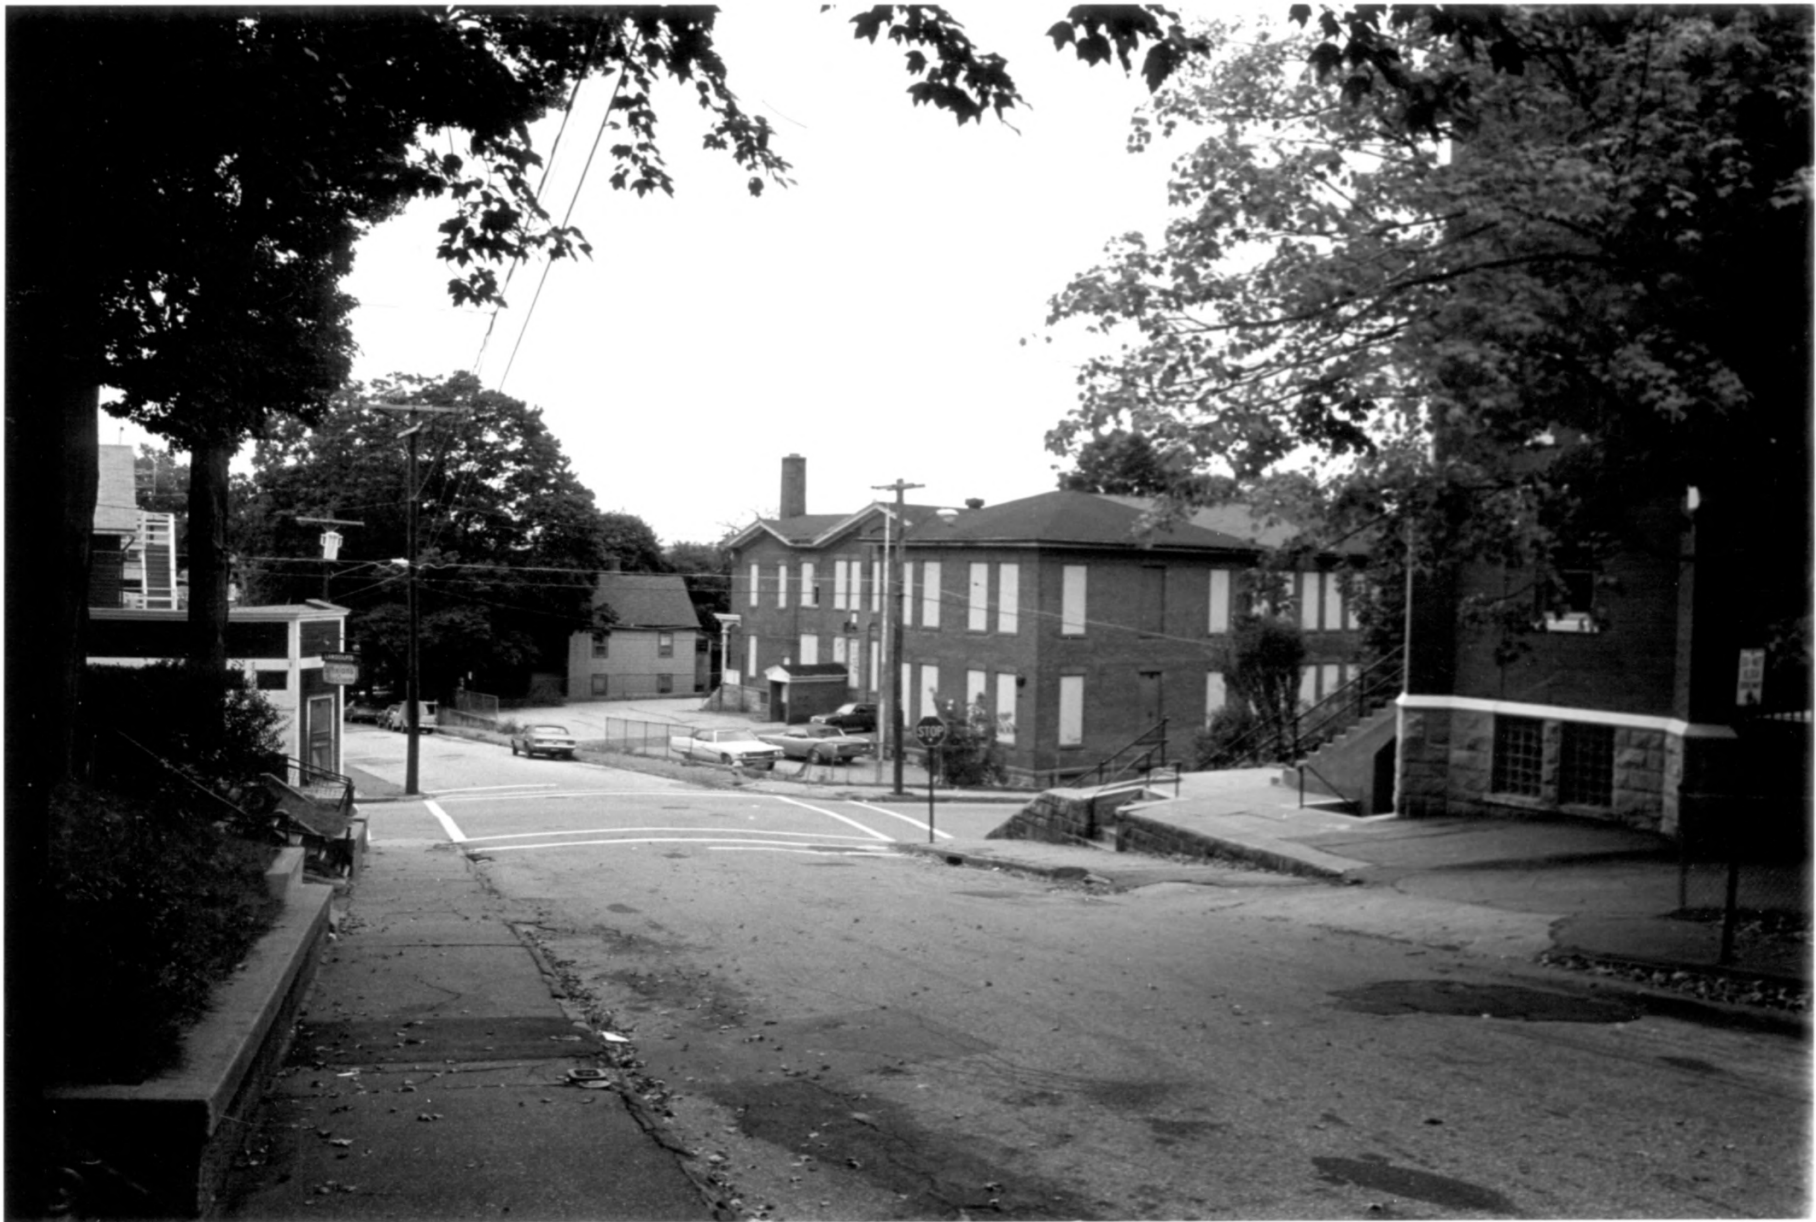
Photo # 2 Date: 12/5/80  
Neg. on file: Conn. Hist Comm.

View: Looking down Beacon St.  
with Bishop School on rt.  
1895 addition is in fore-  
ground with windows boar-  
ded in. Note neighborhood  
scale and atmosphere.

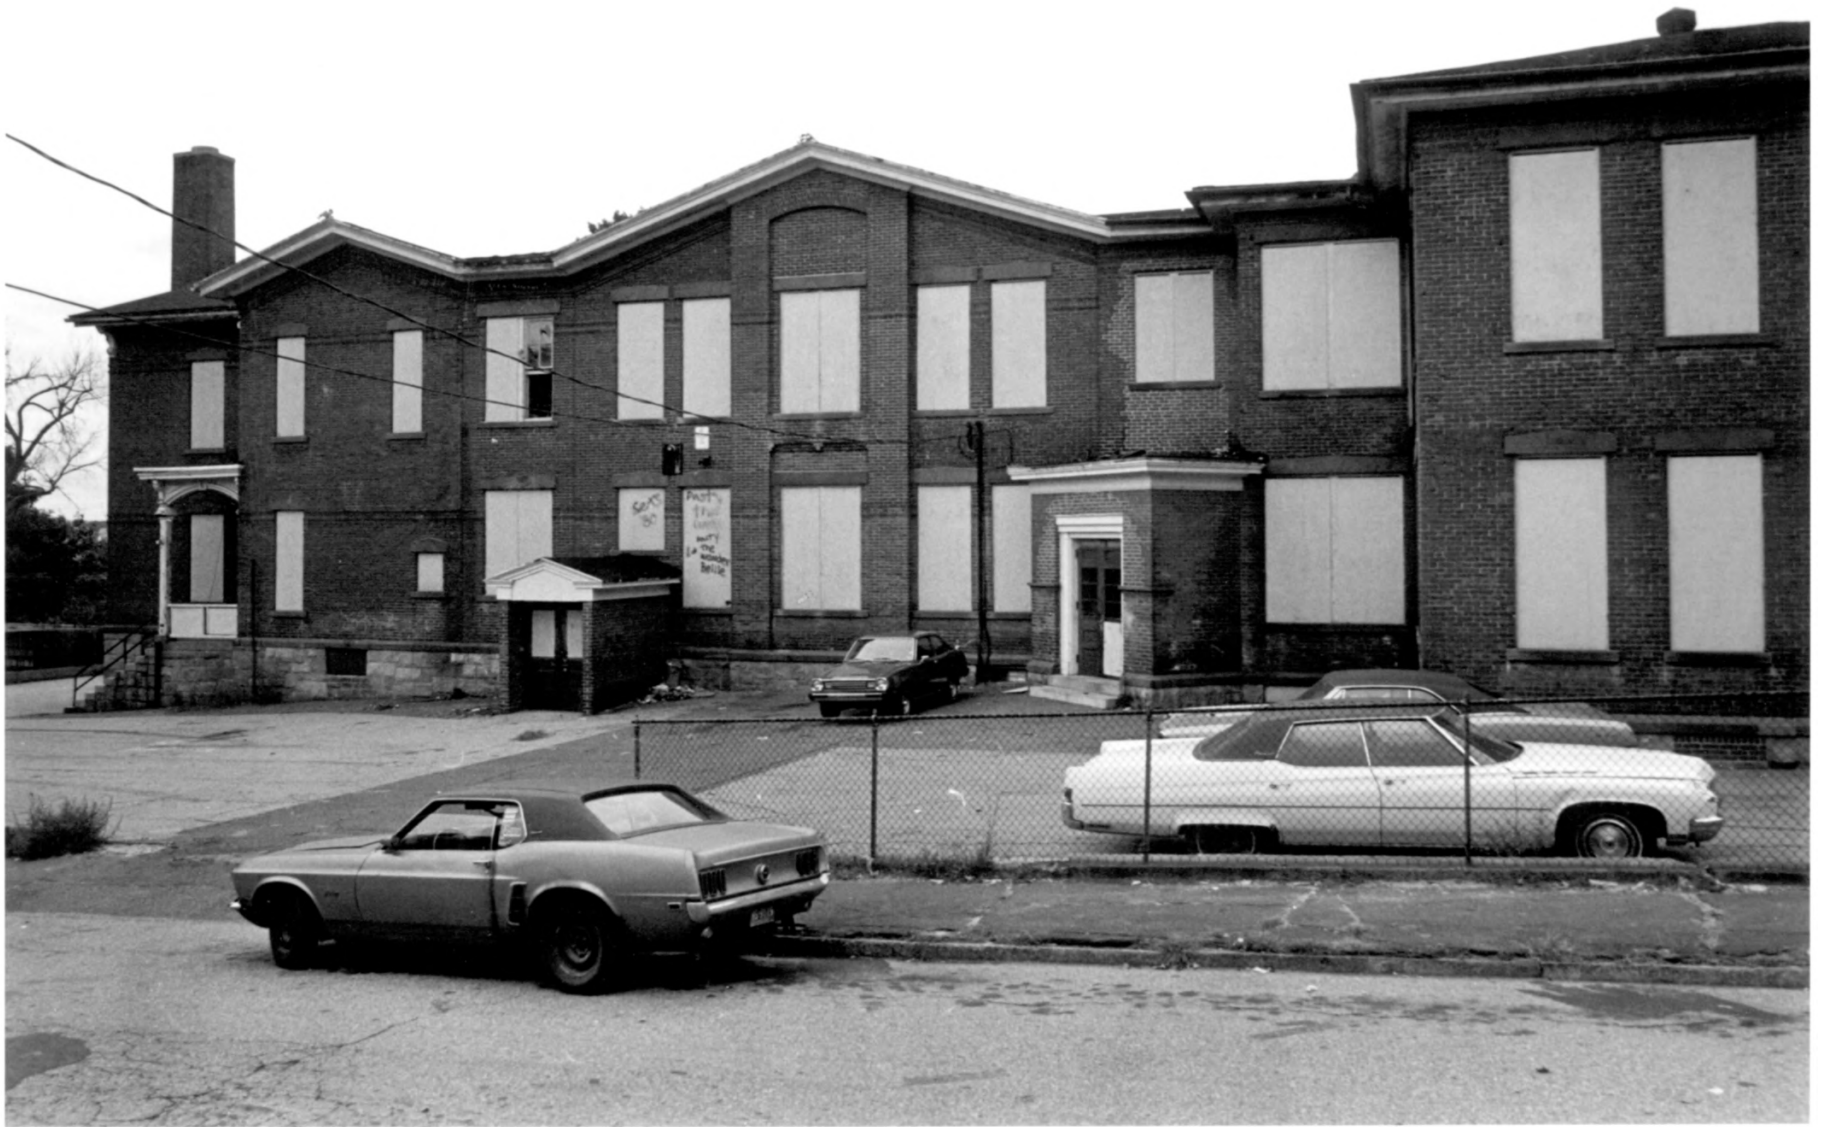
Photo # **3** Date: 12/5/80  
Neg. on file: Conn. Hist. Comm.

View: Beacon St. facade - looking  
due west. 1886 addition is  
wing at far left - 1895 ad-  
dition is block at far right

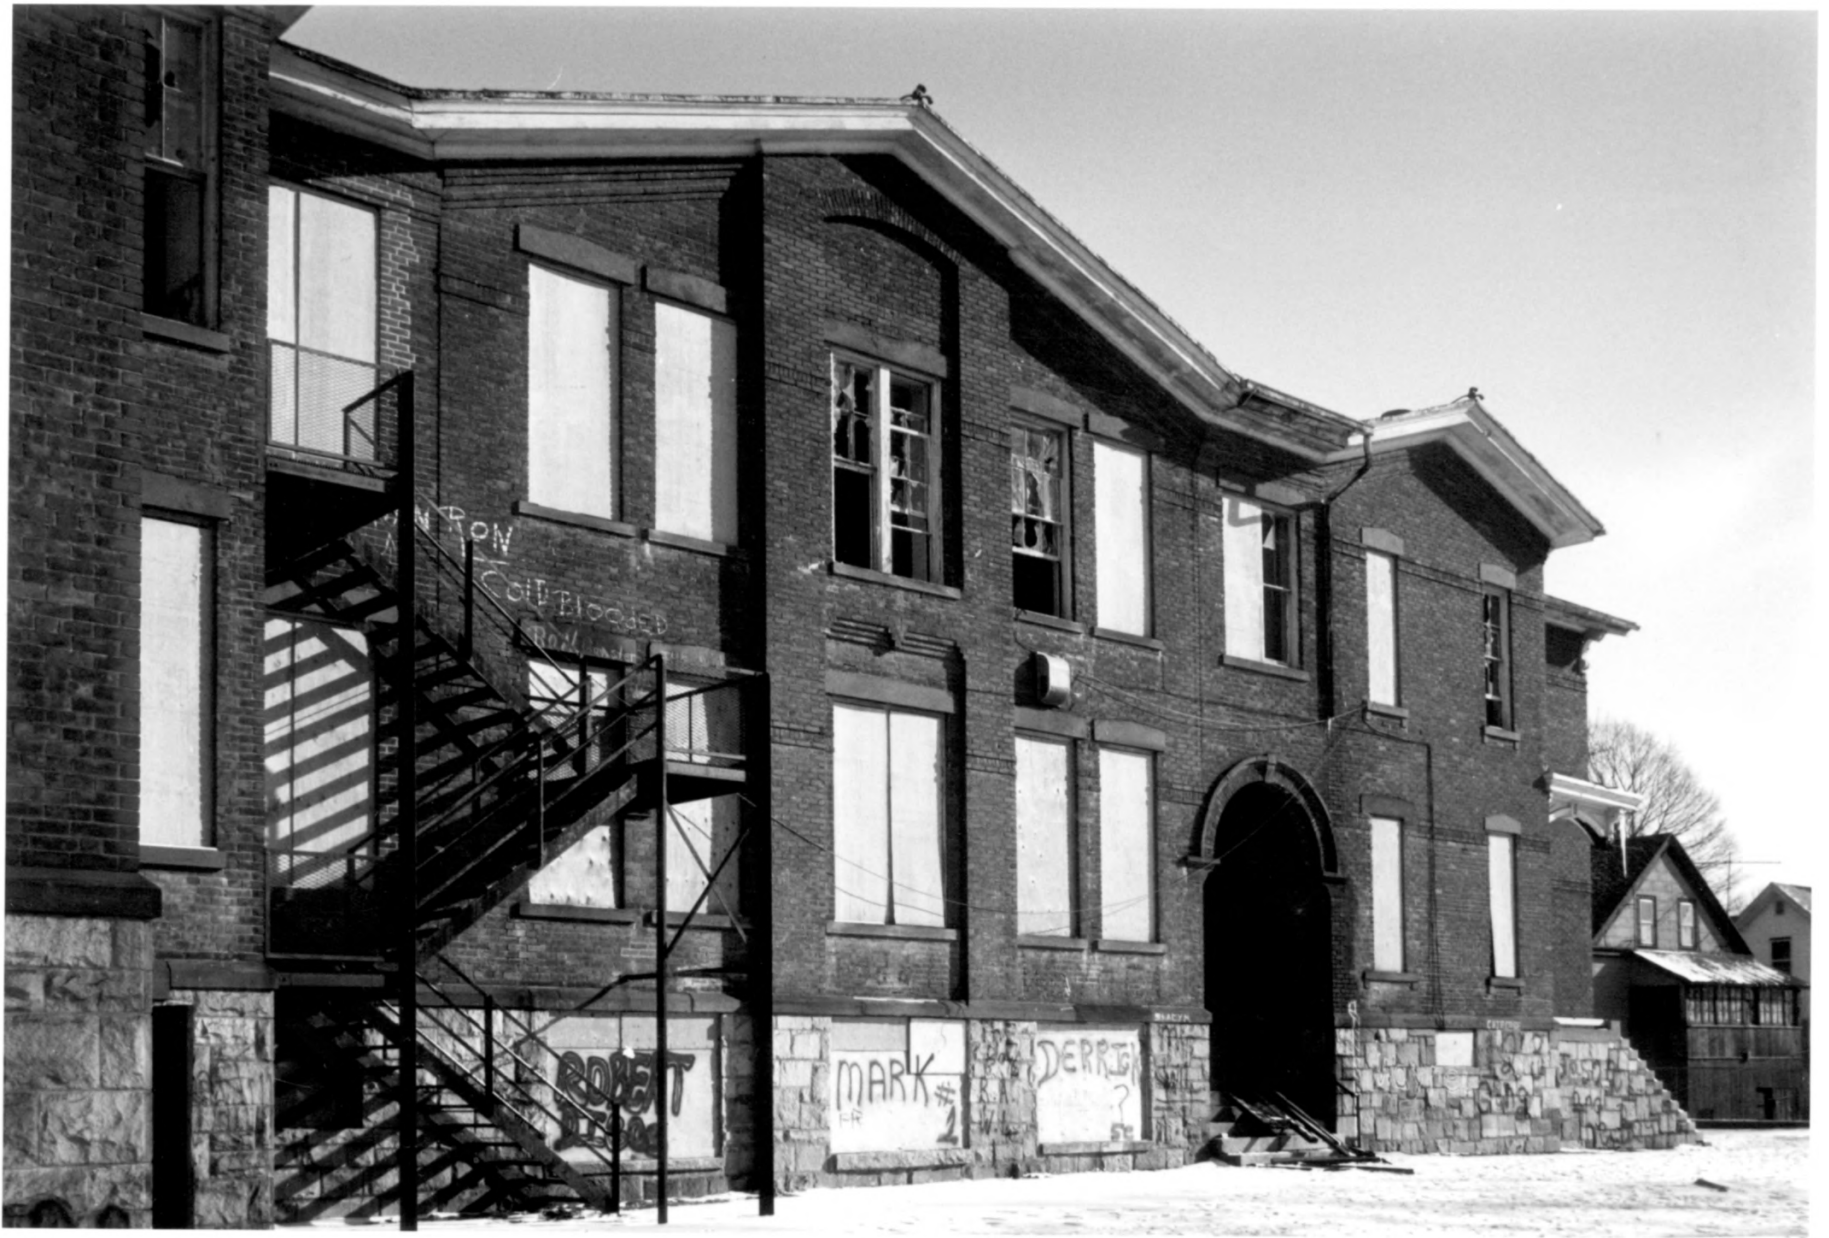
Photo # 4 Date: 12/5/80

View: West facade looking SE.  
Note recessed arched entrance; details of wall gable; foundation.

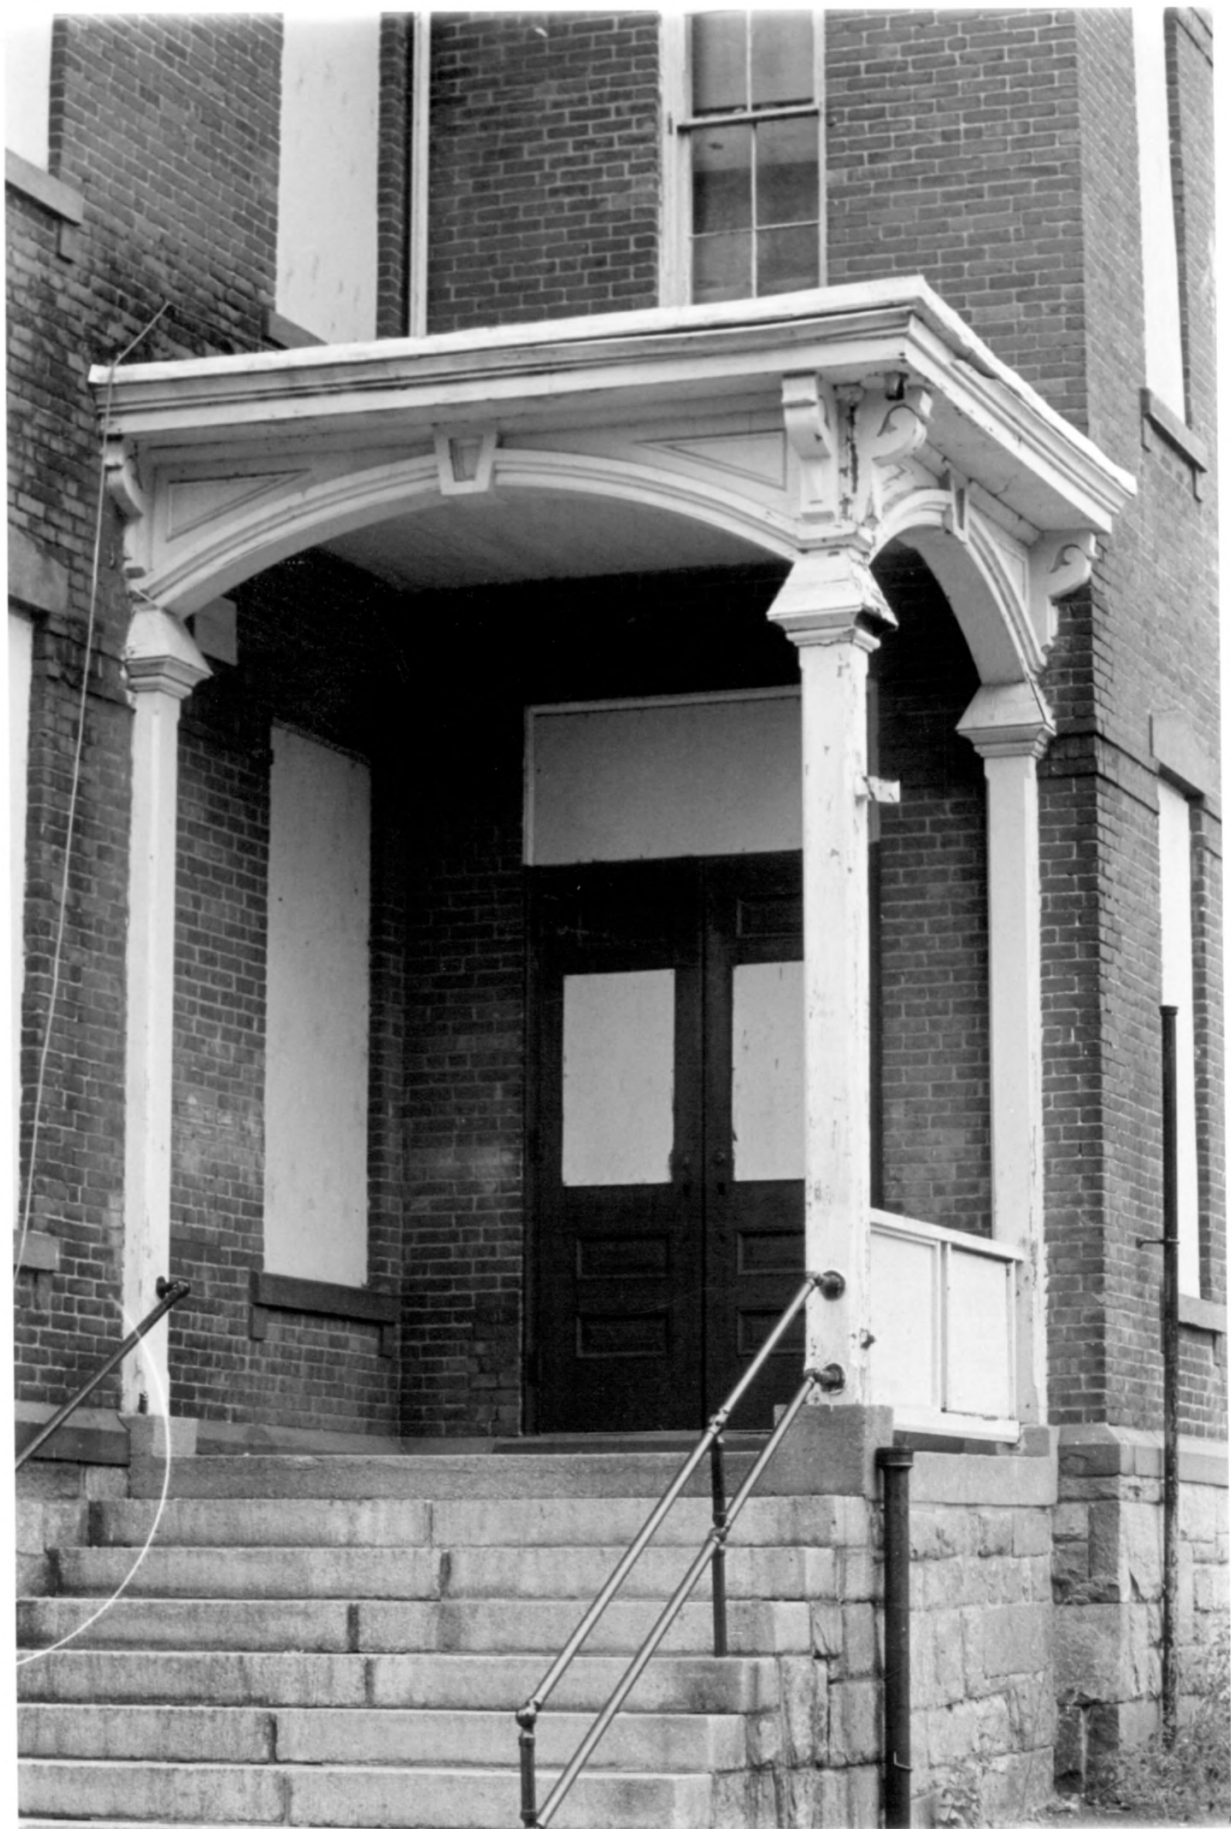
Photo # 5 Date: 12/5/80

View: Bracketed porch (one of a pair) at SE corner of building - 1886 addition.

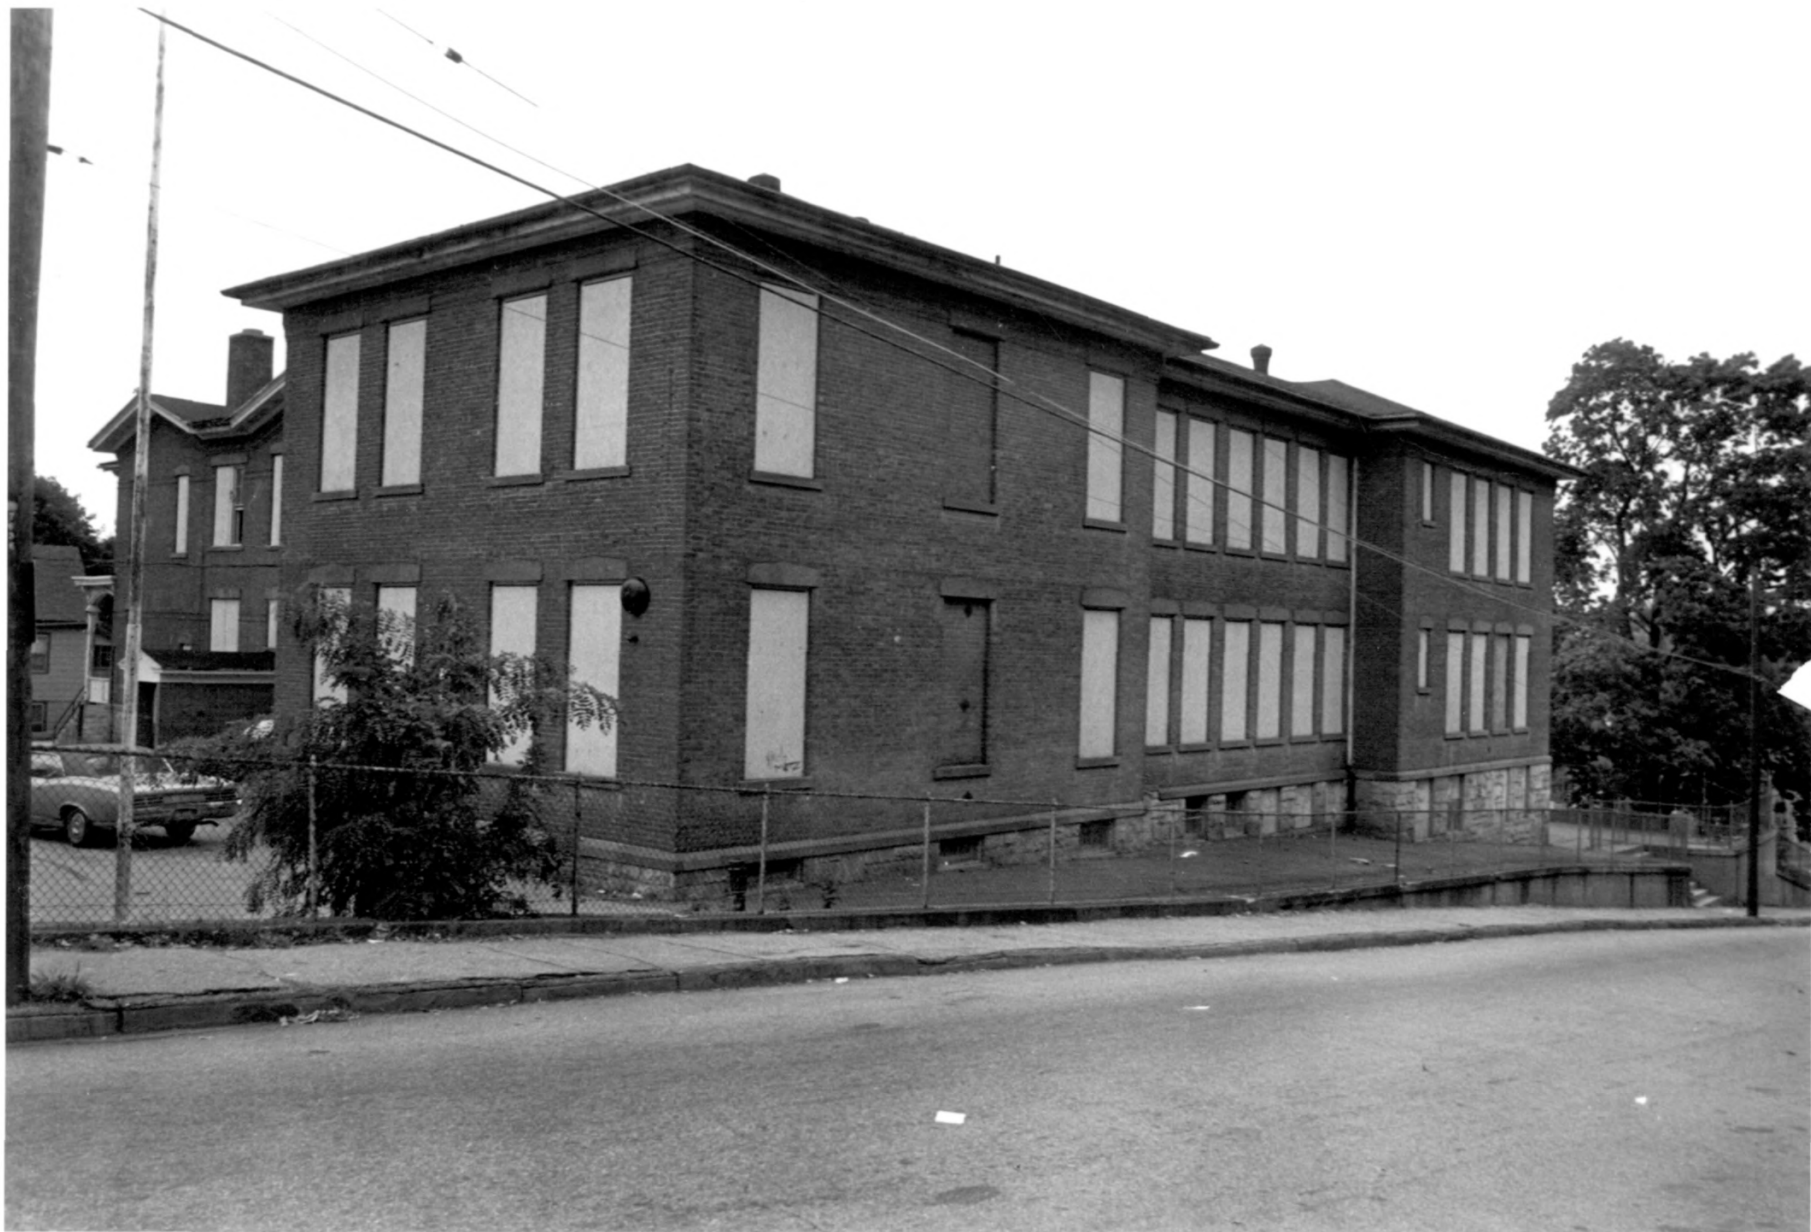
Photo # 6 Date: 12/5/80

View: 3/4 view looking south of  
1895 addition. Note low  
hip roof; brownstone trim;  
sloping site and exposed  
foundation and water table.

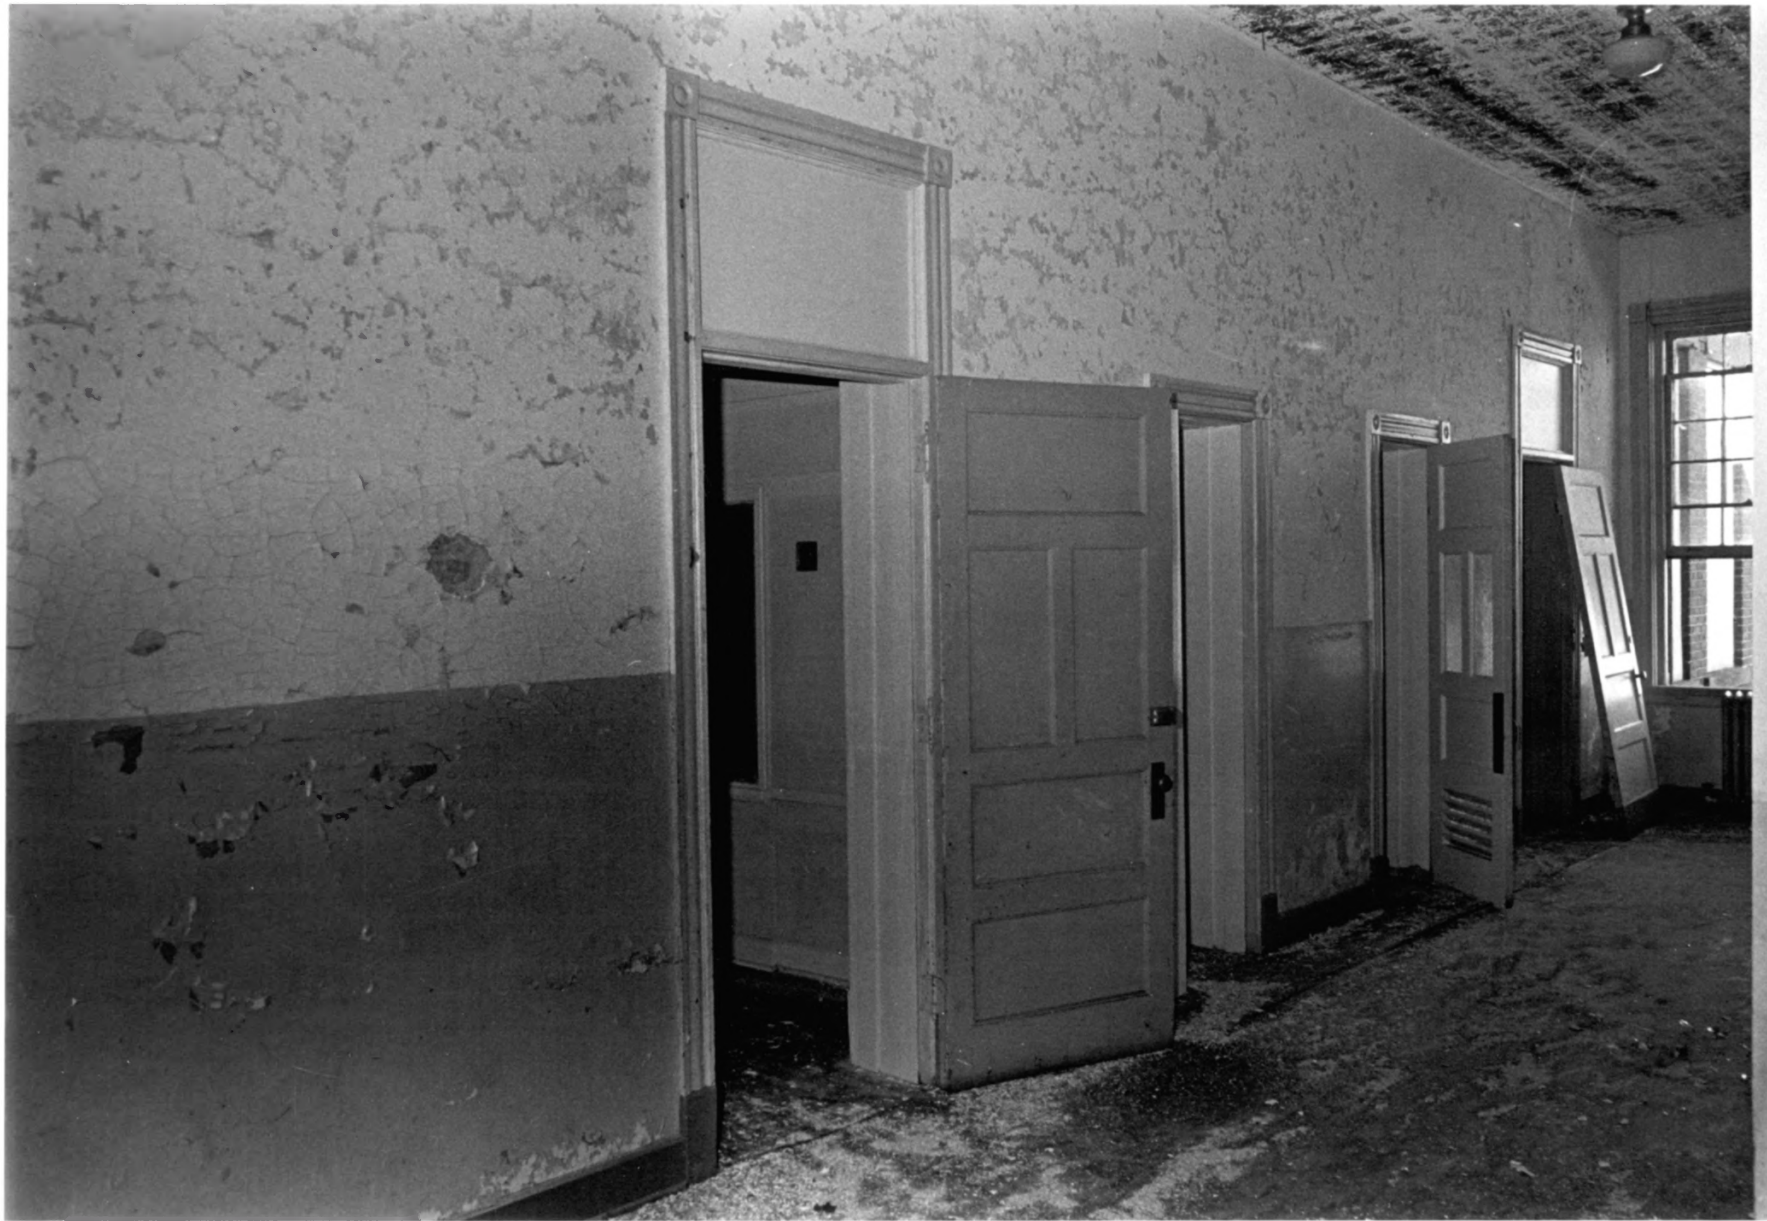
Photo # 8 Date: 12/5/80

View: Transverse hallway in  
1895 addition. Note tran-  
soms for light/ventilation  
and pressed metal ceiling.  
Three classrooms served by  
this corridor.

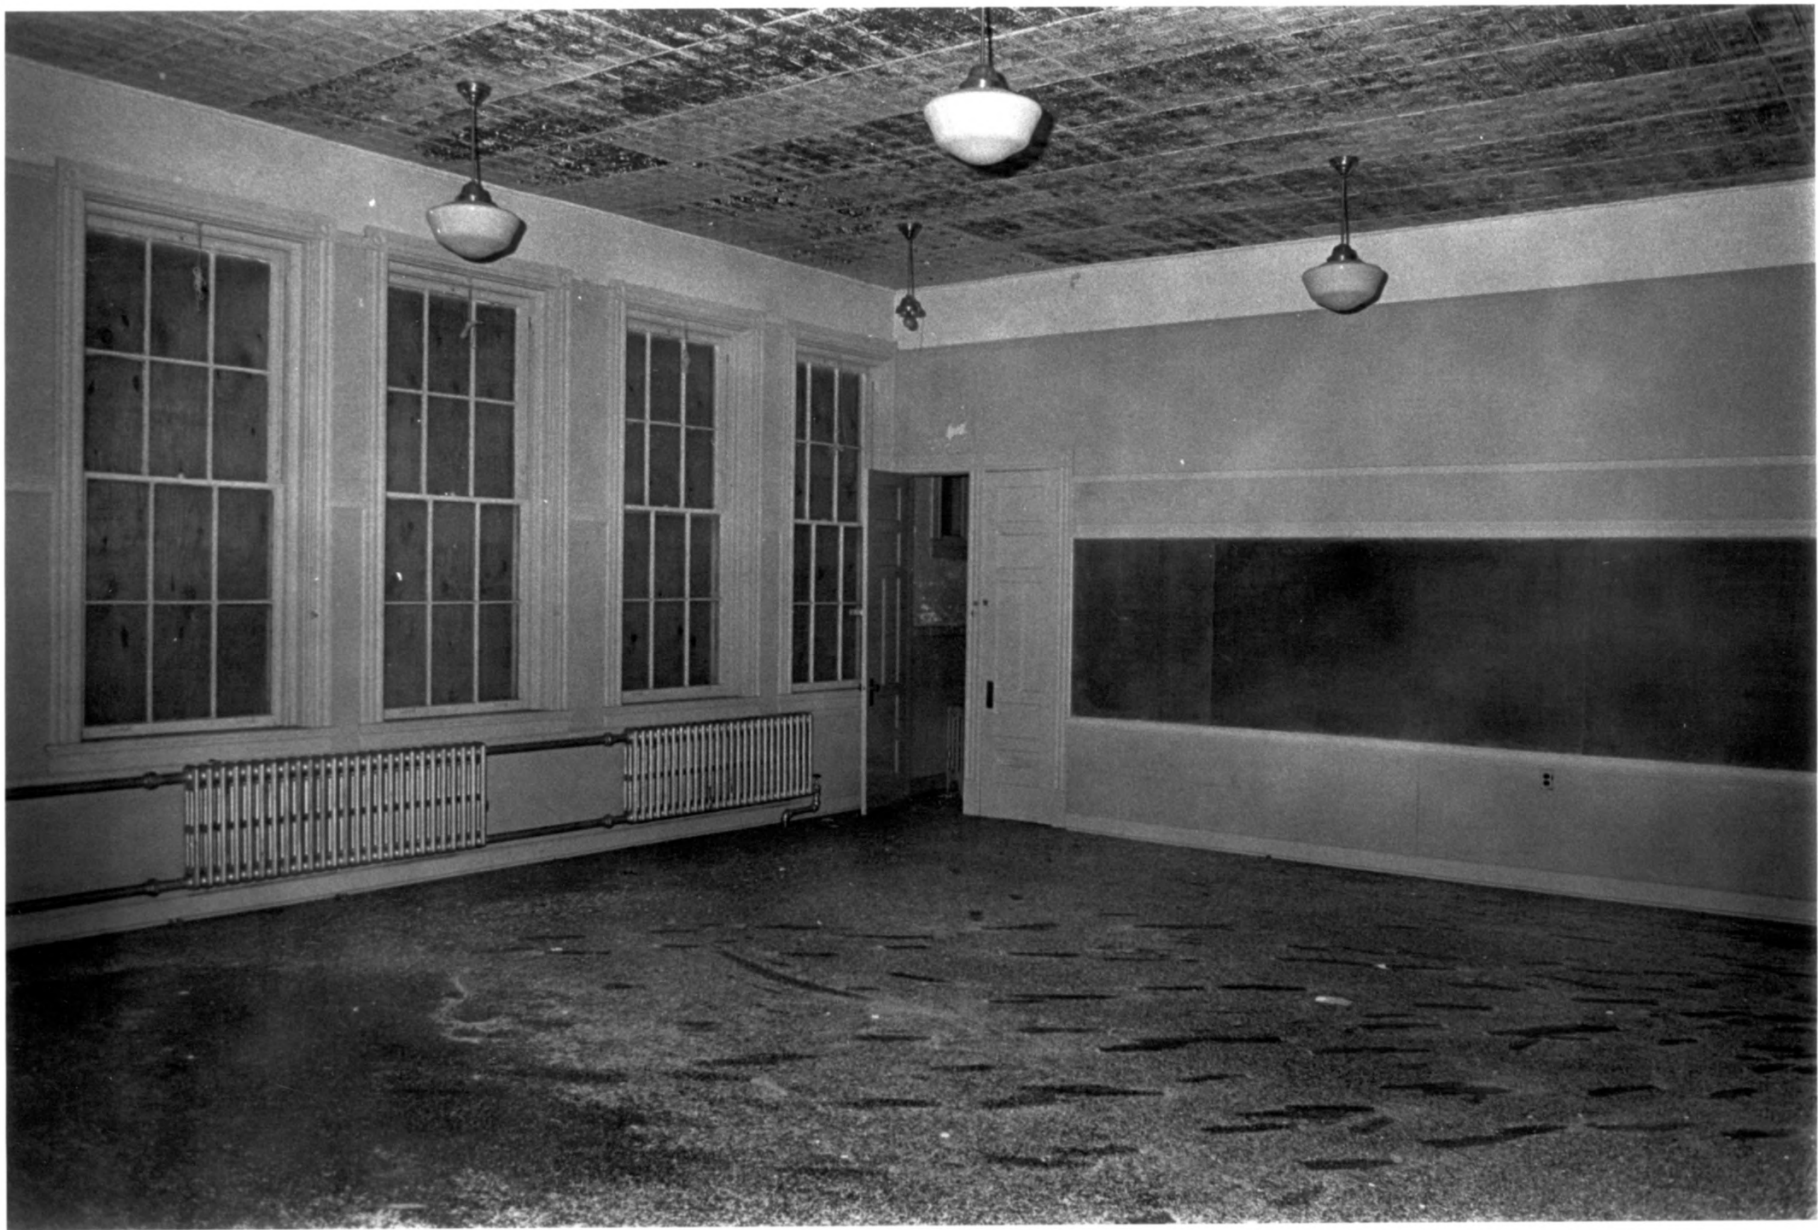
Photo # 9 Date: 12/5/80

View: Typical view of classroom in 1895 addition.  
Note: compound window moldings/corner blocks.  
Also tin ceiling; lighting.

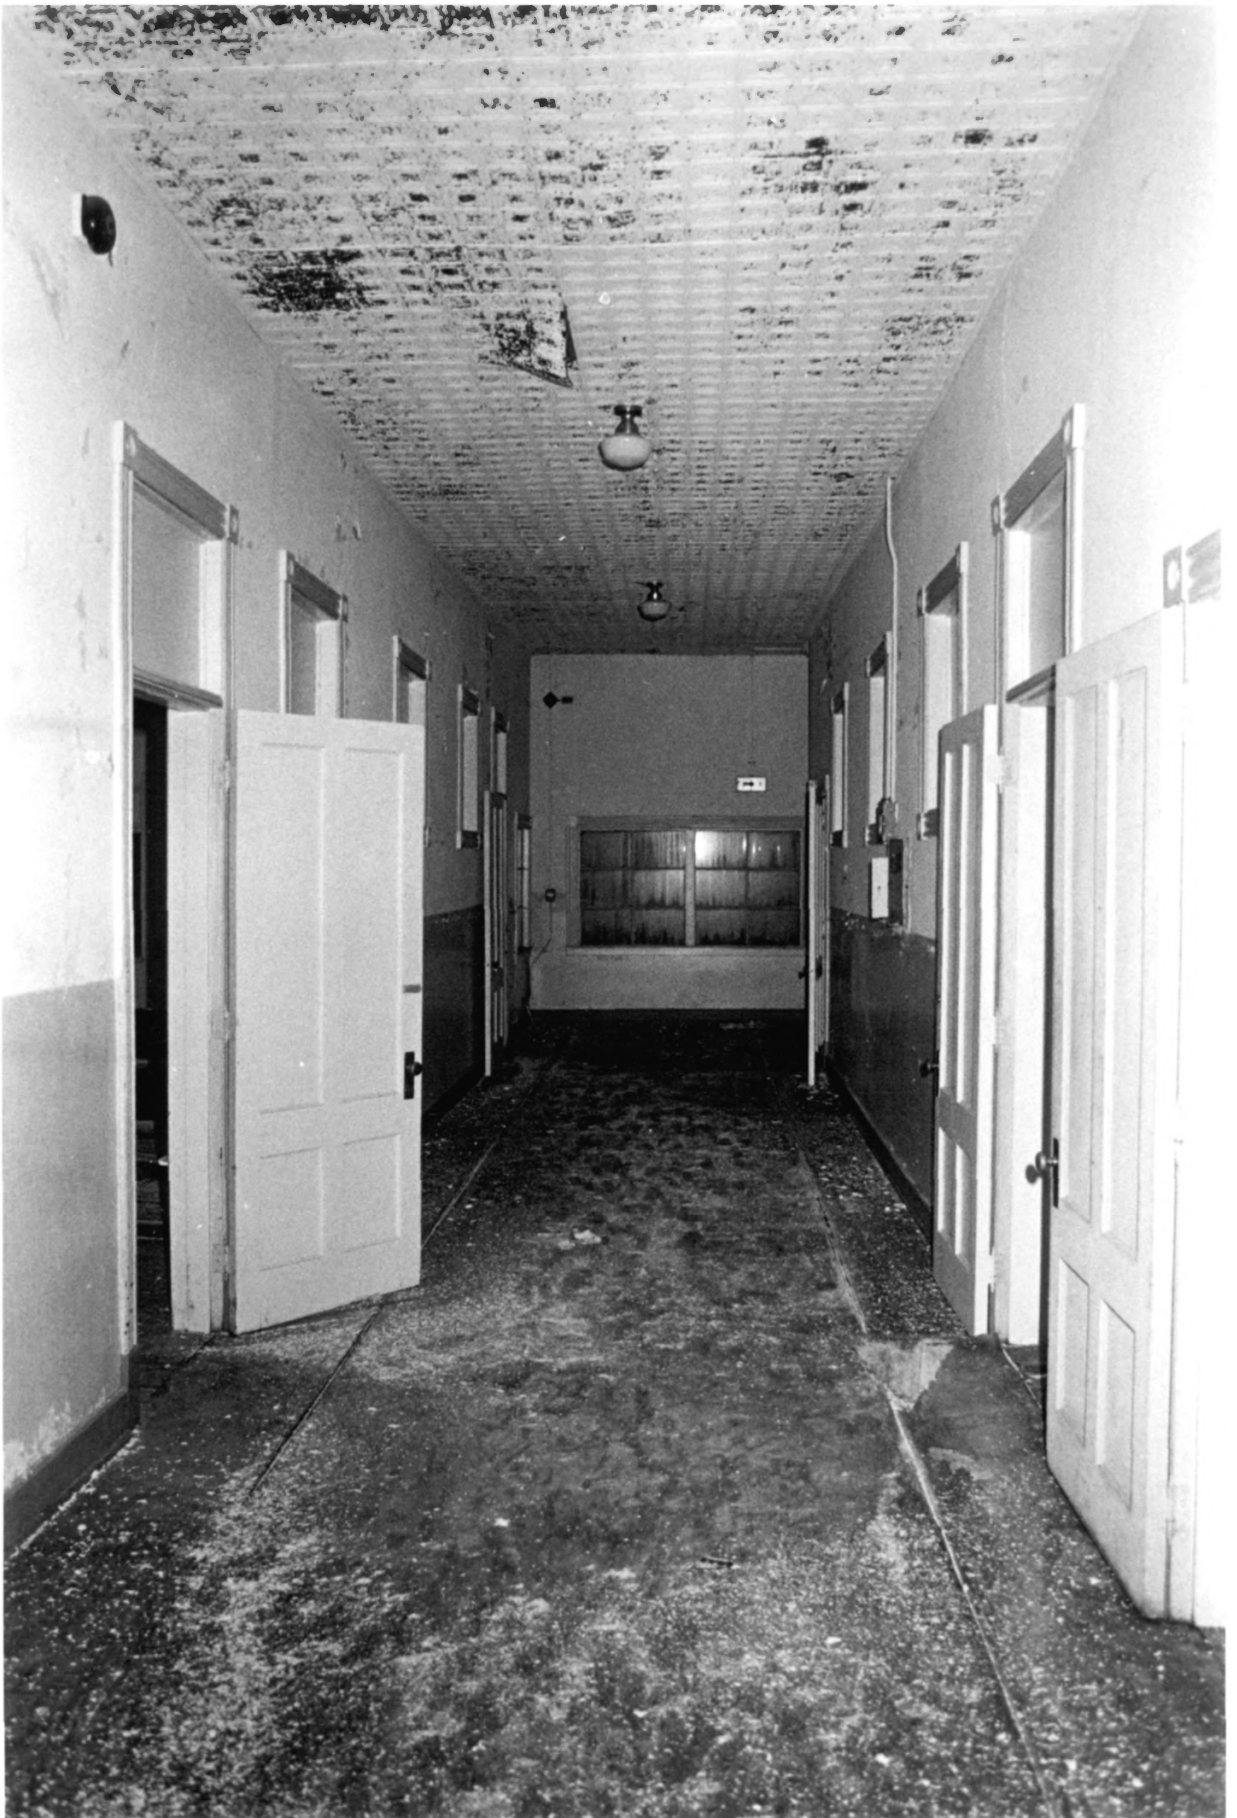
Photo # 10 Date: 12/5/80

View: Looking south in main  
corridor of original 1879  
structure. Typical on both  
floors. Note transoms; dec-  
orative metal ceiling.

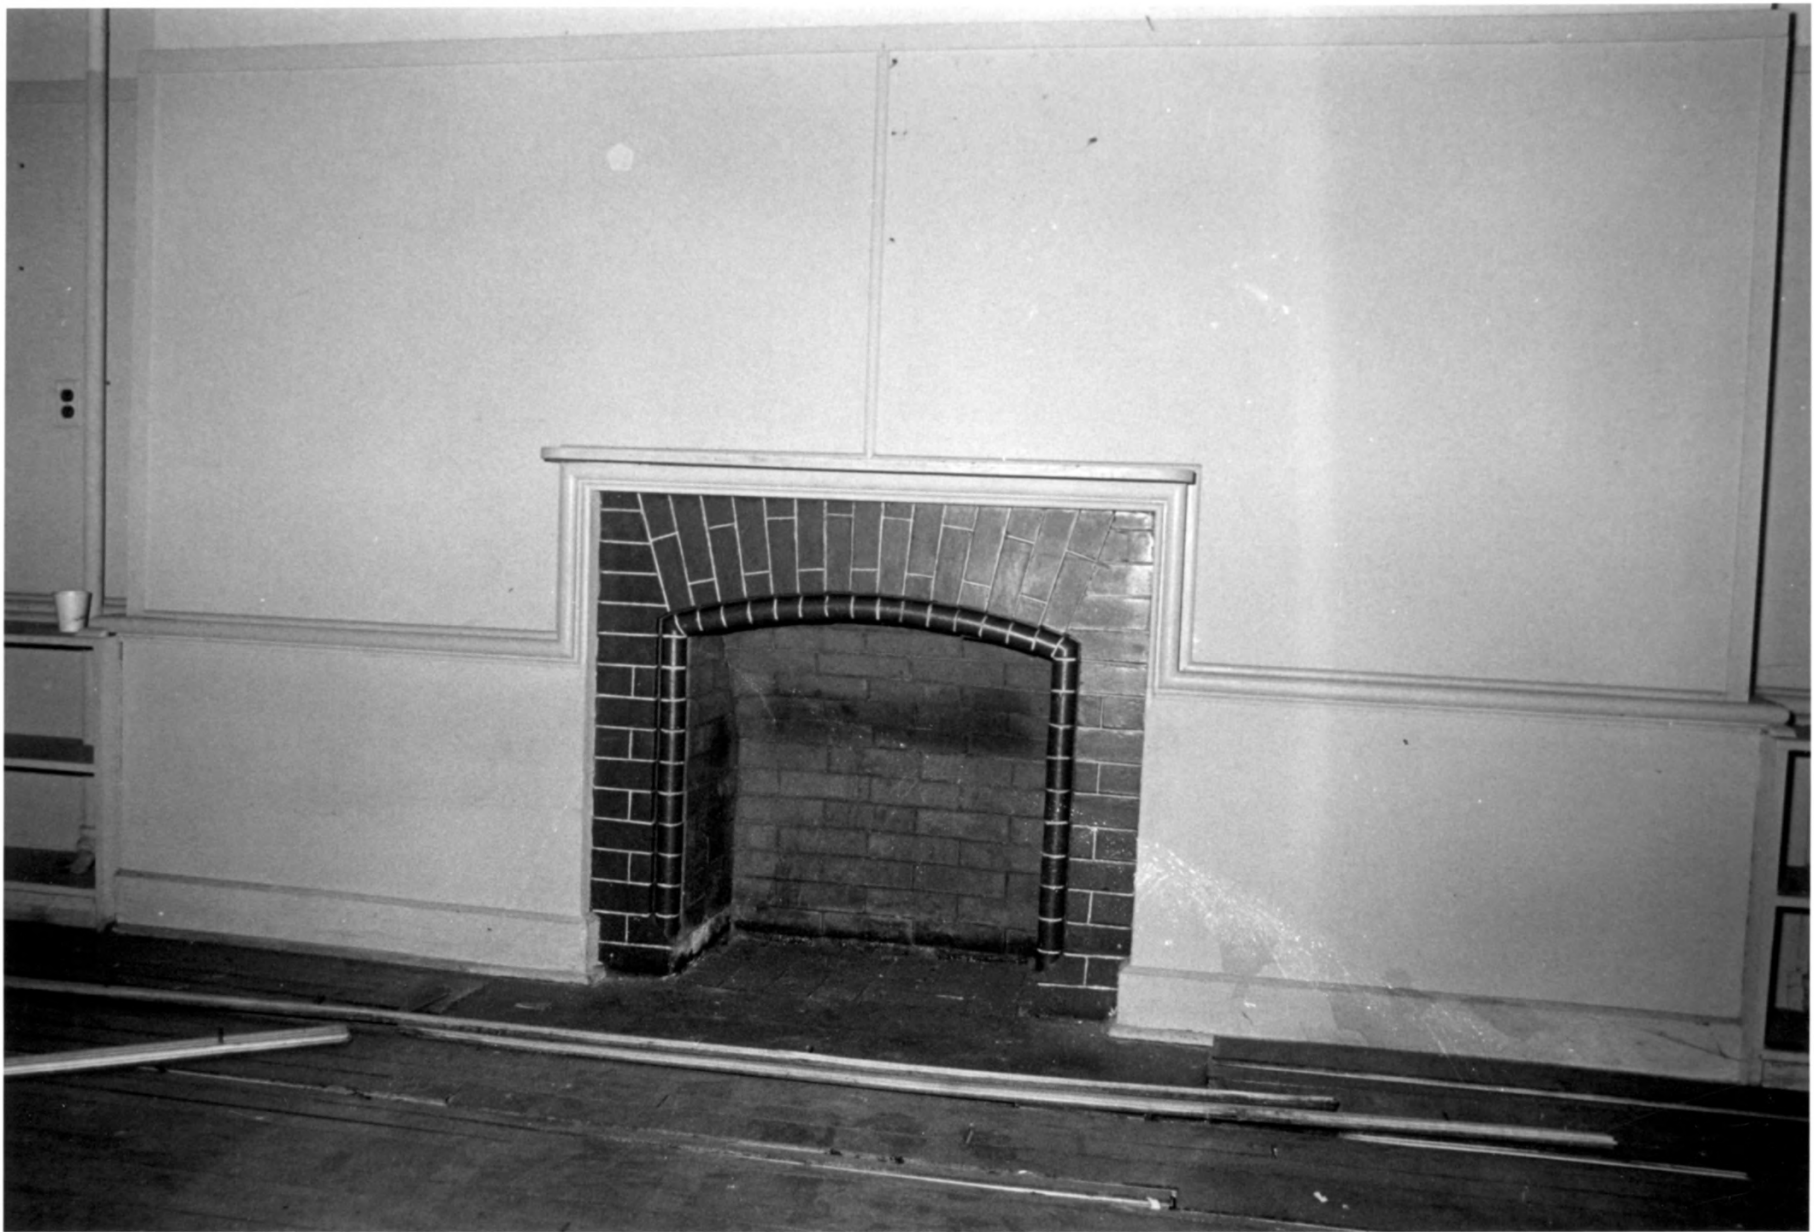
Photo # 11 Date: 12/5/80

View: Fireplace at southern end  
of building in classroom  
(1886 addition). Note bo-  
lection molding and mantel;  
segmental arch in brick.
