BISHOP SCHOOL

Waterbury, Connecticut

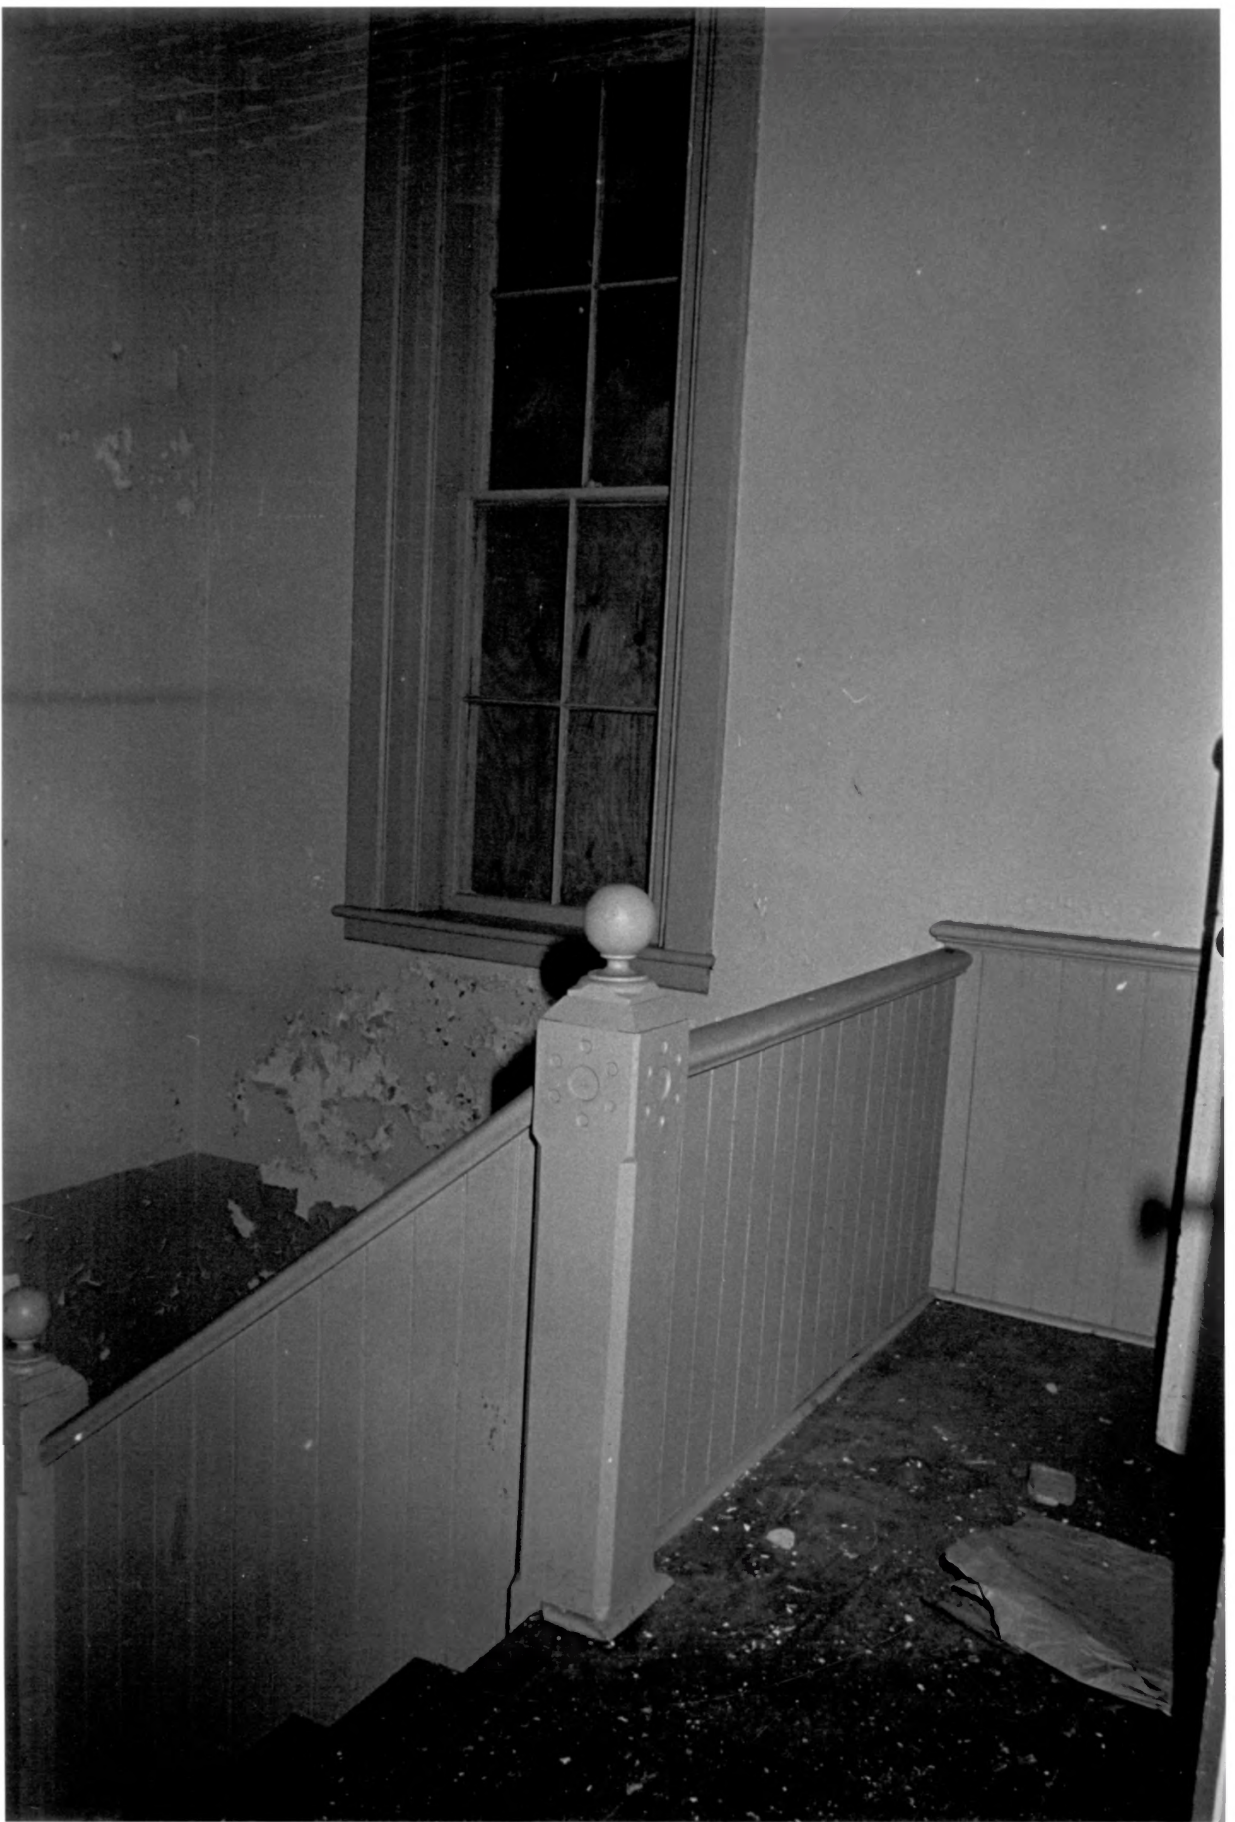
Photo # 12 Date: 12/5/80  
Neg. on file: Conn. Hist Comm.

View: Stairway, turned newel post and screen of matched boards serving SE corner of original 1879 structure. Landing below opens onto bracketed porch.

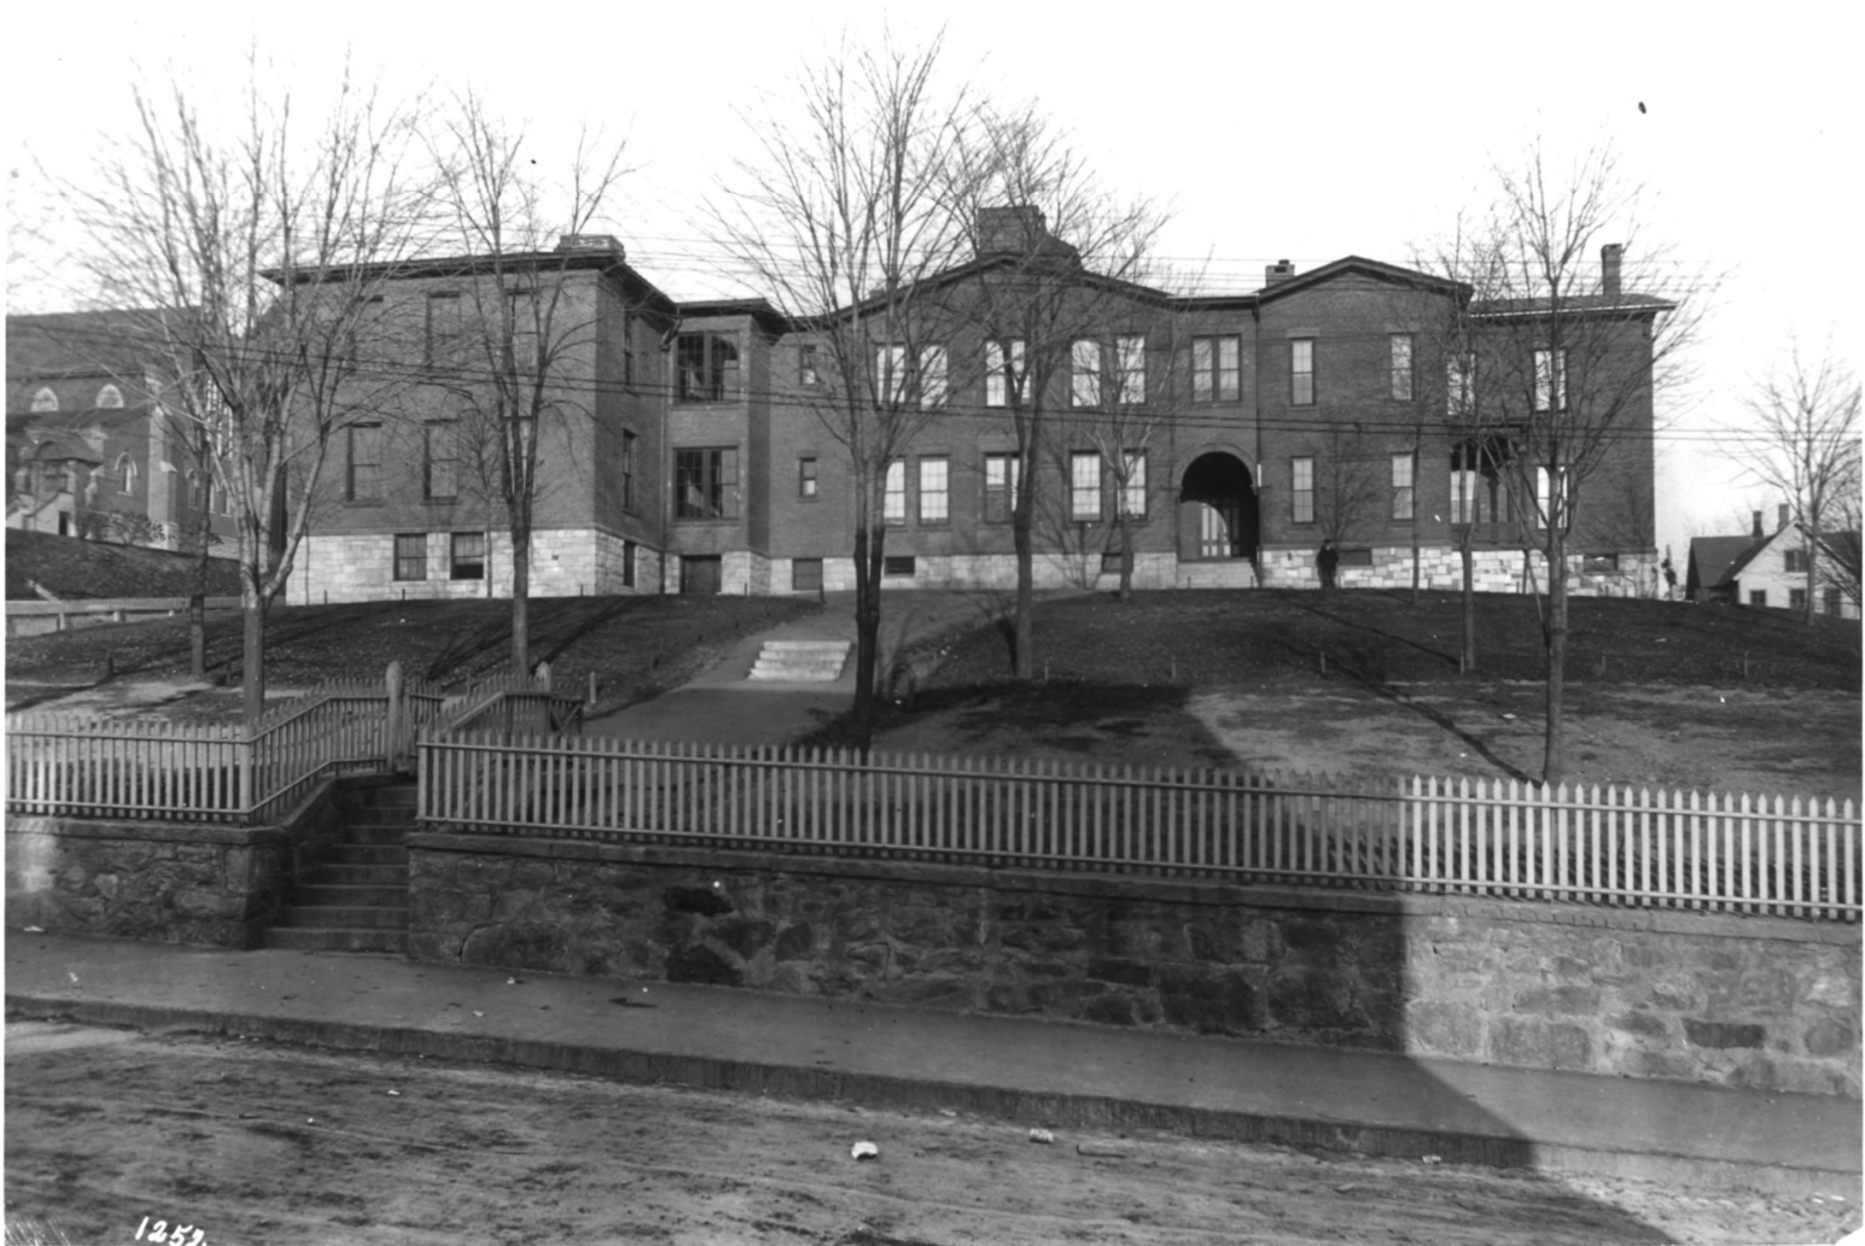
Photo # 13 Date: c.1906-1916

View: W Elevation - looking E. This is an early view (only known historical photo) taken between 1906-1916. St. Thomas Church at extreme left rear.
