DESCRIPTION

BERGEN COUNTY STONE HOUSE SURVEY

HISTORIC NAME: Ackerman-Van Emburgh House
 COMMON NAME: "Maple Homestead"
 LOCATION: 789 East Glen Avenue
 (Block 4804, Lot 13)
 MUNICIPALITY: Ridgewood
 OWNERSHIP: Public Private
 OWNER/ADDRESS: Mr. & Mrs. Nicholas Syrotiuk
 795 East Glen Avenue

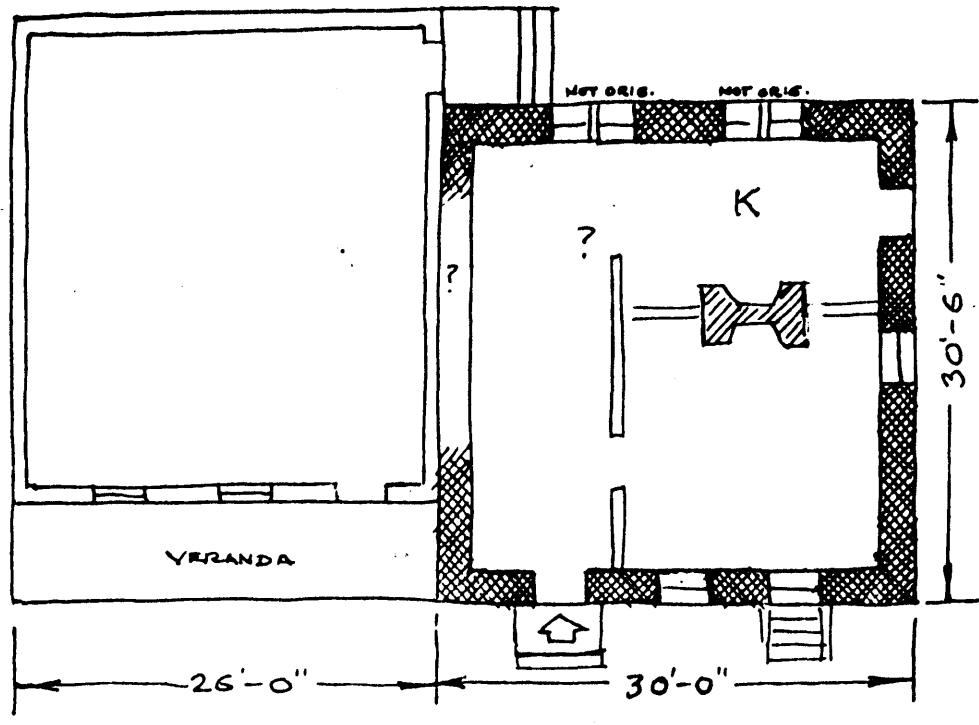
FLOOR PLANS 136

FORM/PLAN TYPE:
Similar to "H", 2 rooms deep, side hall, but interior fireplaces.

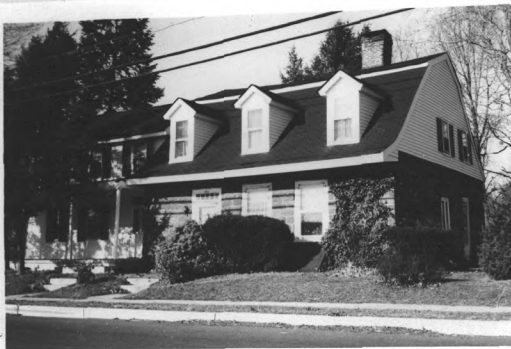
PHOTO

EXTERIOR WALL FABRIC:
Rough cut sandstone on facade, rubble and broken stone on east and rear.

The exterior appears to be early and in good condition. The gable ends are covered with aluminum siding.
