4. National Park Service Certification

5. Classification

The Pittsburgh Mercantile Company department store, now functioning as an apartment building, occupies the southeast corner of S. Twenty-sixth and E. Carson streets in Pittsburgh's South Side neighborhood. The nearly rectangular building is situated in a densely-developed, urban area with a mixture of commercial, residential, and industrial uses. The property consists of one contributing building originally constructed in 1907-1908 and added onto in 1936 and ca. 1950 during the period of significance. The 1907-1908 six-story and mezzanine core of the building measures 108ft wide by 116ft deep, fronting on E. Carson Street. The building is of steel frame construction with concrete floors and roof and exhibits Beaux Arts and Commercial Style stylistic influences. The building is faced in buff colored roman brick and features glazed terra cotta first story wall cladding and classically-inspired trim work on the cornice and window and storefront surrounds. The decorative iron or steel storefront and mezzanine window frames on the building's principal elevation are intact and also feature classically-inspired ornamental motifs.

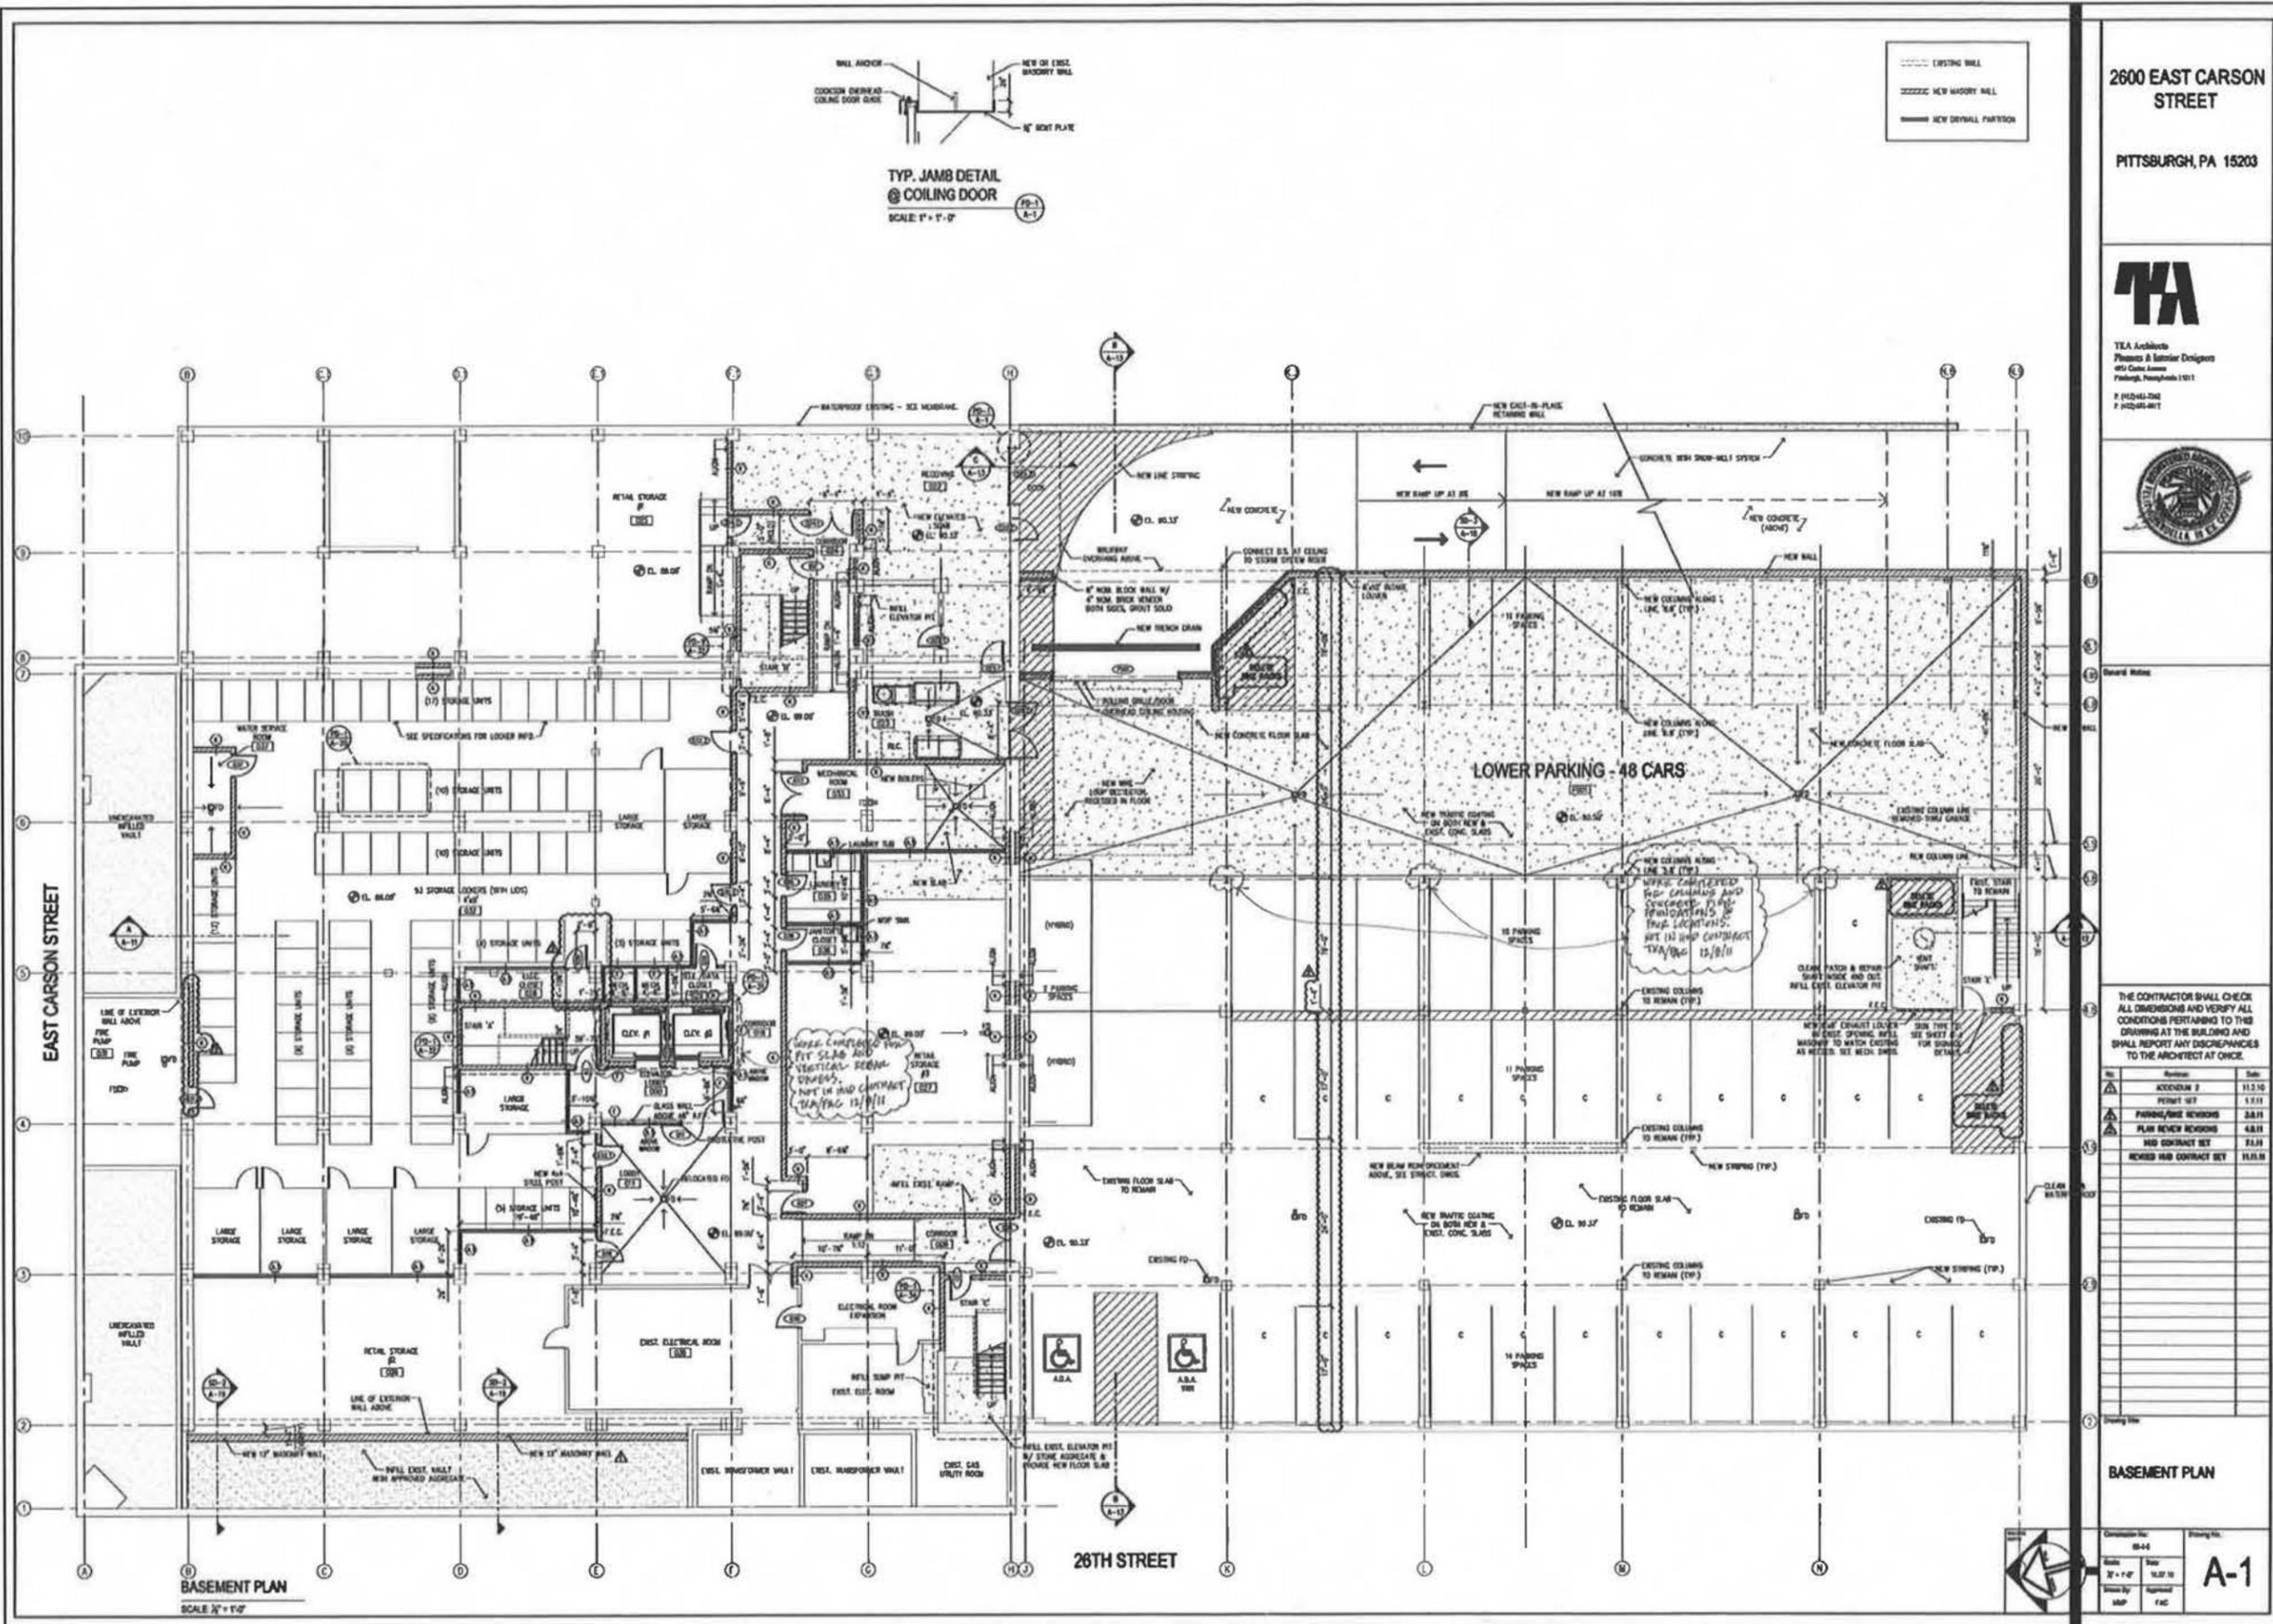
Scale:	1/4" = 1'-0"	Sheet No.:	A-1
Drawn By:	MAP	Approved:	TAC

BASEMENT PLAN

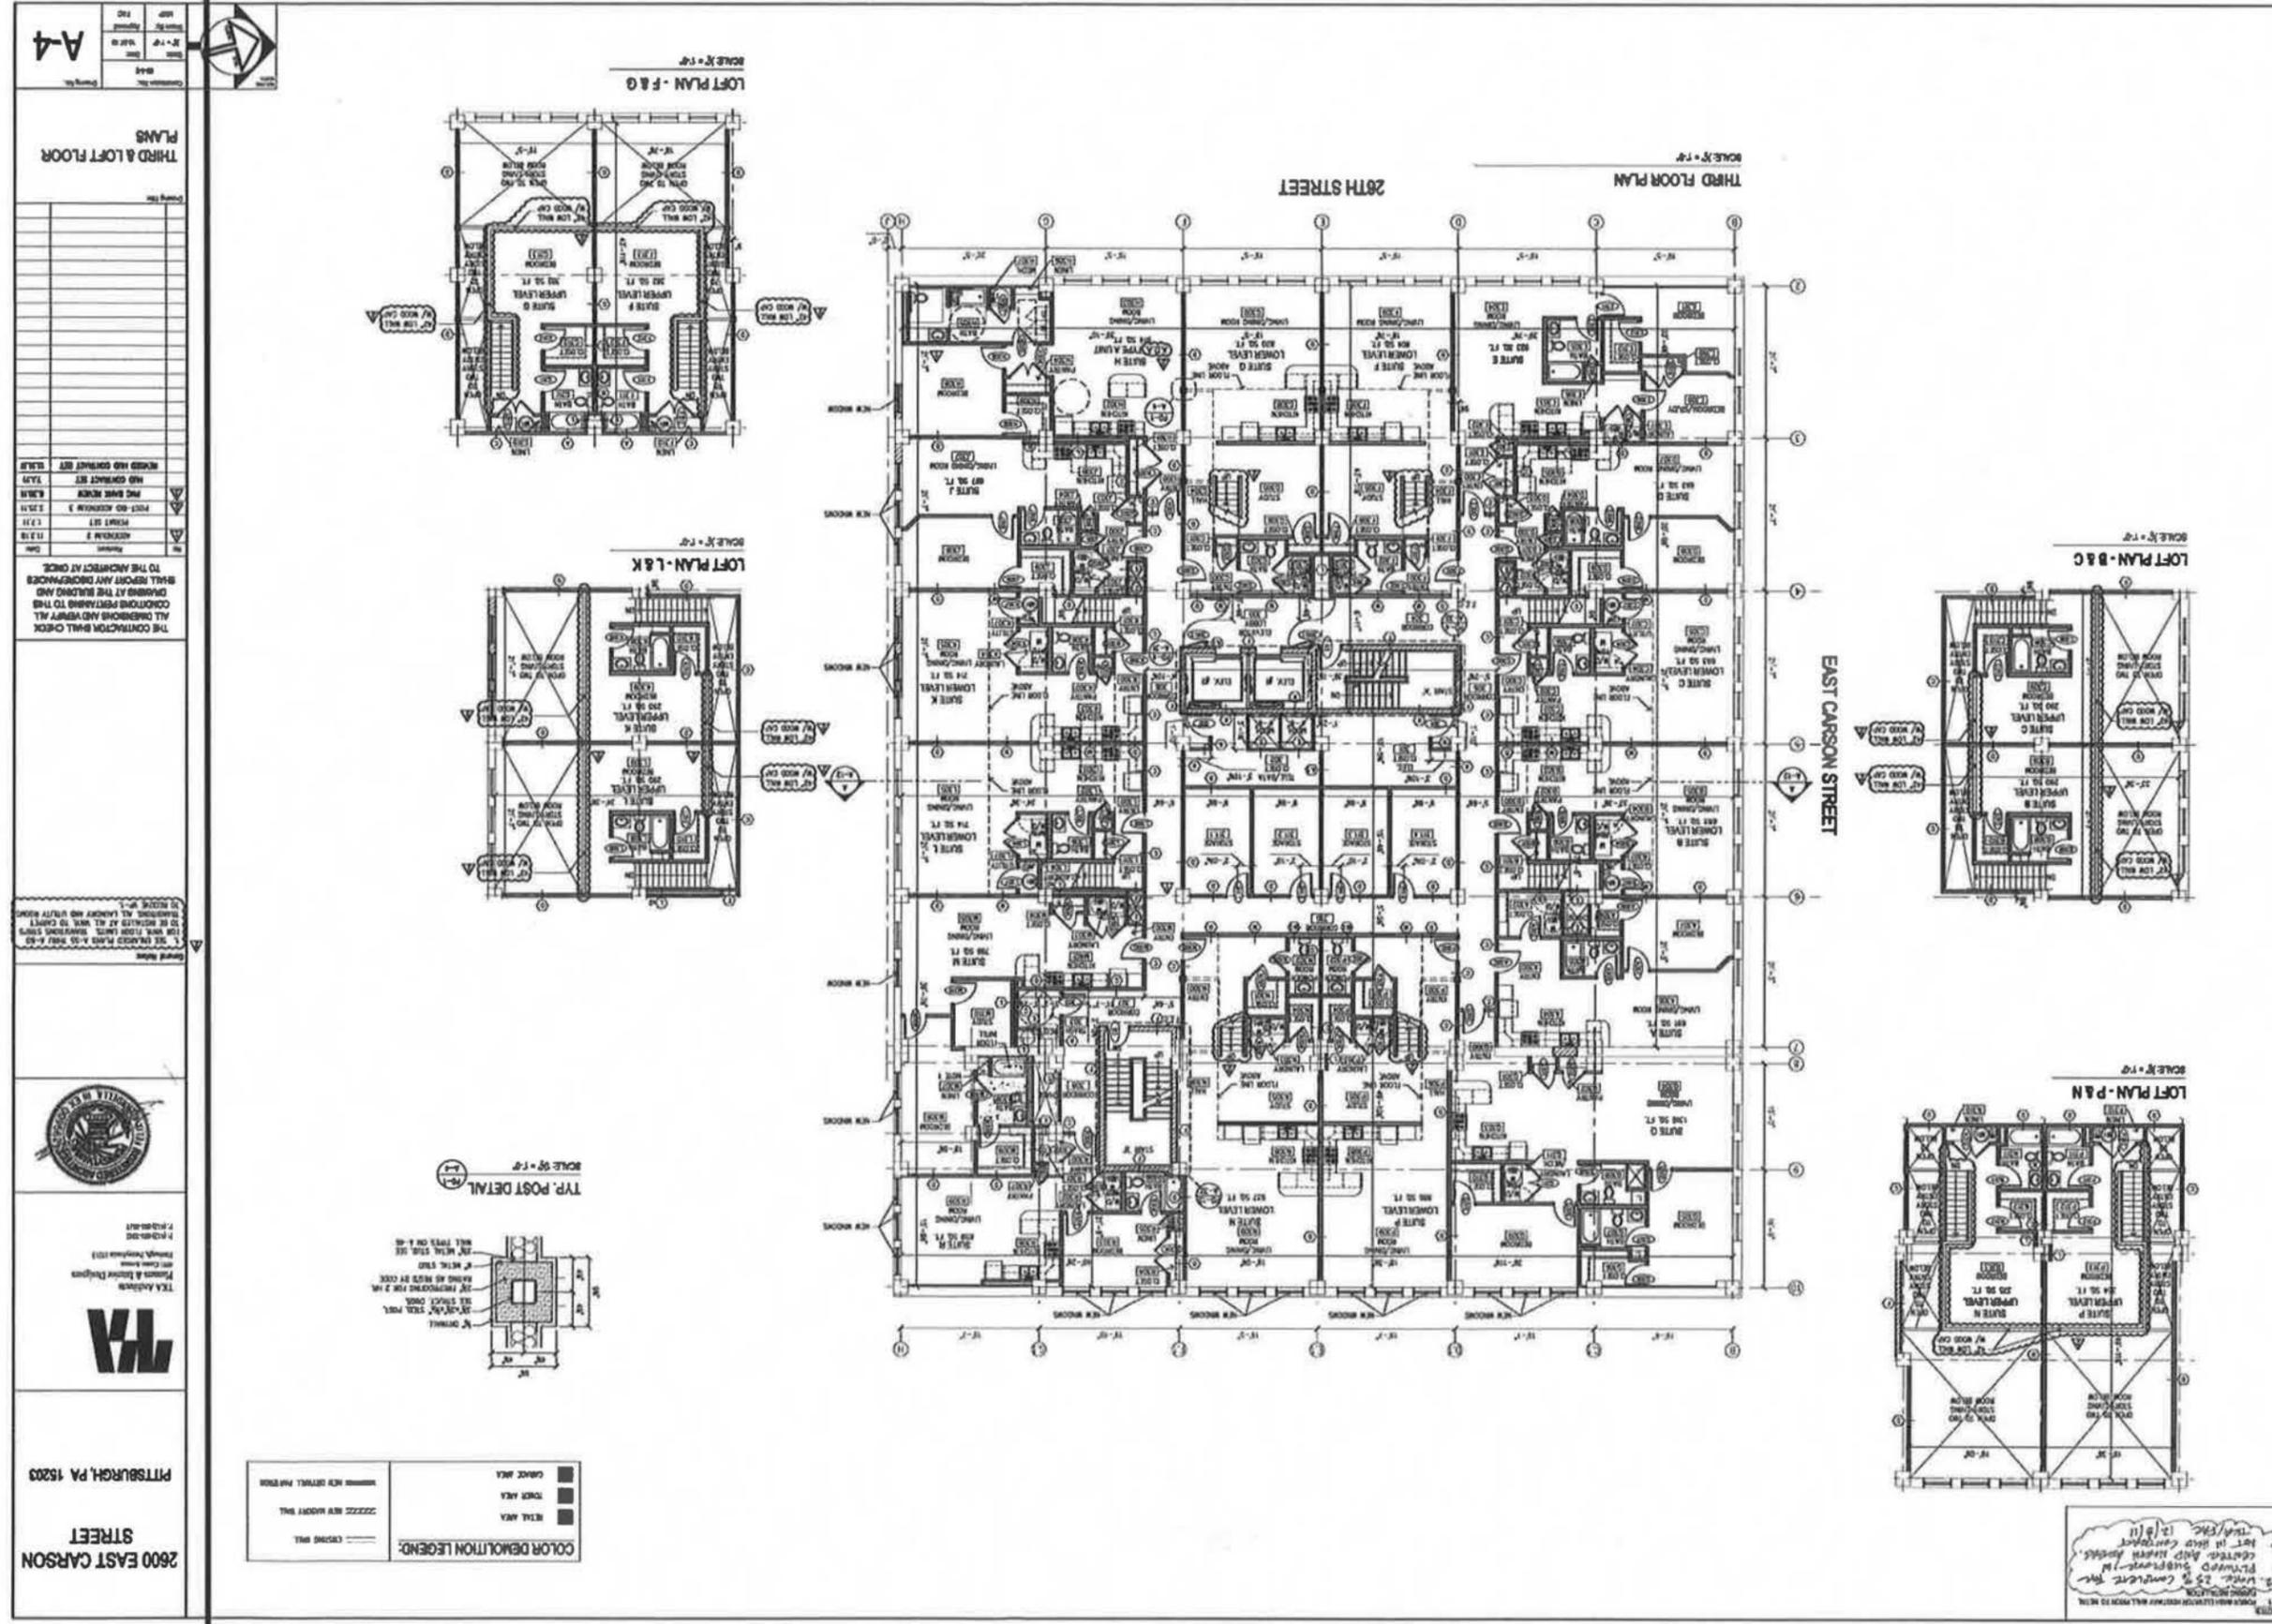
THIRD & LOFT FLOOR PLANS

THIRD FLOOR PLAN SCALE: 1/8" = 1'-0"

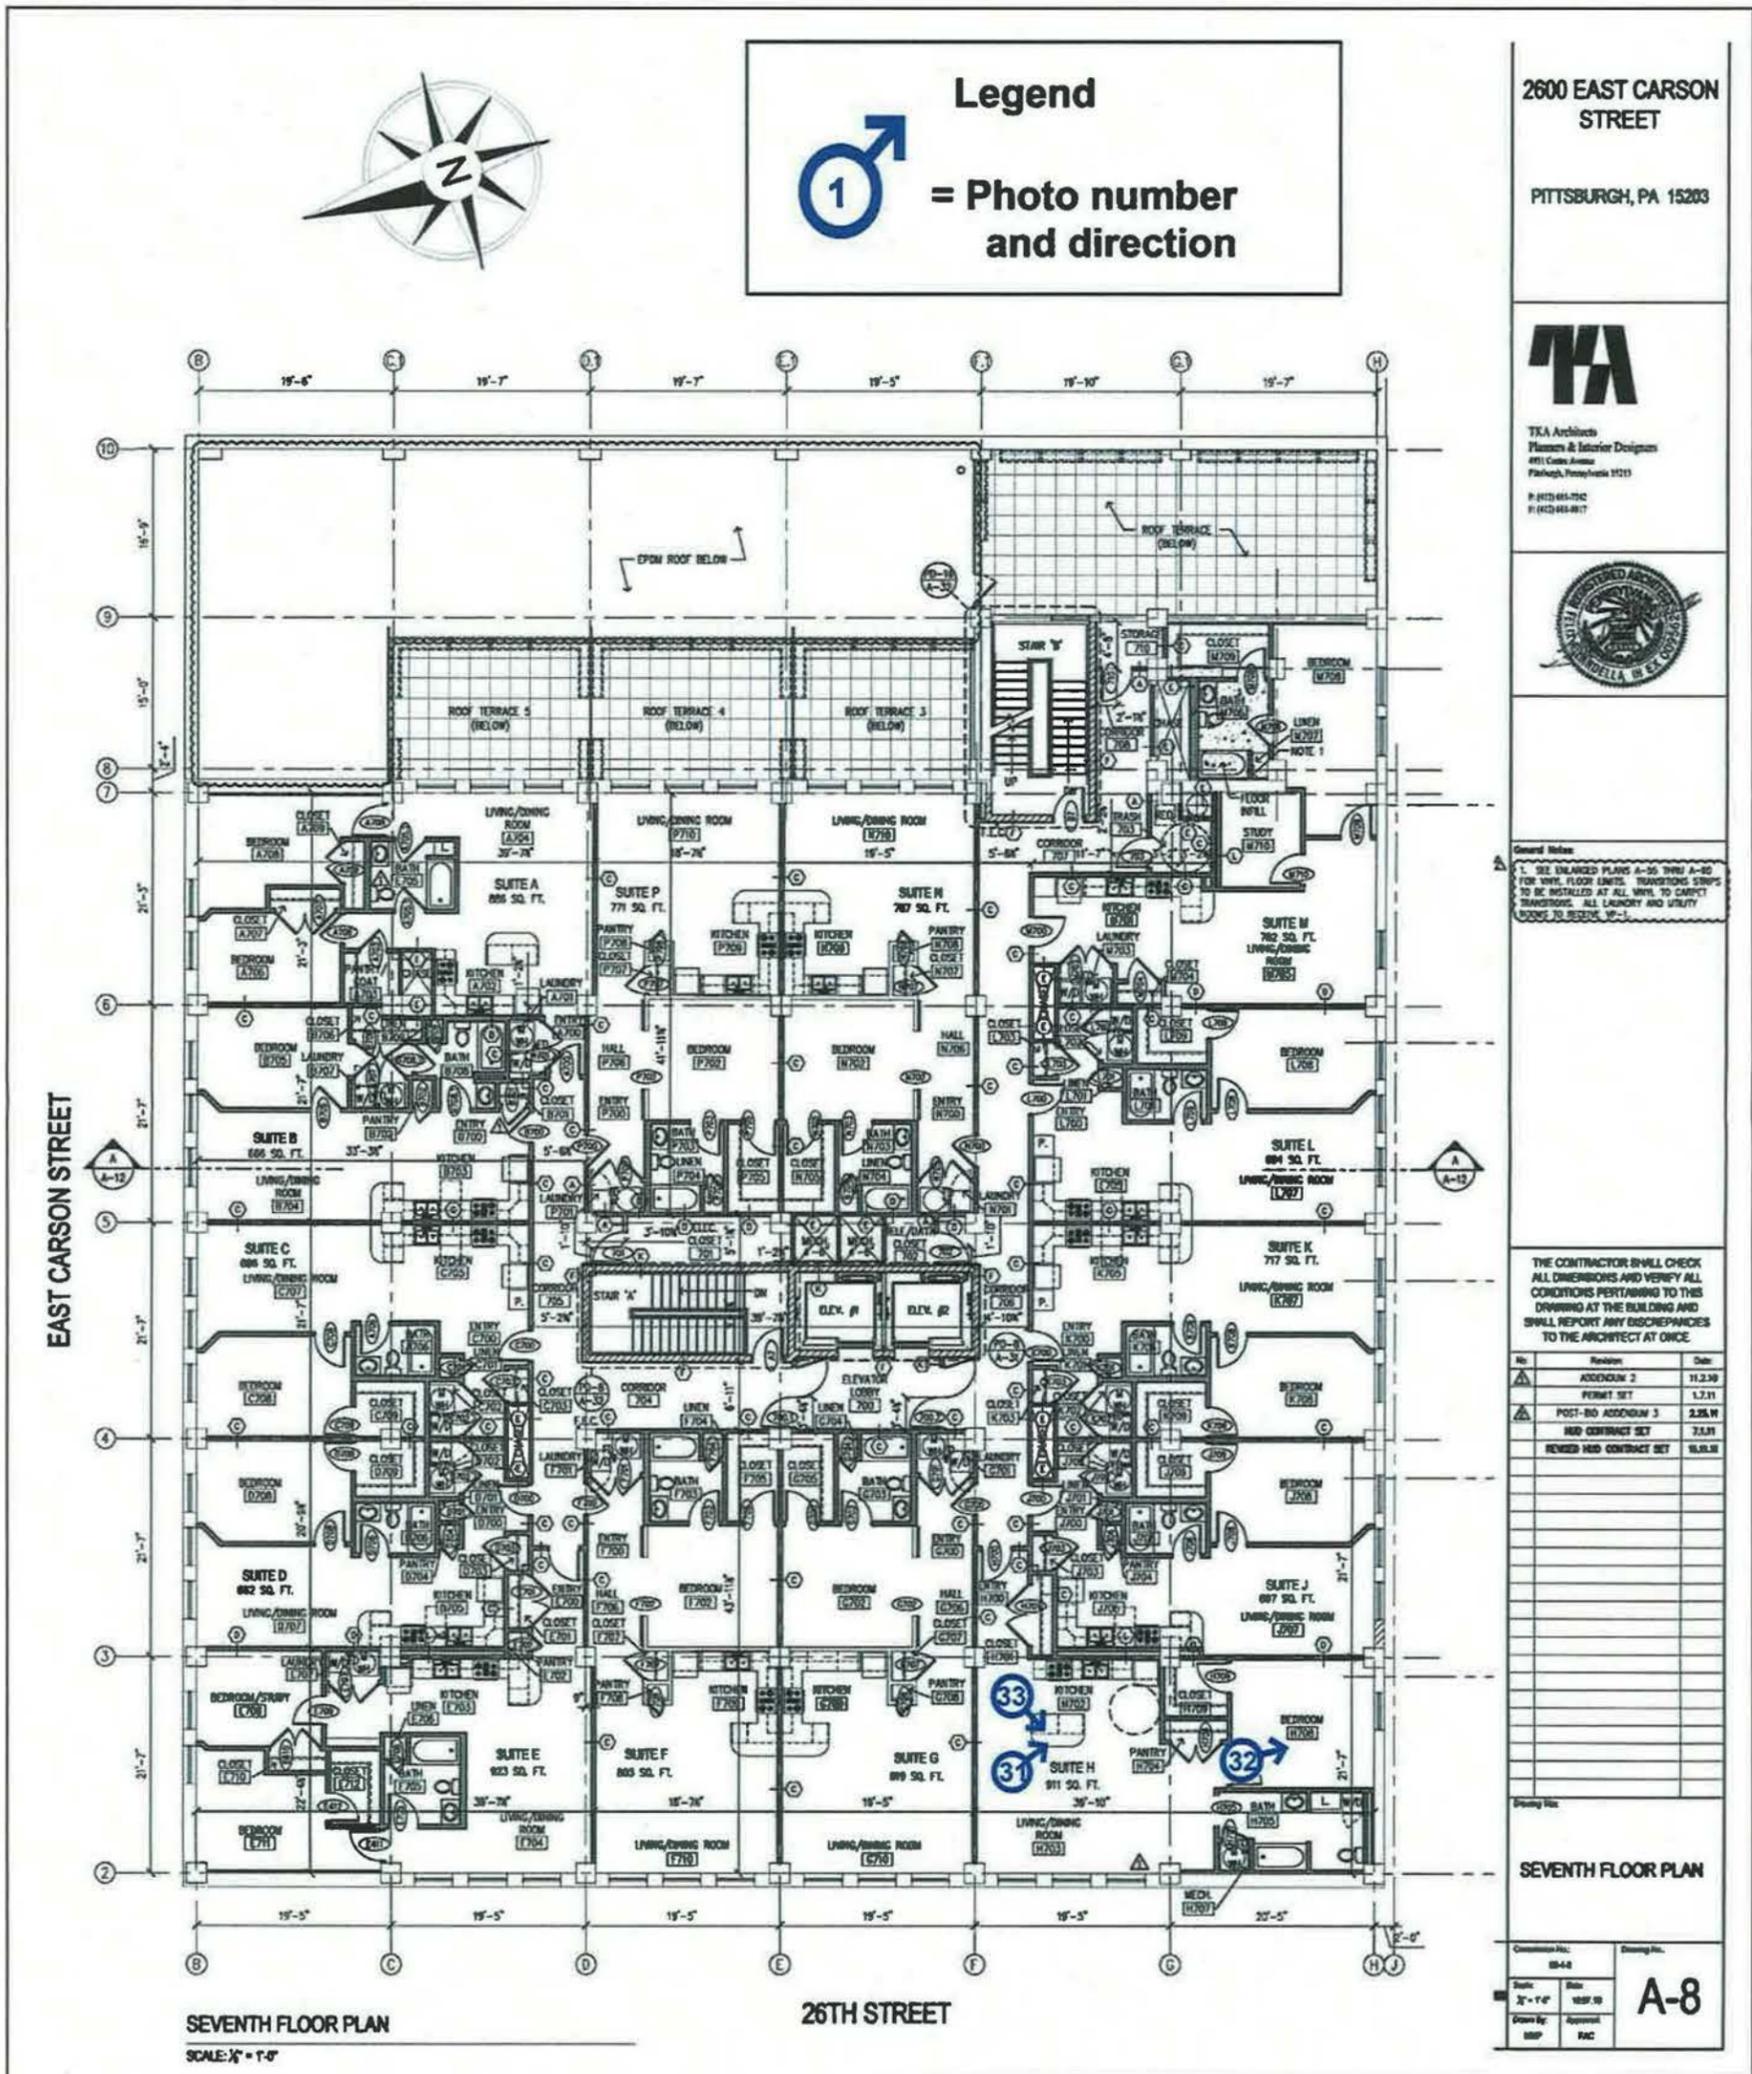
Commission No. 104-4	Drawing No. A-8
Scale 1/8" = 1'-0"	Date 10/19/10
Drawn By WSP	Approved PAC

SEVENTH FLOOR PLAN

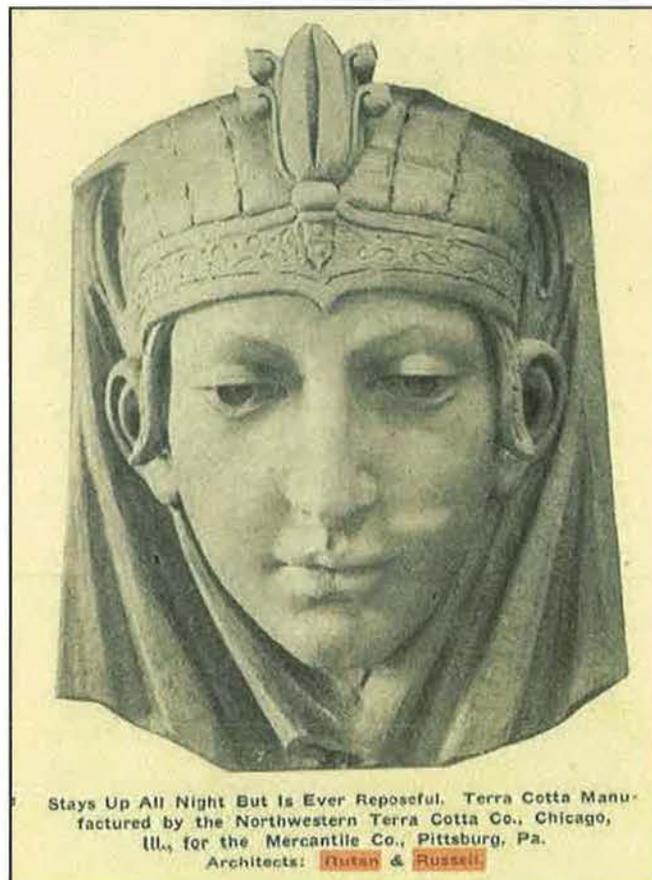
Figure 2: Detail of Egyptian terra cotta cornice ornament, from the January 1, 1908 issue of *Brick*.

The upper four floors (second through fifth floors) of the façade have a five-bay fenestration pattern with window groupings of 2-3-3-3-2 (Photo 13). End bays have paired window openings that feature a plain terra cotta sill and terra cotta lintel with a flat arch configuration and decorative floral keystone. The central three bays feature windows in triple groupings with plain terra cotta sills and no visible lintels. Sashes on all upper-story windows are black aluminum with one-over-one-light double glazing. Upper-story window frames are also black aluminum with molding profiles that are similar to that of the original wood frames. The top story (sixth floor) of the building is framed by projecting courses of brick and terra cotta, which include terra cotta window surrounds and terra cotta columns between window pairs, marble panels between window groupings, brick corbels and dentils, ornamental classically-themed terra cotta cornice moldings that include both floral motifs and the visages of male Egyptian figures (except at corners, where classical female heads are used) (Photos 16 and 23; Figure 2).
