Property Name: Conchas Dam Historic District

1. NAME OF PROPERTY: CONCHAS DAM HISTORIC DISTRICT

Conchas Dam Historic District
Conchas Dam, San Miguel County, New Mexico

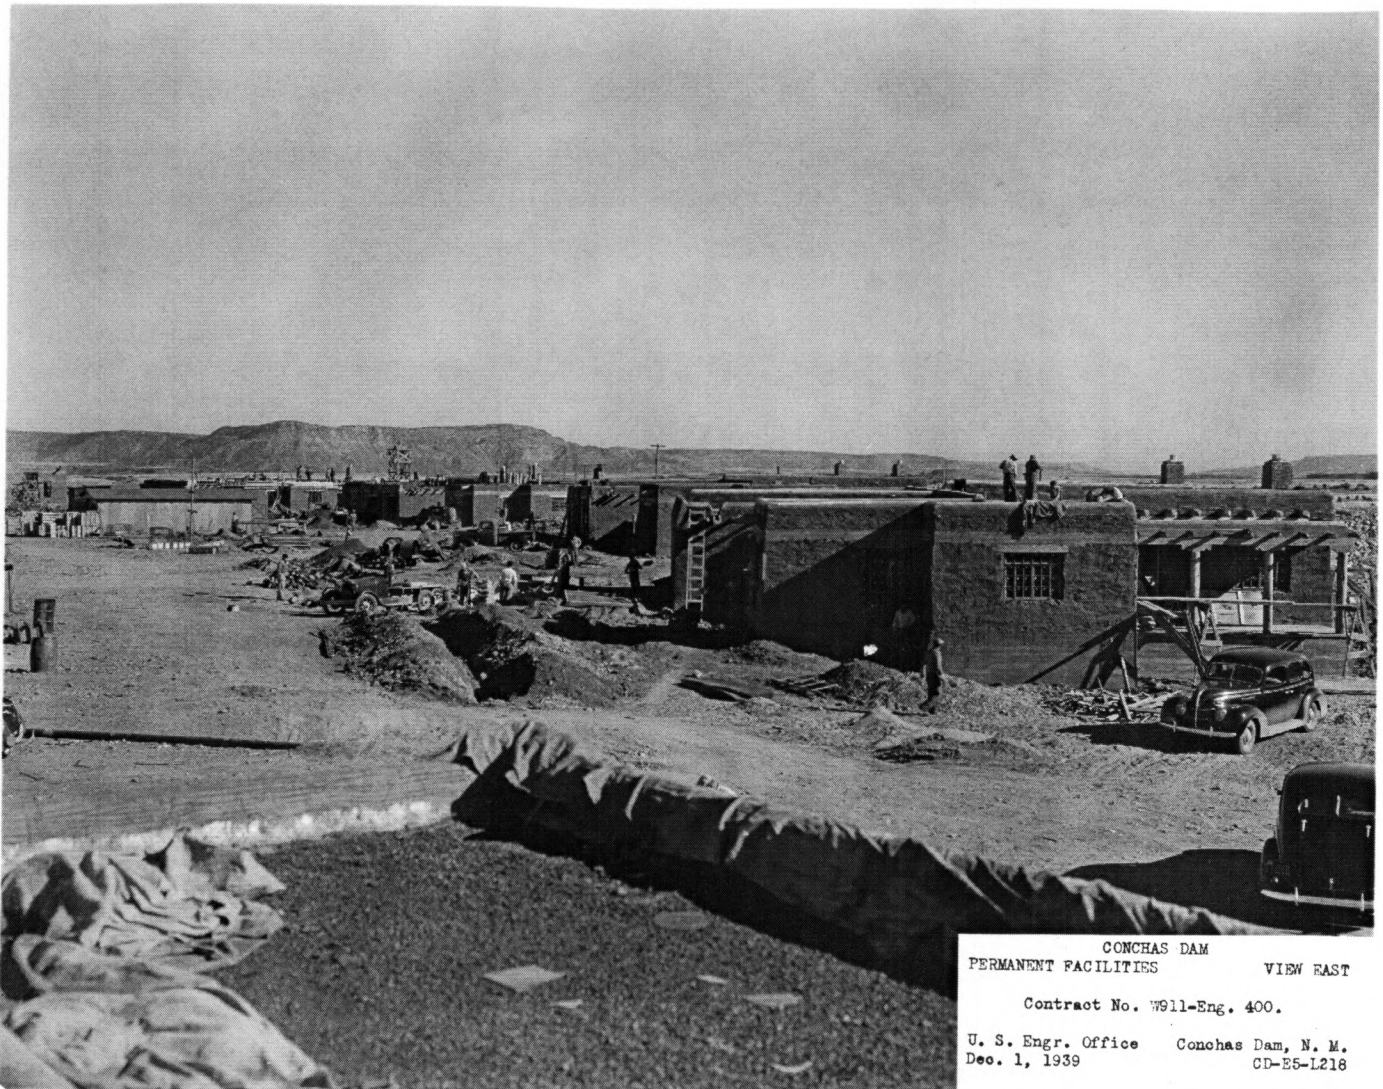
Figure 8-2 Building of Permanent Housing, December 1, 1939

CONCHAS DAM
PERMANENT FACILITIES VIEW EAST
Contract No. W911-Eng. 400.
U. S. Engr. Office Conchas Dam, N. M.
Dec. 1, 1939 CD-E5-L218

The first employment peak occurred during the creation of the construction town, Conchas City, in the summer of 1936 (see Figure 8-2). This major undertaking relied almost exclusively on relief laborers from New Mexico and the Texas Panhandle. Construction of the town began in the winter of 1935, and by the time it was completed in the summer of 1936, over 2,500 relief workers had been involved at a cost of 1.5 million dollars. Over 745,000 adobe bricks were manufactured for use in the buildings of the construction town. In order to

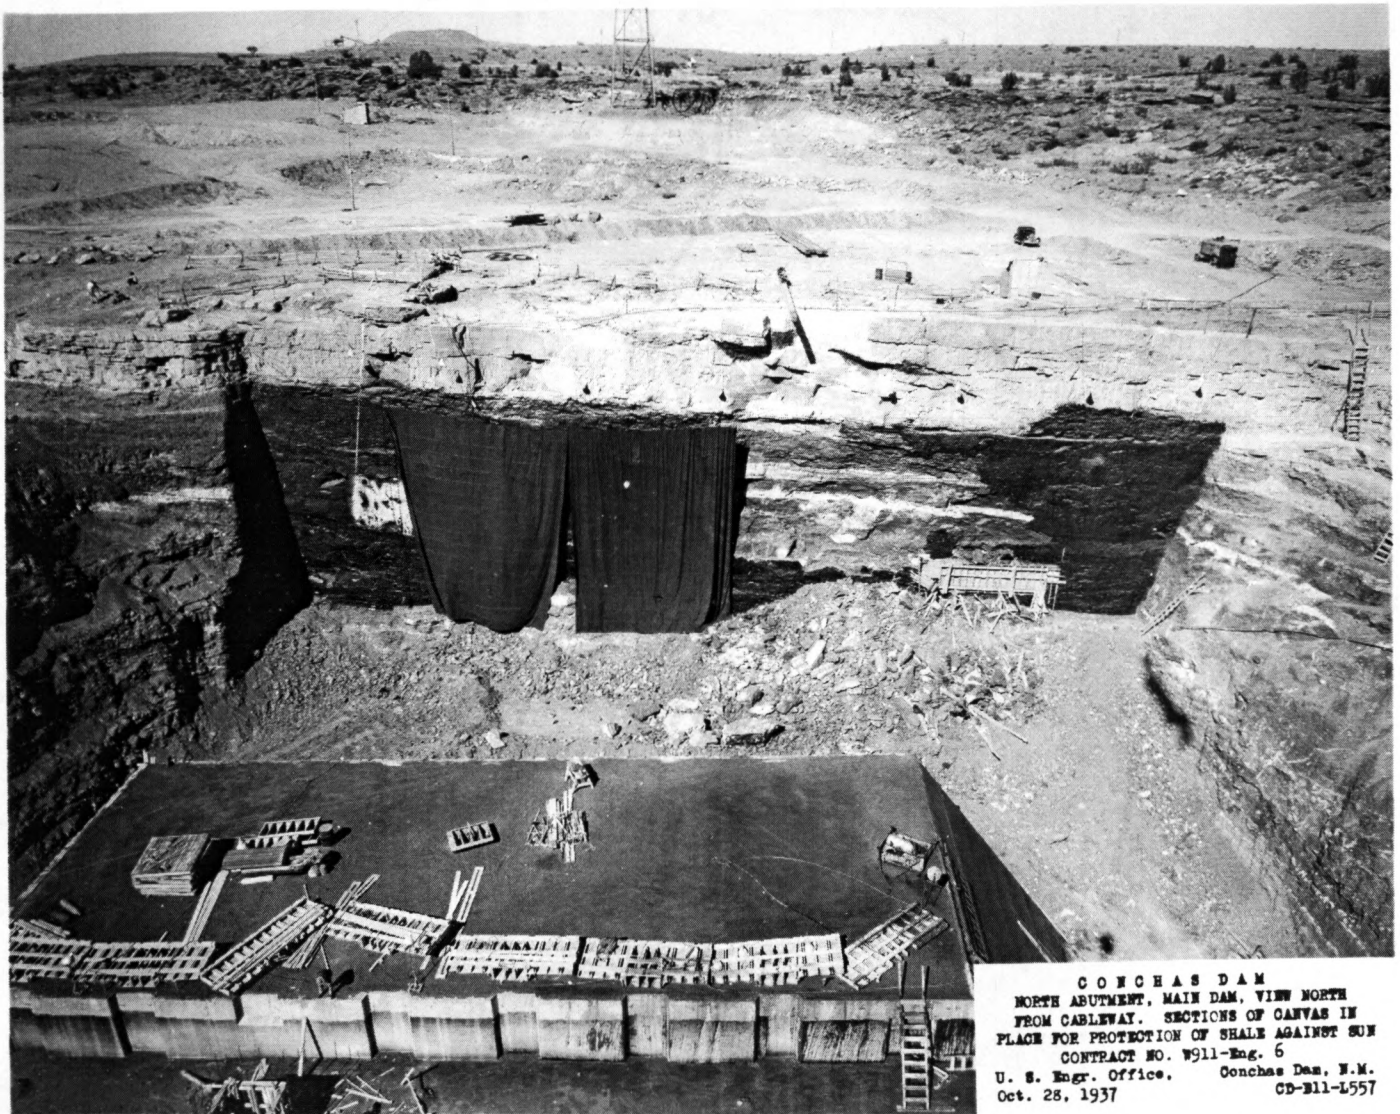
Figure 8-3 North Abutment Construction, October 25, 1937

The excavation at the north abutment was proceeding as per design until a vertical face approximately 55 feet high had been established. (The north abutment had a 20-foot cap of Canyon Sandstone underlain by about 70 feet of Red Shale). As soon as it was exposed, the Red Shale layer began to dry out and spall off, continuing until nearly the entire vertical face had caved off. As the overlying soil and loose materials were being cleared from the top of the cap rock, large and extensive cracks were observed. Excavation was temporarily halted in the immediate vicinity and numerous meetings were held to contemplate procedures to halt the drying and spalling material. The first attempt was to spray a bituminous sealant over the shale face. Initially, it appeared to work, but within hours, the black bituminous material absorbed even more sunlight and became hotter than the untreated shale face. Huge curtains were then hung in an attempt to shade the face, however, between the wind and the insufficient shade, it was clear that this would not be a viable solution (see Figure 8-3).

Following additional meetings, it was decided to move the abutment face 100 feet farther to the north and to then excavate six individual shafts several hundred feet down to the solid rock foundation. The excavation of the six shafts and concrete placement in each occurred sequentially until the six sections formed a single concrete monolith 50 feet wide and 180 feet long. As the excavation proceeded downward in each shaft, timber bracing was employed. A system of keys and grout outlets were included, and a sealant between the concrete and shale face was placed as the concrete was poured. Once this monolith was completed, excavation for the adjoining monoliths began. Excavation at the south abutment posed similar difficulties, and was overcome by similar methods.
