KENTUCKY HISTORIC RESOURCES
Individual Inventory Form

Resource # GpG-15
Greenup County

1. Name of Resource: Colonel Worthington House

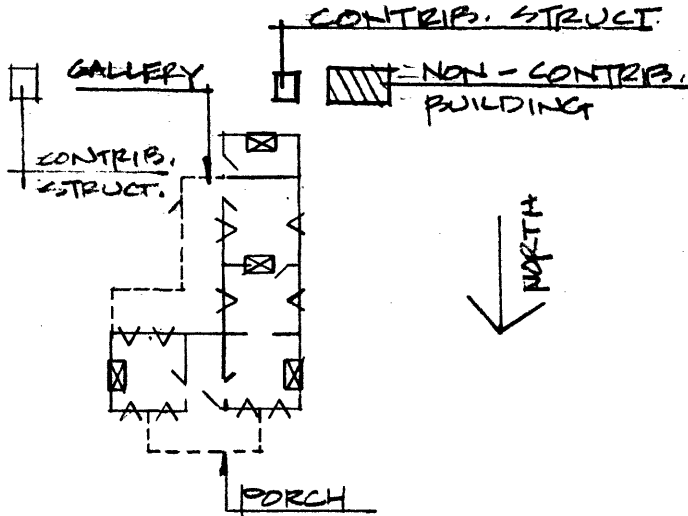
44. Site Plan (and boundary description and justification for N.R. sites):

Beginning at a point which is also the NE corner of the lot of the Worthington House then south along the east property line 450 feet to the SE corner of the lot; then west 400 feet along the south property line to the SW corner of the lot; then north 450 feet along the west property line to the NW corner; then east with the north property line 400 feet to the NE corner or the point of beginning.

The boundary contains 1 contributing building, 1 non-contributing building, and two contributing structures and all of the domestic space associated with the Worthington House.
