NATIONAL REGISTER OF HISTORIC PLACES
REGISTRATION FORM

historic name Stedman-Thomas Historic District

other names/site number Indian Town
AHRS Site No. KET-341

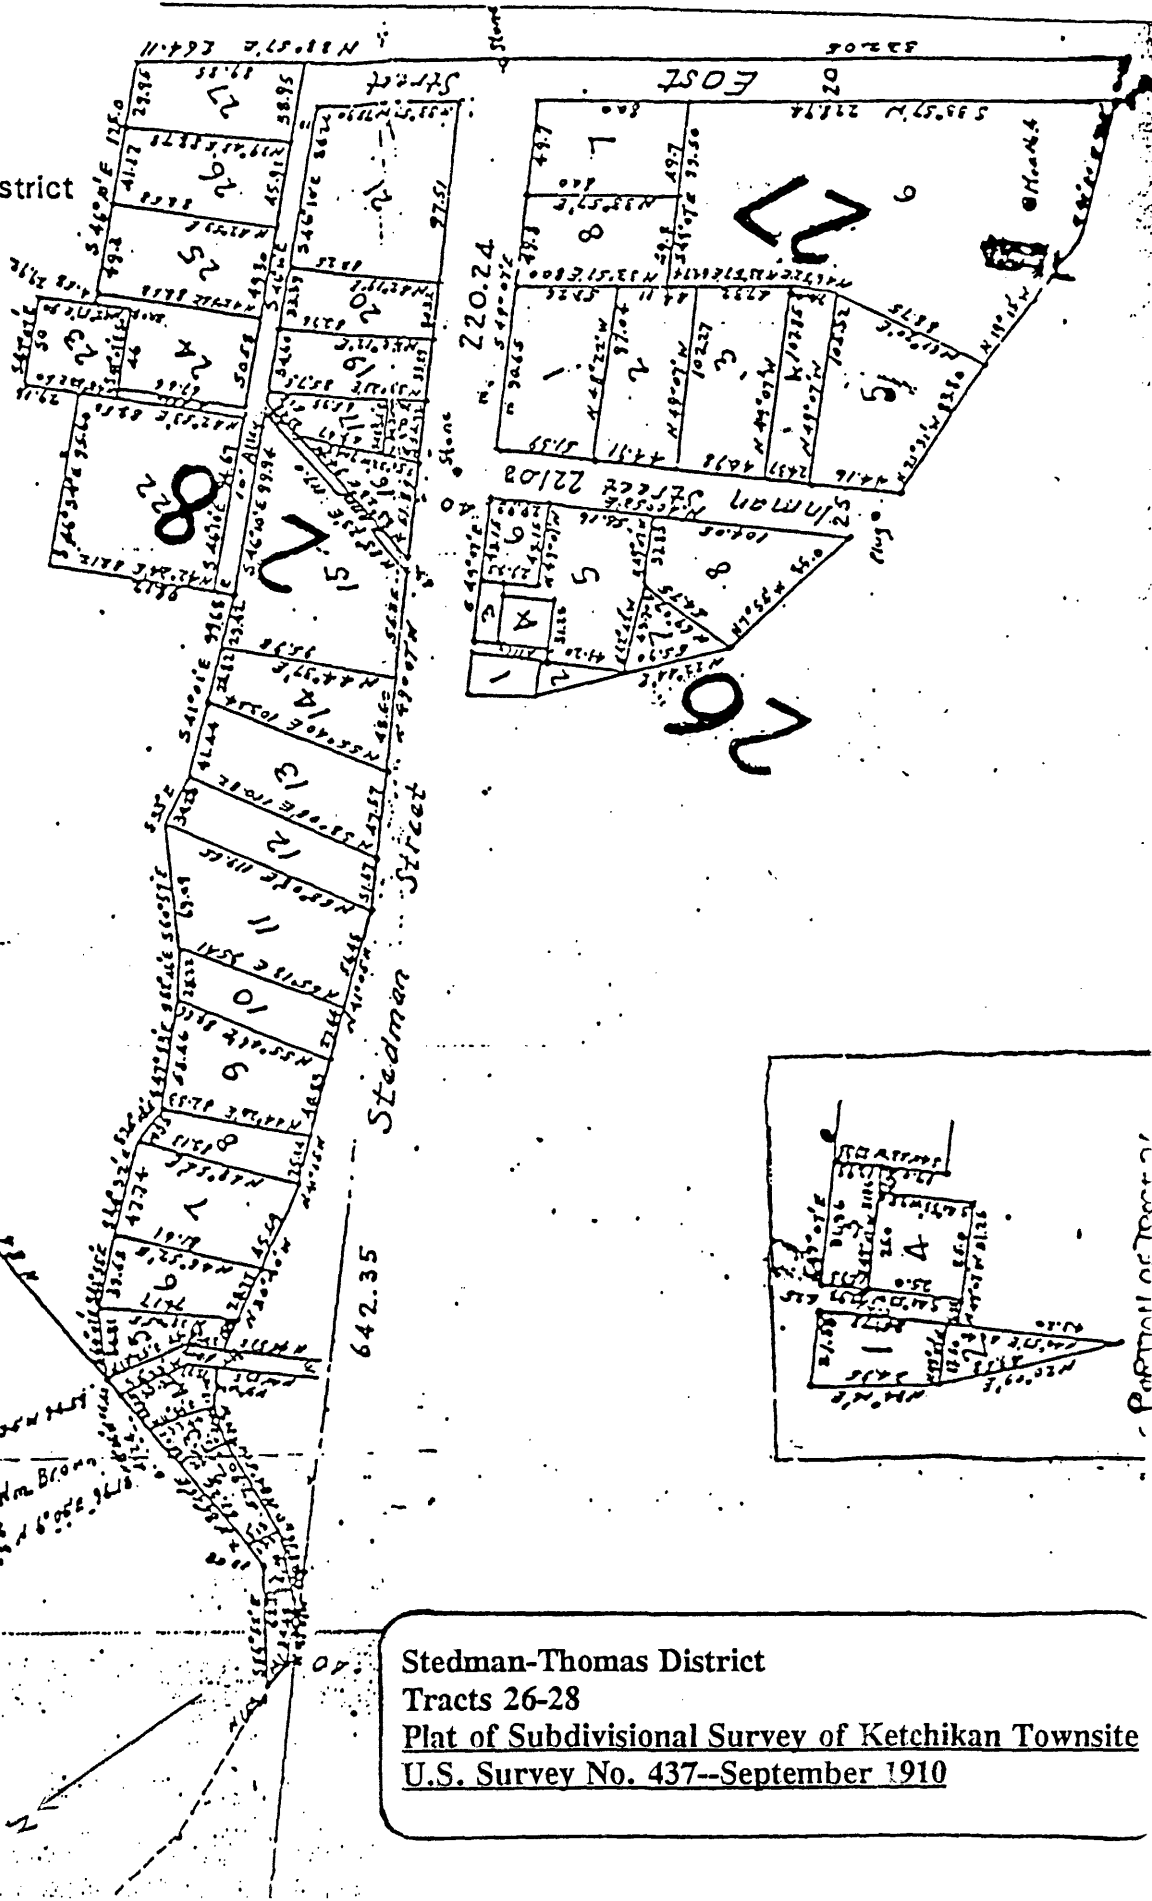
Stedman-Thomas District
Tracts 26-28
Plat of Subdivisional Survey of Ketchikan Townsite
U.S. Survey No. 437--September 1910

The Stedman-Thomas Historic District includes tracts 26-28 of the Ketchikan Townsite Plat (U.S. Survey #437), and a small section of the Venetia Lode Mining Claim (Survey #731), along the northern boundary of the district. Included within the neighborhood are the 200-500 blocks of Stedman Street, the length of Thomas Street, as well as the remnants of three stairway streets known as Inman Street, Brown Way (formerly Bucey Way), and Tatsuda Way. The limits of the district follow geographical and historical boundaries. The district is traversed, from north to south, by Stedman Street which follows the natural shoreline of a small harbor. The northern boundary is delineated by Ketchikan Creek which, historically, separated downtown Ketchikan from "Indian Town," as the district was then known. To the east, a steep mountain slope serves as a natural barrier, while the ocean forms the western boundary. The southern limit of the neighborhood is bounded by Inman Street Hill, a rocky outcropping which juts into the ocean forming the U-shape of the basin. Historically, the city's southern limit also ended just south of this hill. Only during the late 1930s did
