National Register of Historic Places
Registration Form

historic name Second Methodist Church Parsonage
other names/site number Leonard House (preferred) CAR-116

National Register of Historic Places
Continuation SheetSection number 7 Page 1Leonard House
Caroline County, Maryland

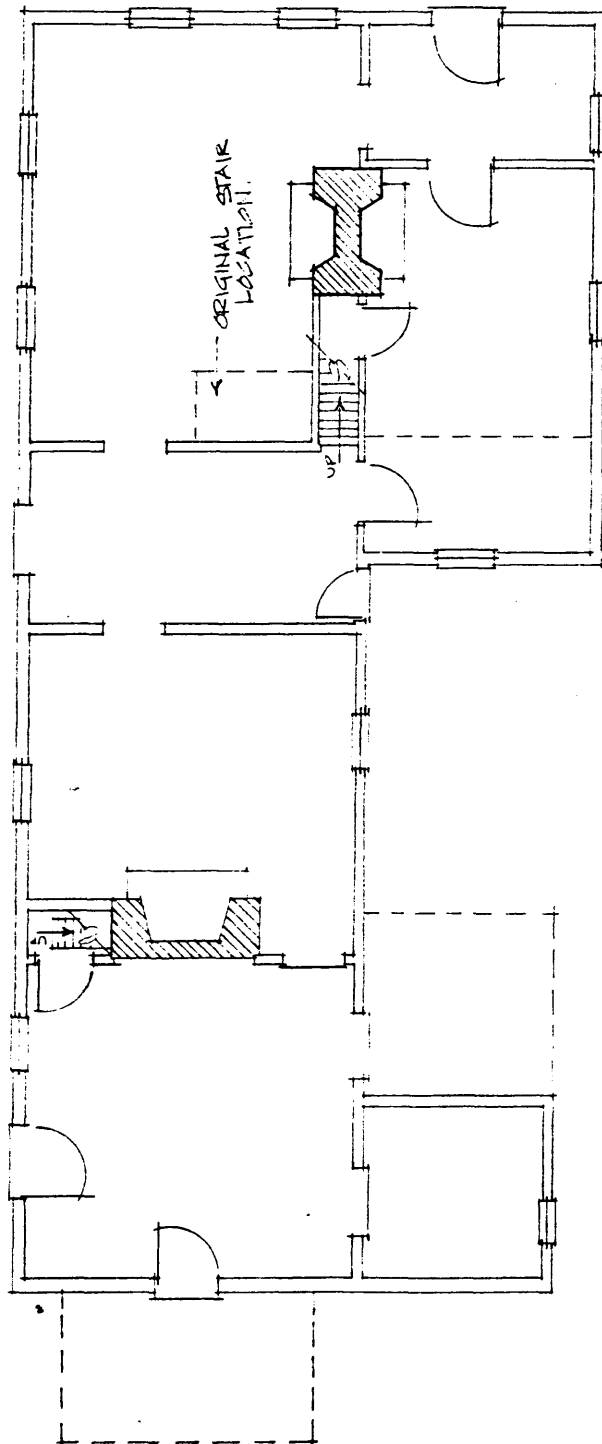
- FIRST FLOOR PLAN

SCALE - 1/8" = 1'-0"

The interior is laid out in a highly unusual center-chimney plan, with a small entrance vestibule in the northwest corner, opening into a long narrow room across the north side and a larger parlor to the south. The central chimney stack provides fireplaces for both the main rooms. The back passage

extends across the rear of the parlor to the north room. A steep narrow stair off the north end of the passage ascends to two chambers in the half-story; this represents a reconfiguration of the original stair, which rose against the east partition wall of the parlor and turned. This plan is unique in Caroline County, and indeed no precise analogues are known elsewhere in Maryland.

The unusual rear passage runs across the east side of the house. This area is finished with plaster, and has a beaded baseboard; interior door openings are framed with a wide half-round surround. A peg rail is set in the plaster on the west wall. Floorboards here are wider than in the other rooms, and irregular in width.

In the mid to late 19th century, the stair was moved from its original location in the northeast corner of the parlor to a steep, narrow single run rising at the north end of the west wall of the rear passage. This reorientation retained the top two steps and landing of the original stair.
